Whitehall Mill Condominium Association, Inc.

Athens, GA • September 27, 2022

FULL RESERVE STUDY

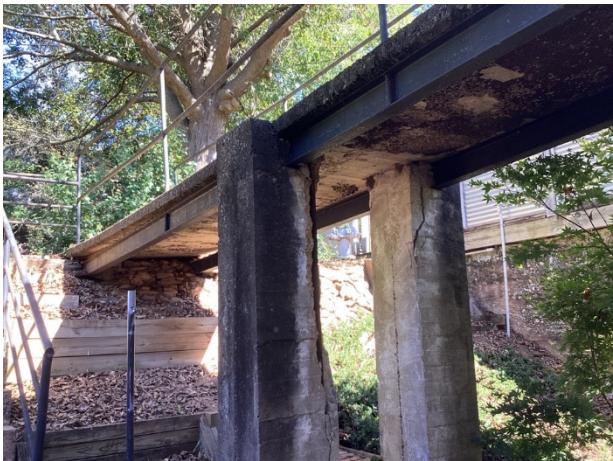
Catwalk at unit 31 (Note exposed concrete reinforcement at column)

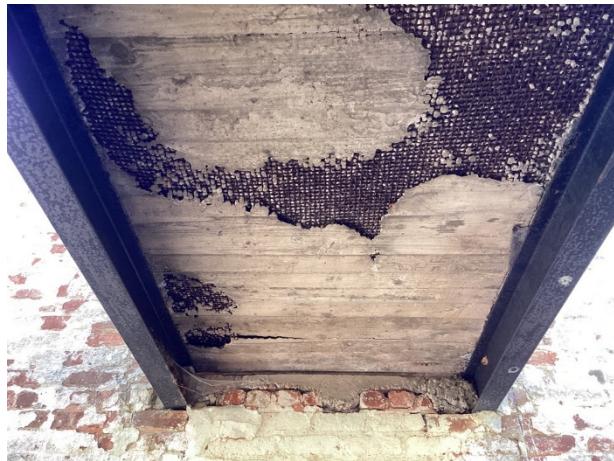
Catwalk unit 31 (Note exposed concrete reinforcement)

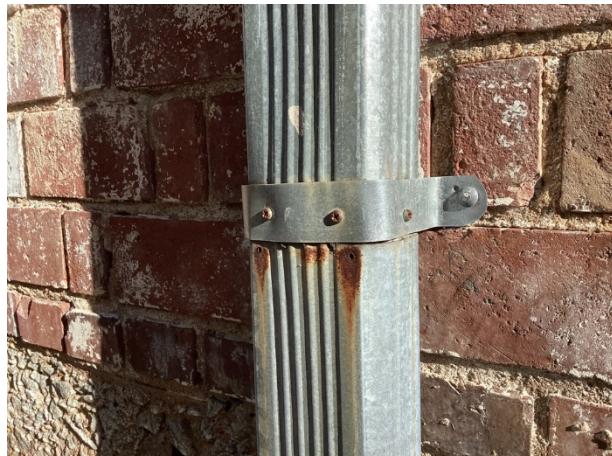
Condition: Good to fair overall with rust evident.

Rust at downspouts

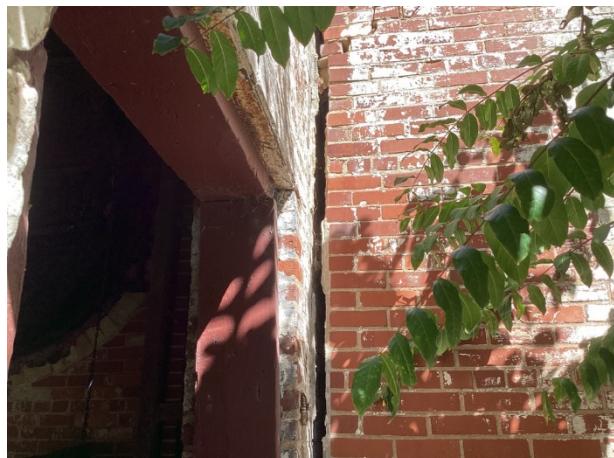
Separation at chimney joint at historic equipment house

Useful Life: We recommend the Association have the historic equipment house and dampers inspected and potentially make repairs or preservation measures every six- to eight-years.

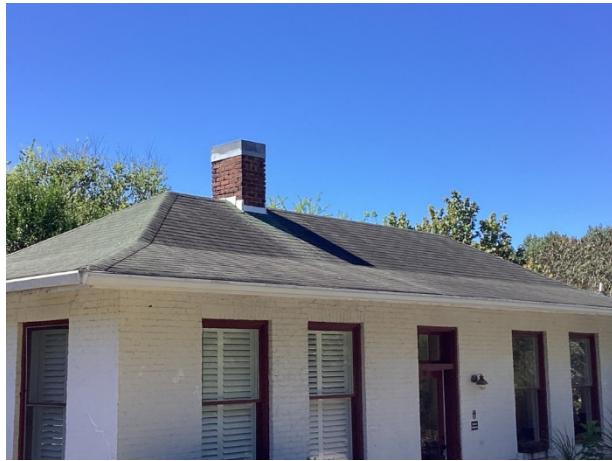
Condition: Fair to poor overall with significantly weathered three-tab shingles evident.

Weathered three-tab shingles at building 3

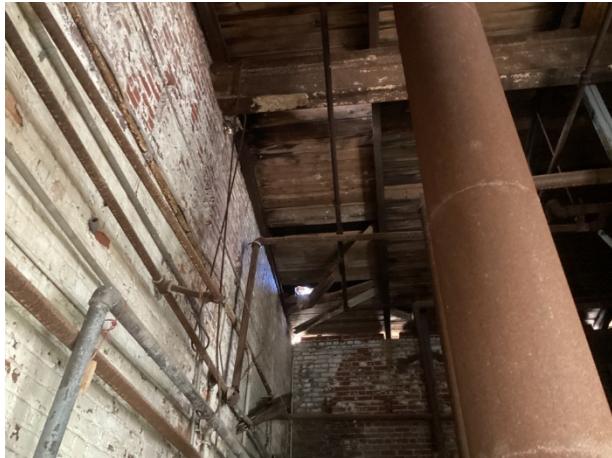
Condition: Poor overall with significant wood deterioration and one area of complete failure of the roofing system.

Significant wood deterioration at underside of roofing system at historic mill equipment

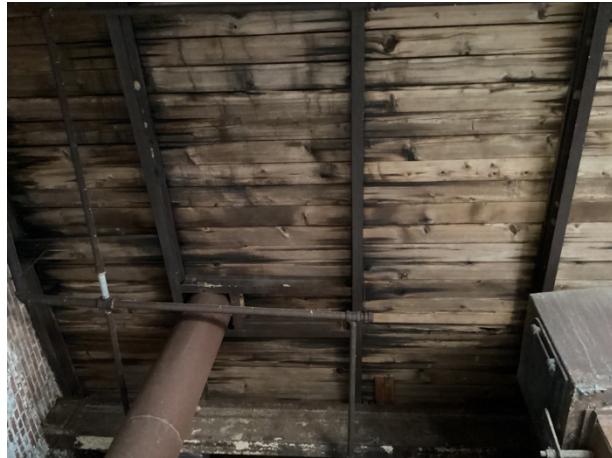
Weathered wood base layer

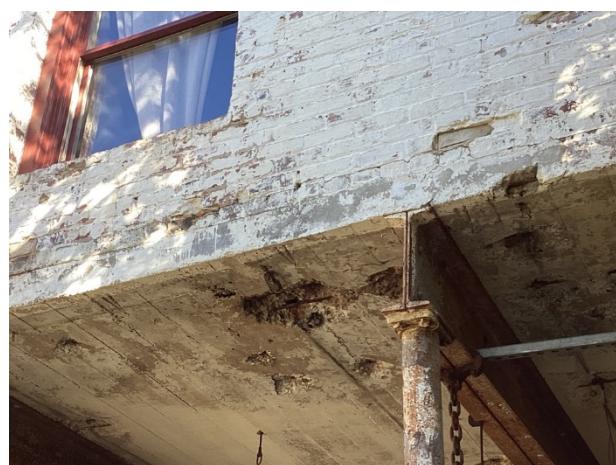
- Common Brick Masonry and Limited Quantities of River Rock and Concrete Construction
- Extensive previous repairs evident
- Excessive lintel rust is evident
- Masonry exhibits systemic cracks, spalls and significant weathering.
- We note significant concrete deterioration with exposed reinforcement evident.

Masonry cracks and concrete deterioration with exposed reinforcement

Useful Life: We advise a complete inspection of the masonry and related masonry repairs 8- to 12-years to forestall deterioration. We note a need for concrete restoration to be likely at up to 35 years.

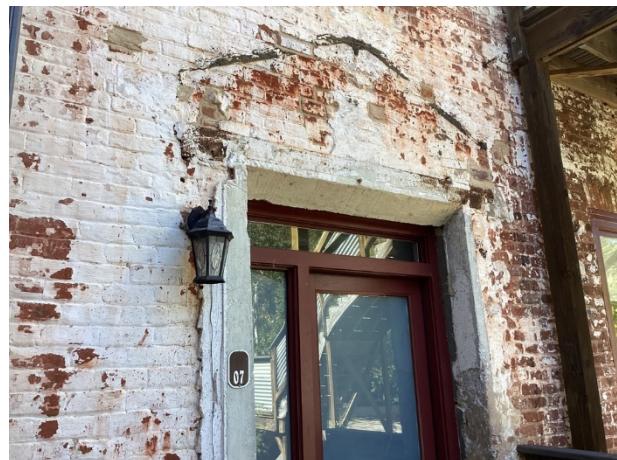
Significant masonry repairs at doorway

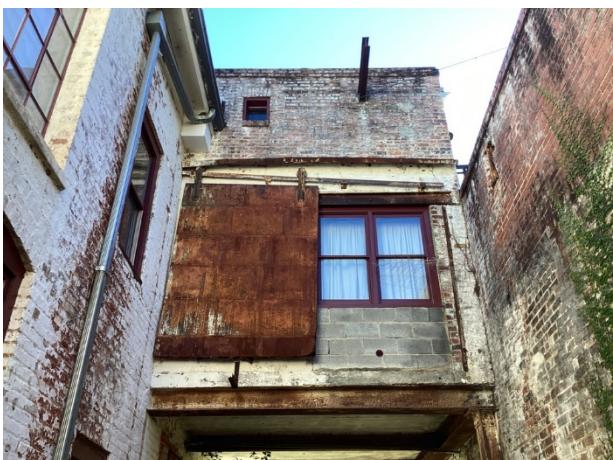
Weathered masonry with partial replacements at unit 5

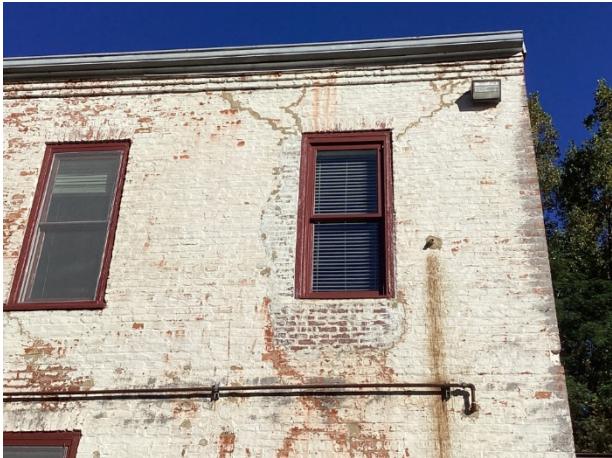
Frequent previous repairs evident

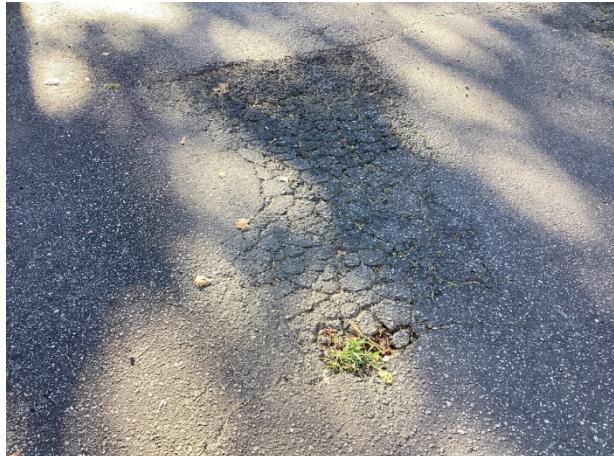
Condition: Fair to poor overall with significant deterioration including pothole formation and alligator cracks.

Pavement deterioration

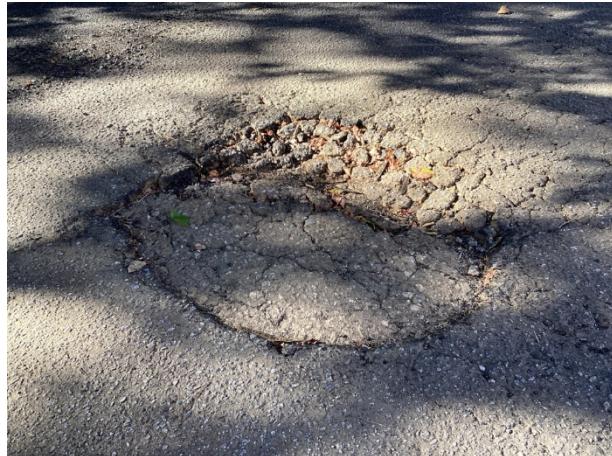
Significant deterioration of asphalt pavement

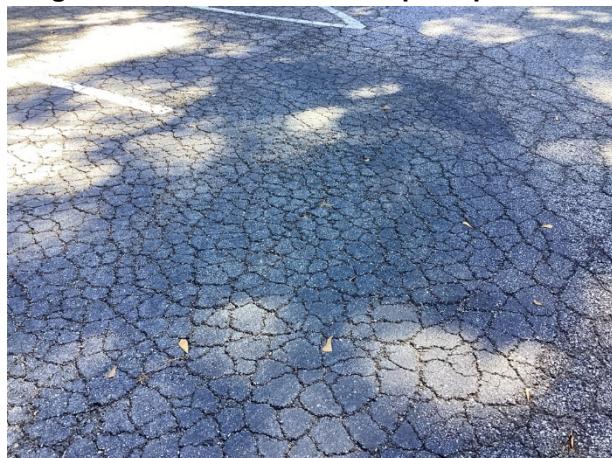
Alligator cracks at upper parking area

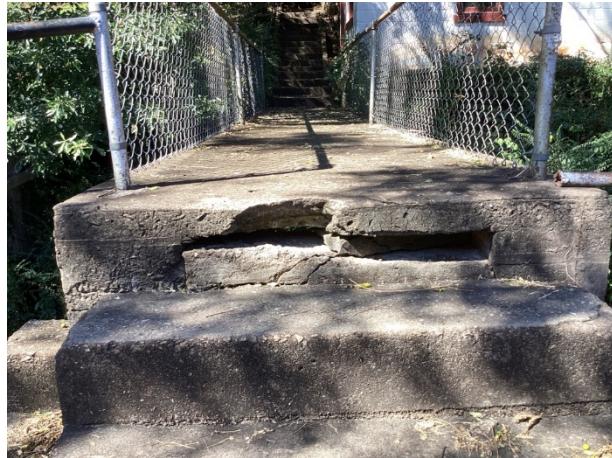
Condition: The sidewalks and stairs vary in condition from fair to poor, we note damage and trip hazards evident. We note significant deterioration at the pedestrian bridge. We recommend the Association to contract a structural engineer to opine on whether or not the pedestrian bridge should be remediated or restored, as opposed to completely replaced.

Deterioration at concrete stairs at pedestrian bridge

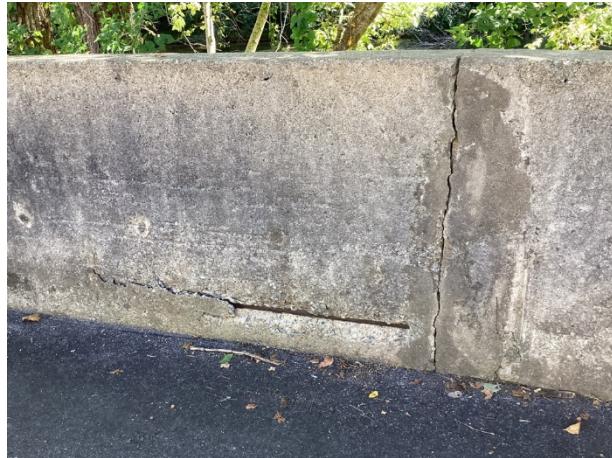
Condition: Fair overall with frequent stains, cracks and isolated exposed concrete reinforcement evident

Cracks and exposed concrete reinforcement

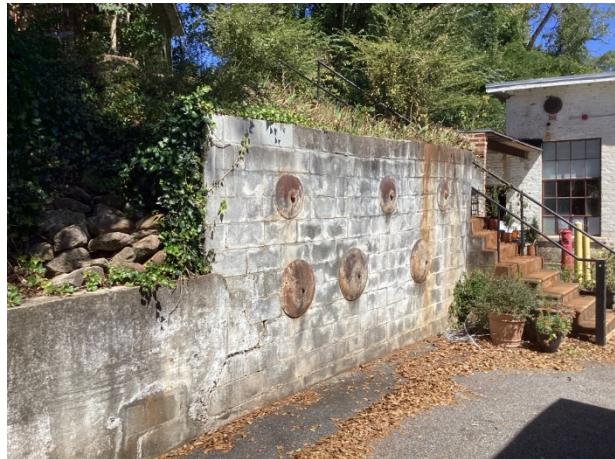
Condition: Varying from fair to poor overall condition. We note stabilization at the retaining wall near building 4.

Stabilized retaining wall with repairs

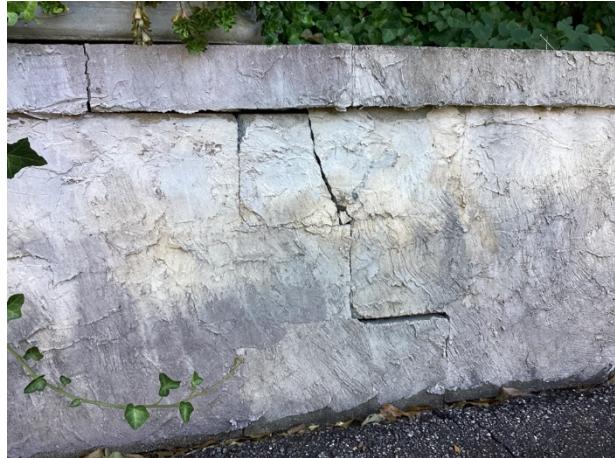
Step cracks and header deterioration

Useful Life: Concrete retaining walls have indeterminate useful lives. However, we recommend the Association plan for inspections, capital repairs and partial replacements every ten years to forestall deterioration.

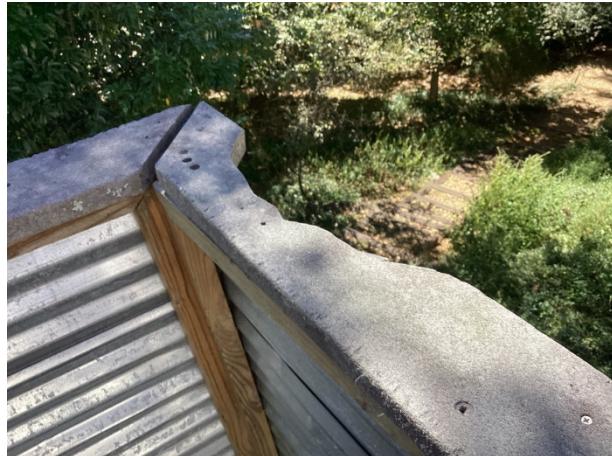
Condition: Good to fair overall condition with damaged composite railings and weathered wood decking evident.

**Damaged composite railing**

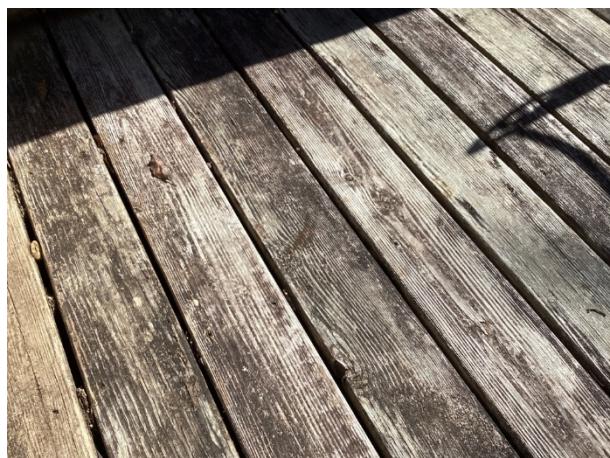
**Weathered wood decking**

Useful Life: Up to 35 years with the benefit of deck board replacement and interim repairs every 12- to 18-years.
