ATKINS ENGINEERS

FEBRUARY 16, 2007

Hamptons South Condominium
20201 E. Country Club Dr.
Aventura, FL

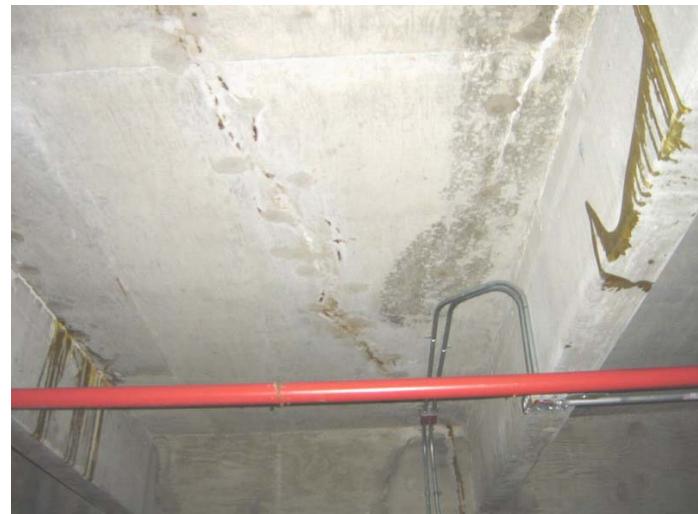
03-02 Formwork*Observation*

There is formwork (plywood) remaining on the structure.

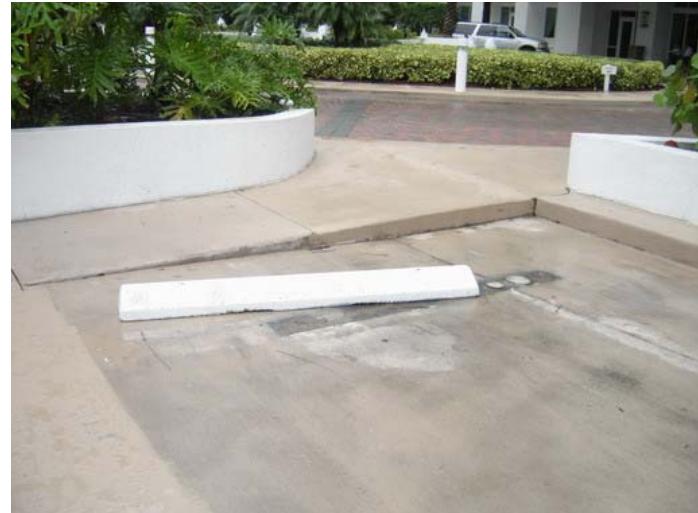
Front entry Valet and Parking Garage

The parking bumpers are loose and/or broken.

Repair or replace damaged concrete bumpers as required. Attach bumpers as shown on the drawings after removal of old dowels and epoxy.

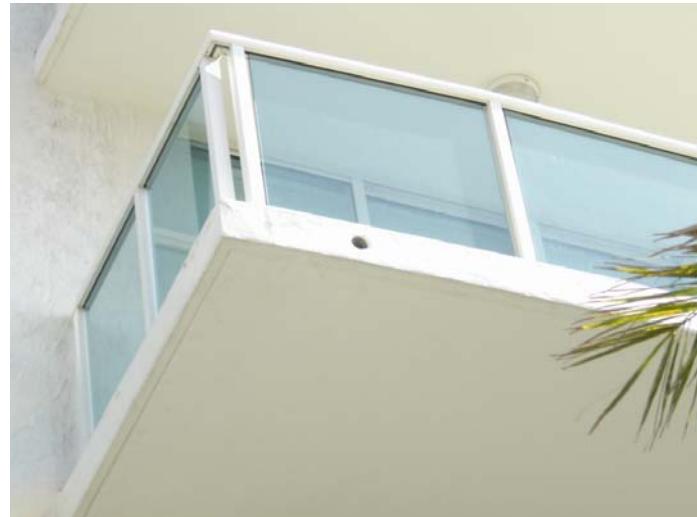
**03-05 Railing Post Pockets***Observation*

The railing post pockets are not completely filled with grout.

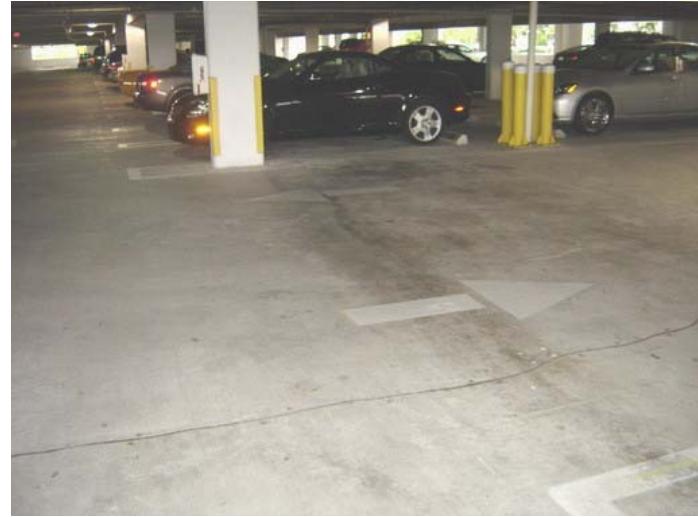
Parking Garage

03-06 Slab on Grade Cracks**Observation**

The slab on grade has cracks.

Detail cracks, clean and seal with flexible sealant.

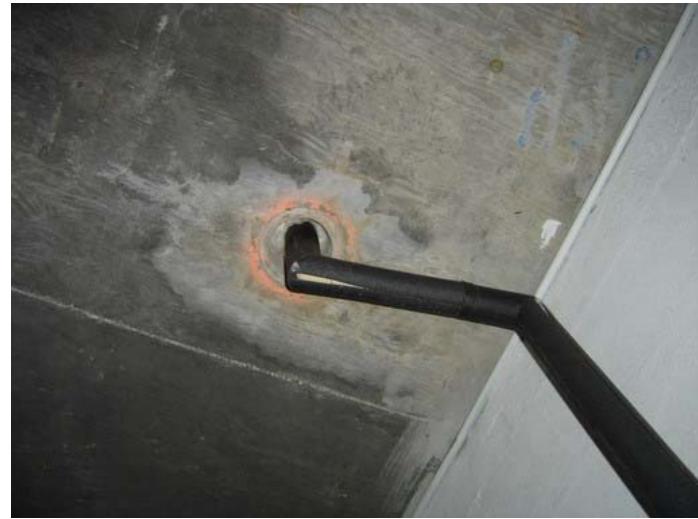
**07-03 Planter Waterproofing***Observation*

The planter waterproofing is not as per the plans.

Repair planter per Architectural and Landscape drawings.

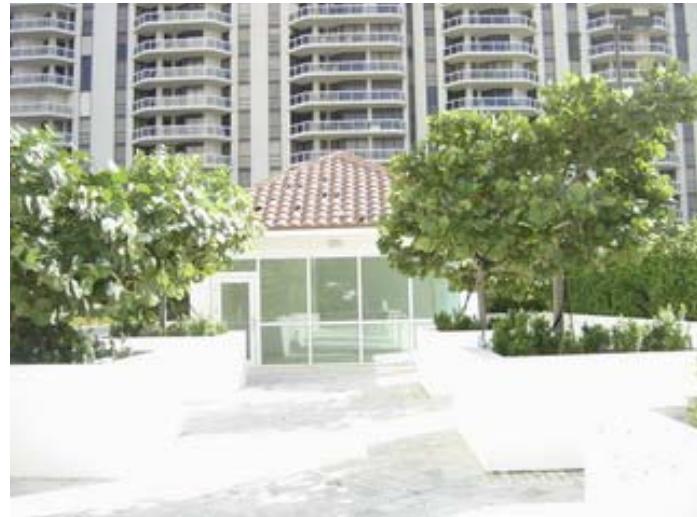
Pro shop building at tennis court level

07-04 Roof Tiles**Observation**

There are missing and/or broken roof tiles.

Remove and replace damaged roof tile.

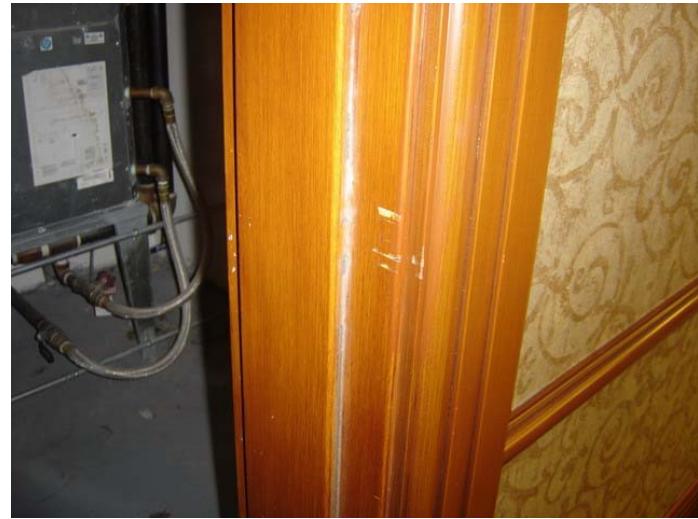
Club Room and Gym/Spa

The closet door frame is wood instead of metal as shown on the drawings and the hardware missing.

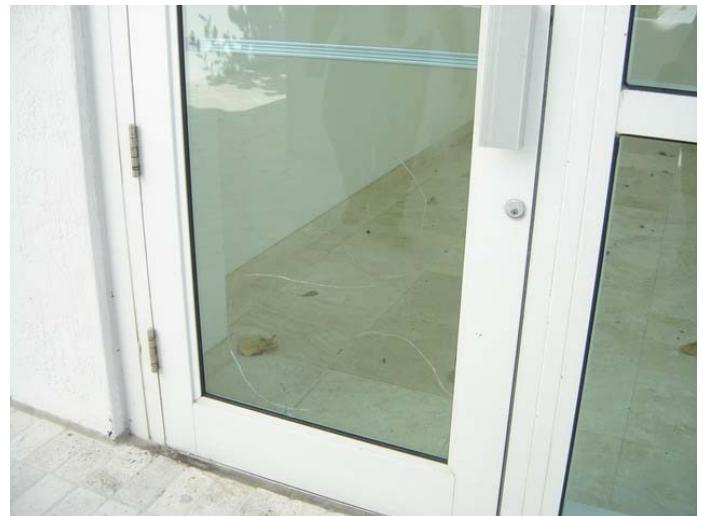
Pro Shop at Tennis Level

The glass door is broken.

Replace in kind aluminum and glass door per plan and details.

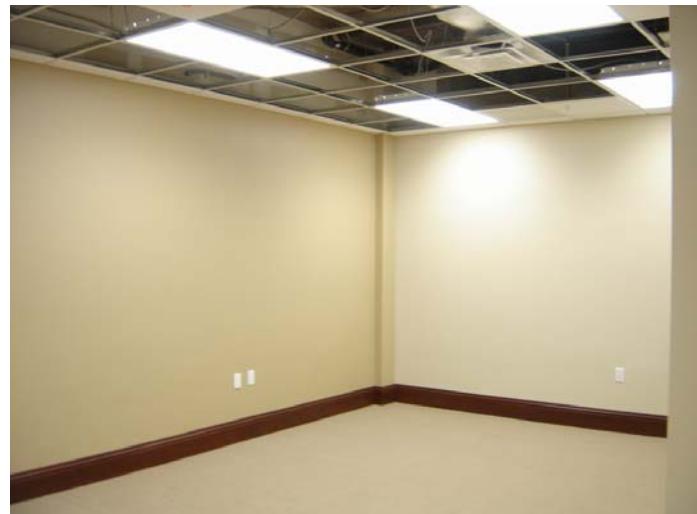
Property Manager Office

There were missing ceiling tiles.

Replace missing ceiling tiles.

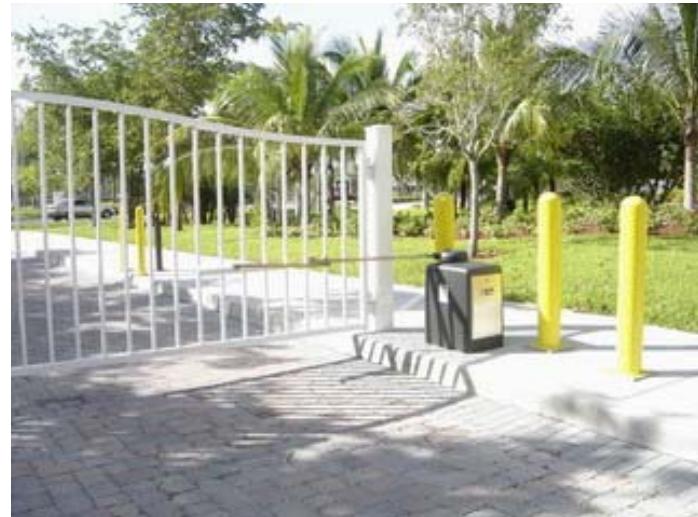
**32-04 Sidewalk and Curb***Observation*

The concrete sidewalks, curb and gutter are cracked and spalling.

Clean, apply bonding agent and patch with grout. Remove and replace sections that are beyond repair.

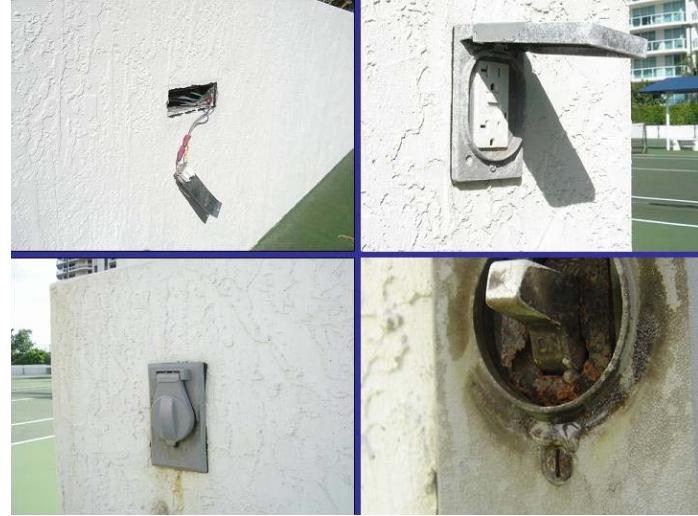
Tennis Court Area

Open light fixture outlet, deteriorated GFCI receptacle and cover, and corroded switch was observed in the tennis court area.

Verify outdoor devices for appropriate weather proof rating. Close and seal all open electrical outlets. Replace damage components.

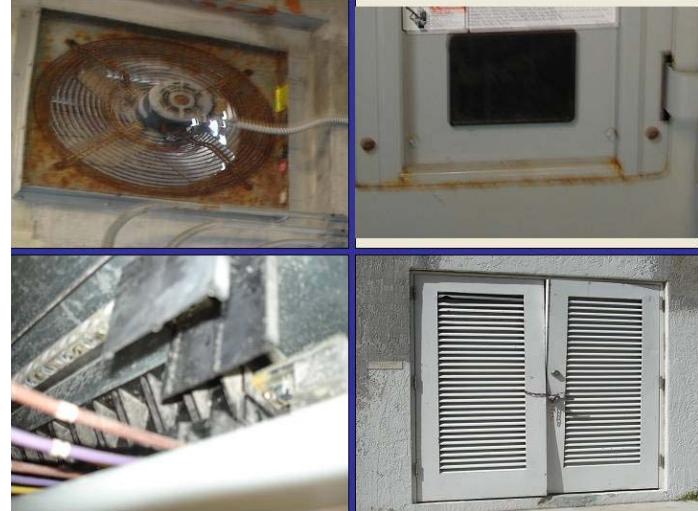
Main Electrical Room

Electrical components exhibit signs of deterioration and corrosion. Equipment appears to have been exposed to high humidity levels.

Provide appropriate ventilation and humidity controls for the environment. Replace damaged components, replace as required.

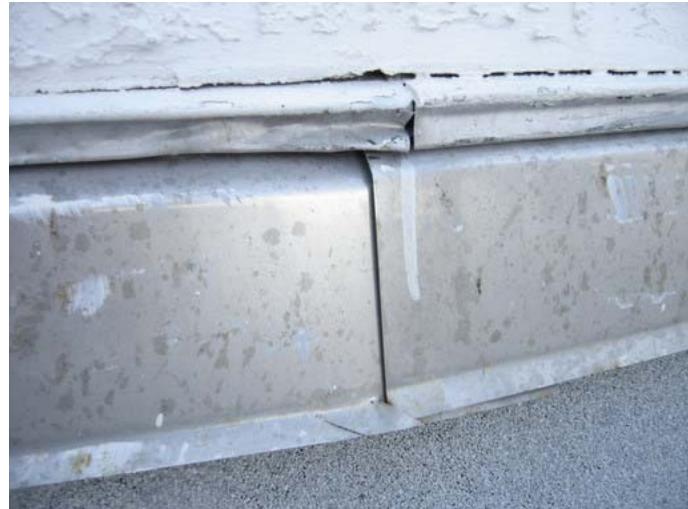
Main Roof

Counter flashing laps are loose and unsealed.

Repair loose flashing installations and seal flashing joints.

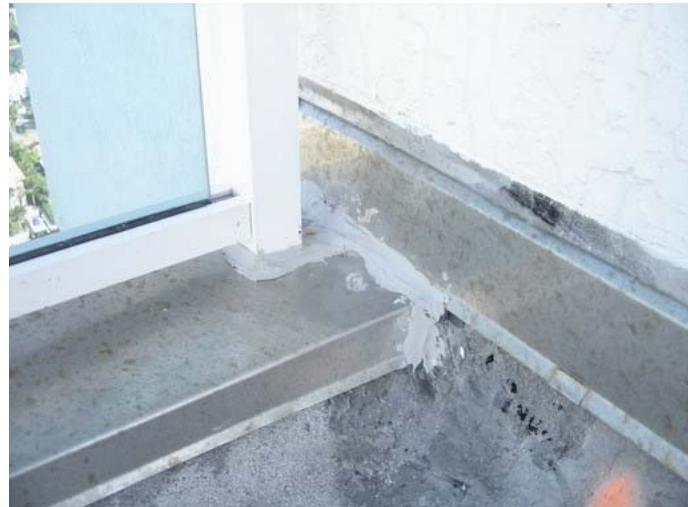
07-02 Flashing Deterioration*Observation*

The metal flashing is corroded.

Remove the rust stains and provide a protective coating to prevent future corrosion. Replace flashing as required.

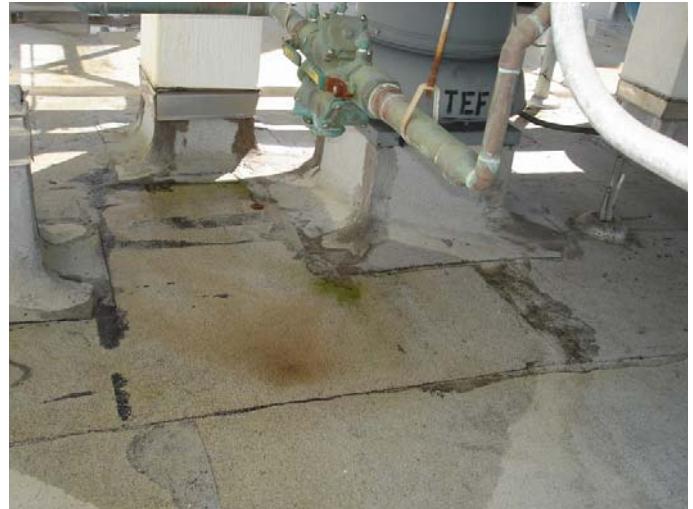
**23-01 Condenser Water Pump Spring Isolators***Observation*

The spring isolators for the condenser water pumps are corroded.

Remove and replace corroded spring isolators with ones suitable for exterior exposure.

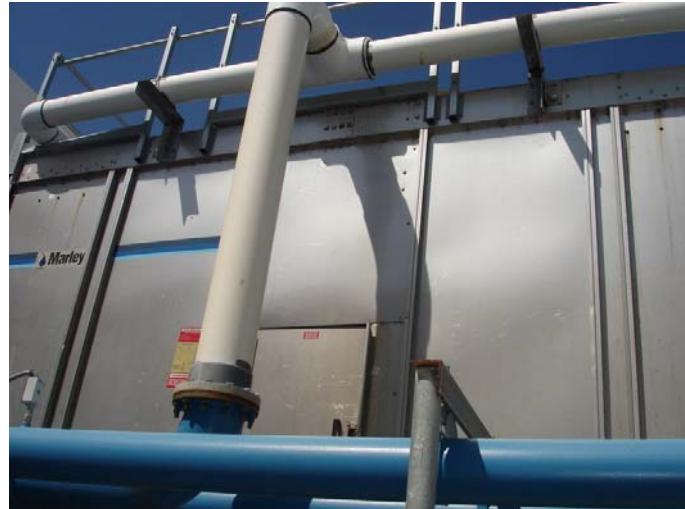
**23-03 Cooling Tower Access Doors***Observation*

The cooling tower basin access doors and locks are corroded and not functioning properly.

Replace access door hardware and refinish doors, replace doors as required.

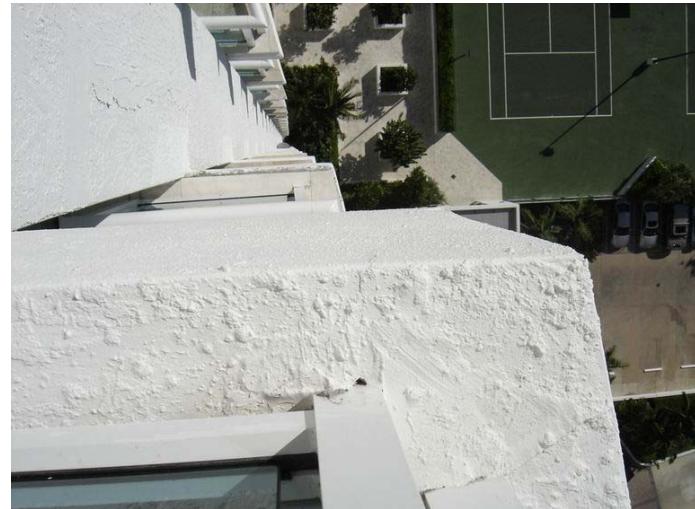
The railing post pockets are not completely filled with grout.

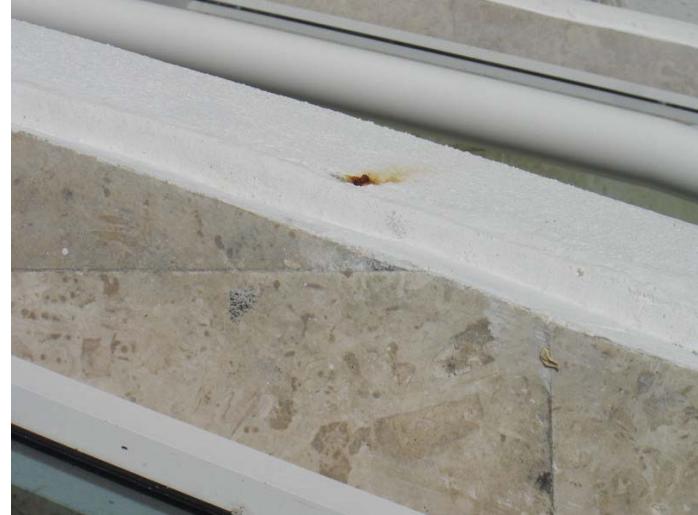
There is exposed and corroded wire ties, nails and/or reinforcing at the balcony slab.

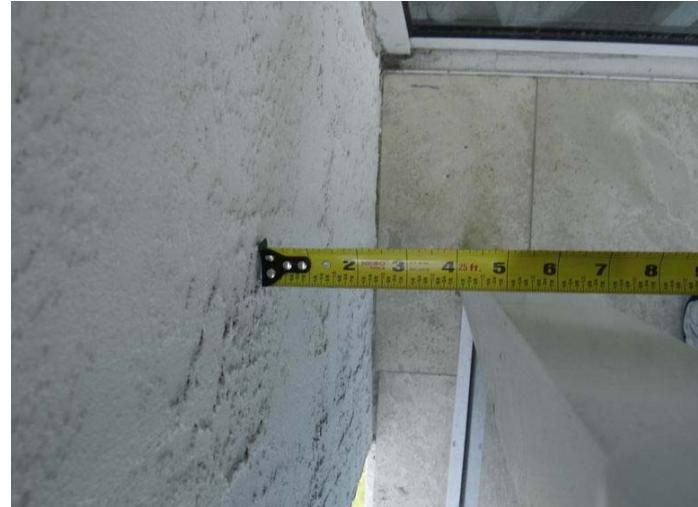
Gaps at railing terminations are approximately 4-3/4" which is larger than allowed by Code.

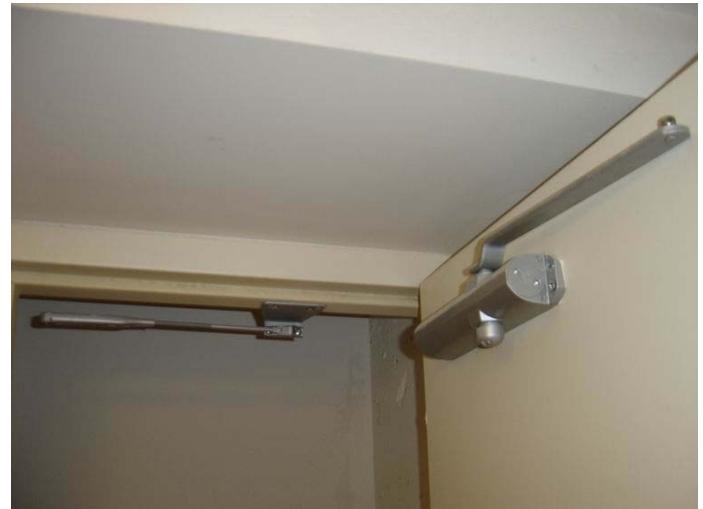
Several doors do not have closers or the closers are not working properly.

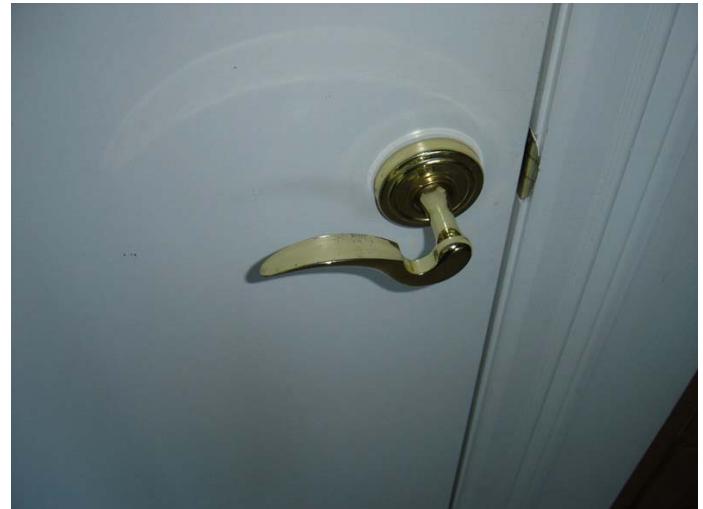
Doors have hardware that is not secure and/or is corroded.

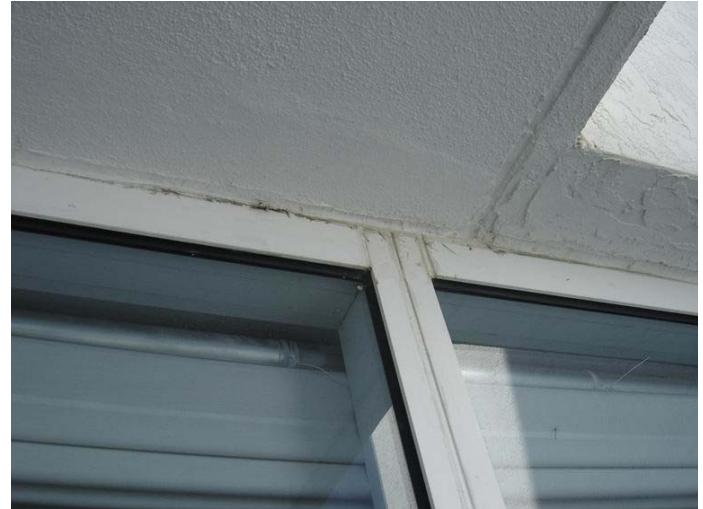
Sliding glass doors and/or windows are not properly caulked or sealed.

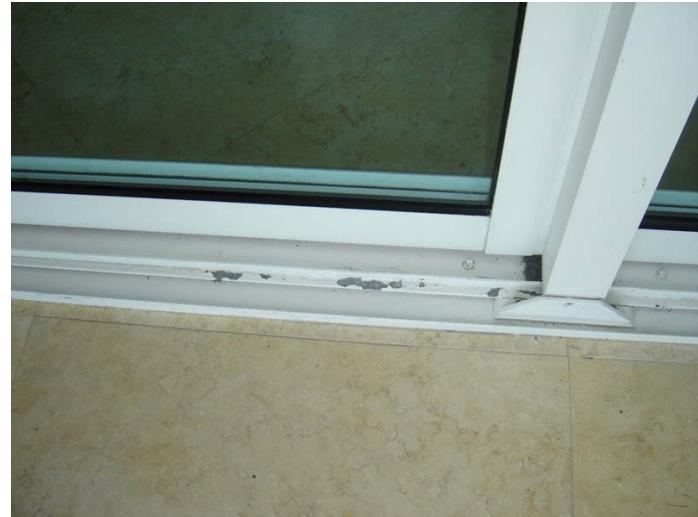
Sliding glass doors and/or windows exhibit signs of deterioration.

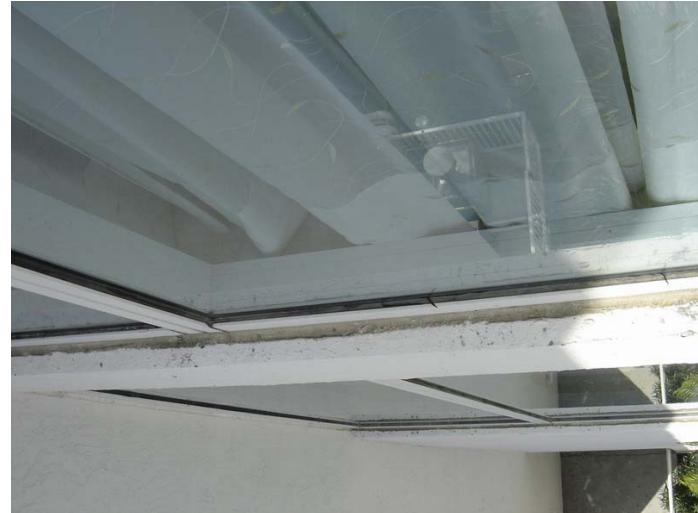
Sliding glass door and/or window glazing gaskets are deteriorated, loose or missing.

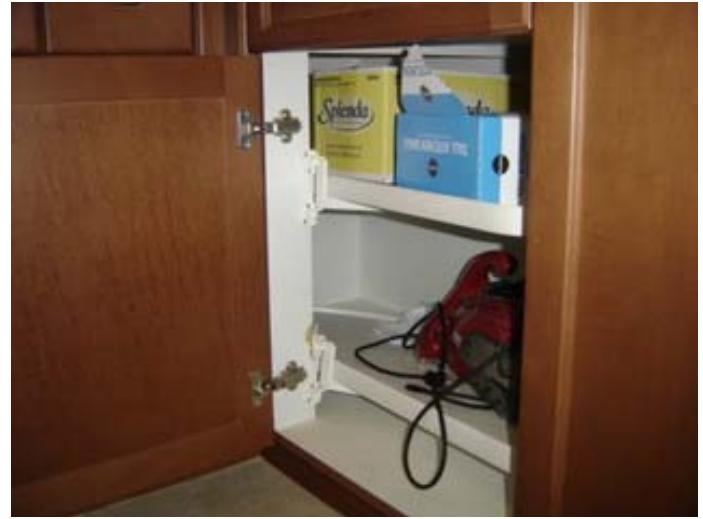
Cabinets are not installed properly, are misaligned and/or caulking is cracked.

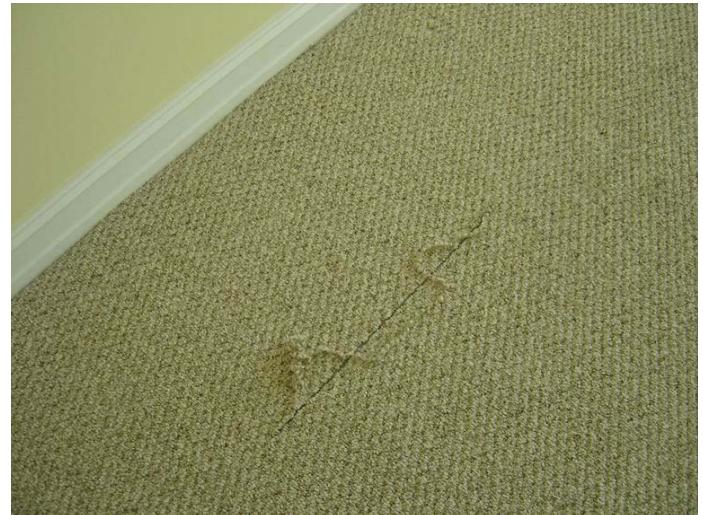
Carpet is damaged and/or improperly installed.

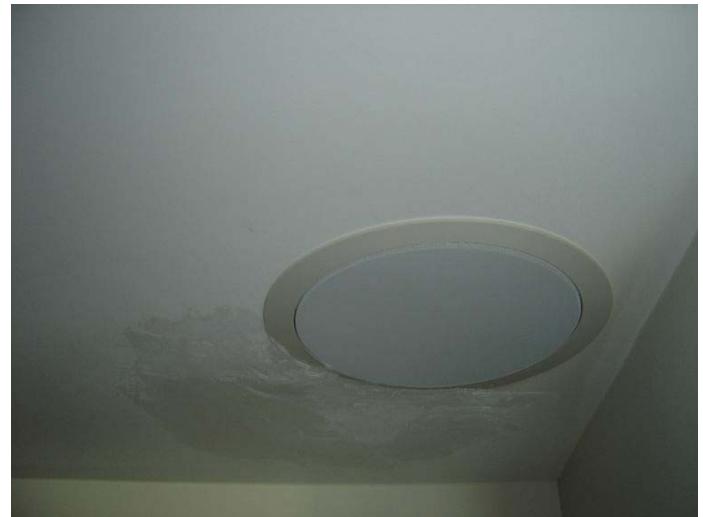
The ceiling is damaged and not properly finished.

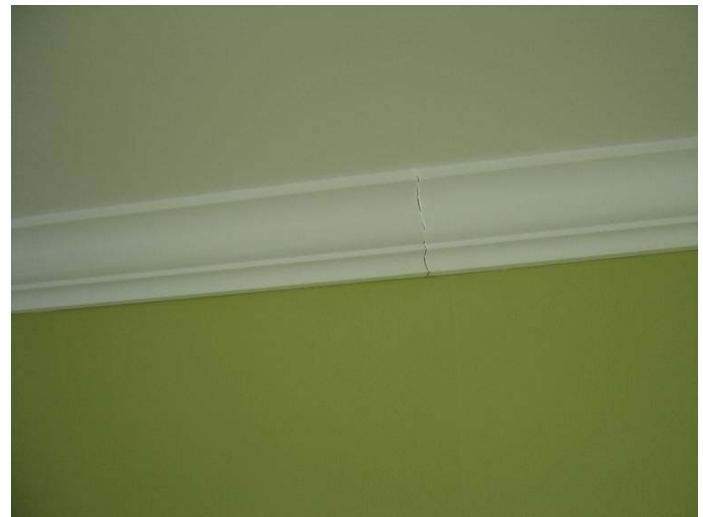
The crown molding has gaps at the joints and/or wall/ceiling.

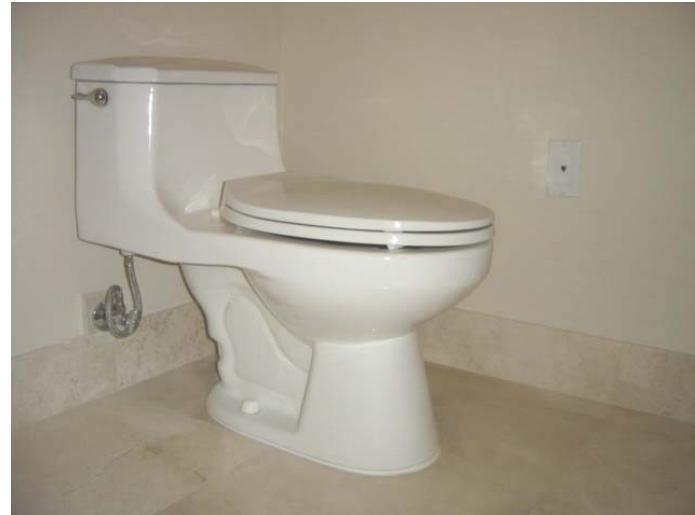
Water closets did not flush properly.

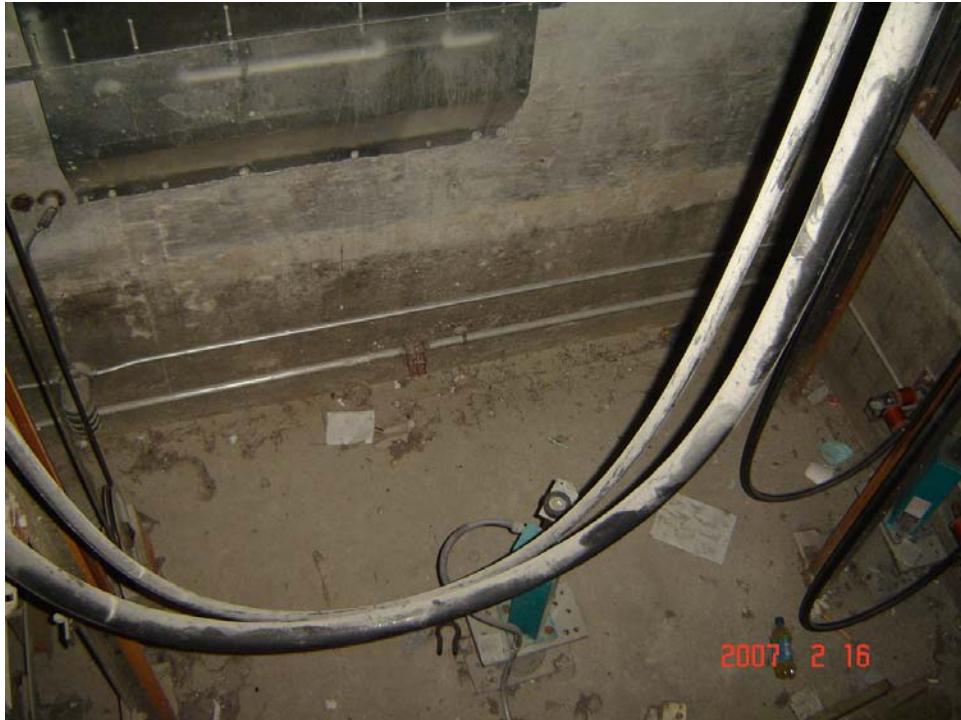
VIEW OF TEMPORARY JUMPER WIRES THAT MUST BE REMOVED FROM
BUILDING TO PREVENT UNSAFE OPERATION OF ELEVATORS.

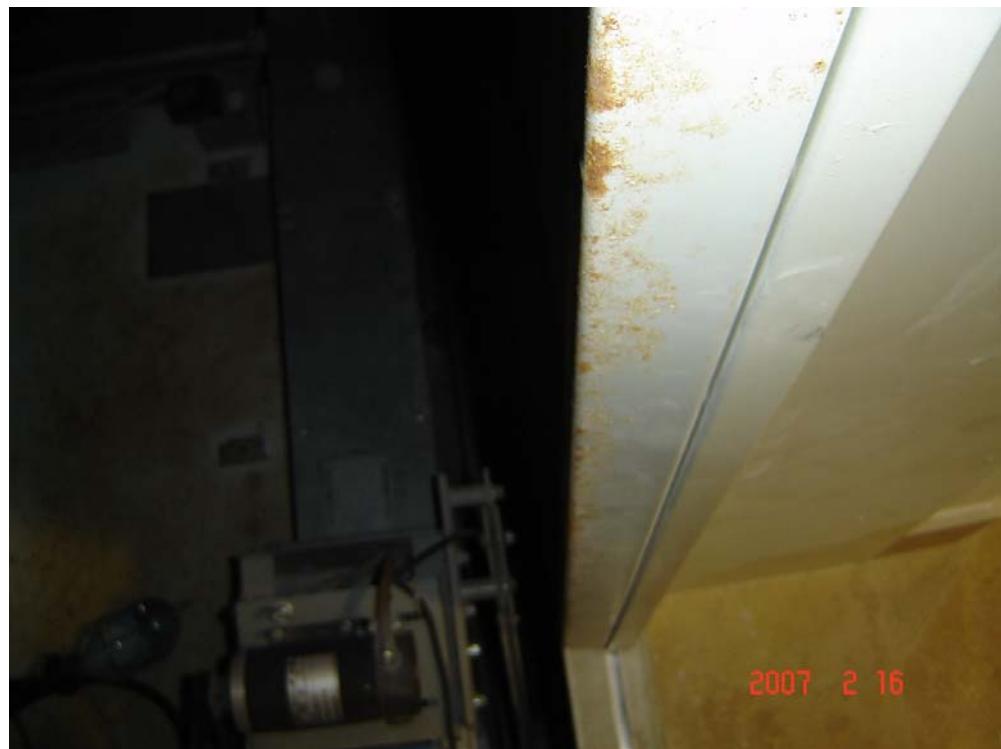
TYPICAL VIEWS OF UNFINISHED CAB INTERIORS SHOWING SHELL CAB
WALL (WHITE) INSTEAD OF MOSTLY FINISHED INTERIORS. THIS
CONDITION IS ON THE "CONTRACTOR CARS" PE2, PE4, PE6, PE8, PE10 IN
EACH CORE OF THE BUILDING.
