PRO-TECH INSPECTIONS

## WHOLE HOME INSPECTION

711 E Suber Rd  
Greer, SC 29650

Mike MacGregor  
09/25/2025

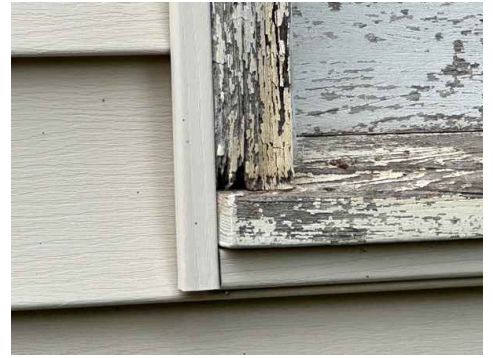
### 2.8.1 Window/Door Trim

## WOOD ROT PRESENT

Repair/Replace

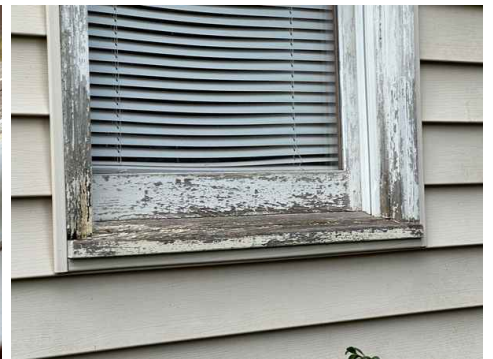
### 2.8.2 Window/Door Trim

## WEATHERED WOOD/TRIM

Repair/Replace

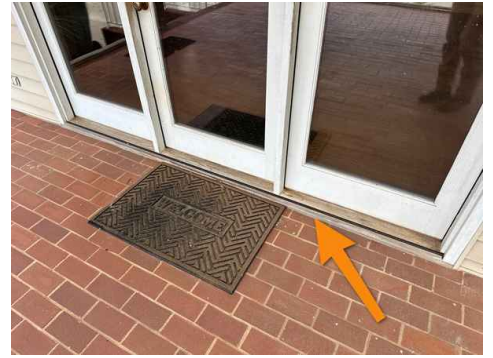
### 2.8.3 Window/Door Trim

## UNPAINTED TRIM - BOTTOM TRIM

Contact a qualified professional.
