SUMMARY

8211 Yorkridge Dr, Newburgh, IN
47630

JoAnn Hendrickson
11/24/2025

Von Lamey
InterNACHI Certified Professional
Inspector, IAC2 Certified Mold Inspector,
NRSB Certified Radon Measurement
Specialist
Precision Home Inspections

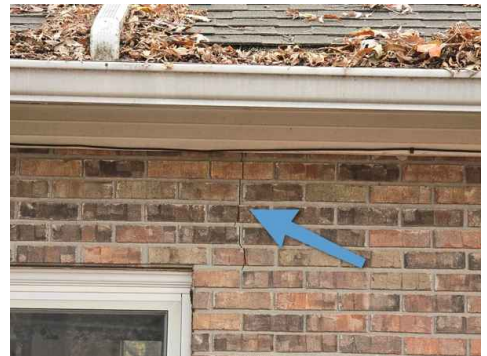
2.2.1 Siding, Flashing & Trim CRACKING - MINOR

BACK LEFT

Siding had cracks in one or more places. This may be a result of an impact or temperature changes. Recommend a qualified professional evaluate and repair as necessary.

Seller addressing

(Contractor says needs
to be above 50°)

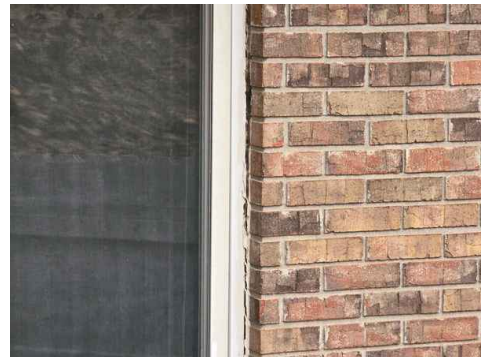
2.3.1 Exterior Doors CAULKING NEEDED

One or more areas around exterior doors was missing caulking. This can lead to moisture intrusion around the door frame. Recommend a qualified handyman apply caulk or sealant.

Seller addressing

(needs above 50°)

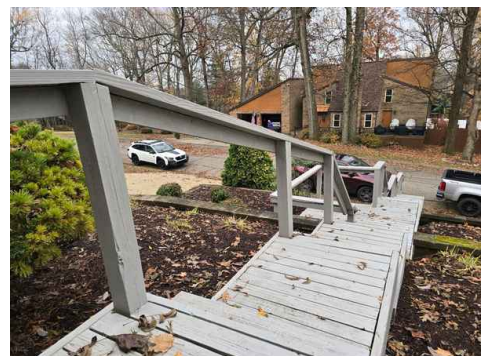
2.4.1 Decks, Balconies, Porches & Steps NO BALLUSTERS

Balusters were not present on handrails. This can create a fall hazard. Recommend a qualified carpentry contractor install balusters for safety.

Recommendation
Contact a qualified carpenter.

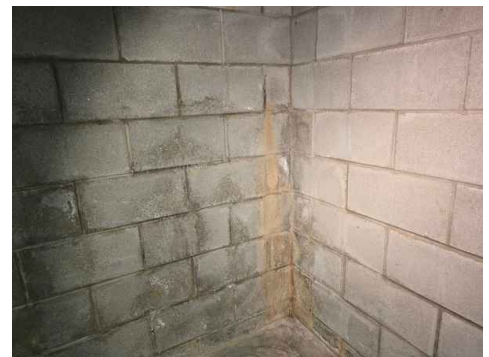
4.1.1 Foundation

Evidence of moisture intrusion on the surface of the wall in the basement. This can compromise the soil's ability to stabilize the structure. Recommend a qualified contractor identify the source of moisture and remedy.

Former leak; remedied w/ French Drains.

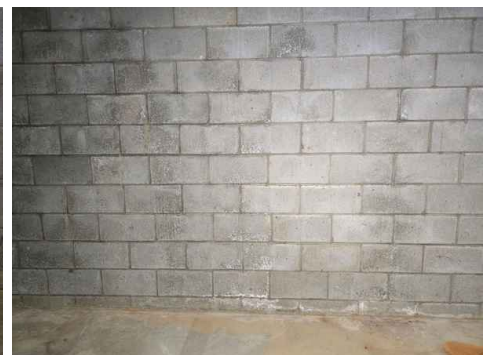
4.2.1 Basements & Crawlspaces

EFFLORESCENCE

Efflorescence noted on the basement surface. This is a white, powdery deposit that is consistent with moisture intrusion. This can compromise the soil's ability to support the home structure and/or lead to mold growth. Recommend a qualified contractor identify source of moisture and correct.

Treated w/ mold Killer by contractor

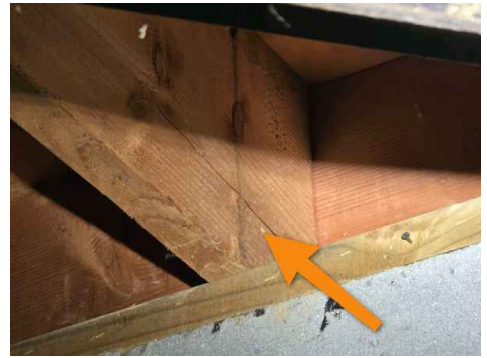
4.2.2 Basements & Crawlspaces

FLOOR JOISTS DAMAGED

Floor joists were damaged at the time of the inspection. This can cause floors to sag and become unlevel. Recommend a qualified carpentry contractor repair.

*Have been
sistered / repaired*

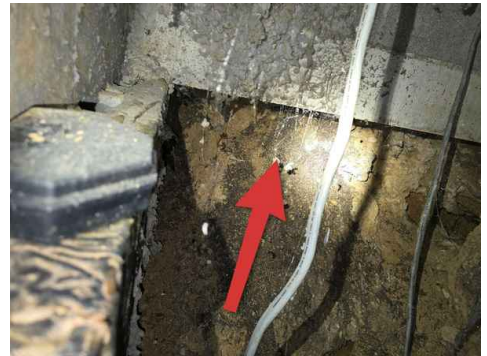
4.2.3 Basements & Crawlspaces

UNSUPPORTED FOUNDATION

Areas in crawlspace had area of unsupported masonry block or concrete. Recommend a qualified structural engineer evaluate to determine structural stability.

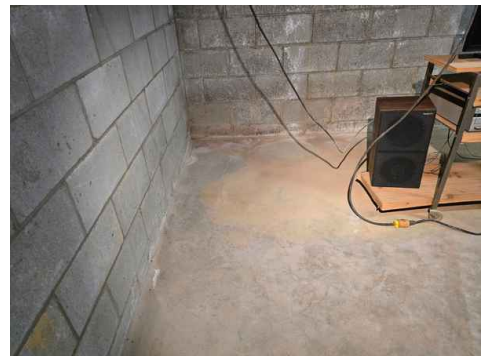
4.4.1 Floor Structure

EVIDENCE OF WATER INTRUSION

There were signs of water intrusion at the floor structure. Recommend a qualified contractor identify source of moisture and remedy.

*Former leak;
Remedied w/ French
Drain*

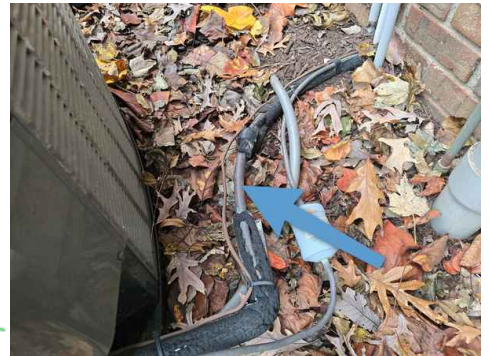
INSULATION MISSING OR DAMAGED

Missing or damaged insulation on refrigerant line can cause energy loss and condensation.

*Seller addressed.
Replaced/Repaired*

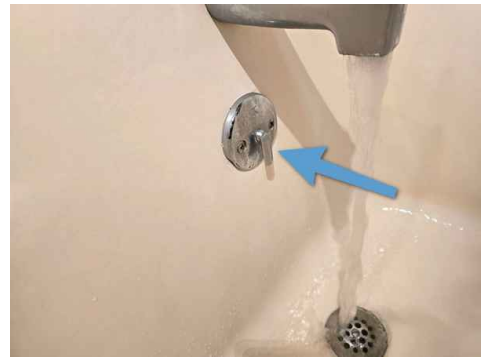
One or more plumbing hardware devices were not working at the time of the inspection. Recommend a qualified plumber replace or repair.

*Seller addressed.
Charged to rubber stopper*

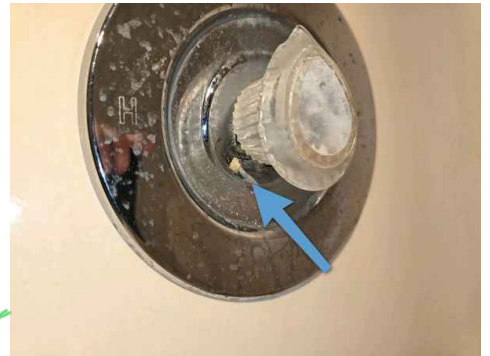
7.3.2 Water Supply, Distribution Systems & Fixtures

PLUMBING HARDWARE MISSING OR DAMAGED

Plumbing hardware was missing at the time of the inspection. Recommend a qualified plumbing contractor install new plumbing hardware.

*seller addressed.
Screw replaced*

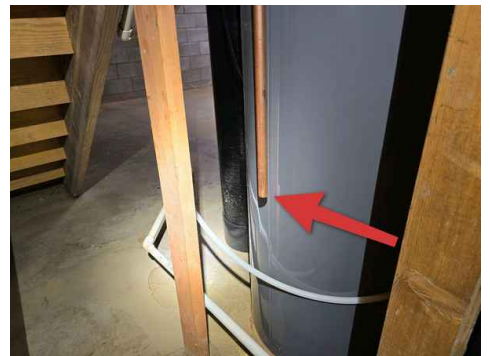
7.4.1 Hot Water Systems, Controls, Flues & Vents

The TPR (Temperature Pressure Release) Valve pipe was too short. The TPR valve pipe should be no more than 6 inches from the floor surface. This will help prevent a burn hazard from very hot water. Recommend a qualified plumbing contractor install TPR valve pipe with proper floor clearance.

*seller addressed.
Longer TPR valve
installed*

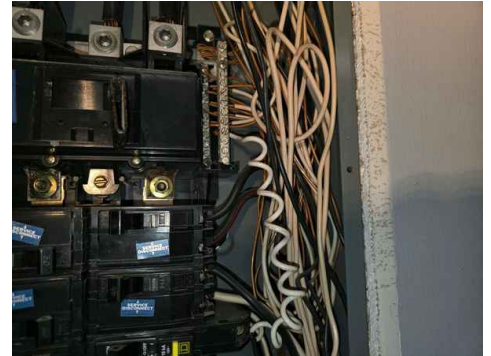
IMPROPERLY BONDED

Improper or no bonding at the time of the inspection. Inspector was unable to identify proper bonding. Recommend a qualified electrical contractor evaluate and remedy.

seller addressing

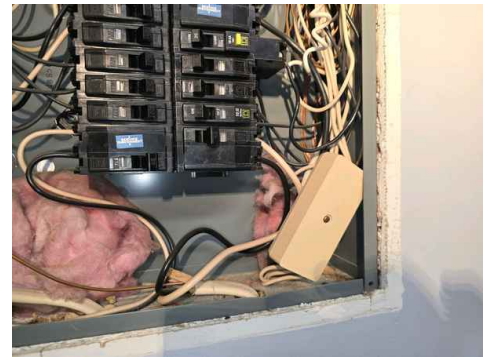
Low voltage wires located inside electrical panel. Class 2 conductors should not be mixed with service conductors inside the panel. Recommend a qualified electrical contractor evaluate and remedy.

seller addressing

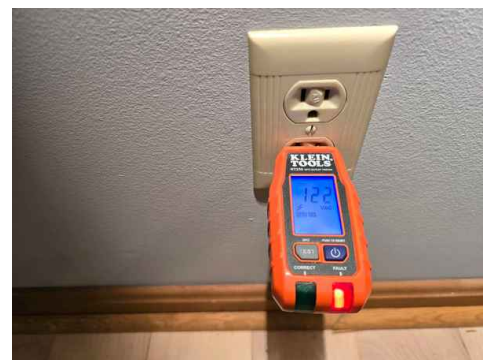
One or more outlets indicated "Open Ground". Outlets that are not grounded can create a shock hazard. Recommend a qualified electrical contractor outlets and remedy.

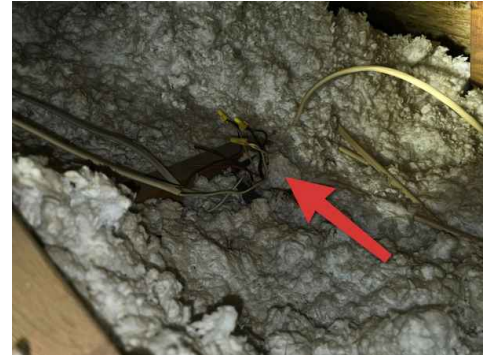
MISSING JUNCTION BOX

Junction box was missing at the time of the inspection. Recommend a qualified electrical contractor house wires in a new junction box.

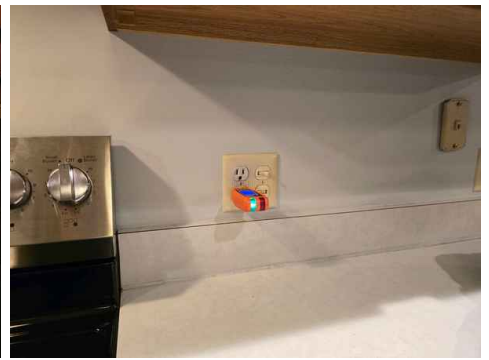
No GFCI protection present. Recommend a licensed electrician upgrade by installing ground fault receptacles in proper locations to help prevent shock hazard.

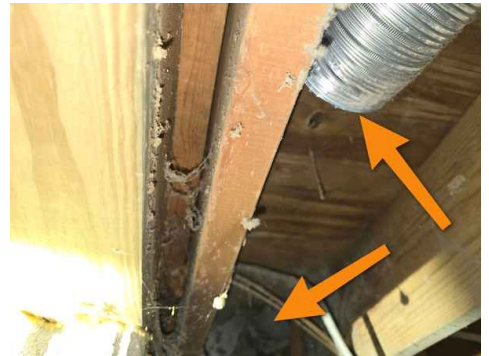
Dryer vent was detached at the time of the inspection. Recommend a qualified handyman re-attach and seal dryer vent.

*Seller Addressed.
Corrected*

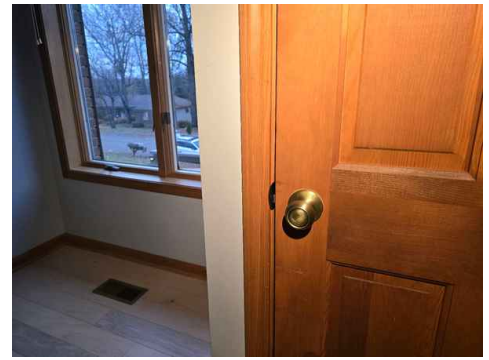
Doors did not latch properly. Recommend handyman repair latch and/or strike plate.

*Seller
Addressed.
Corrected*

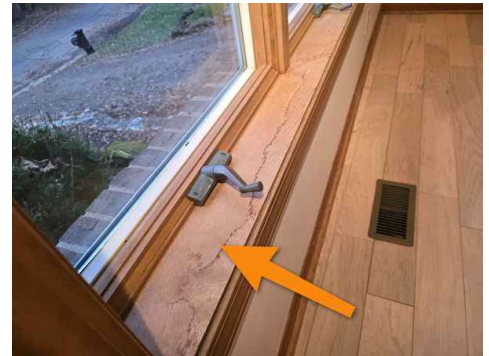
11.2.1 Windows

WINDOW TRIM STAINS

Water staining observed around window trim areas. Recommend a qualified window contractor evaluate for moisture and repair as necessary.

*From ice dam yrs. ago. No current
leakage*

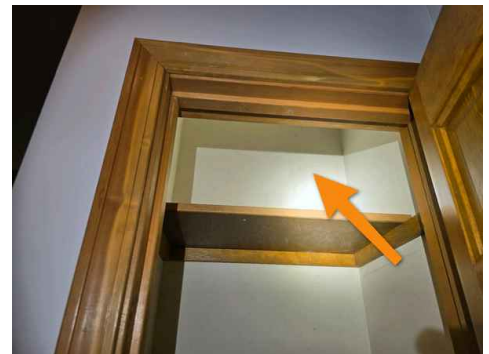
Evidence of organic growth on wall structure. Recommend a qualified mold inspector sample and send to lab for testing.

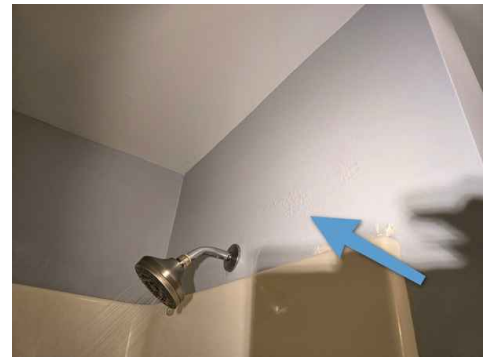
11.4.3 Walls

PAINT CRACKING

Wall paint was cracking in one or more areas. Recommend a qualified painter evaluate and apply a new coat.

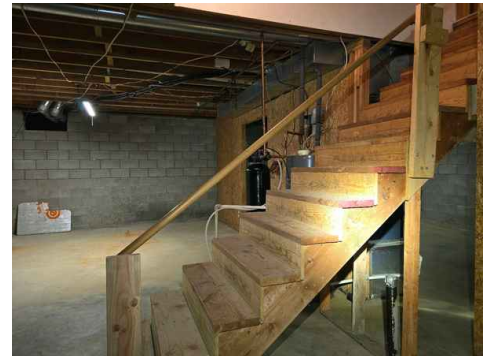
11.6.1 Steps, Stairways & Railings

NO BALUSTERS

There were no balusters present on the stairwell. Recommend carpentry contractor install balusters to prevent fall hazard.

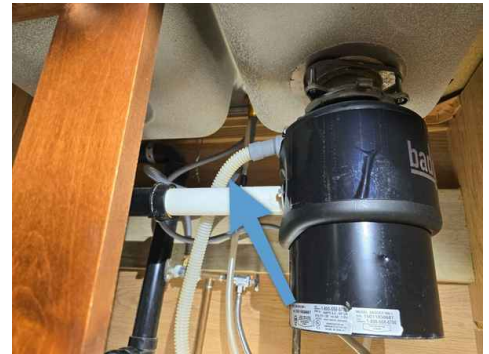
12.1.1 Dishwasher

NO HIGH LOOP

There was no high loop present from the dishwasher. Recommend a qualified plumbing contractor repair.

*Seller addressed.
Corrected.*

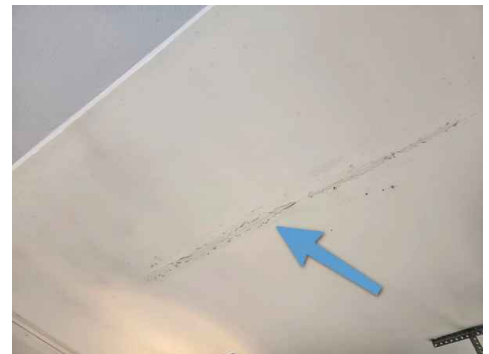
13.1.1 Ceiling

PEELING/CRACKING

Garage ceiling showed signs of peeling and/or cracking. This may be due to moisture. Recommend a qualified contractor evaluate and repair.

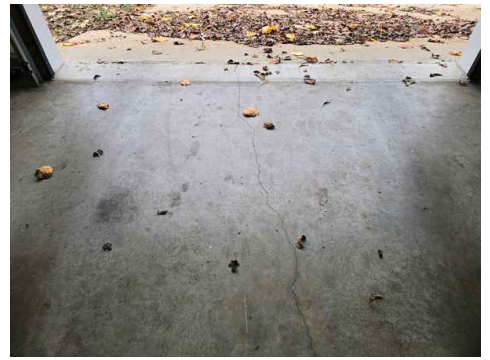
13.2.1 Floor

CRACKING - MINOR

Minor cracking was evident on the garage floor at the time of the inspection. Recommend monitoring or sealing any open cracks.

Seller
addressed.

Sealed.

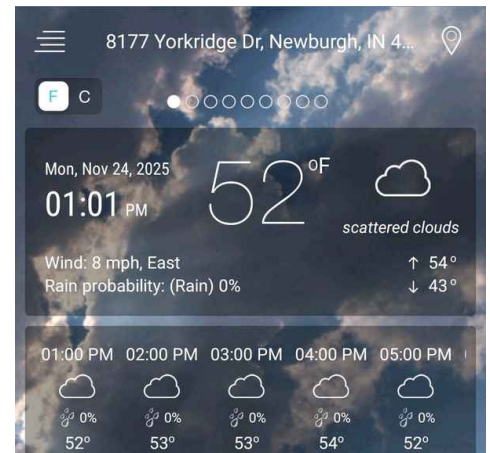
Air conditioning was not tested. Air temperature at the time of the inspection was below 65 degrees. There is a safety and equipment protection protocol.

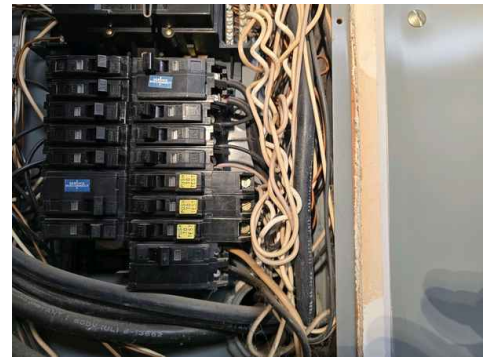
PANEL OVERCROWDED

Panel was overcrowded. This made it difficult to view components of the system that may be hidden.
