PROPERTY INSPECTION REPORT

1108 Sidney Ave
Inspection Prepared For: Michael McBride
Agent: Breona Enbom - Infinity Real Estate

Date of Inspection: 7/19/2023
Age of Home: 118 Size: 1483
Weather: Sunny

This report was updated on 8 August, 2023 to reflect corrected deficiencies. Only deficiencies identified in the original report conducted 19 July, 2023 which were reported by the client or the client's agent as being corrected were inspected.

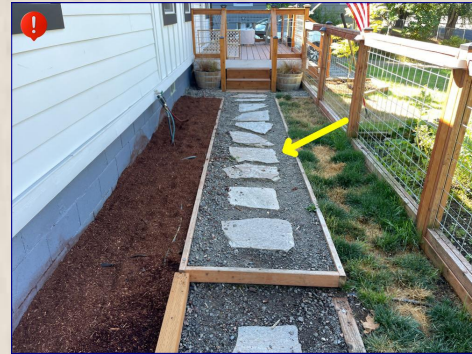
- **There are uneven slabs at the walkways, which could be a tripping hazard. Recommend using additional caution in these areas. Recommend having a licensed contractor repair or replace as needed.**

There are uneven slabs at the walkways, which could be a tripping hazard. Recommend using additional caution in these areas. Recommend having a licensed contractor repair or replace as needed.

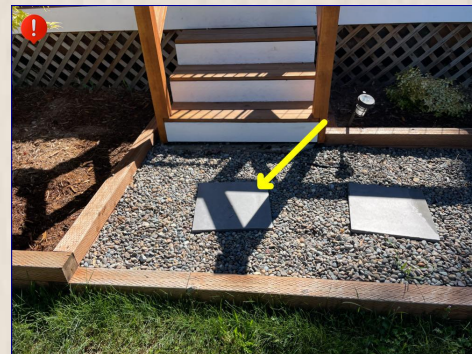
- The deck stairs are missing or have an improper landing, which is a tripping concern. Recommend a licensed contractor repair.

The deck stairs are missing or have an improper landing, which is a tripping concern. Recommend a licensed contractor repair.

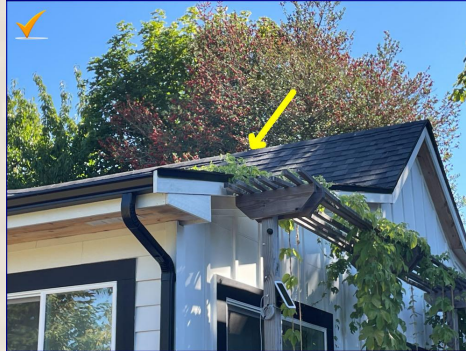
There is vegetation in contact with the house. Vegetation can penetrate siding causing damage and increases risk of water damage. Recommend trimming trees/vegetation, so it is doesn't come into contact with the home.

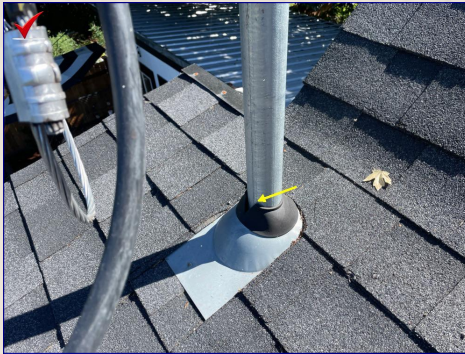
There are one or more areas of the roof flashing in need of sealing/repairs. Risk of water damage. Recommend a licensed roofer evaluate and repair or replace the flashing as needed.

CORRECTED 8AUG23

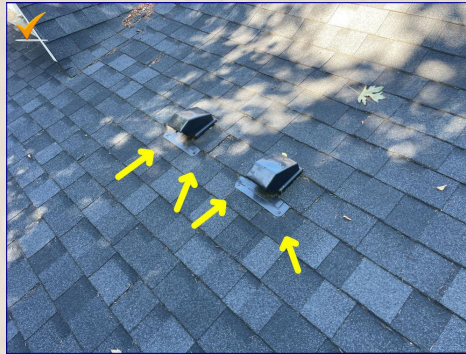
There are exposed nail heads securing the flashing to the roof. Exposed nail heads can allow water to penetrate the roof. Recommend a licensed roofer repair as necessary.

CORRECTED 8AUG23

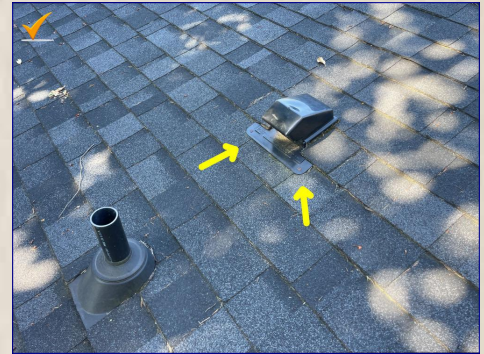
There are exposed nail heads securing the flashing to the roof. Exposed nail heads can allow water to penetrate the roof. Recommend a licensed roofer repair as necessary.

CORRECTED 8AUG23

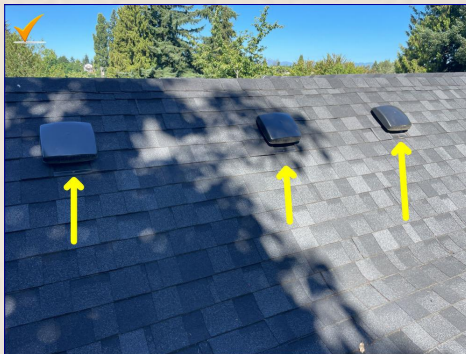
There are exposed nail heads securing the flashing to the roof. Exposed nail heads can allow water to penetrate the roof. Recommend a licensed roofer repair as necessary.

CORRECTED 8AUG23

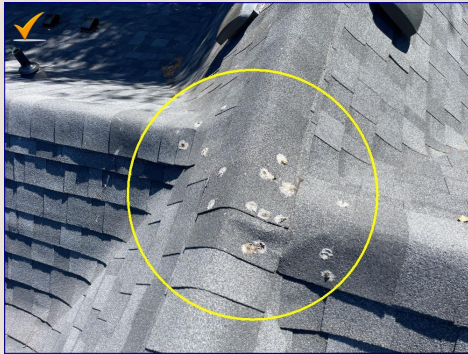
There are exposed nail heads on the roof. Exposed nail heads may allow water to seep through and damage the sheathing over time. Recommend a licensed roofer evaluate and repair as needed.

CORRECTED 8AUG23

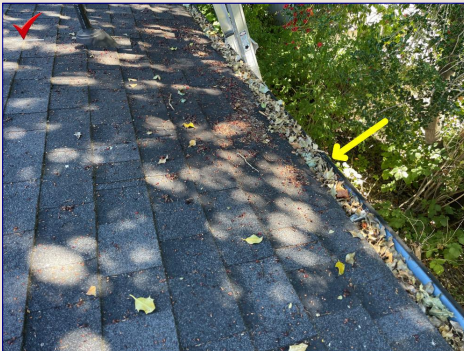
The gutters are dirty. Recommend cleaning the gutters to ensure proper water flow to the downspouts.

CORRECTED 8AUG23

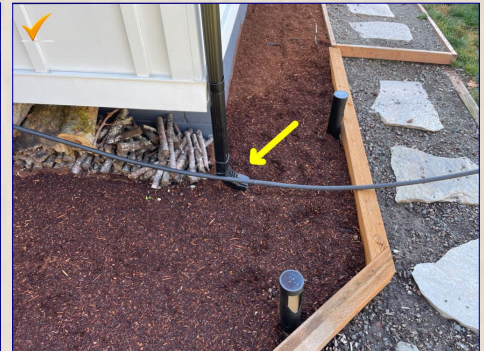
The gutter downspouts don't direct water far enough away from the house. Recommend adding downspout extensions (5-6' extensions recommended) to discharge away from the home.

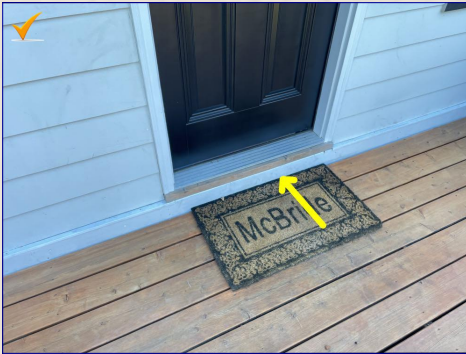
The exterior trim was in need of normal painting maintenance. Recommend a licensed painter repair/paint the exterior trim.

CORRECTED 8AUG23

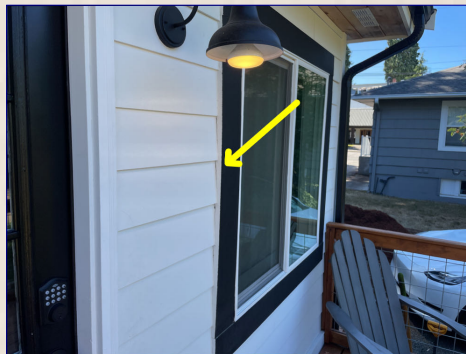
Recommend caulking around windows, doors, corners, and utility penetrations to prevent moisture and pest intrusion.

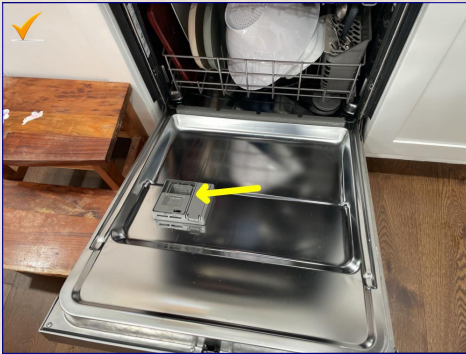
The soap door did not operate properly. Recommend an appliance technician evaluate and repair.

CORRECTED 8AUG23

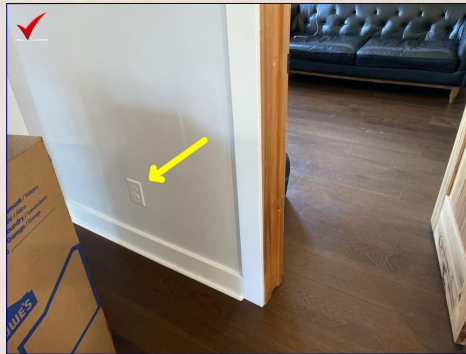
The receptacle was not operational during the inspection. Recommend a licensed electrician repair.

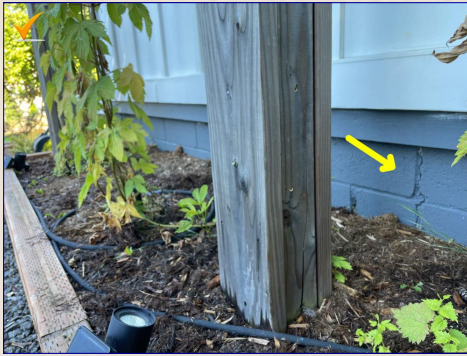
There are expected cracks in the foundation. All cracks have a potential for leaking and for future movement, which can not be predicted. Recommend monitoring and consulting a licensed foundation expert if any cracks start leaking or become active.

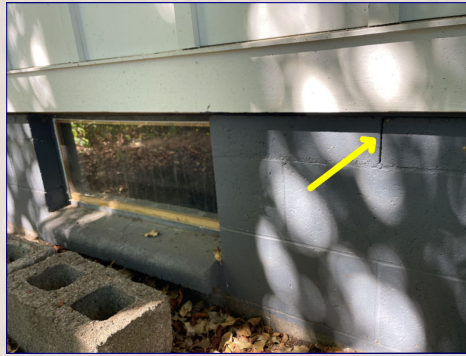
There was missing grout between the blocks which may allow water intrusion. Recommend a licensed contractor repair.

CORRECTED 8AUG23

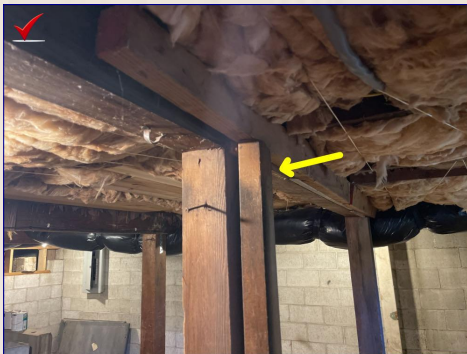
The beam had been repaired/modified and may not support the intended load. Recommend a licensed contractor specializing in structural support evaluate and repair as needed.

CORRECTED 8AUG23

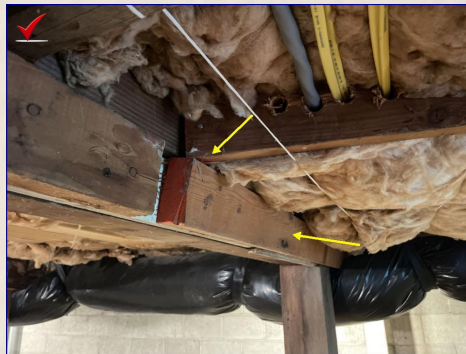
Girders and/or beams had some damage, as seen in the basement. Recommend a licensed contractor specializing in structural support evaluate and repair as needed.

CORRECTED 8AUG23

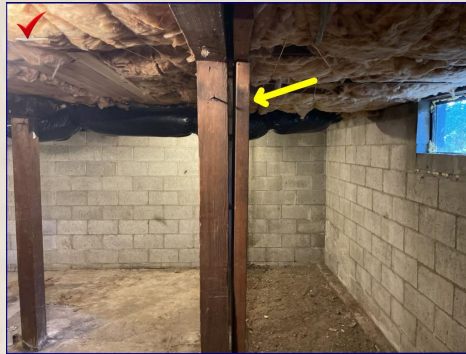
Columns had been modified and may not support their intended load. Recommend a licensed contractor specializing in structural support evaluate and repair as needed.

CORRECTED 8AUG23

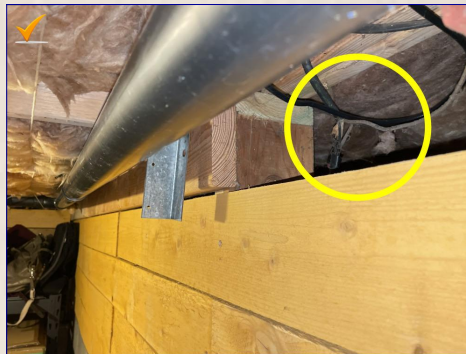
Wiring appeared to have been abandoned in place in multiple areas of the basement/crawlspace. Recommend a licensed electrician remove any unused wiring for additional safety.

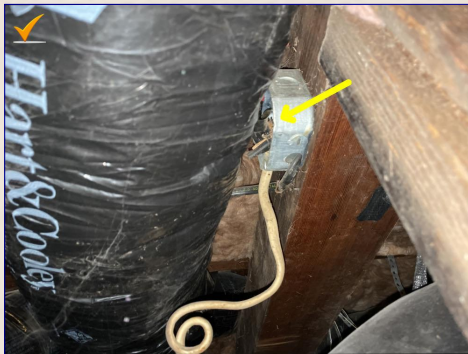
Wiring appeared to have been abandoned in place in multiple areas of the basement/crawlspace. Recommend a licensed electrician remove any unused wiring for additional safety.

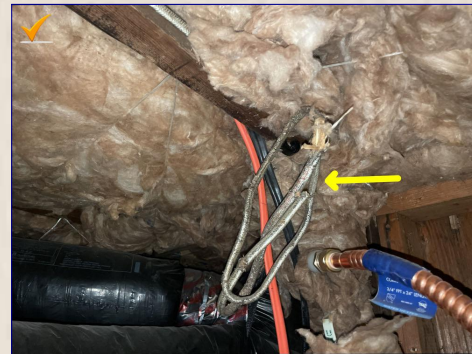
Wiring appeared to have been abandoned in place in multiple areas of the basement/crawlspace. Recommend a licensed electrician remove any unused wiring for additional safety.

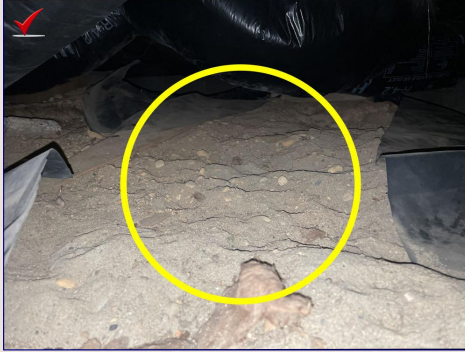
The vapor barrier is missing or damaged on the crawlspace floor. The vapor barrier is used to prevent ground moisture from moving up and into the living area of the home. Recommend a licensed contractor install a proper vapor barrier.

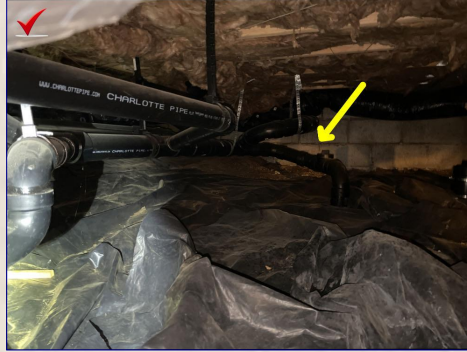
The vapor barrier is missing or damaged on the crawlspace floor. The vapor barrier is used to prevent ground moisture from moving up and into the living area of the home. Recommend a licensed contractor install a proper vapor barrier.

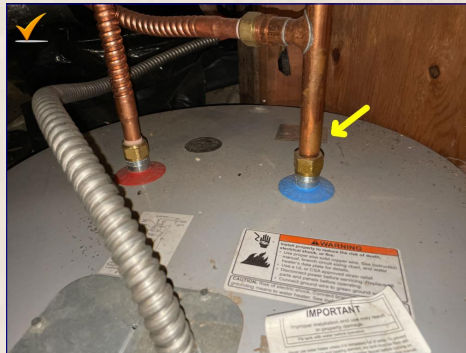
The connection was missing a dielectric union and may result in galvanic corrosion. Recommend a licensed plumber install a dielectric union.

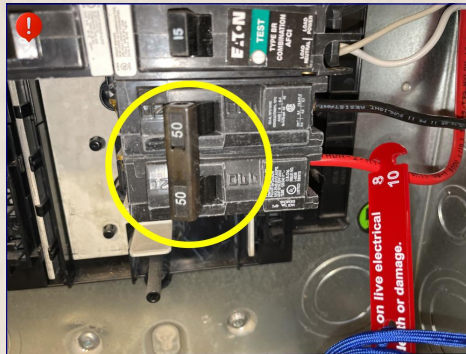
Page 35 Item: 9	Branch Wire	<ul style="list-style-type: none"> Branch wires are undersized, or the breaker is overrated at the main electrical panel, which is a safety hazard. Recommend a licensed electrician evaluate and repair.
-----------------	-------------	--

- Branch wires are undersized, or the breaker is overrated at the main electrical panel, which is a safety hazard. Recommend a licensed electrician evaluate and repair.

Branch wires are undersized, or the breaker is overrated at the main electrical panel, which is a safety hazard. Recommend a licensed electrician evaluate and repair.
