SOUTHERN IDAHO HOME INSPECTIONS, LLC

RESIDENTIAL INSPECTION

3348 Highlawn Dr
Twin Falls, ID 83301

04/14/2025

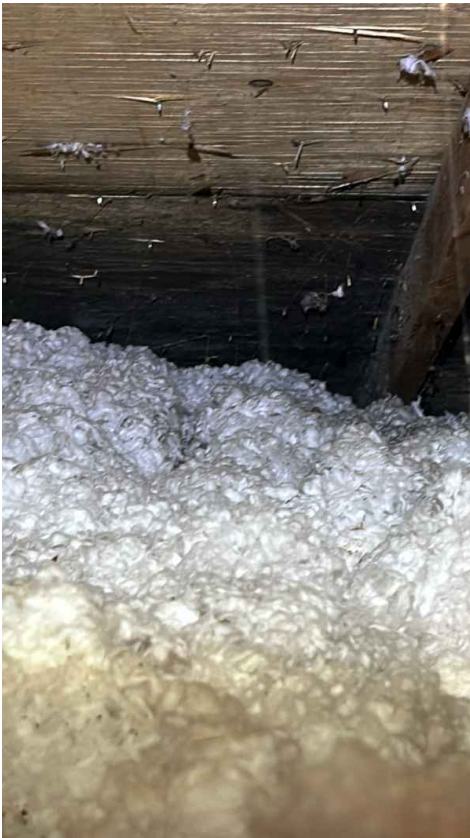
Attic

MICROBIAL GROWTHS

Microbial growths were observed in some areas (click individual pictures for specific locations). Moisture, poor ventilation, and leaks are typically the cause. Recommend that a licensed restoration company evaluate, test, and remediate all microbial growths as necessary.

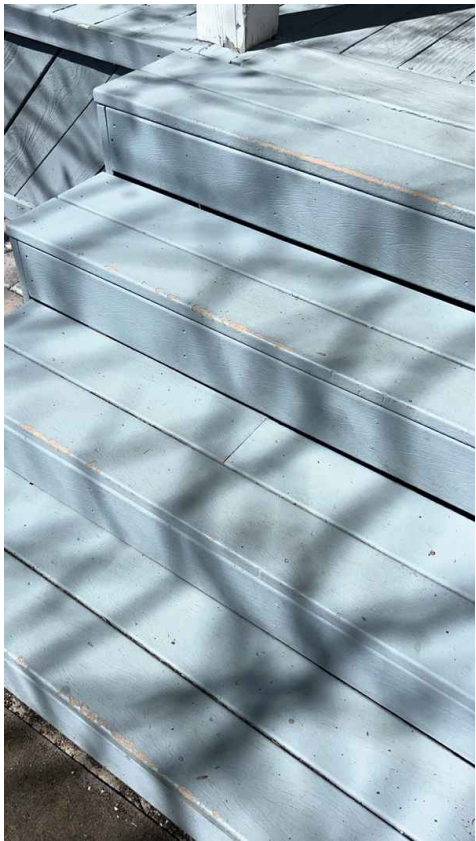
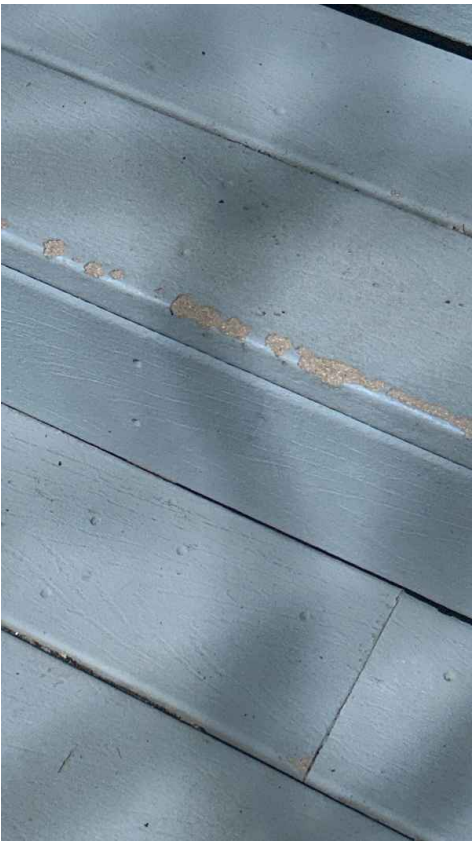
Rear patio stairs

PAINT DETERIORATED ON DECK

Failing paint was observed at exterior stairs/deck areas. Recommend maintenance as necessary by a qualified professional.

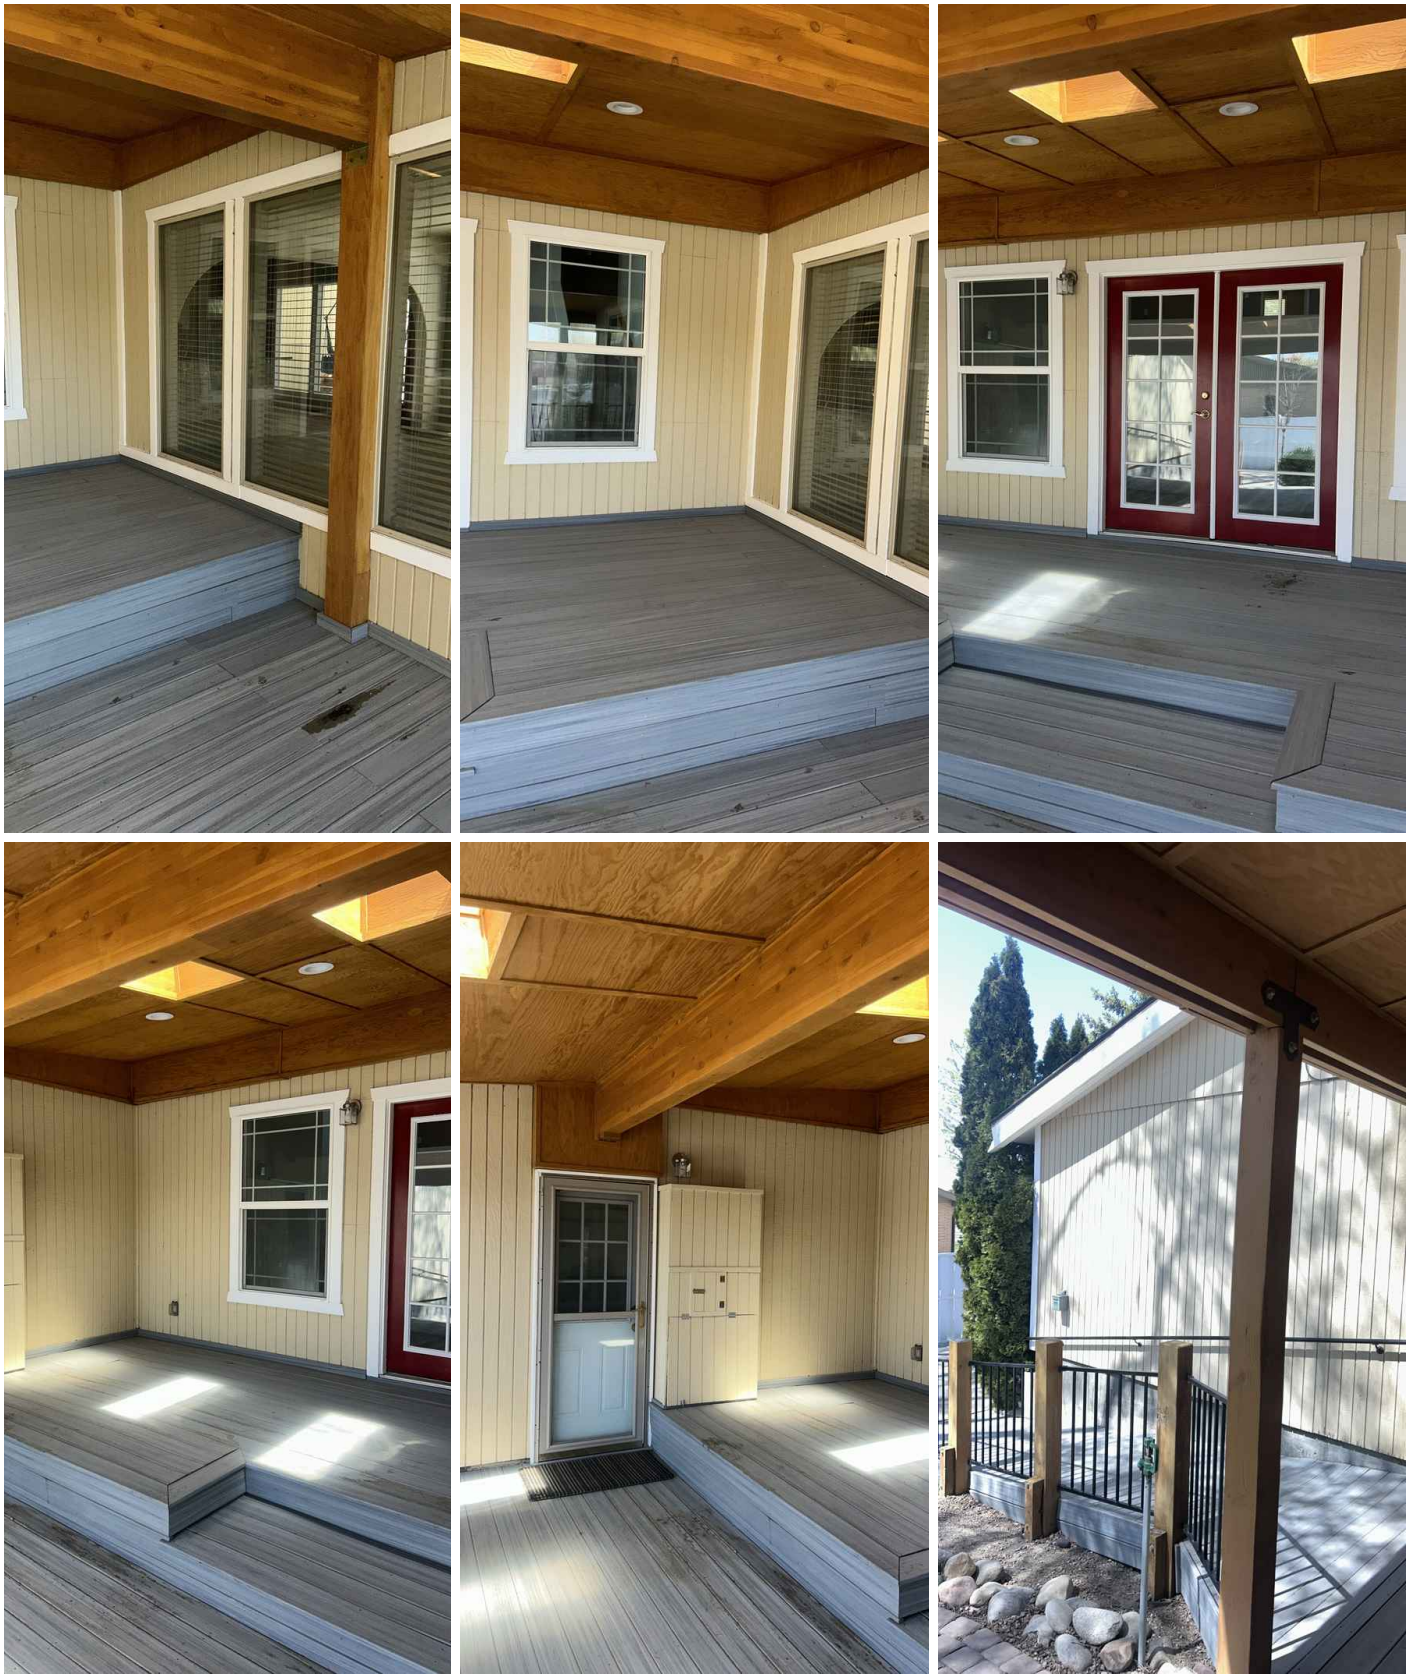
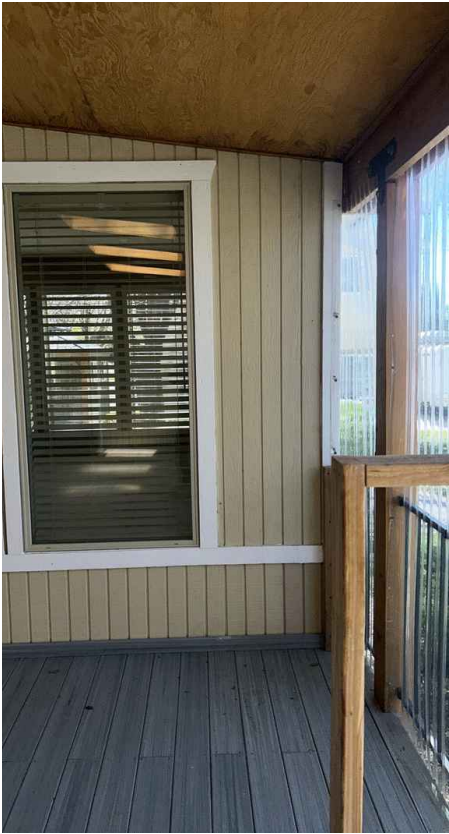
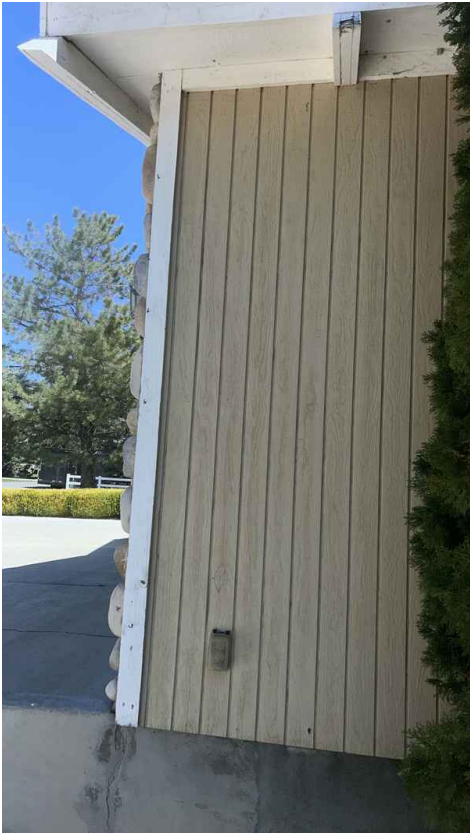
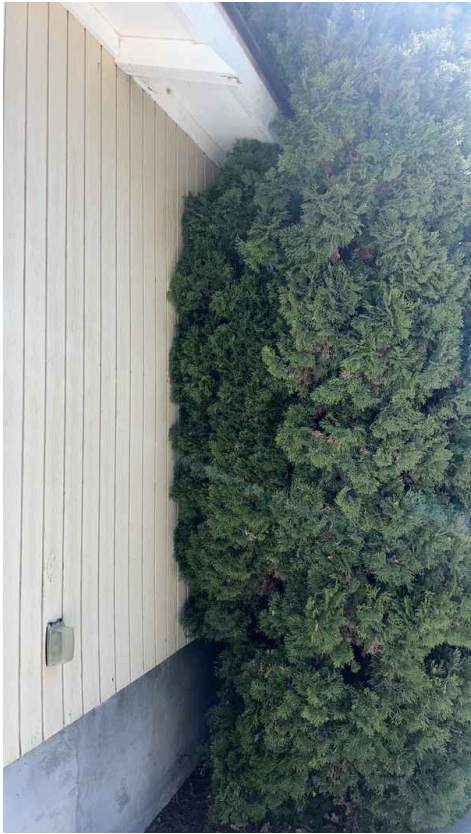
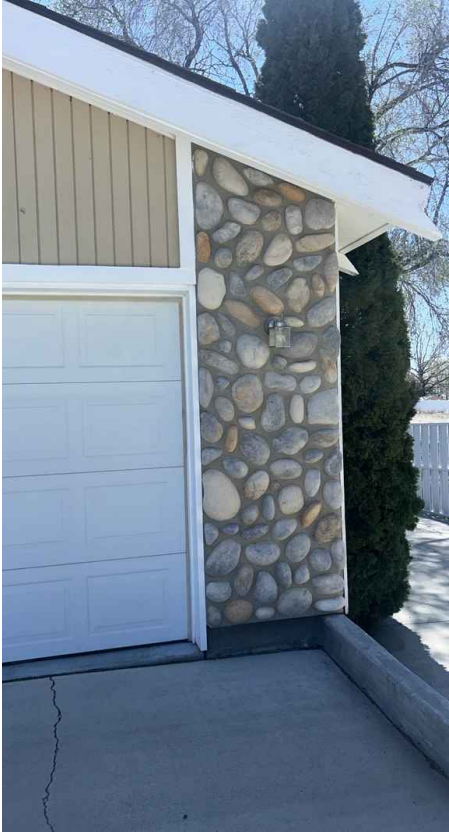
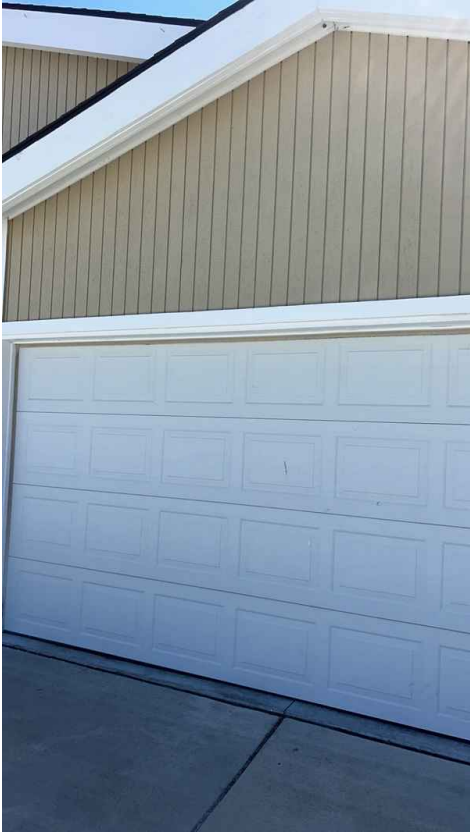
General: Exterior

Exterior Walls / Trim: Wall Cover Wood, Stone or faux stone veneer	Exterior Walls / Trim: Wall cover condition Required repairs or replacement	Exterior Walls / Trim: Wall structure Wood frame
Foundation: Condition Appeared serviceable	Foundation: Material Poured in place concrete	Foundation: Type Crawl space, Some basement

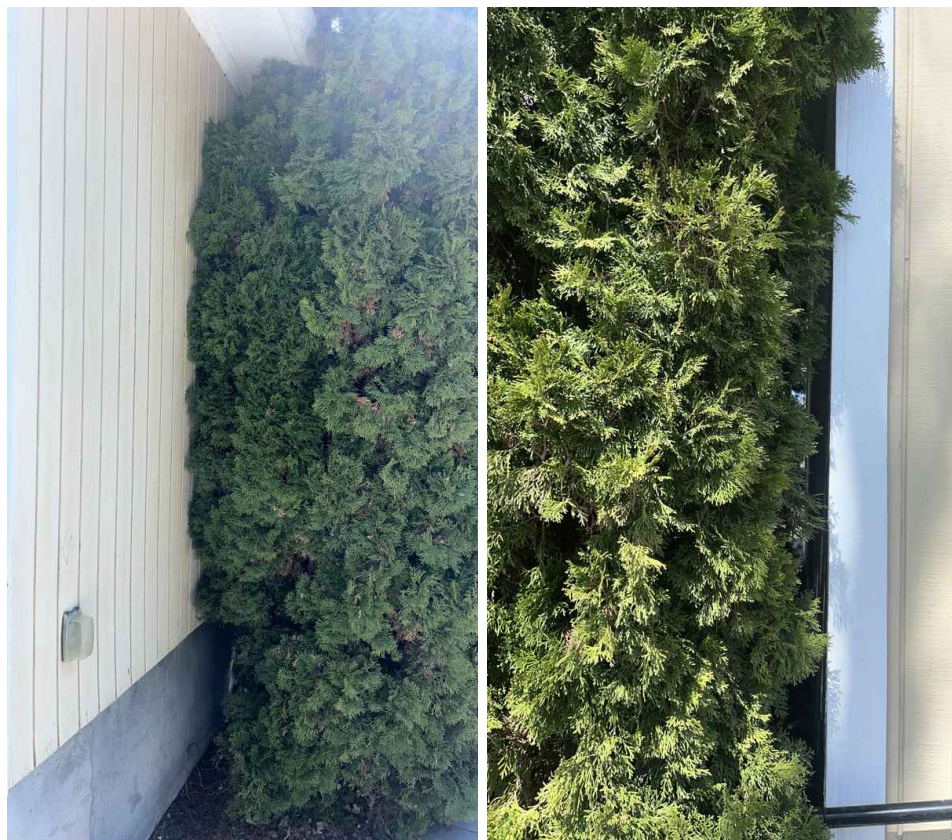
Vegetation was in contact with the home's exterior. Vegetation can retain moisture against the exterior after it rains. Recommend pruning or moving vegetation as necessary to maintain at least 6 inches of space between it and the building exterior. A 1-foot clearance is better.

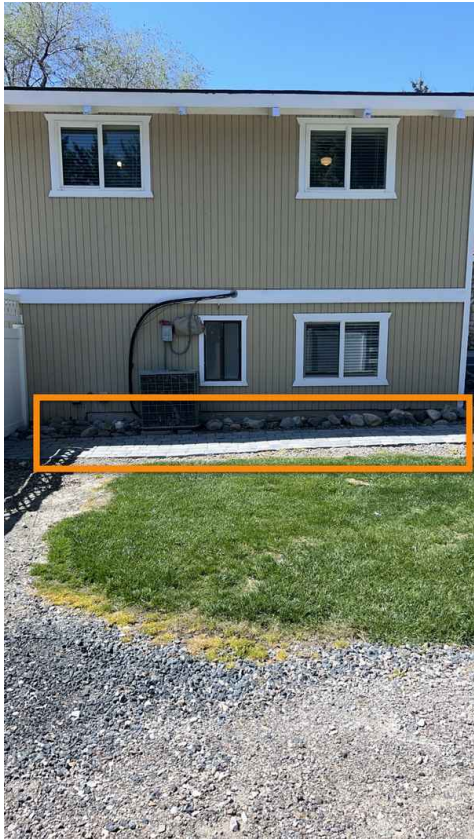
East

SIDING DEFICIENCIES AND ROT

The home's exterior exhibited damaged and/or substandard siding, with areas of rot noted. Evaluation and repair or replacement by a licensed siding contractor are recommended.

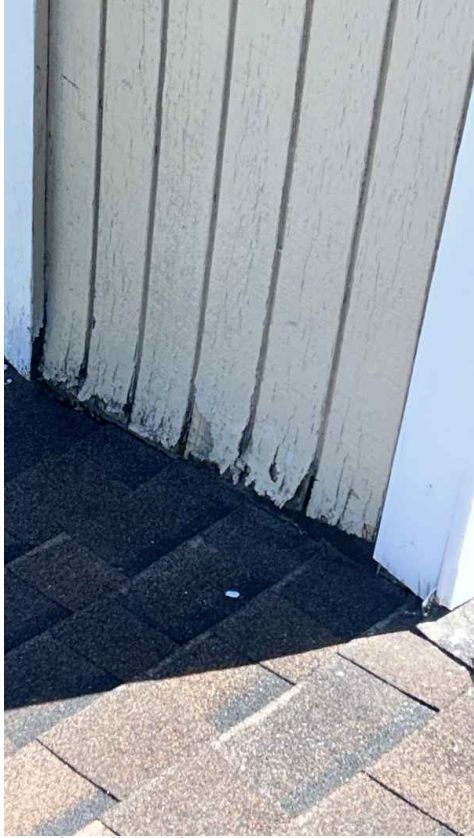
East

Gas fireplace plenum

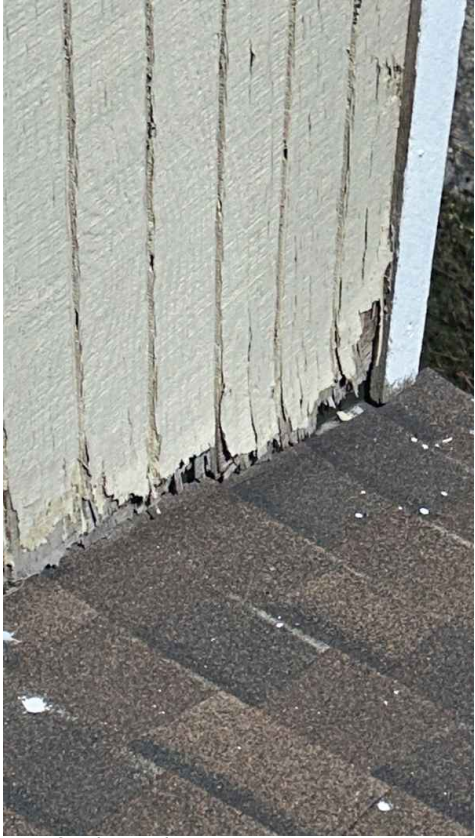
Gas firplace plenum

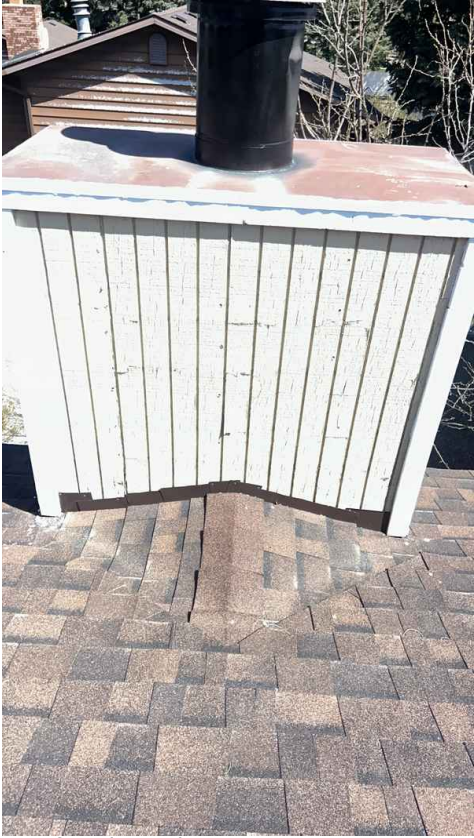
Gas fireplace plenum

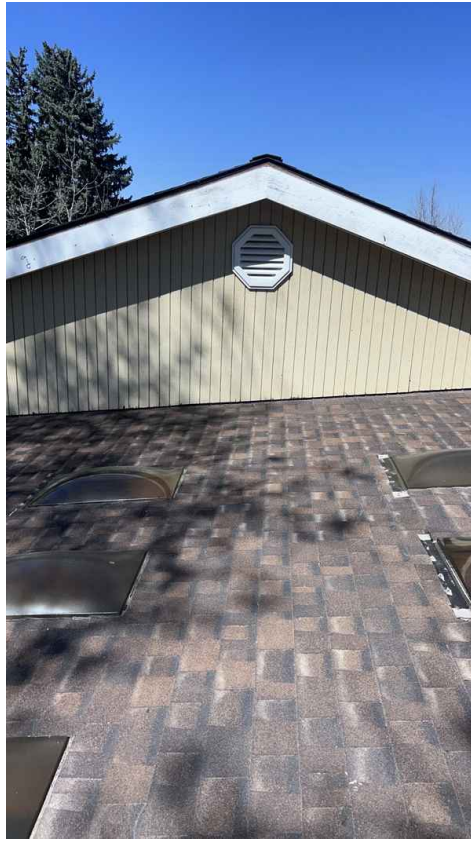
South garage wall over west patio cover

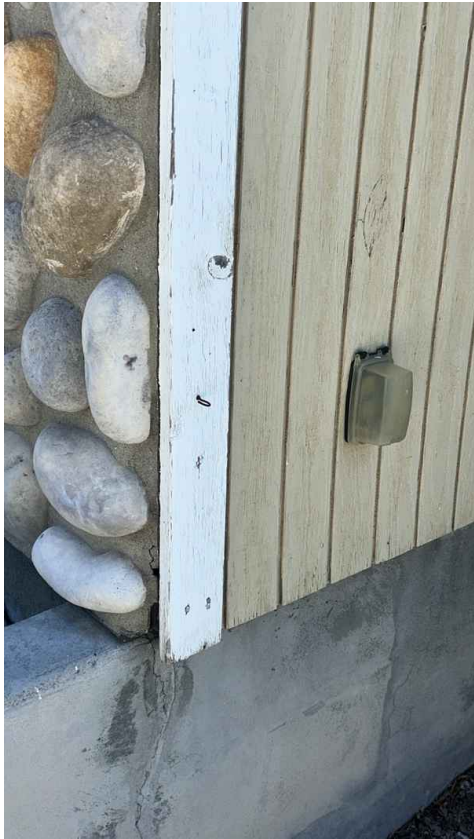
West

Failing paint was observed at the home's exterior which can lead to moisture damage. Recommend maintaining siding/trim where needed.

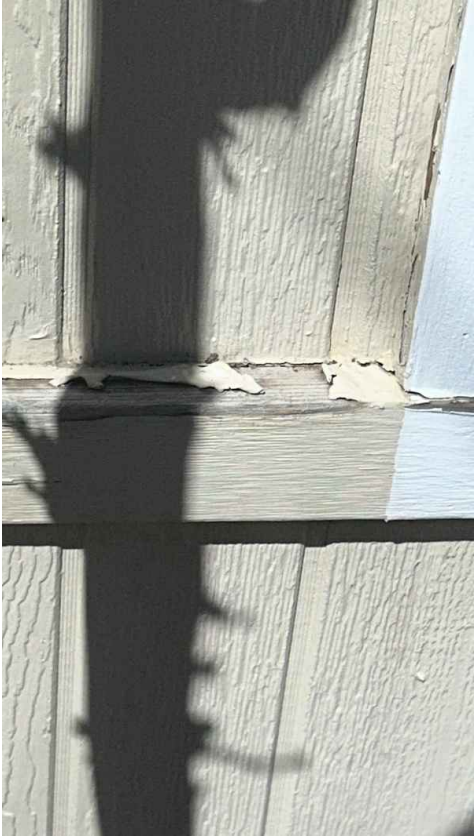
Gas fireplace plenum

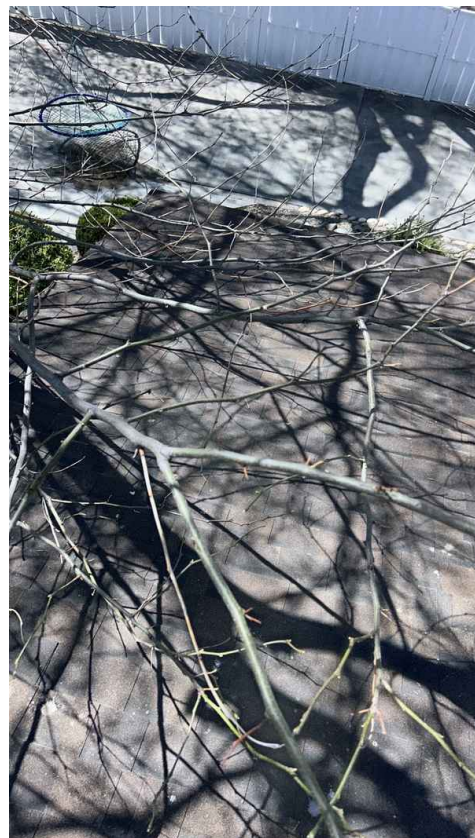
TREE BRANCHES IN CONTACT WITH THE ROOF

Tree branches were in contact with the roof which can damage the roof surface. Recommend pruning vegetation so as to not be in contact with the roof and to not overhang the roof surface. If vegetation is too tall then it should be pruned at least 5 feet above the roof surface.

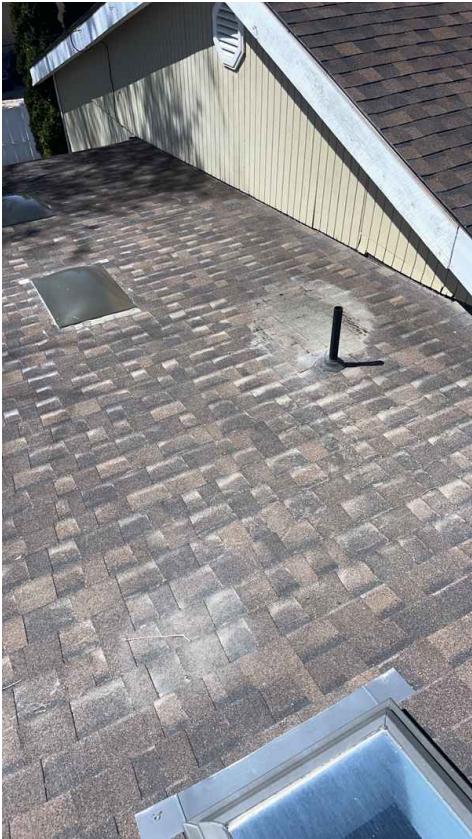
West patio cover

COMPOSITION SHINGLES ON LOW SLOPE SURFACE

The composition shingles were installed on a roof with a slope below the manufacturer's minimum of 3/12. This improper installation leads to slow water runoff, making it highly susceptible to leaks, which have already occurred (as shown in the pictures). Furthermore, this can contribute to roof deck sagging and a decreased ability to handle snow loads. Manufacturer warranties are typically void on such installations. We recommend a qualified contractor repair or replace this roofing area using materials designed for low-slope applications.

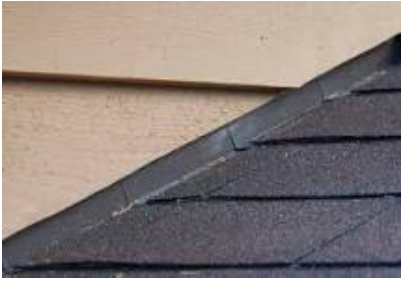
Step flashing was missing where second story siding meets the roof. Water damage has occurred as a result. Recommend installation of proper flashing by a qualified contractor.

Stock image of proper step flashing

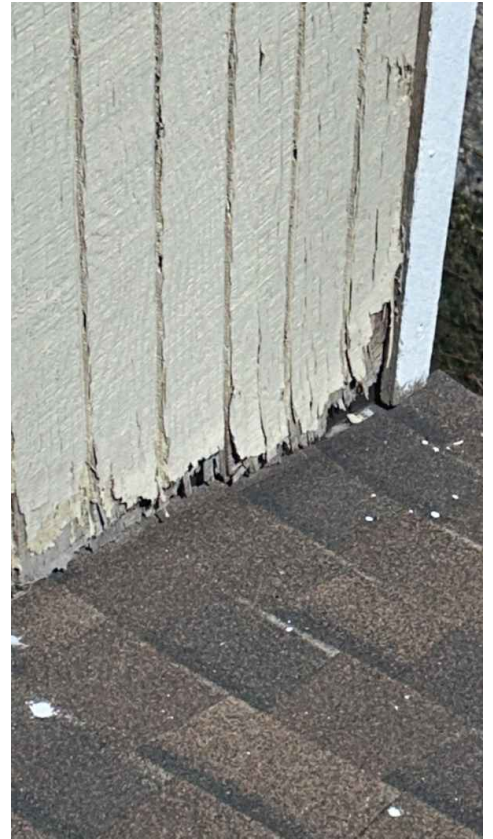
MISSING STEP FLASHING

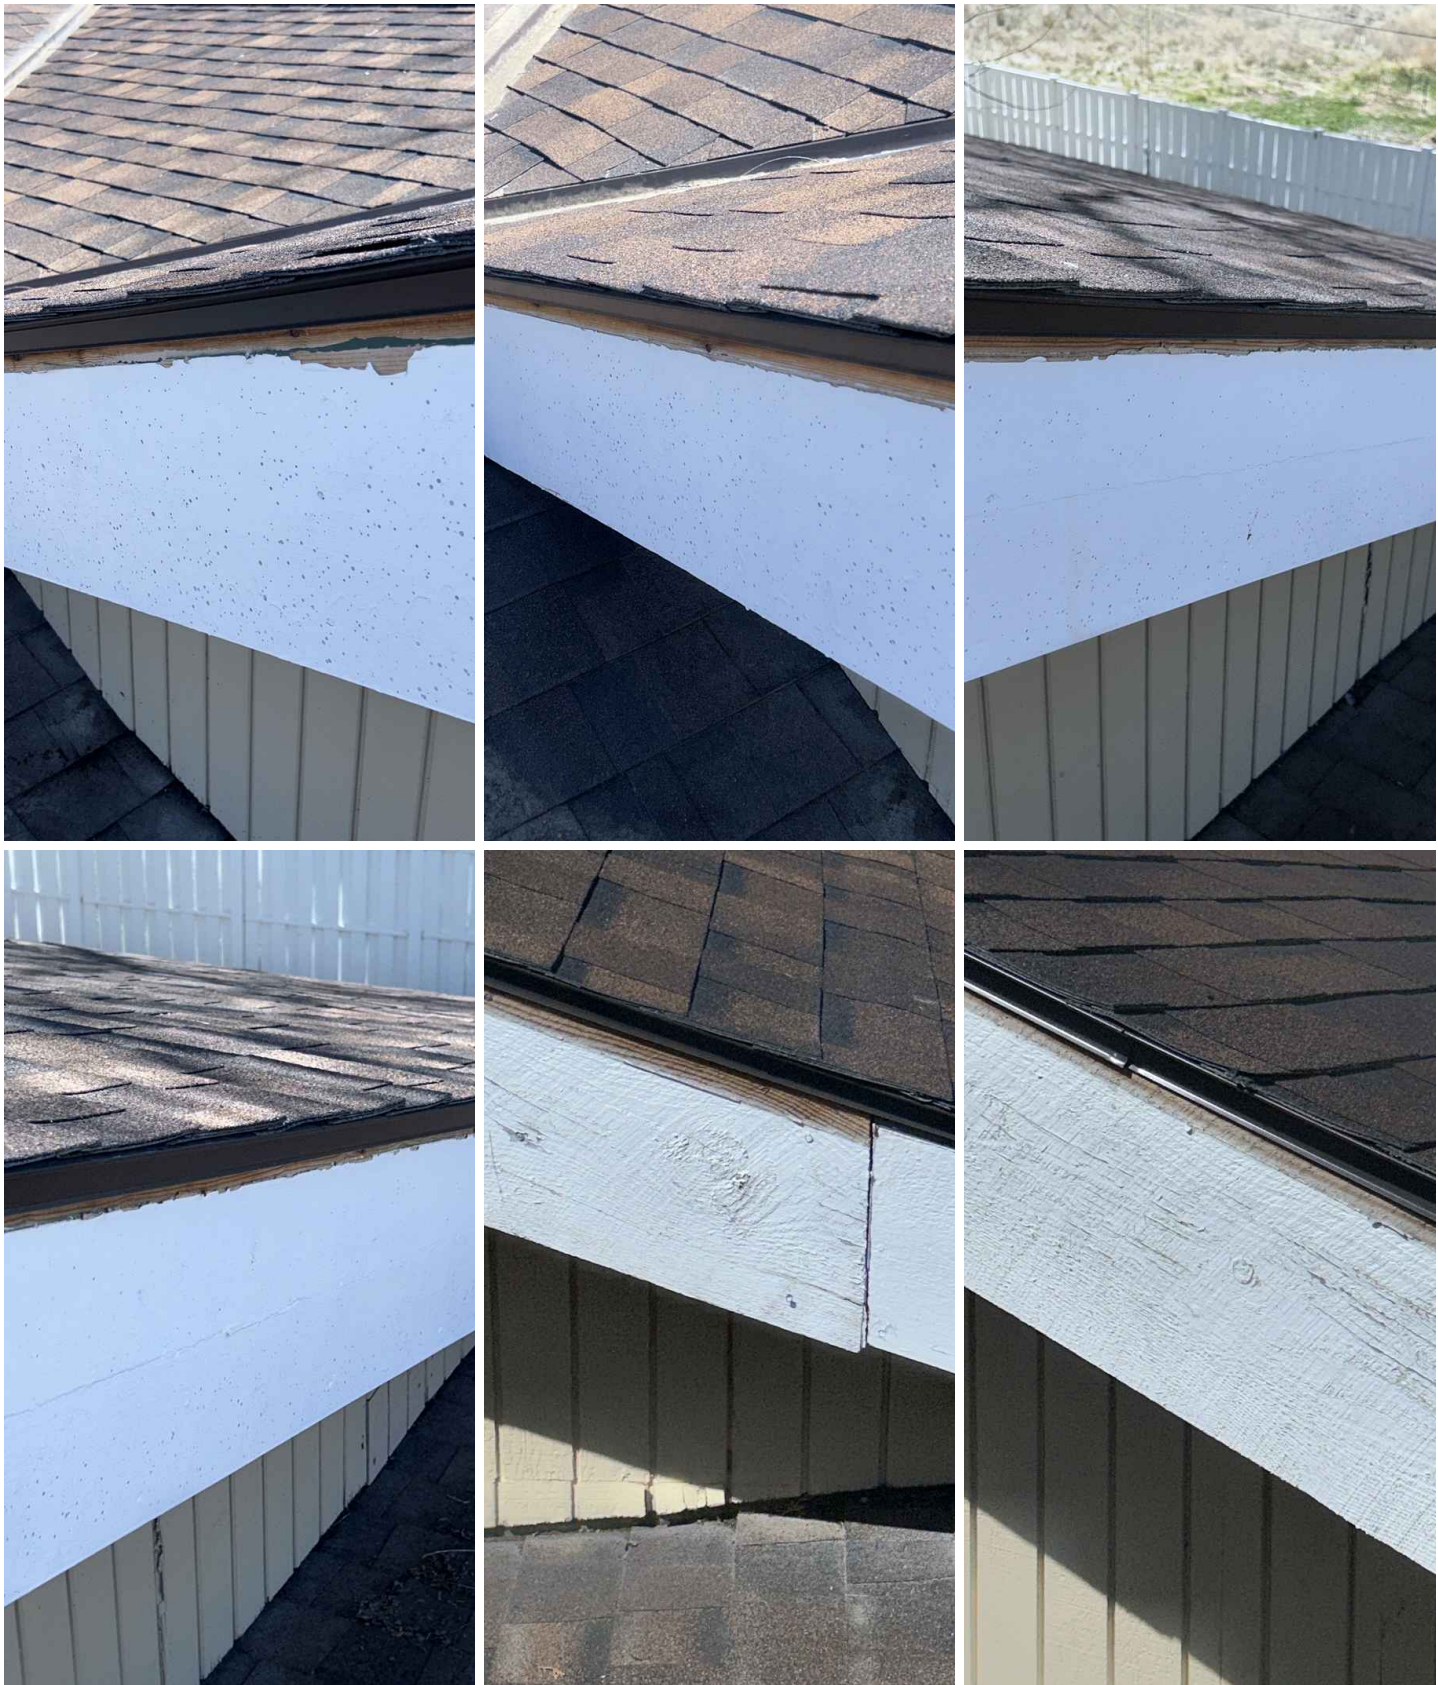
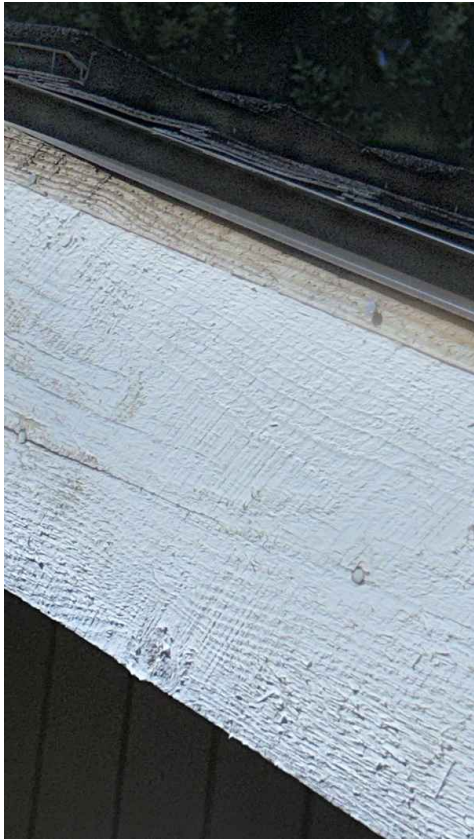
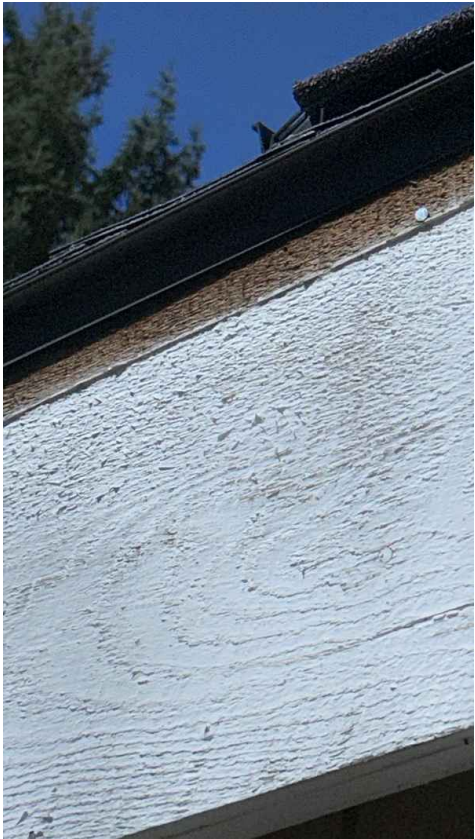
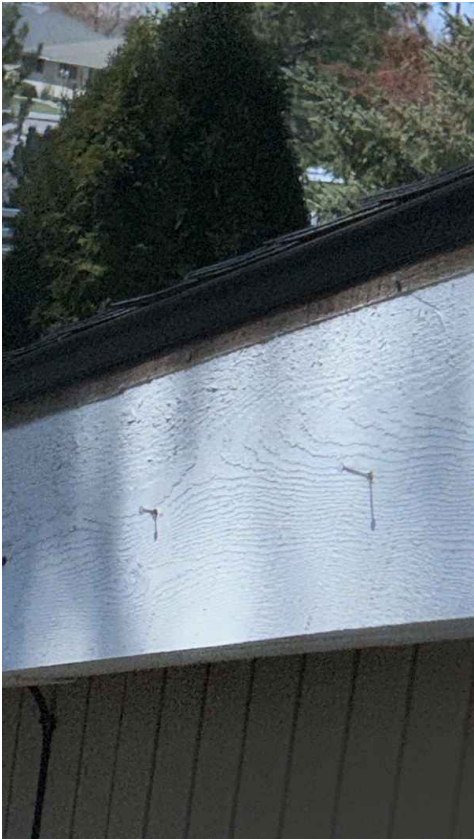
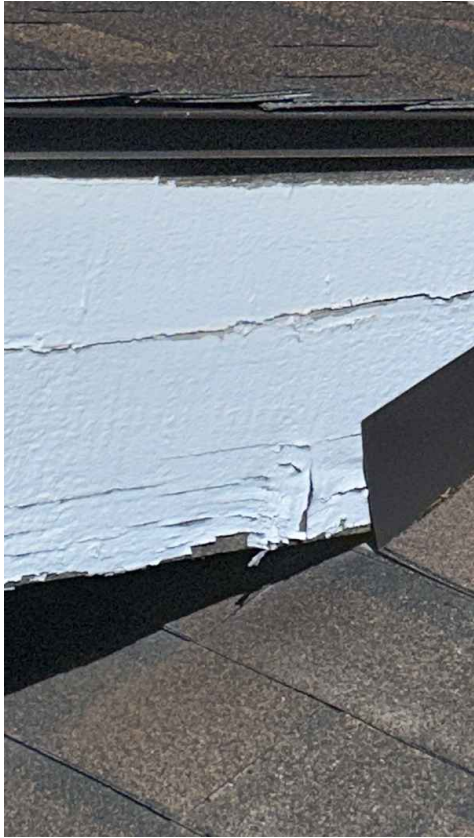
DETERIORATION ON FASCIA

The fascia boards are deteriorated in one or more areas. Recommend evaluation and maintenance as necessary by a qualified person.

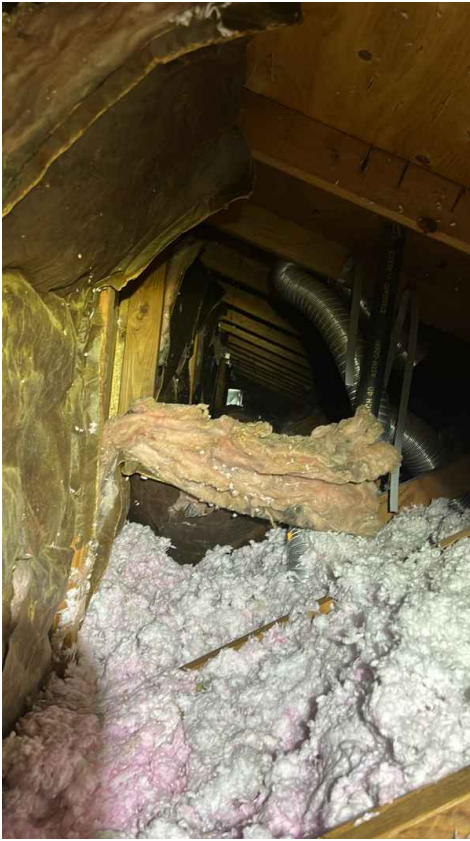
FIBERGLASS INSULATION FALLEN

Some fiberglass rollback insulation had fallen back. Recommend reinstalling by licensed and qualified professional.

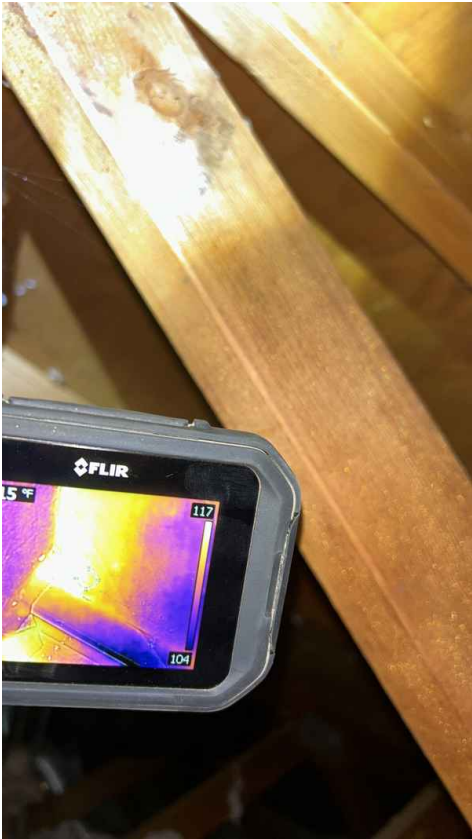
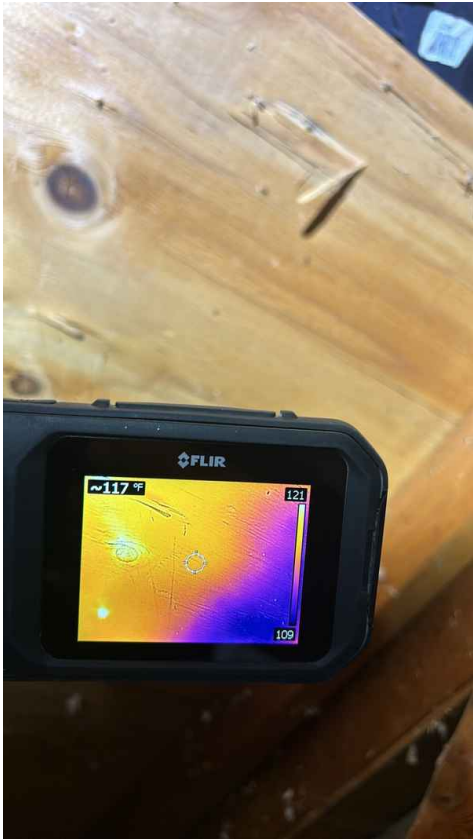
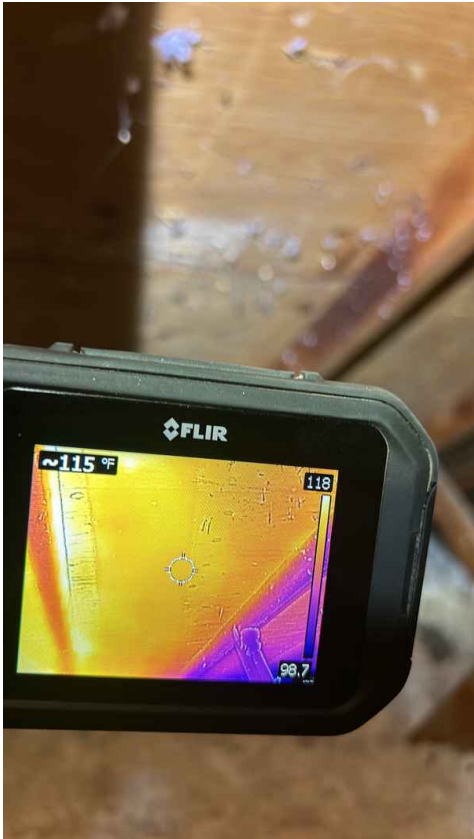
SUBSTANDARD VENTILATION

The roof structure appears to have inadequate ventilation. This deficiency can result in excessive attic and roof surface temperatures, premature deterioration of roofing materials, increased energy consumption for cooling, and moisture accumulation, which can promote mold growth. Standard building practices require balanced ventilation, typically achieved through a combination of soffit and ridge vents, and often mechanical ventilation, to maintain attic temperatures within 10-20 degrees of ambient. Recommend a qualified contractor evaluate and rectify the ventilation system to comply with current building standards.

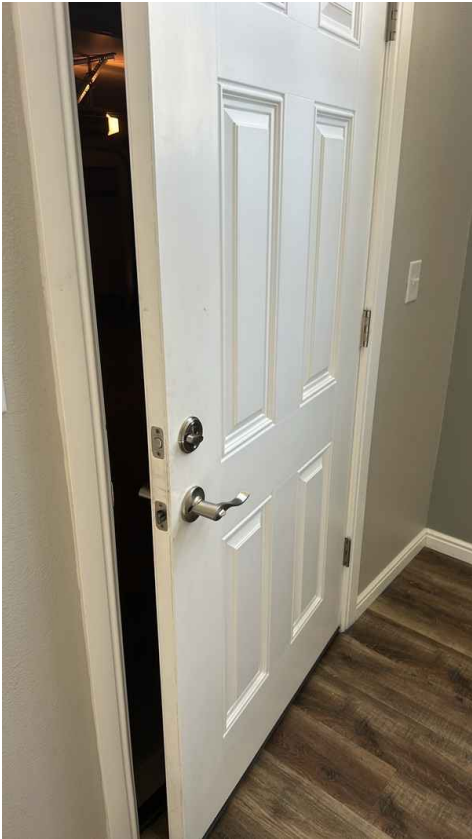
As a safety upgrade, we recommend installing adjustable spring door hinges on the door separating the house and the garage to help prevent the spread of flames should a fire occur inside the garage.

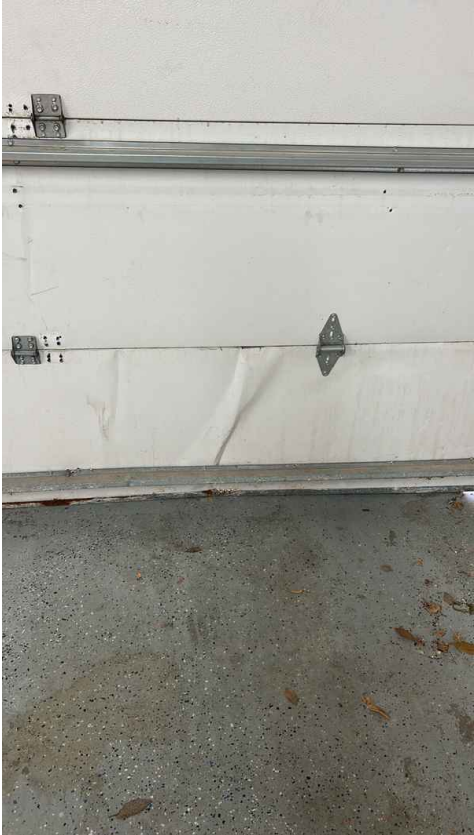
The garage vehicle door was damaged. The damage did not appear to affect the functionality of the door; however, client may want to repair for cosmetic purposes.

Door on the right hand side

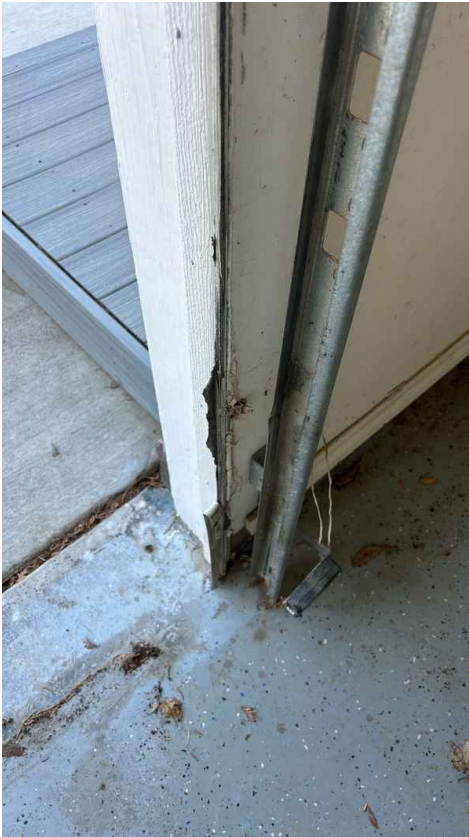
Door on the right hand side

WEATHERSTRIPPING DAMAGED

Weatherstripping on garage doors was damaged. Recommend replacement by a qualified professional.

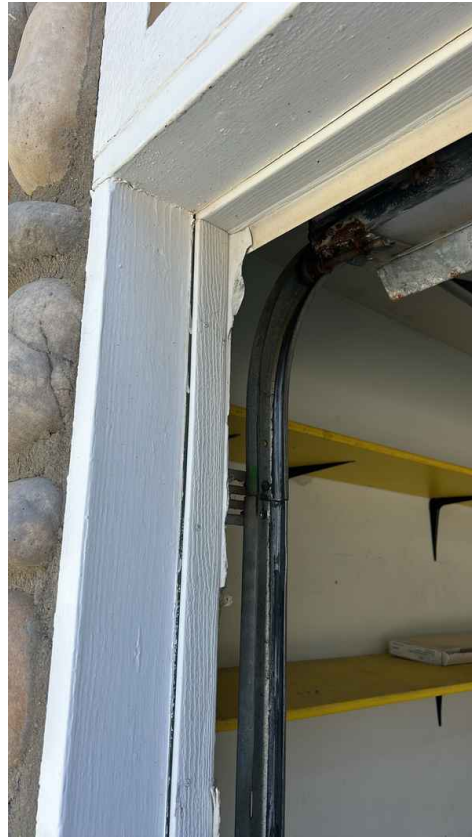
Door on the right hand side

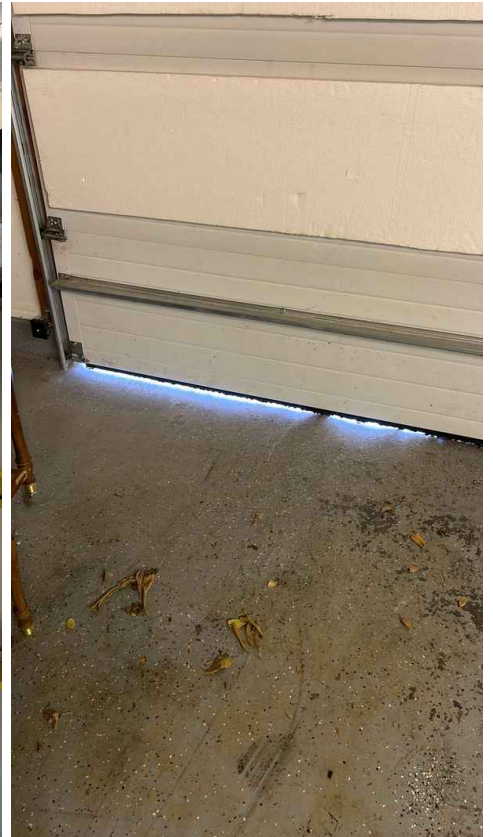
Door on the left-hand side
