SOUTHERN IDAHO HOME INSPECTIONS, LLC

RESIDENTIAL INSPECTION

3348 Highlawn Dr
Twin Falls, ID 83301

04/14/2025

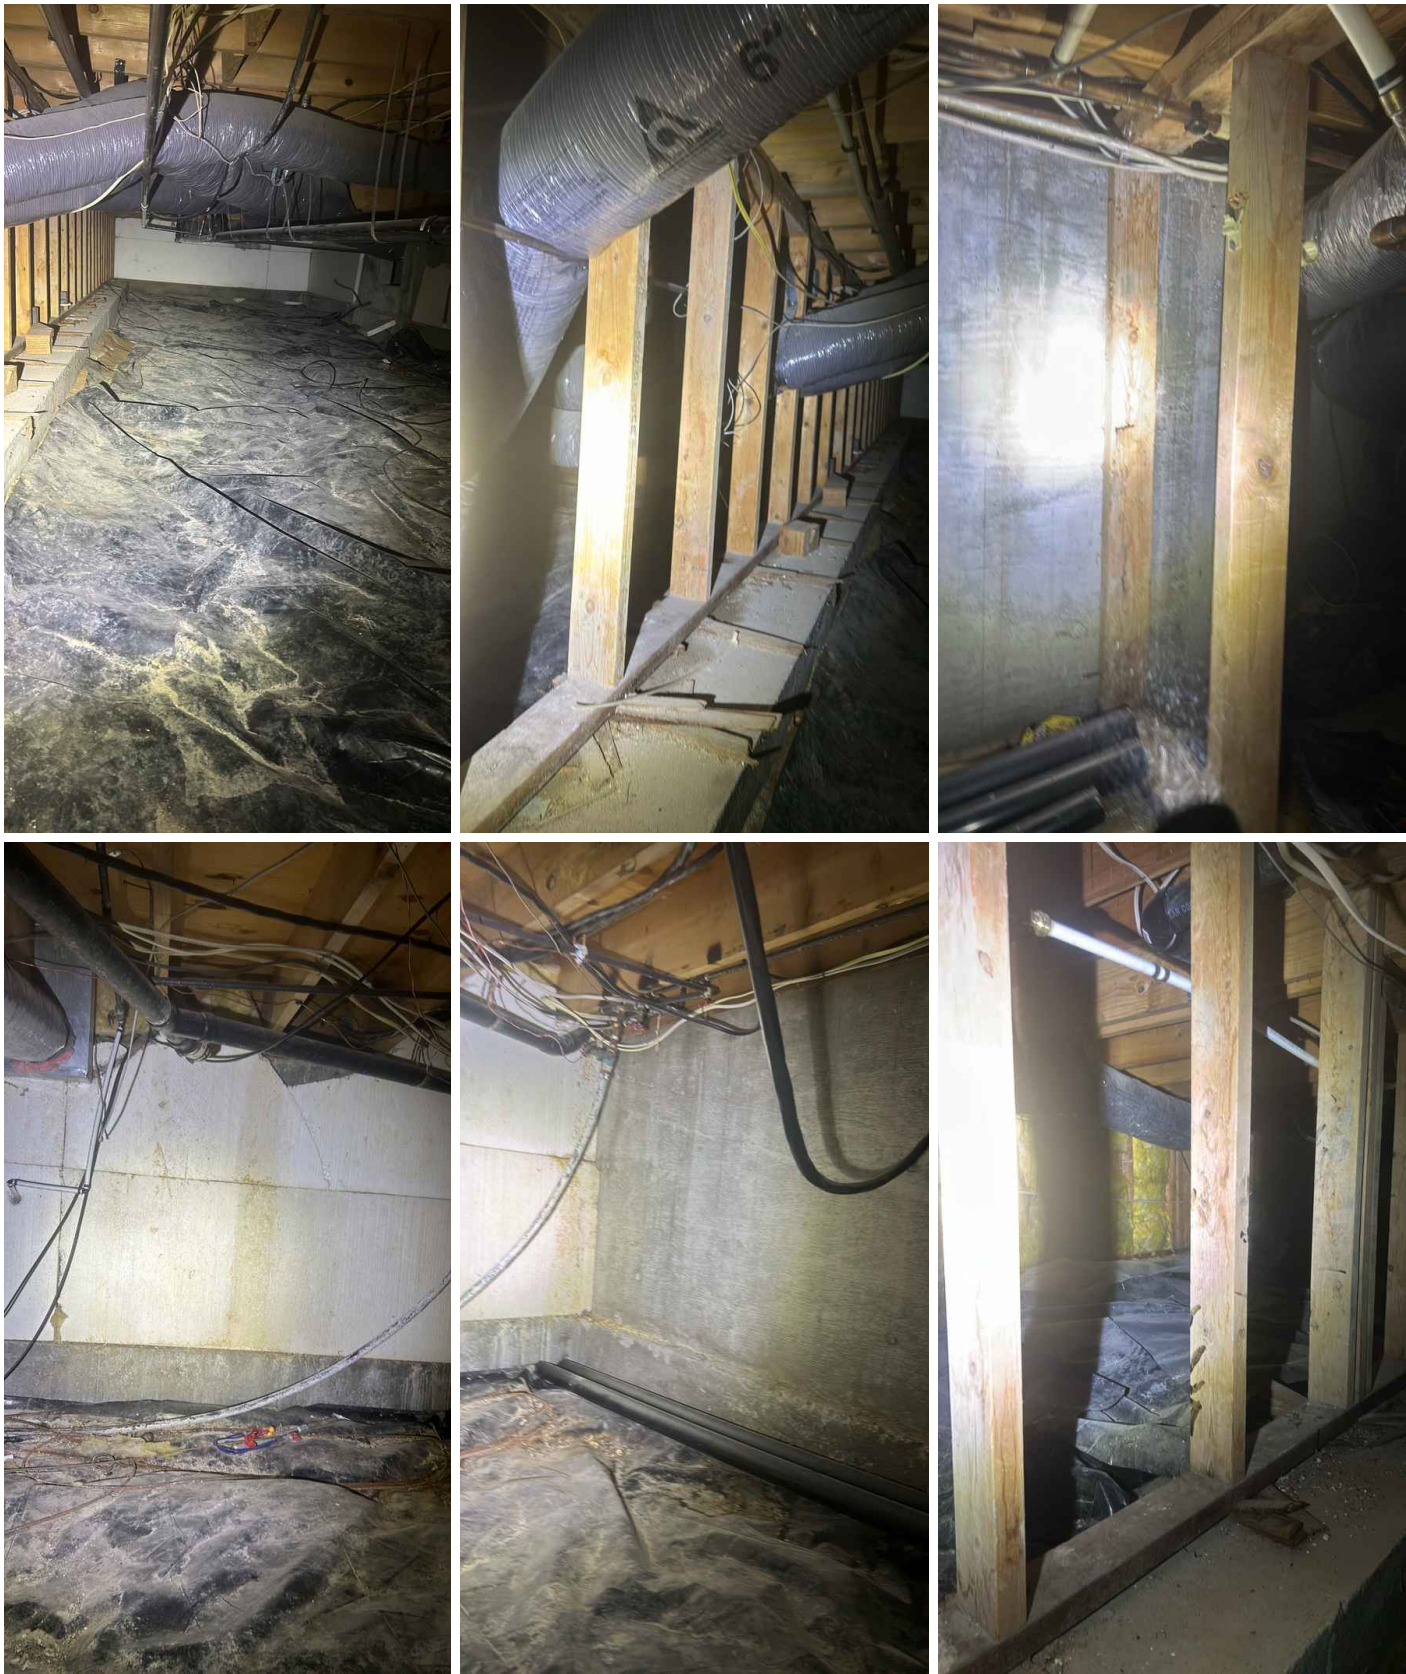
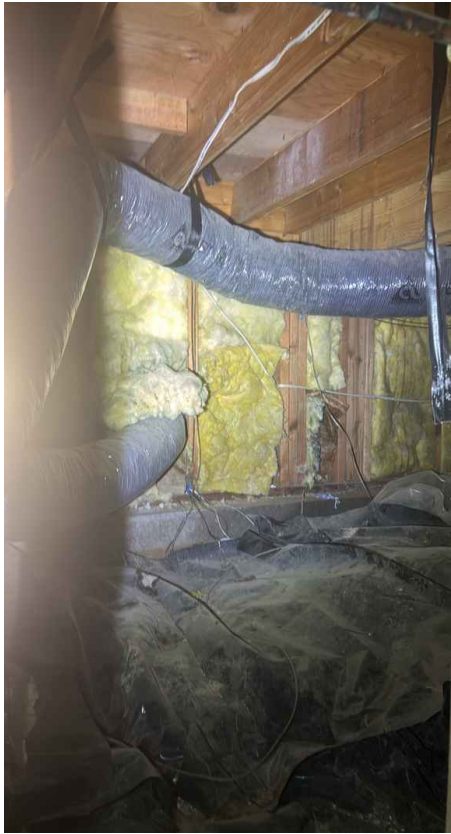
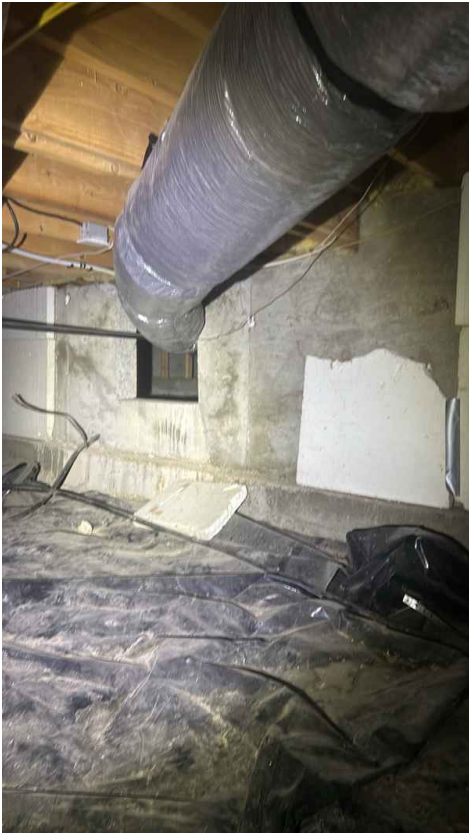
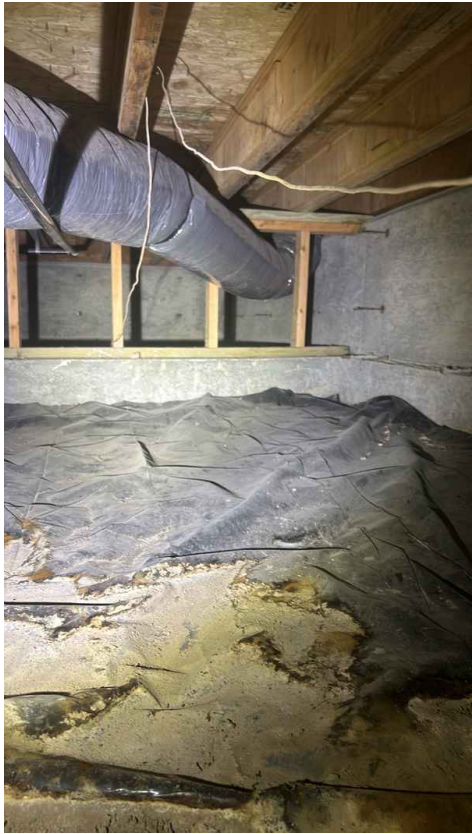
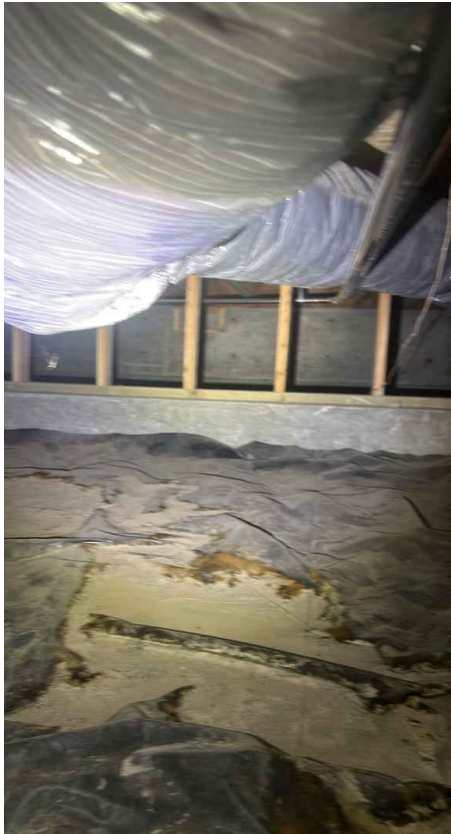
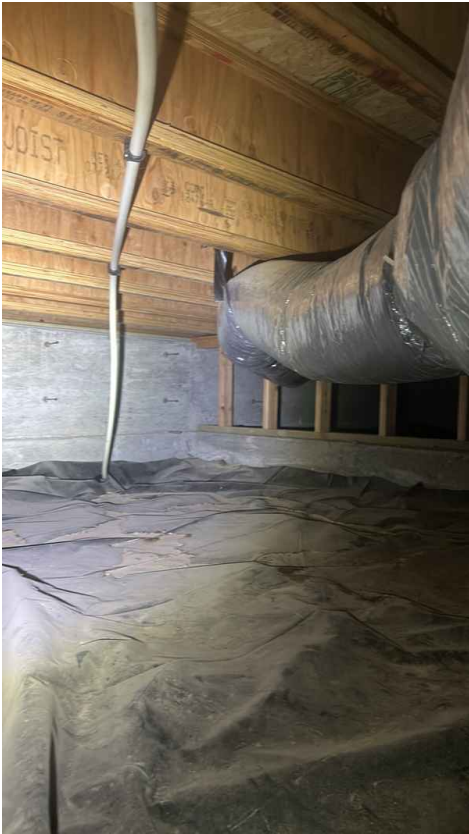
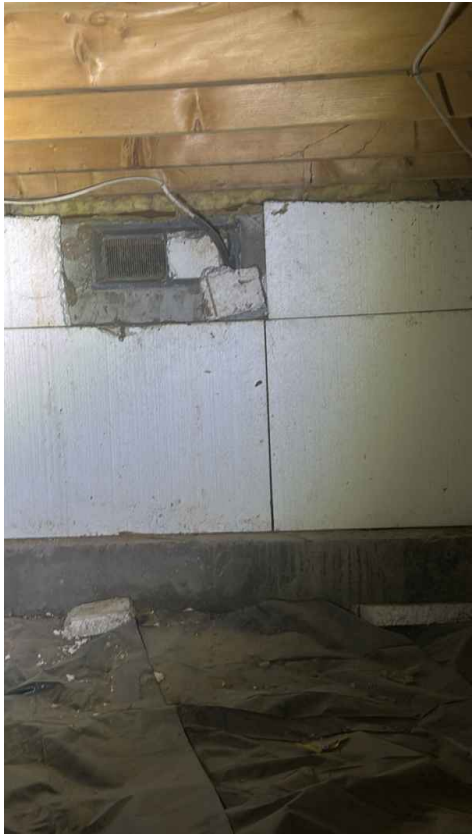
General: Crawl Space

Vapor Barrier: Condition
Appeared serviceable

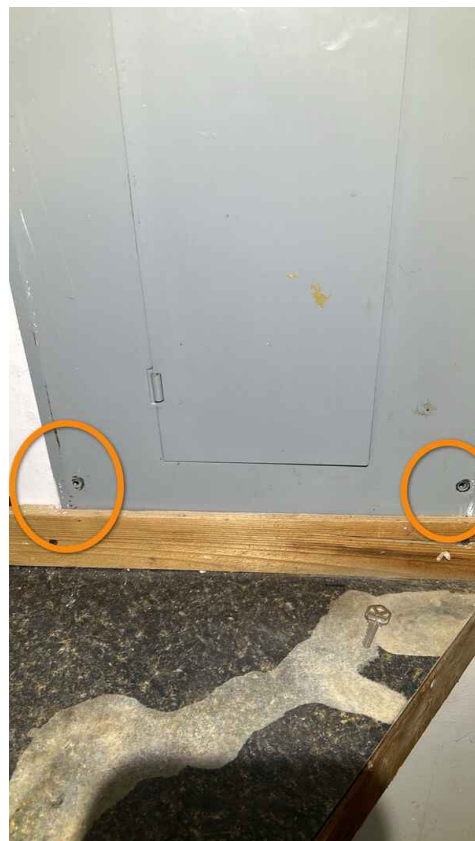
MISSING FASTENERS

The electrical panel cover was missing fasteners. Recommend repair by a qualified professional.

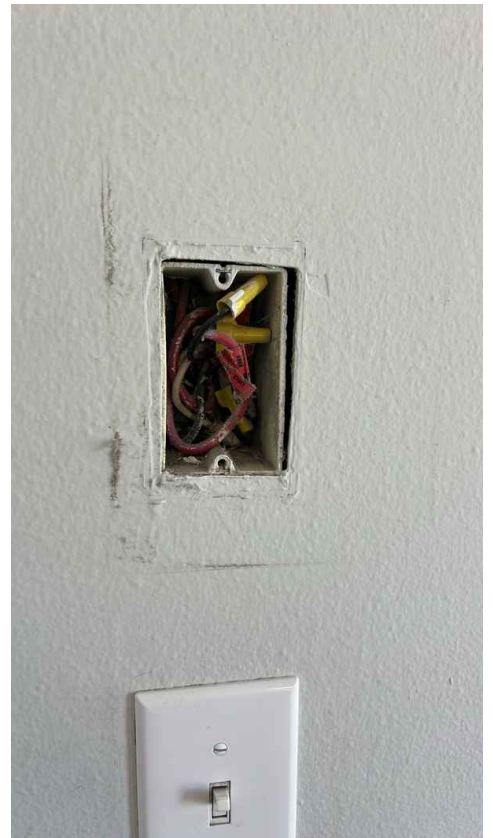
North bedroom

MISSING OR DAMAGED COVER PLATES

Missing and/or damaged cover plates were observed. This is a shock hazard due to exposed electrical wires. Recommend that a qualified professional install/replace cover plates where necessary.

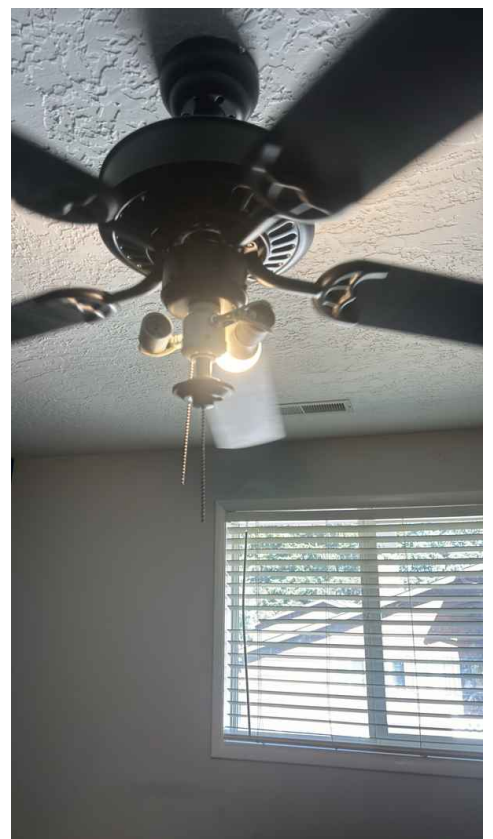
East bedroom

GLOBES OR COVERS MISSING

Globes or covers for light fixtures were missing. Recommend replacing as necessary to avoid exposed bulbs.

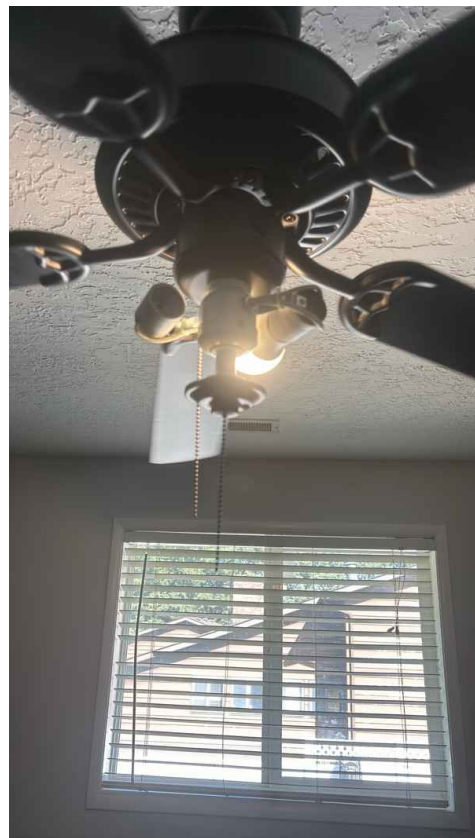
East bedroom

INOPERABLE OR MISSING BULBS

The bulbs in one or more light fixtures appeared to be inoperable. Recommend replacing bulbs and verifying proper operation.

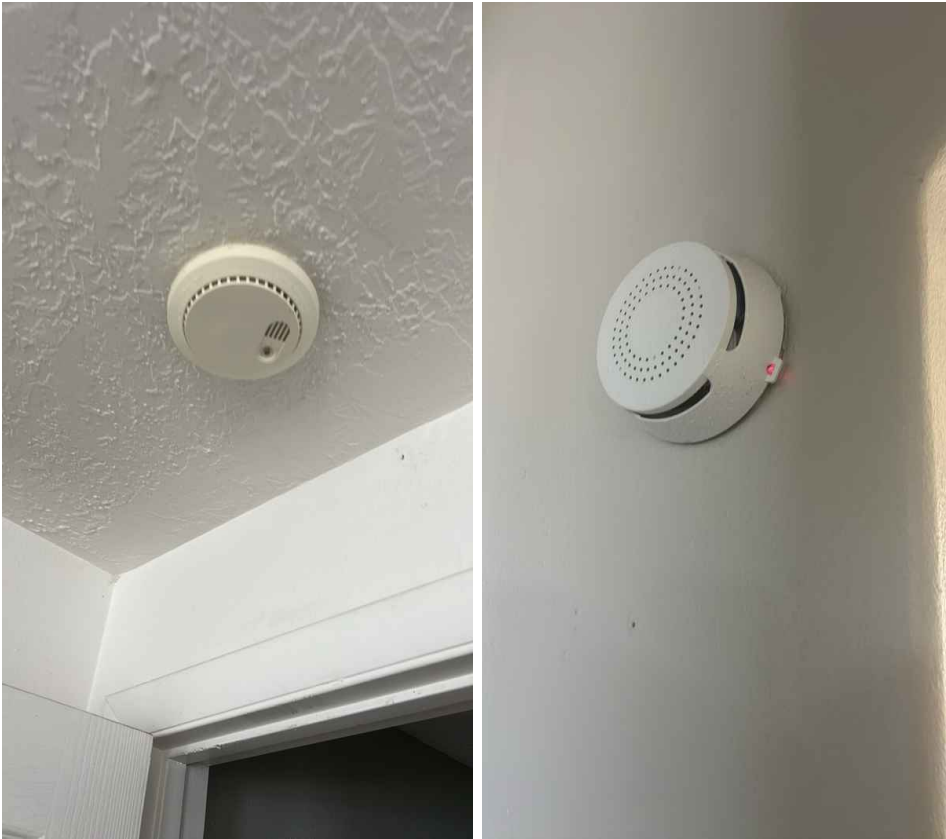
OLD SMOKE ALARMS

Most smoke alarms have a life span of 8-10 years. After this time, the entire unit should be replaced. As alarms get older, the potential for failure increases, as the sensitivity, and therefore the effectiveness of the smoke detector continues to reduce over time. Most alarms have the date of manufacture inside the unit. If you cannot find the date, replace it. When you install the new alarm, write the purchase date inside the cover.

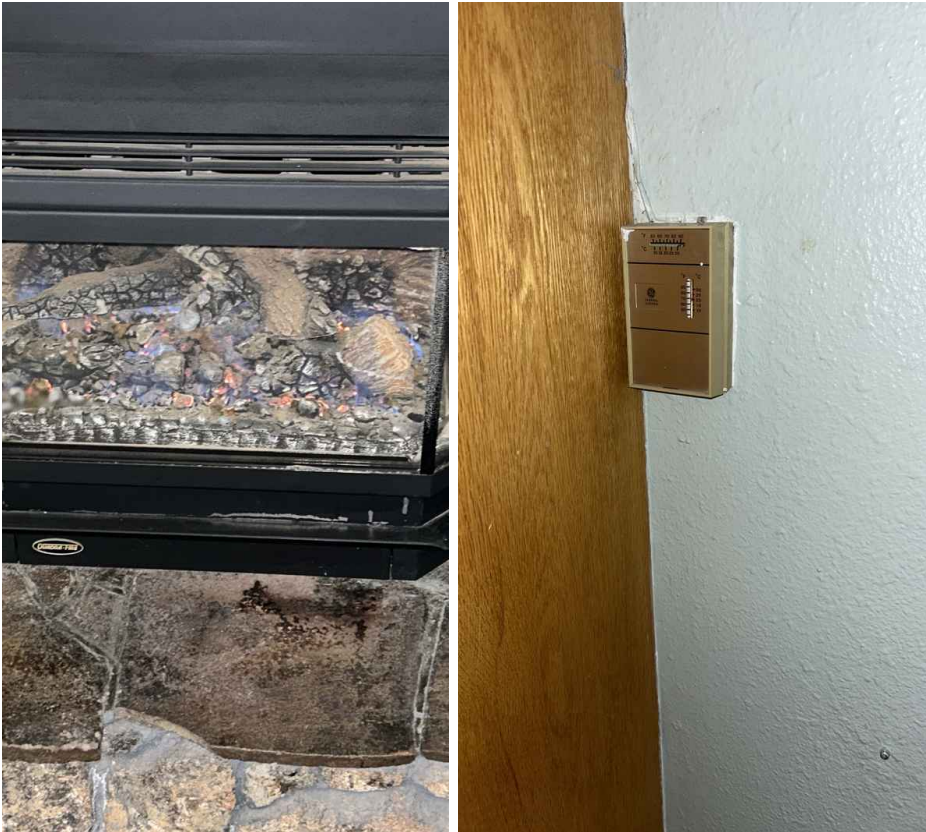
General: Fireplace

Gas-fired fireplace, stove, or log lighter: Condition Appeared serviceable	Gas-fired fireplace, stove, or log lighter: Gas Type Metal pre-fab fireplace
--	--

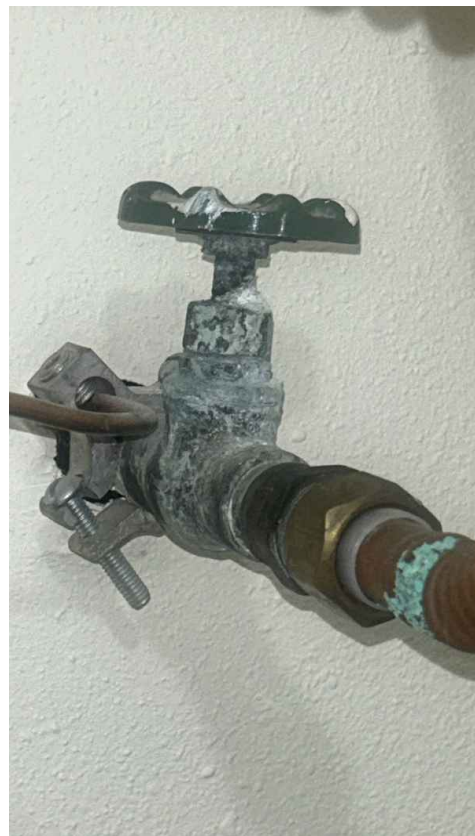
Water heater room

CORROSION ON SHUT-OFF VALVES

Corrosion was observed on the water heater's shut-off valve. A qualified plumber should evaluate and repair if necessary.

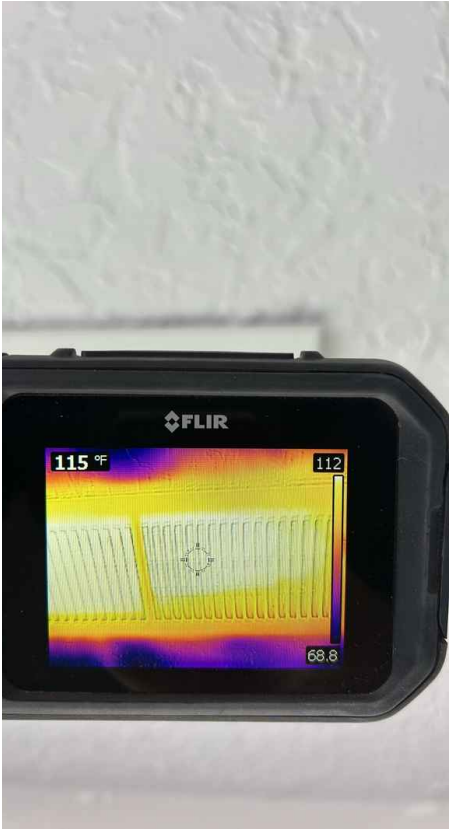
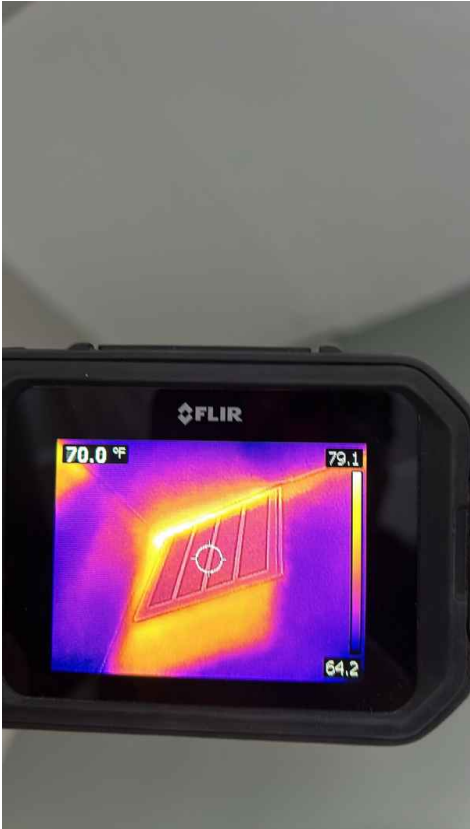
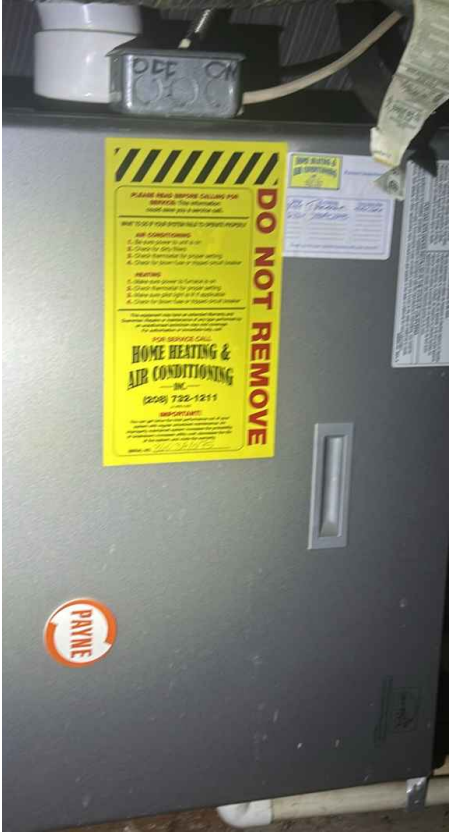
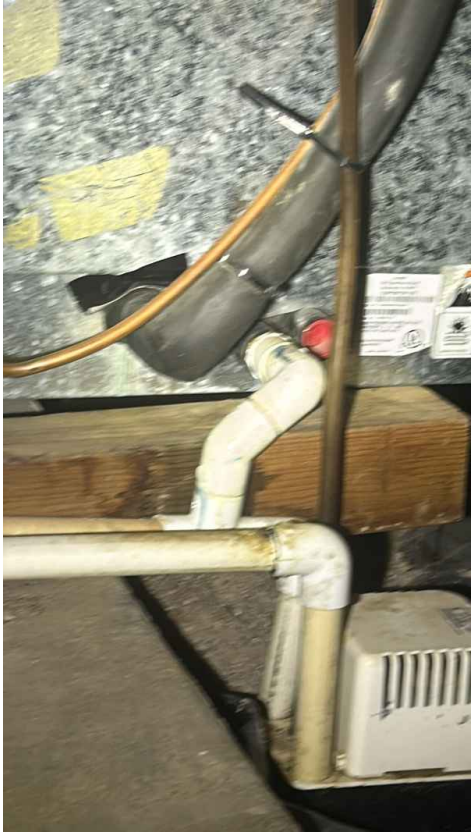
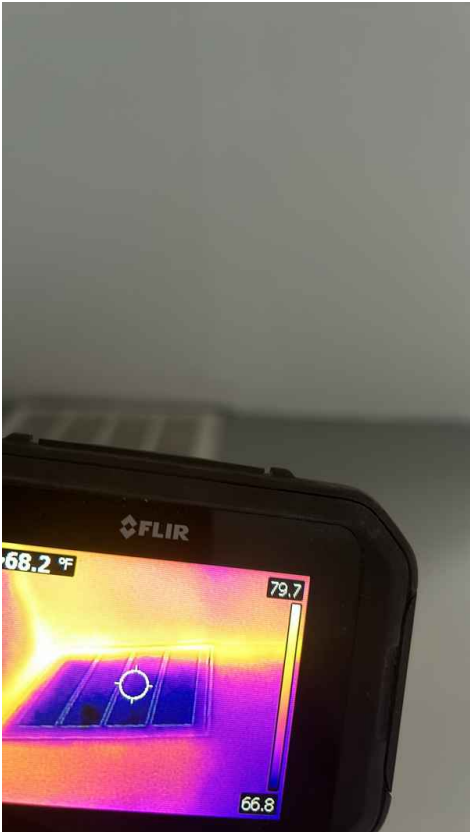
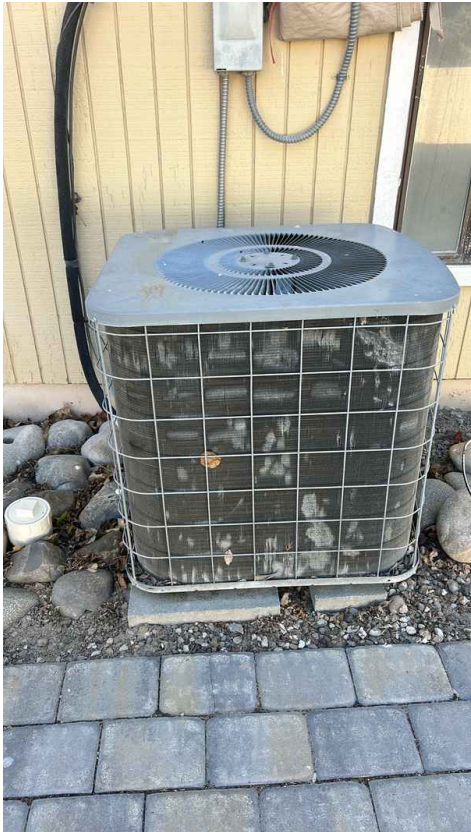
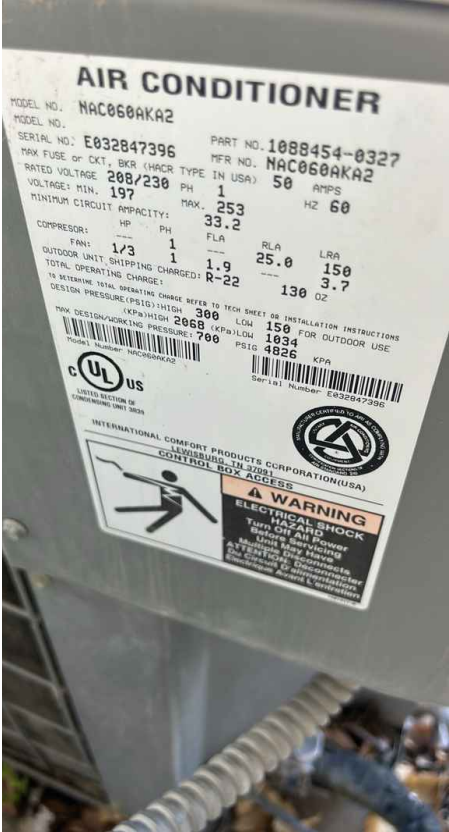
General: HVAC system

Appeared serviceable

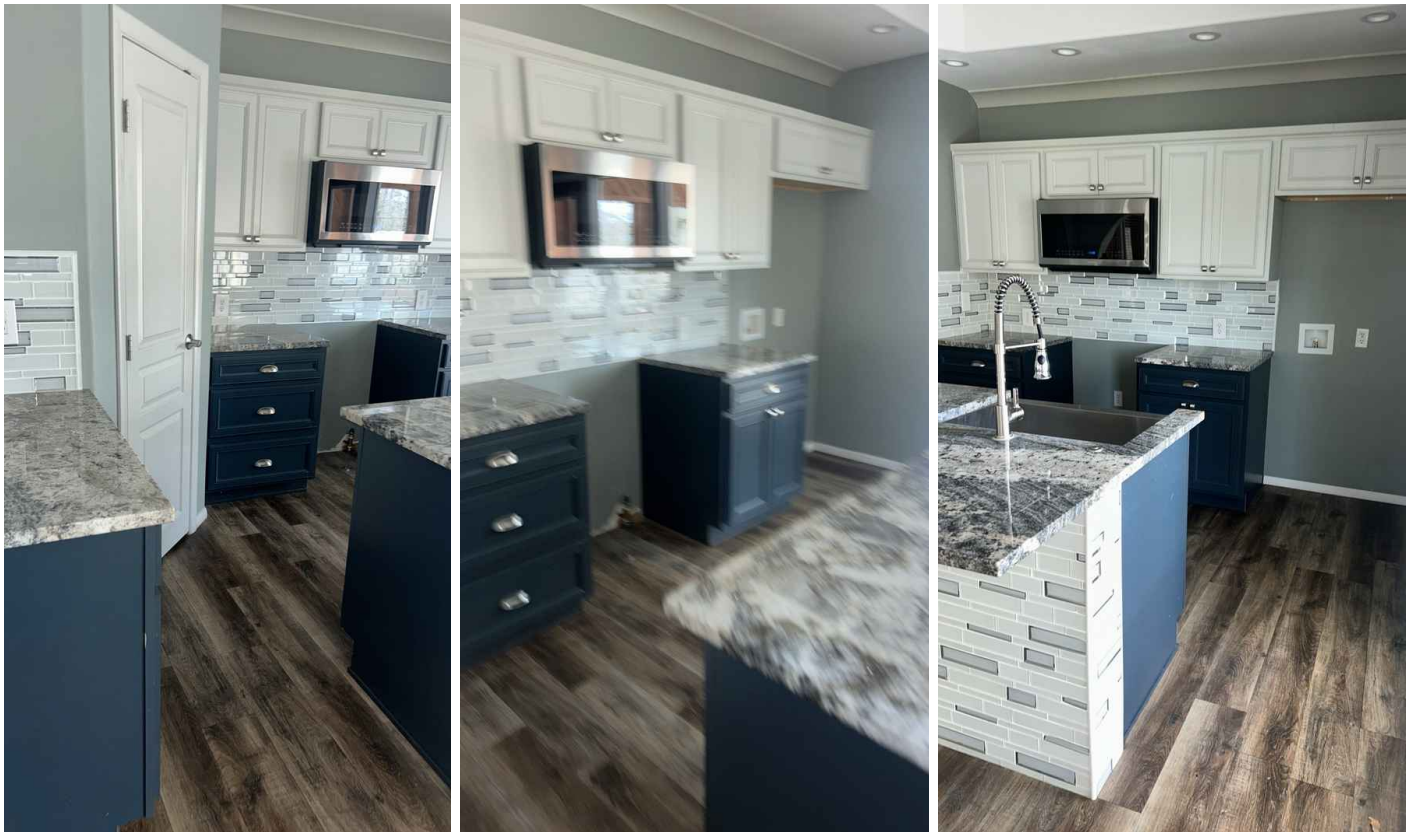
General: Kitchen

Appeared serviceable

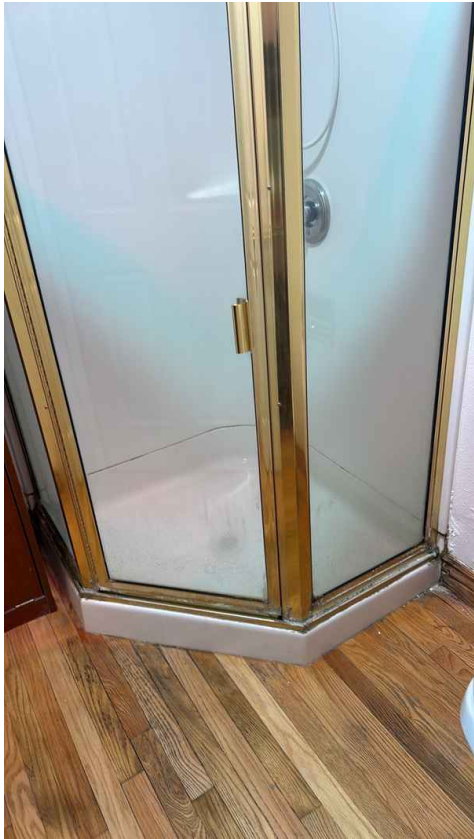
Master shower

Due to a leaking and/or substandard primary bathroom shower enclosure, water has caused damage to the surrounding wall areas. We recommend evaluation and repair or replacement by a qualified contractor.

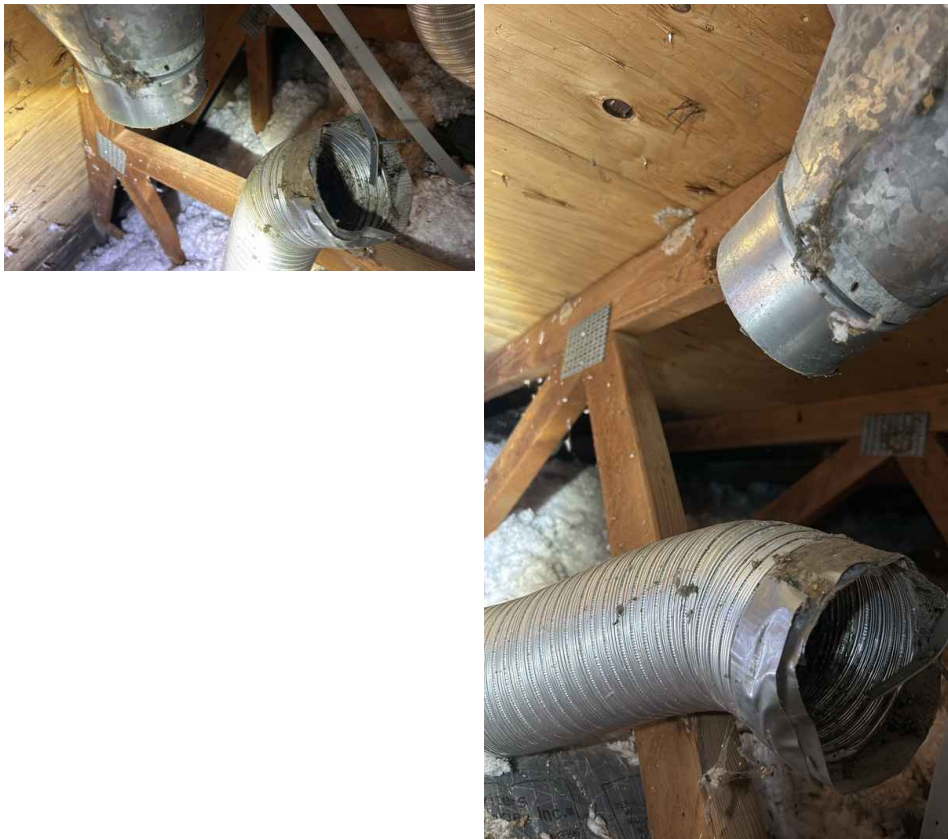
Bathroom exhaust fans vent into the attic. This creates high levels of moisture and is a conducive condition for mold. Fans should exhaust to the exterior; either through the roof or the sidewall. A qualified professional should evaluate and and repair as per standard building practices.

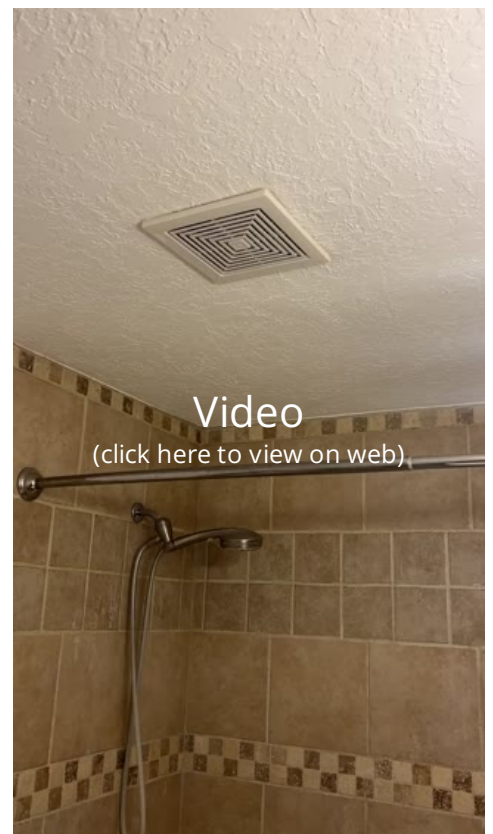
EXHAUST FAN- REPLACE

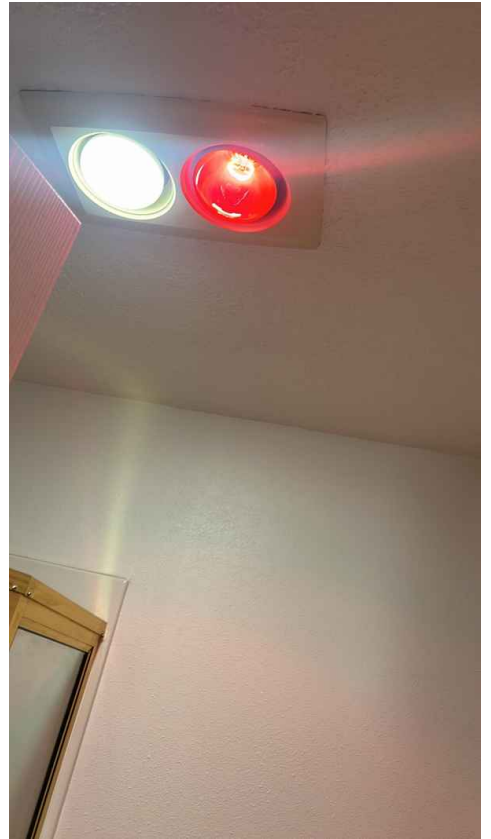
Fan/light/heater lamp combo

INADEQUATE EXHAUST FANS

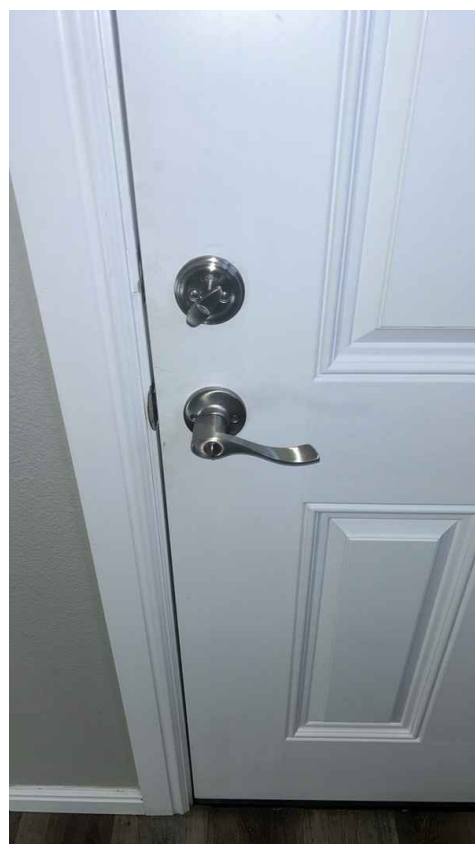
Garage to house door

DEADBOLT INOPERABLE

The deadbolt on the garage to house door was inoperable. Recommend repair by a qualified professional.

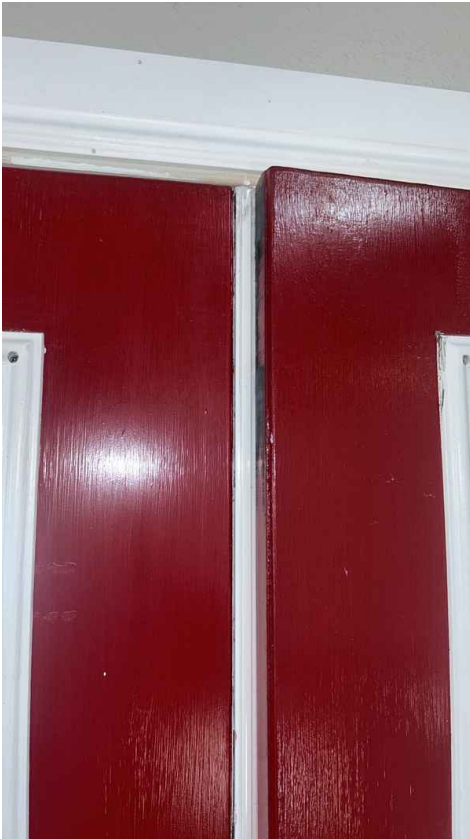
Rear exterior, french door

REAR FRENCH DOOR

One door was binding in the jam when operated. Adjust and make repairs as necessary.

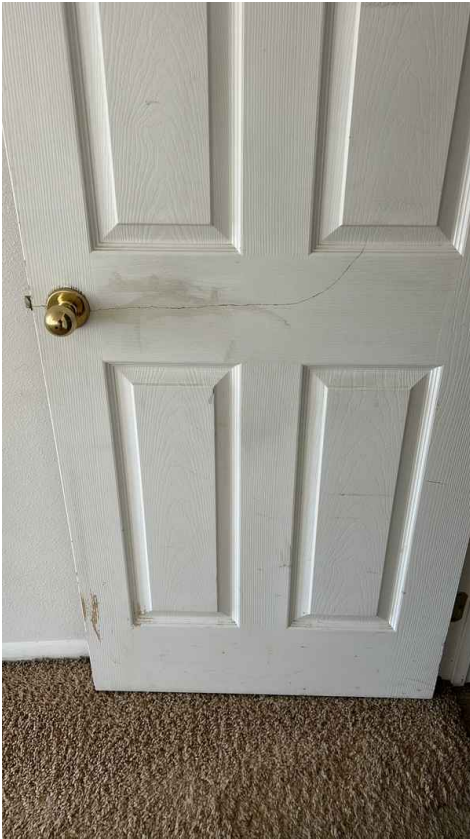
Master bedroom

Damage on interior doors was observed. Recommend repair or replacement by a qualified professional.

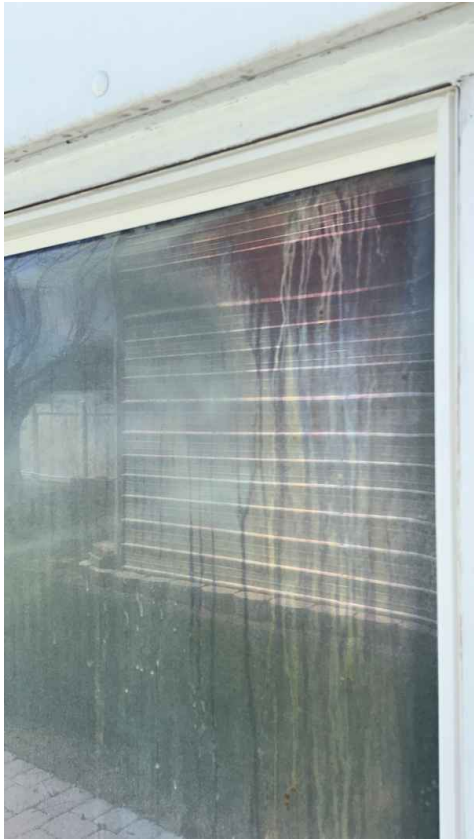
Jacuzzi area, East wall

One or more windows exhibited failed seals between the panes of glass. This can lead to obscured views, reduced energy efficiency (R-value), and potential water damage to the wall structure from condensation. We recommend a qualified contractor evaluate all windows and repair or replace glass as necessary, which often involves replacing the insulated glass units (IGUs). Note that evidence of seal failure can vary depending on environmental conditions.

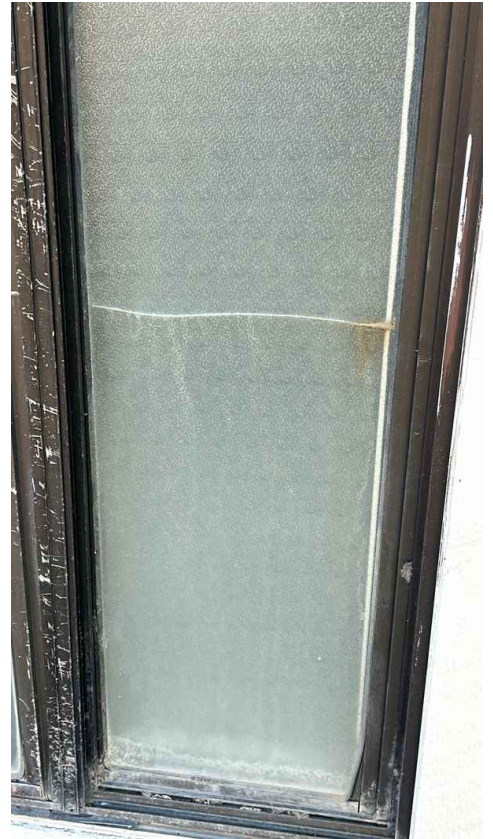
East wall

15.4.2 Windows & Skylights
WINDOW BROKEN
EAST EXTERIOR

Glass in one window was cracked. Recommend that a licensed contractor evaluate and replace glass where necessary.

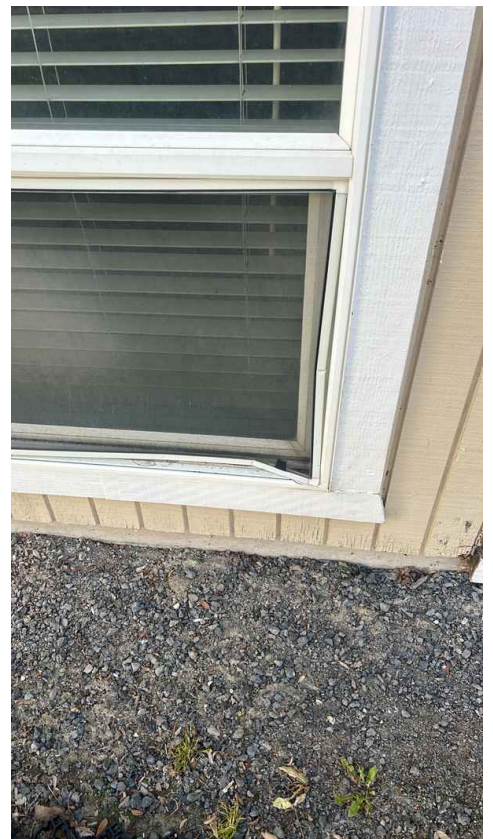
East wall

WINDOW SCREENS DAMAGED

Damaged window screens were observed. Repair or replace screens as necessary.

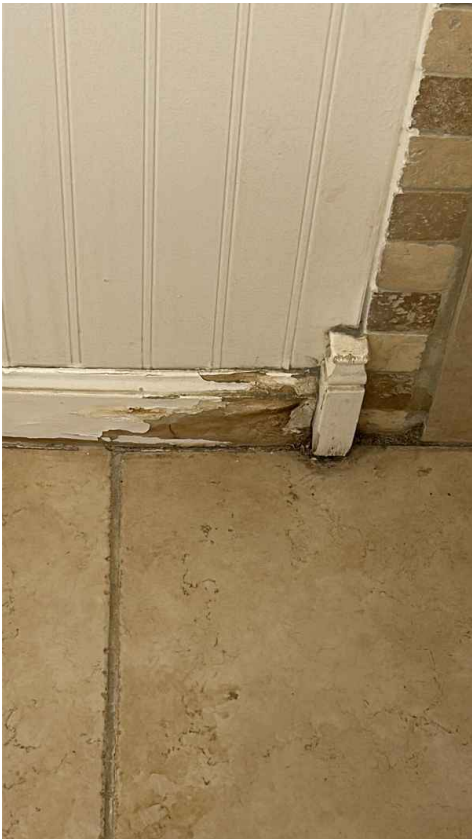
2nd Floor, guest bathroom

ELEVATED MOISTURE/WATER DAMAGE

Stains and elevated levels of moisture were observed in some walls areas (click individual pictures for specific locations). Recommend that a qualified contractor evaluate and repair as necessary.

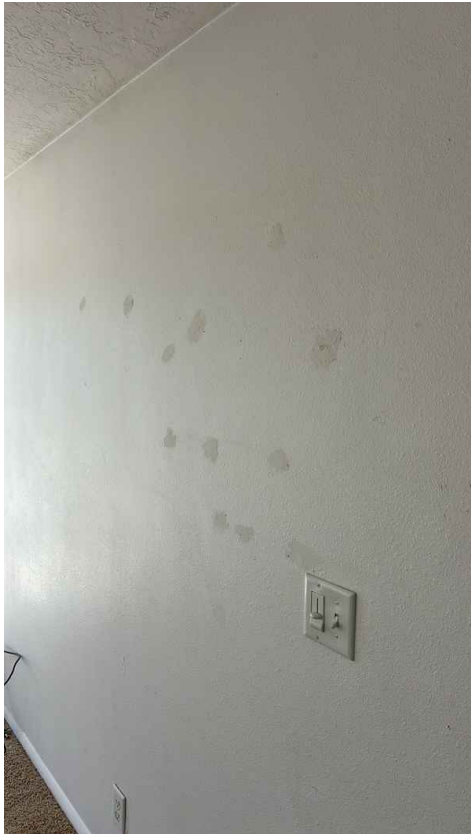
Master bedroom

There are several substandard patch and paint repairs throughout the home. Recommend repair as necessary by a qualified professional.

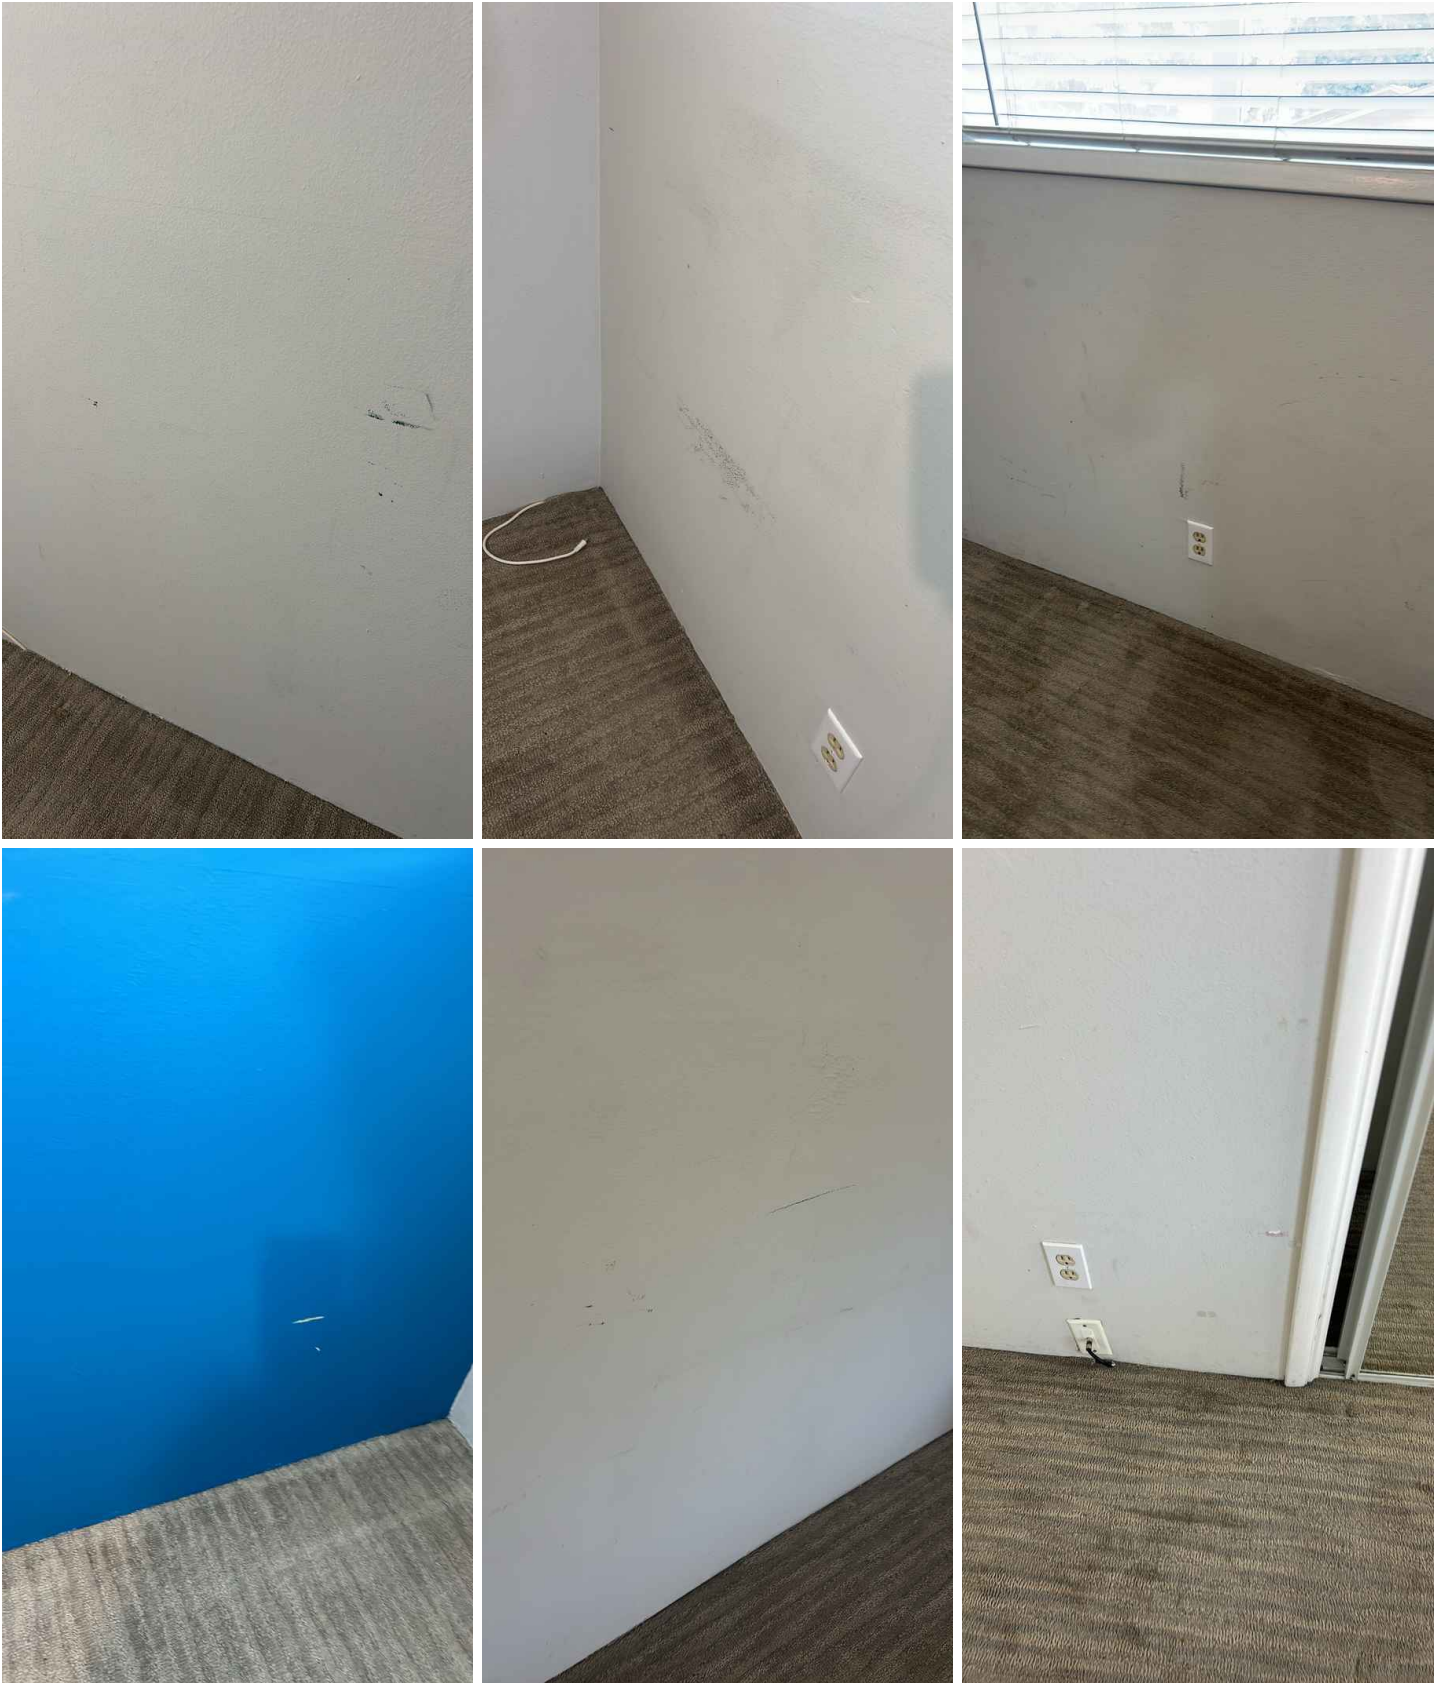
An average amount of wear and tear was observed throughout the home. Client may want to make repairs for aesthetic purposes.

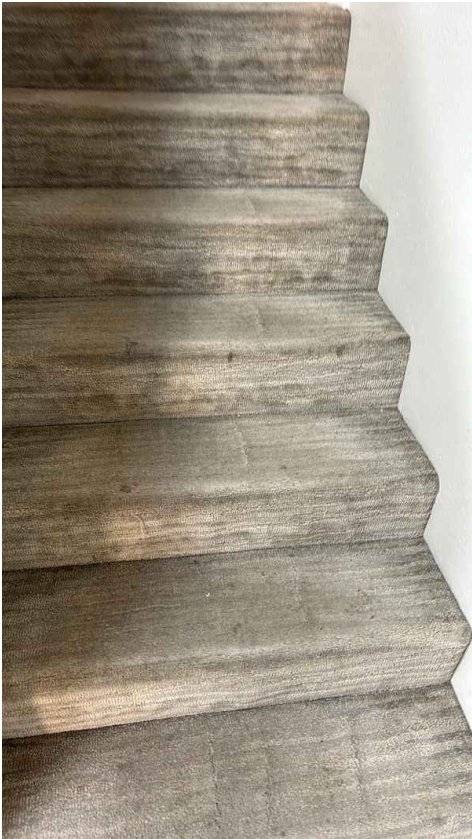
Staircase

CARPET LOOSE

Carpeting in one or more areas was loose. Recommend that a qualified contractor repair as necessary. For example, by stretching or replacing carpeting.

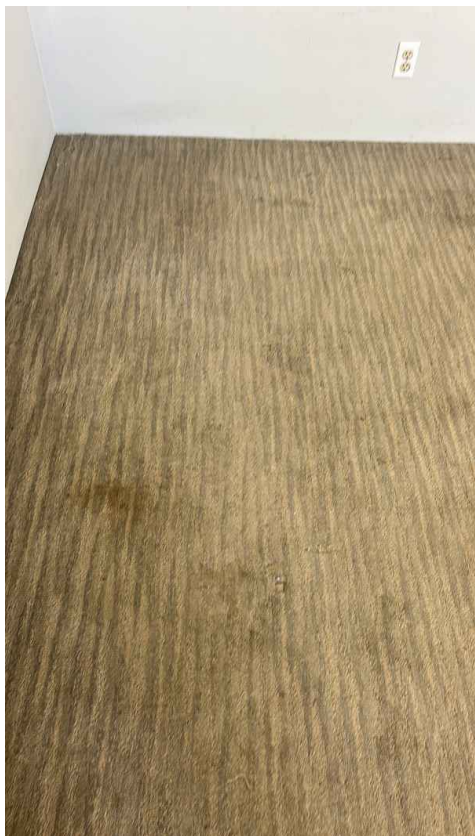
North bedroom

Carpeting in one or more areas was significantly stained or soiled. Recommend having carpeting professionally cleaned. Some stains may be permanent.
