SOUTHERN IDAHO HOME INSPECTIONS, LLC

RESIDENTIAL INSPECTION

3348 Highlawn Dr
Twin Falls, ID 83301

04/14/2025

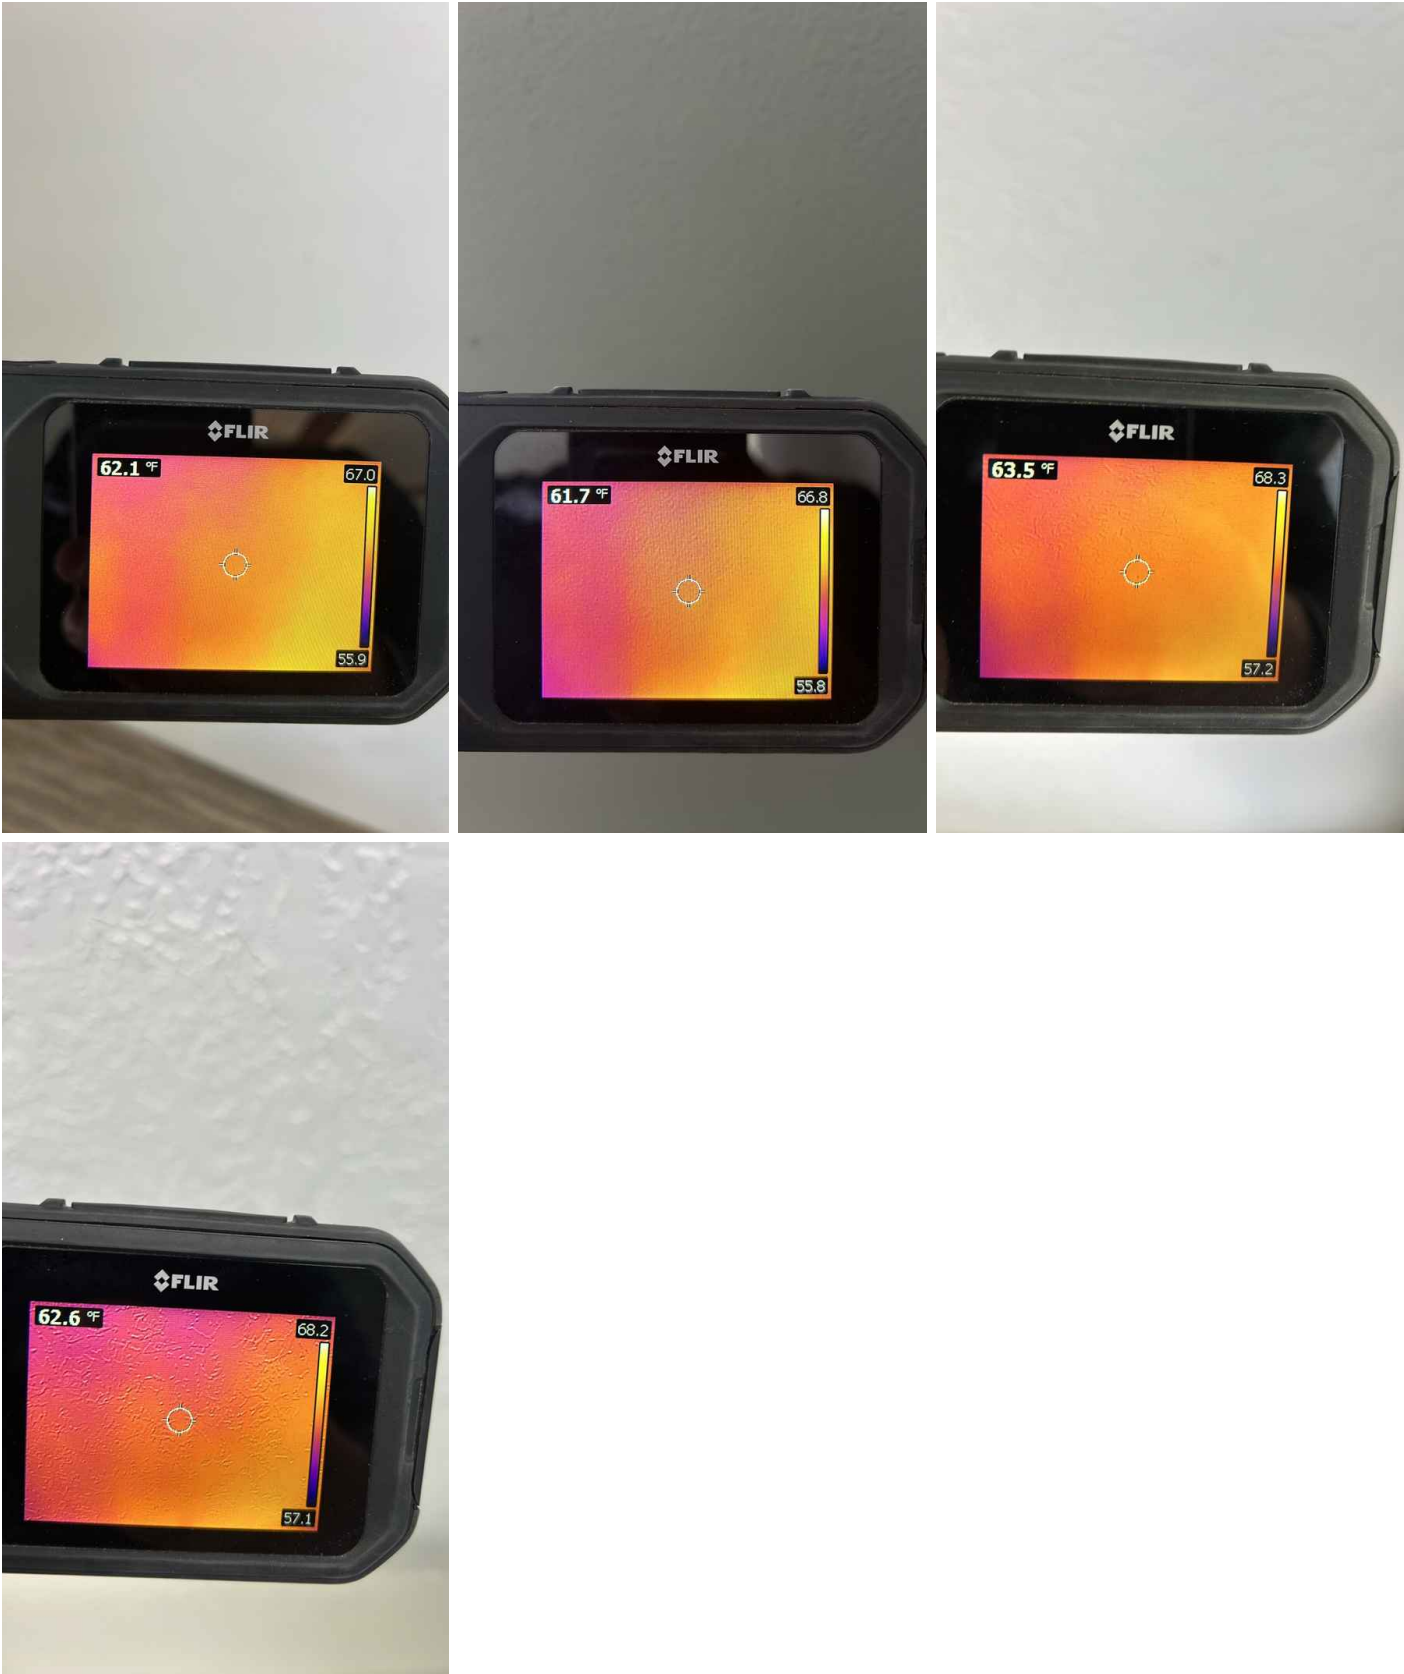
16.1.1 Thermal imaging scan

INSULATION MISSING OR LOW

Insulation was low or missing in some areas. This will result in reduced energy efficiency. Recommend a qualified contractor evaluate and install insulation as necessary.
