RHI HOME INSPECTIONS

INSPECTION REPORT

816 Southfield Rd Evansville, IN 47715

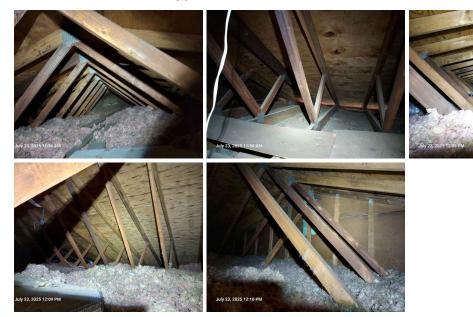
Ventilation: Ventilation TypeSoffit Vents, Thermostatically
Controlled Fan, Fixed-Field Vents

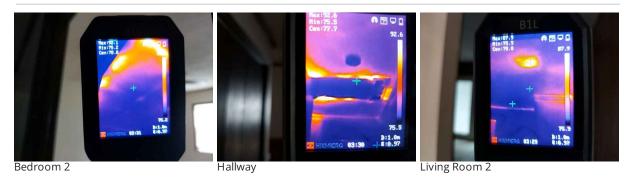
6.5.1 Evidence of Leaks

LEAKS - INACCESSIBLE

Evidence of leaking was viewed at the time of inspection. The stains were not readily accessible to test with a moisture meter and the inspector was unable to determine how long ago they occurred. Recommend further evaluation & correction by a qualified contractor.

Recommendation
