RHI HOME INSPECTIONS

## INSPECTION REPORT

816 Southfield Rd  
Evansville, IN 47715

07/23/2025

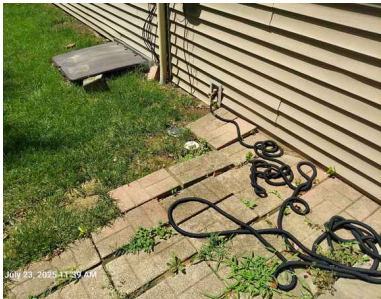
Exterior Drainage Clean-out

East

These are recommended in the event a sewer line problem occurs or a person needs access to the sewer lateral. A clean-out should be readily accessible at the building exterior and every 100' after until sewer lateral reaches city main or septic tank.

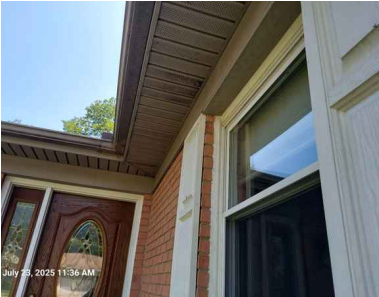
**Fascia, Soffit, Trim, & Columns: Moisture Stains**

Moisture stains were noted on soffits at one or more locations at the time of inspection. This indicates the presence of moisture, whether previous or active the inspector could not determine. Recommend monitoring soffits & further evaluation if condition worsens.

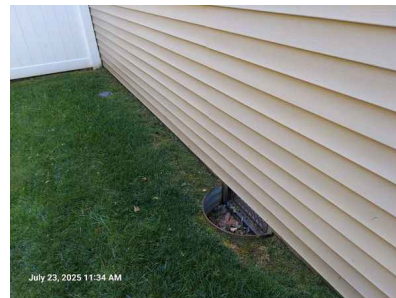
**SIDING - MINOR DAMAGE**

Minor damage to siding was noted at one or more locations at the time of inspection. Recommend further evaluation & correction by a qualified contractor.

Contact a qualified siding specialist.

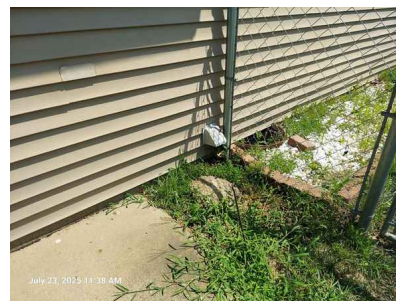
## 2.2.2 Fascia, Soffit, Trim, &amp; Columns

**VENT COVER(S) - IMPROPER CLEARANCE**

One or more vent covers were noted as having improper clearance at the time of inspection. Vents should terminate at minimum 12 inches from ground level. Recommend further evaluation & correction by a qualified contractor.

Contact a qualified handyman.

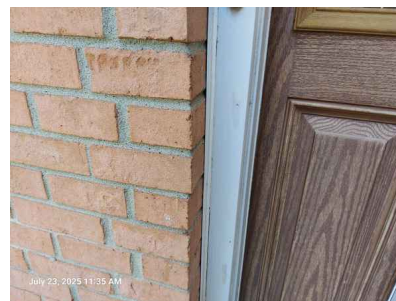
Regular maintenance is required to keep property in good condition, which includes but is not limited to cleaning, caulking, sealing & painting. Recommend surfaces be washed & properly cleaned, gaps or holes be filled, & exposed surfaces, weathering, or peeling paint properly prepped & sealed or repainted as needed.

Contact a qualified professional.

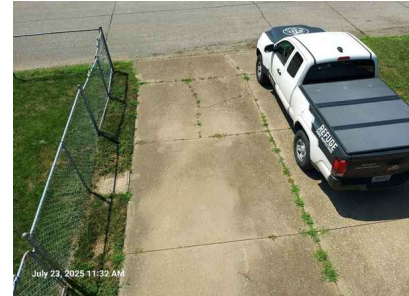
#### DRIVEWAY - MINOR CRACKING

Minor cracks were noted on driveway surfaces at the time of inspection. These do not appear to be negatively impacting the function of the driveway. Recommend sealing the cracks to prolong the life of the driveway.

Contact a qualified handyman.

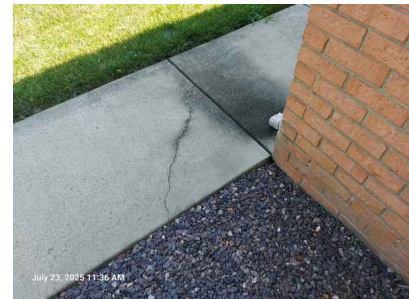
### 3.1.2 Driveways, Walkways & Patios

#### WALKWAY(S) - MINOR CRACKING

Minor cracks were noted on walkway surfaces at the time of inspection. These do not appear to be negatively impacting the function of the walkway. Recommend sealing the cracks to prolong the life of the walkway.

Contact a qualified handyman.

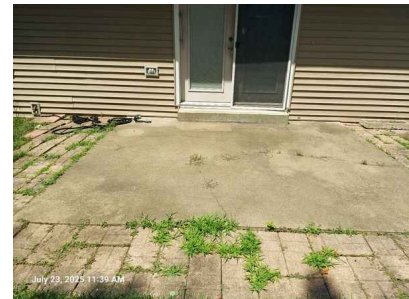
### 3.1.3 Driveways, Walkways & Patios

#### PATIO(S) - MINOR CRACKING

Minor cracks were noted on patio surfaces at the time of inspection. These do not appear to be negatively impacting the function of the patio. Recommend sealing the cracks to prolong the life of the patio.

Contact a qualified handyman.

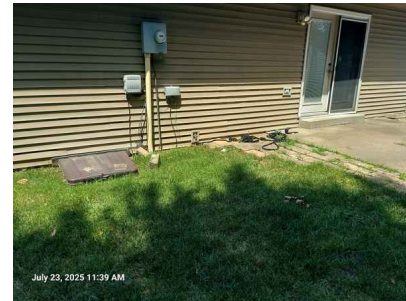
Soil or landscaping material covering the siding was noted at the time of inspection. There should be 4-6" of clearance between the bottom of the siding and the ground to prevent moisture damage and pest intrusion. Recommend further evaluation & correction by a qualified contractor.

Contact a qualified grading contractor.

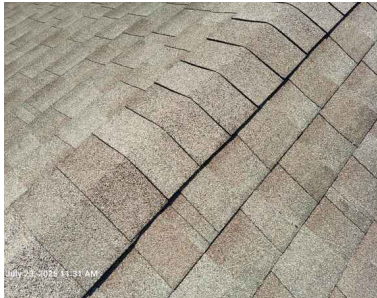
**Roof Coverings: Minor Granule Loss**

Roof coverings were noted as having limited areas of granule loss at the time of inspection. Some granule loss is a normal and expected part of the aging process of asphalt roofing. The roof was still fulfilling their intended function at the time of inspection. Recommend monitoring.

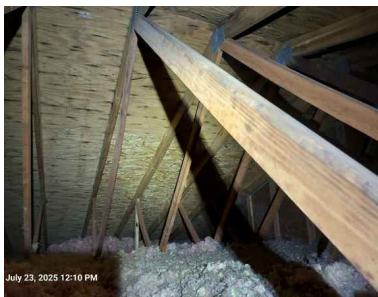
**Roof Structure: Previous Repairs Observed**

Previous repairs were noted at the time of the inspection. The inspector cannot guarantee the function or longevity of any repairs, and if any concerns are present recommend further evaluation by a qualified contractor.

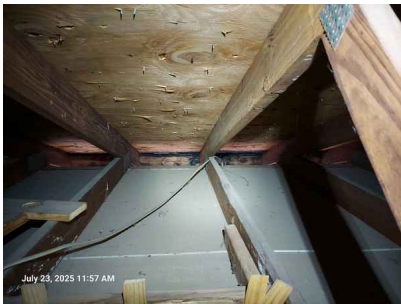
Above Garage

6.5.1 Evidence of Leaks

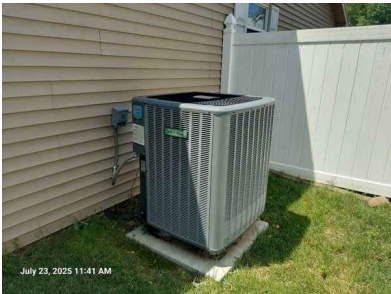
AC / Heat Pump Unit: Location  
North

AC / Heat Pump Unit:  
Manufacturer  
Goodman

AC / Heat Pump Unit:  
Manufacture Date  
2016

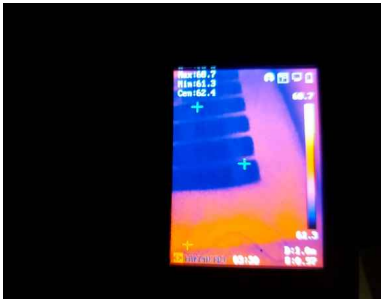
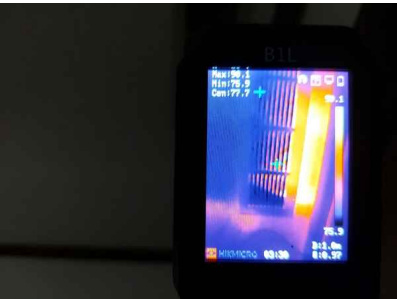
An infrared camera was used to show the system responded to normal operating controls, at the time of inspection. These images are not intended to show the exact temperature differential produced or the efficiency of the system; which lies beyond the scope of a home inspection. HVAC thermometers (wet bulb) are required for accurate readings, and measurement points would be carried out at a different location by an HVAC contractor. Typical temperature differentials between return and supply air is 14 - 20 degrees in cooling mode. Several factors can affect these numbers, such as, but not limited to: indoor ambient air temperature, exterior ambient air temperature, humidity, cleanliness of the air filter and evaporator, etc. Heat pump setting was

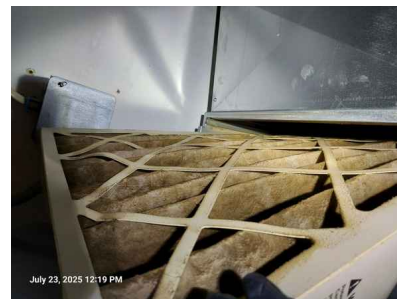
## 7.4.1 Ductwork

**DUCTWORK - CONDENSATING**

Ductwork noted as condensating at one or more locations at the time of inspection. This condition will contribute to elevated moisture levels in areas that it occurs. Recommend further evaluation & correction by a qualified contractor. Repaired by contractor

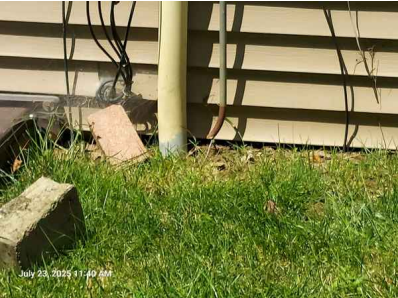
Conduit in place covering the ground wire was noted as damaged or loose at the time of inspection. This is not a safety concern as ground wires do not require any type of protection. Recommend monitoring.

Recommend monitoring.

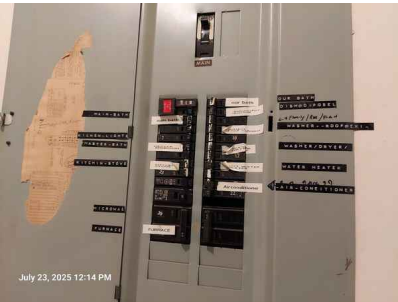
8.3.1 Main Distribution Panel(s)

**PANEL - MISSING / INCOMPLETE / IMPROPER LABELING**

Panel noted not have clear/complete labeling at the time of inspection. All fuse or breaker panels are required to have an accurate listing of what the circuits are connected to. An unsafe condition can exist if the homeowner turns off a breaker, believing to have killed the power on the circuit, only to find that they tripped the wrong breaker. Additionally, the inspector is not able to determine if breakers are properly sized for appliances if the panel is not labeled. Recommend further evaluation & correction by a qualified contractor.

Contact a qualified electrical contractor.

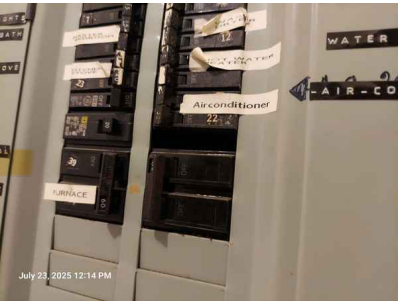
One or more gaps were noted around the panel cover at the time of inspection. Recommend further evaluation & correction by a qualified contractor.

Contact a qualified electrical contractor.

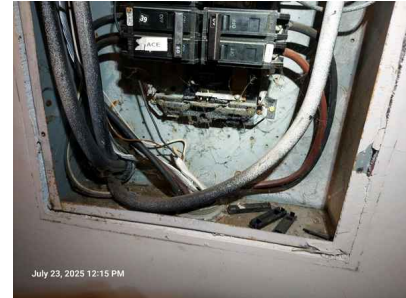
Excessive dust, dirt or debris was noted inside the electric panel at the time of inspection. This can cause an arc flash in the panel. An arc flash occurs when a flash over of electric current leaves its intended path and travels through the air from one conductor to another, or to neutral or ground. An arc flash can cause a serious electrical burn. Recommend further evaluation & correction by a qualified contractor.

Contact a qualified electrical contractor.

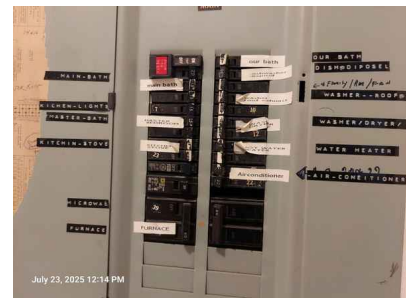
### 8.3.5 Main Distribution Panel(s)

#### **PANEL - OPEN / IMPROPER KNOCKOUT(S)**

One or more openings or improperly covered openings were noted at the time of inspection. This is a potential safety hazard. Approved metal or plastic covers for these types of openings can be purchased from most hardware stores and can be easily installed. Recommend further evaluation & correction by a qualified contractor.

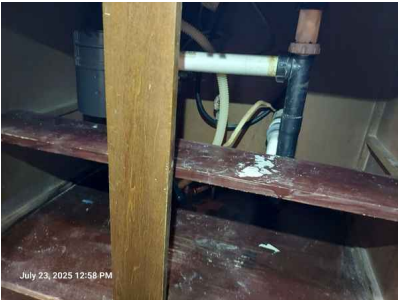
Utility Room

WIRING - EXPOSED WIRING

Unprotected electrical wiring was noted at one or more locations at the time of inspection. Wiring in storage or living areas should be protected in conduit to keep it from being damaged. Wiring on the exterior of home should be rated for exterior exposure or protected by exterior rated conduit. Recommend further evaluation & correction by a qualified contractor.

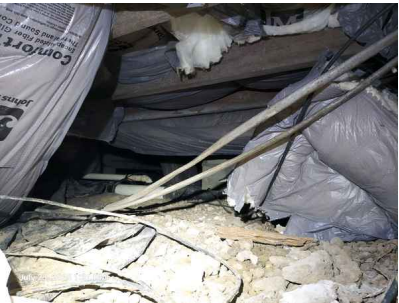
Crawlspace

WIRING - IMPROPERLY SECURED

Improperly secured electrical wiring was noted in one or more areas at the time of inspection. All electrical wiring should be properly secured to framing members to protect it from damage. Recommend further evaluation & correction by a qualified contractor.

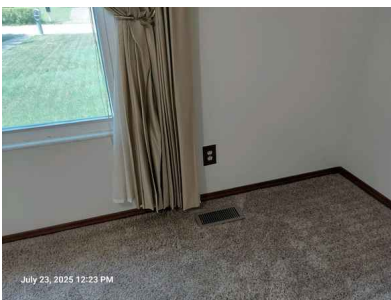
OUTLET(S) - LOOSE

Loose receptacles were noted at one or more locations at the time of inspection. Recommend tightening outlets as needed.

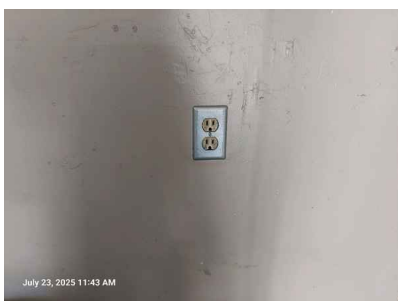
### 8.5.2 Outlets

#### OUTLET(S) - DAMAGED / WORN / OBSTRUCTED

One or more damaged, worn, obstructed outlet(s) were noted at the time of inspection. Damaged or worn outlets can result in arcing and a potential fire when an electronic device or appliance is plugged into the outlet, making this a safety hazard. Recommend further evaluation & correction by a qualified contractor.

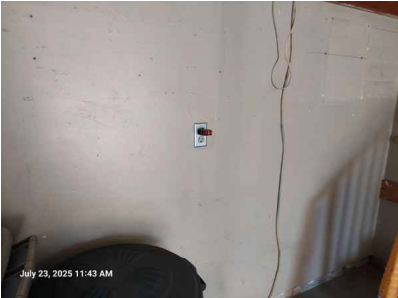
Garage Multiple Locations

#### GFCIS - MISSING

Ground Fault Circuit Interrupter (GFCI) protected receptacles were noted as not installed in some areas where they are required at the time of inspection. While GFCI protection may not have been required by code when the house was built, this is now considered a safety hazard. Recommend further evaluation & correction by a qualified contractor.

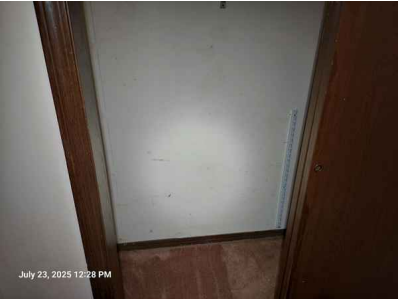
Here is a DIY article on [treating cracking paint](#).

Recommendation **Repaired**  
Contact a qualified painting contractor.

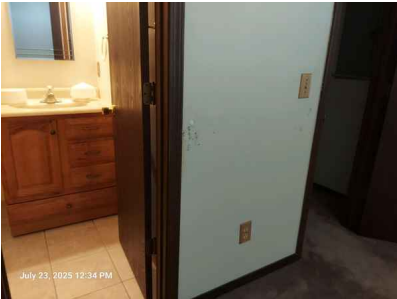
10.2.2 Walls

WALL(S) - MINOR DAMAGE

Minor damage was noted on one or more walls, such as dings, scuffs, or hairline cracks, at the time of inspection. Damage appeared to be cosmetic and not of significant impact to wall coverings. Recommend monitoring for further degradation.

Recommendation **Repaired**  
Contact a qualified professional.

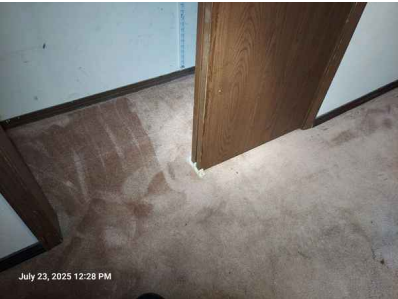
10.4.1 Doors

DOOR(S) - HARDWARE LOOSE

Hardware was noted as loose on interior door(s) at the time of inspection. Recommend tightening door hardware.

Recommendation  
Contact a handyman or DIY project

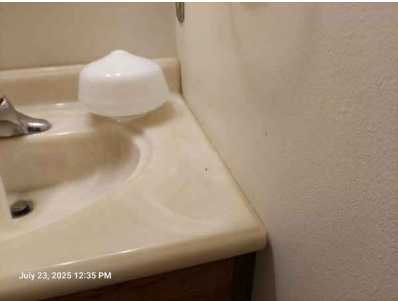
One or more counters noted as having missing, or damaged caulking against the wall at the time of inspection. Recommend further evaluation & correction by a qualified contractor.

Recommendation  
Contact a handyman or DIY project

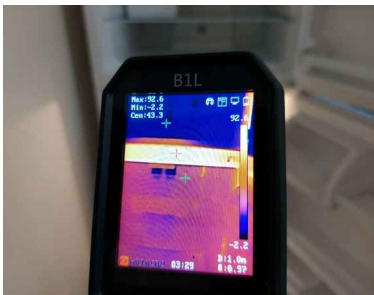
**Refrigerator: Fridge Components**  
Icemaker

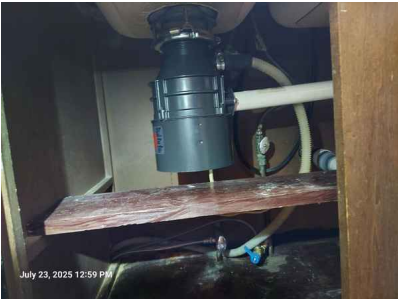
**DISHWASHER - MISSING HIGH LOOP**

Lack of a proper high loop or air gap was noted at dishwasher drain line at the time of inspection. In the event of a drain backing up a high loop prevents waste from entering into the dishwasher. Recommend further evaluation & correction by a qualified contractor.

Contact a handyman or DIY project **Replaced**

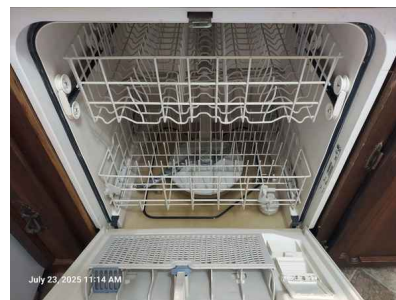
**DISHWASHER - IMPROPERLY DRAINING**

Dishwasher noted as improperly draining at the time of inspection. Recommend further evaluation & correction by a qualified contractor.

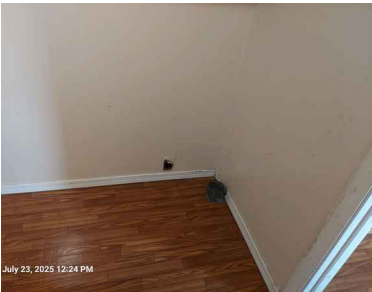
**Dryer Connections: Hook-Up Type**  
Electric

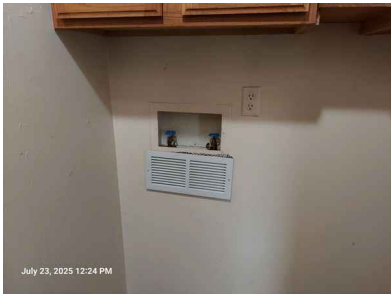
**Washer Hook-Ups: General Photos**

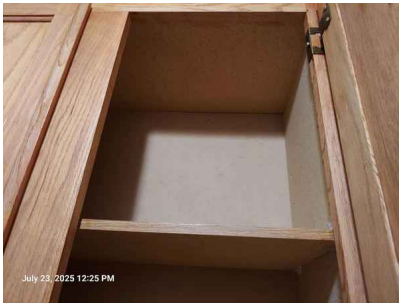
**CABINET(S) - IMPROPER FASTENERS**

Cabinets were noted as being improperly mounted at the time of inspection. A cabinet screw that has a flat head which prevents the screw from pulling out should be used. Recommend further evaluation & correction by a qualified contractor.

Contact a qualified cabinet contractor.

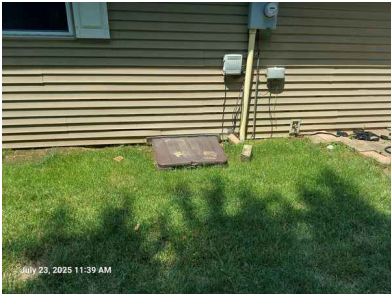
**Crawlspace: Crawlspace Access Location**  
Exterior

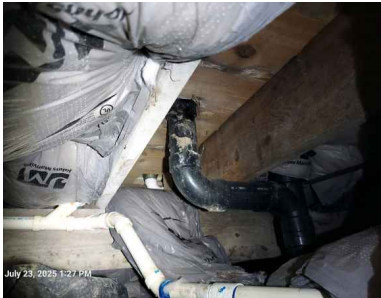
Evidence of Leaks: Leaks - Dry

Evidence of leaking was viewed at the time of inspection. A moisture meter indicated that the stains were dry at the time of inspection.

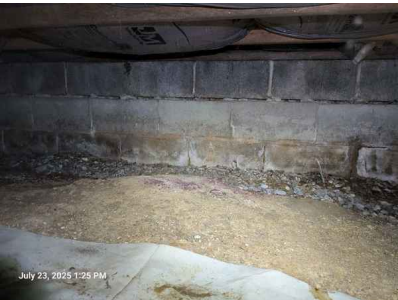
FOUNDATION WALL(S) - EFFLORESCENCE / STAINS

Efflorescence (white mineral deposits) or stains were noted on foundation wall(s). This is a common condition caused by moisture slowly infiltrating through the block, either recently or at some time in the past. Recommend regular maintenance and monitoring to prevent unwanted deterioration.

Contact a handyman or DIY project

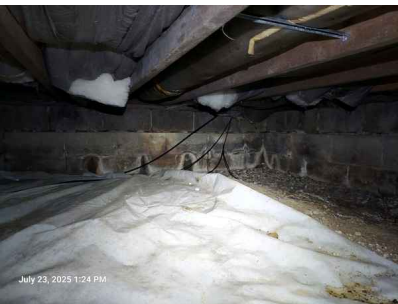
FOUNDATION WALL(S) - MOISTURE INTRUSION

Evidence of moisture was noted at one or more areas of the foundation wall. Moisture may be intruding on the foundation for varying reasons. Recommend further evaluation & correction by a qualified contractor.

Contact a foundation contractor.

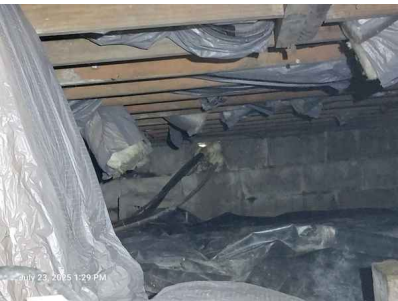
North

FOUNDATION WALL(S) - GAPS TO EXTERIOR

Unsealed gaps to the exterior were noted at the time of inspection. These gaps should be properly filled to prevent moisture and pest intrusion. Recommend further evaluation & correction by a qualified contractor.

Contact a qualified professional.

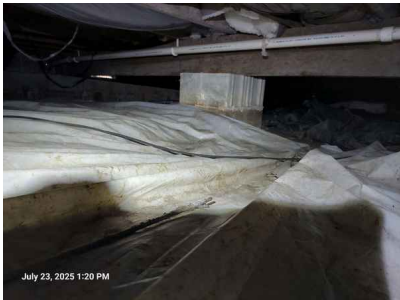
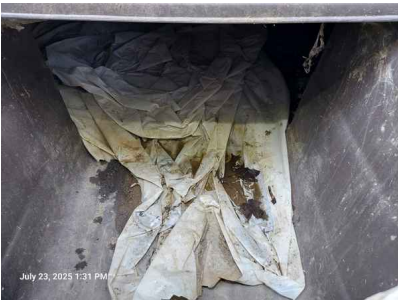
14.4.2 Crawlspace

Standing water was noted in the crawlspace at the time of inspection. The inspector is unable to determine the sole source of the water. Water in the crawlspace may lead to multiple other issues. Recommend further evaluation & correction by a qualified contractor.

Recommendation **Repaired**  
Contact a foundation contractor.

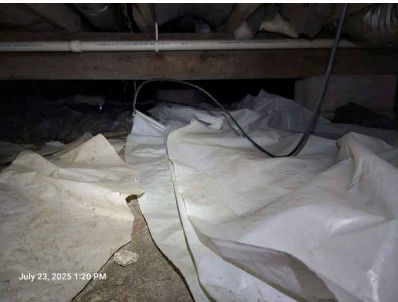
14.4.3 Crawlspace

**VAPOR BARRIER - MULTIPLE LAYERS**

Recommendation  
Contact a foundation contractor.

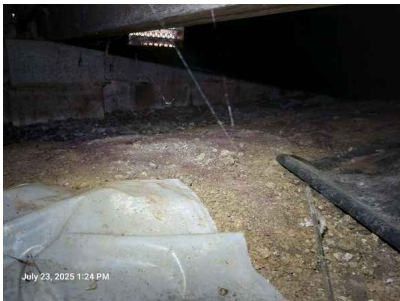
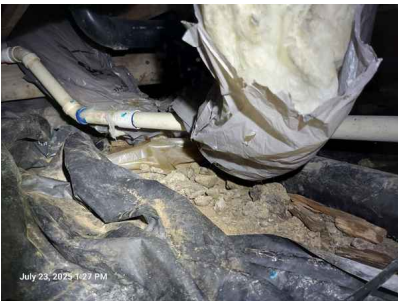
14.4.4 Crawlspace

**VAPOR BARRIER - MISSING / DAMAGED / IMPROPER  
MULTIPLE LOCATIONS**

Recommendation  
Contact a foundation contractor.

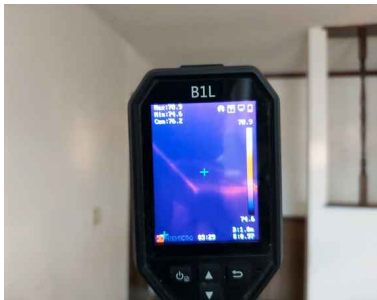
#### **Thermal Scan**

A basic scan of the house was performed with an infrared camera to check for leaks, missing insulation, and overheated electrical conductors. This scan does not ensure the inspector will find all defects that may be hidden in walls or ceilings. Any specific defects that were found pertaining to specific components will be noted in their respective areas of the report.

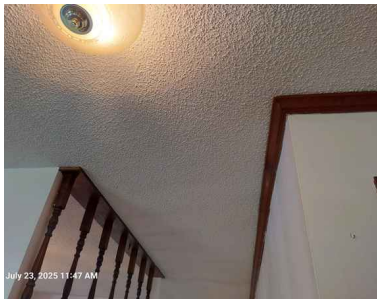
**Asbestos: Suspected Asbestos - Popcorn Ceiling**

Suspected asbestos Ceiling texture noted. Asbestos was widely used prior to the 1980s and is commonly found in older structures. Please note determining the existence of environmental hazards like asbestos is beyond the scope of this inspection. You may want to obtain further evaluation by a licensed asbestos abatement contractor or have the suspected asbestos sealed by a professional. RHI can perform testing to confirm the presence of asbestos for an additional charge.
