**SELLER'S RESIDENTIAL REAL ESTATE SALES DISCLOSURE**

2501 N Lafayette Ave

Evansville

IN 47711

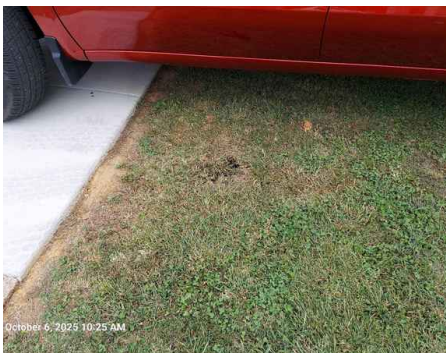
## Water Meter / Well Head Location

Public, Yard Near Street

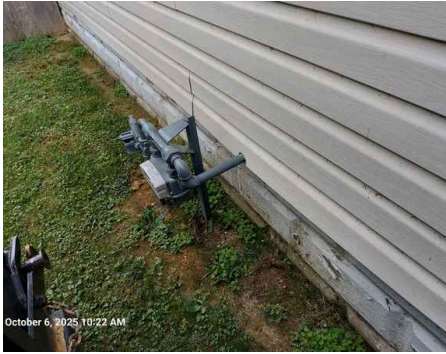
Natural Gas, North

The type of fuel systems and the location of the meter and tank if located. Some systems may have underground tanks, these tanks are outside the scope of a home inspection.

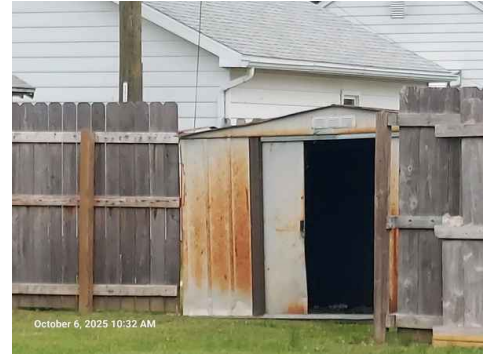
## **DETACHED BUILDING(S) PRESENT**

Detached building(s) was / were present at the time of inspection. These systems are outside the scope of a standard home inspection. RHI can perform this service for an additional fee.

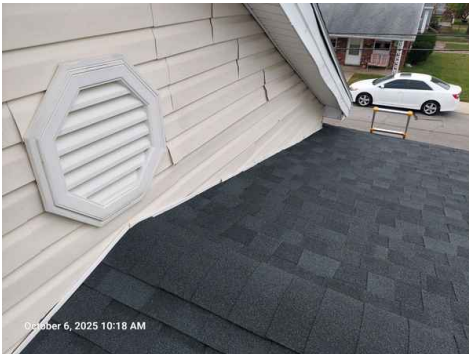
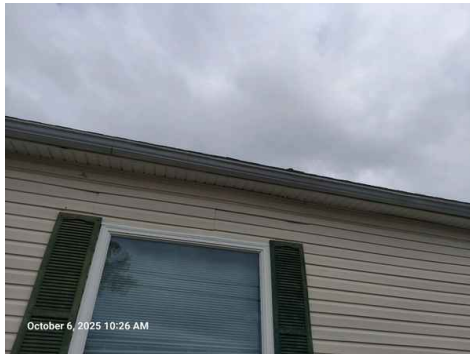
#### 2.1.4 Siding

### **SIDING - LOOSE**

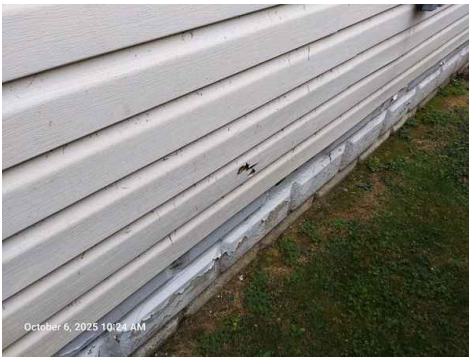
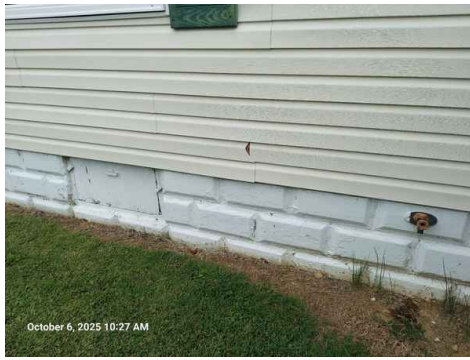
#### 2.1.5 Siding

### **SIDING - DAMAGE**

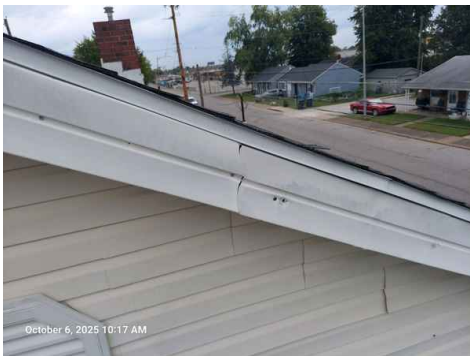
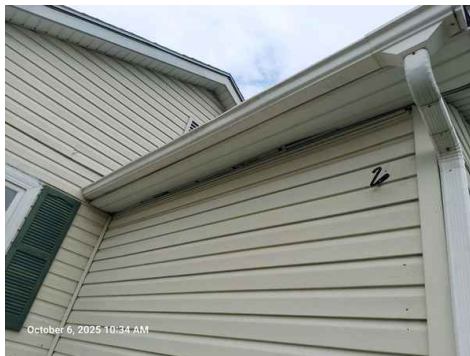
#### 2.2.4 Fascia, Soffit, Trim, & Columns

### TRIM - IMPROPER OVERLAP / INSTALLATION

Recommendation

Contact a qualified siding specialist.

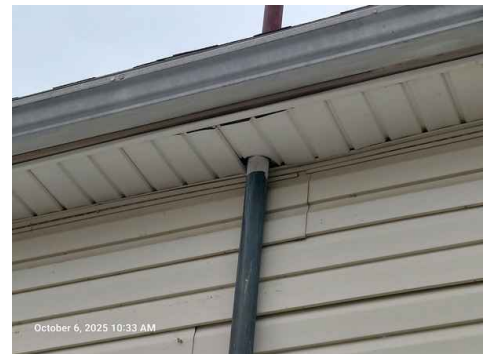
#### 2.2.5 Fascia, Soffit, Trim, & Columns

### SOFFIT(S) - UNSEALED PENETRATIONS

Recommendation

Contact a qualified siding specialist.

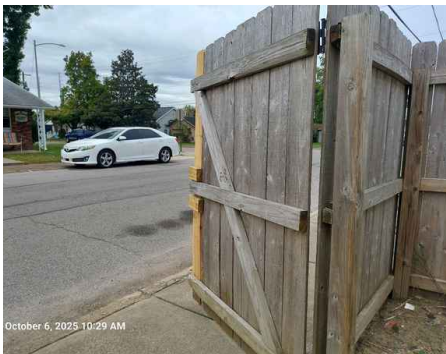
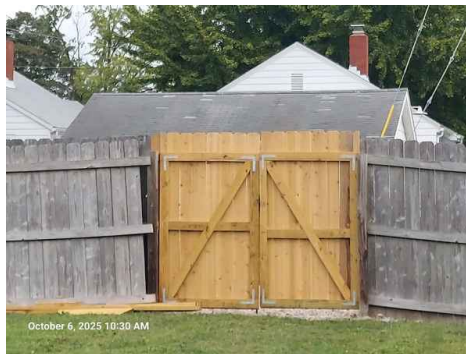
### **Fencing: Previous Repairs Observed**

Previous repairs were noted at the time of the inspection. The inspector cannot guarantee the function or longevity of any repairs, and if any concerns are present recommend further evaluation by a qualified contractor.

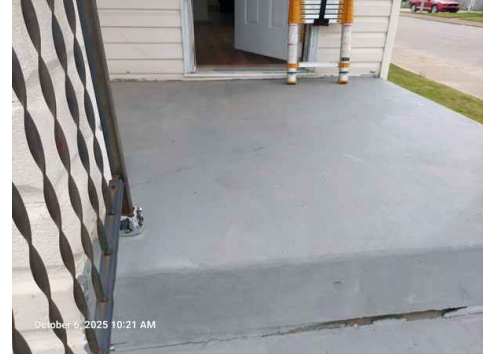
3.4.1 Porches

### PORCH - MAINTENANCE NEEDED

Recommendation

Contact a qualified handyman.

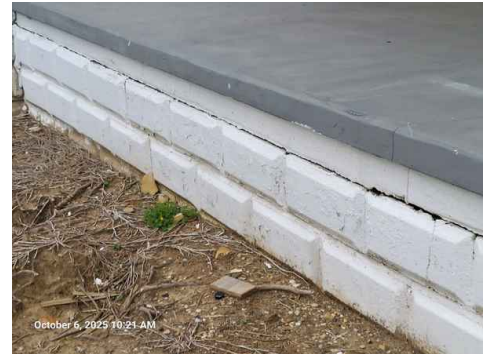
### 3.4.3 Porches

#### PORCH - CRACKING

Recommendation

Contact a qualified professional.

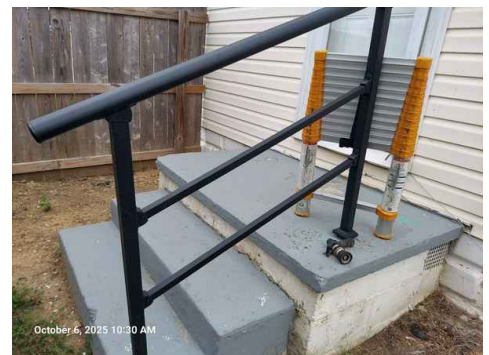
### 3.5.1 Stairs, Ramps, & Railings

#### HANDRAIL - LOOSE

Recommendation

Contact a qualified professional.

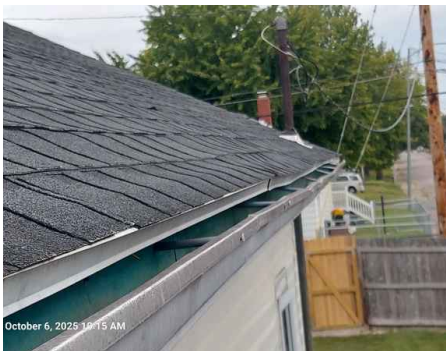
#### Roof Coverings: Sagging / Bowing Roof

Roof covering was noted as sagging or bowing at the time of inspection. The exact cause of this condition could not be determined, however it is fairly common on older homes. If any defects which might be a contributing factor to this condition are found, they will be noted in the report. Recommend monitoring for worsening condition.

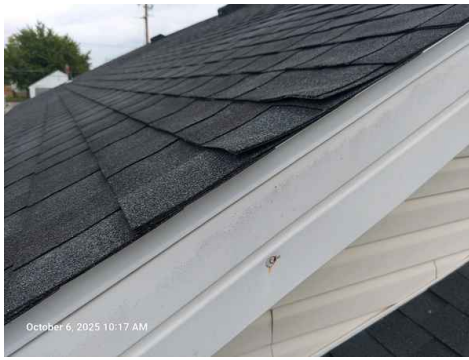
One or more shingles appear to be lifted at the time of inspection. This could be due to a variety of reasons, such as nail pops, etc. Recommend further evaluation & correction by a qualified contractor.

Contact a qualified roofing professional.

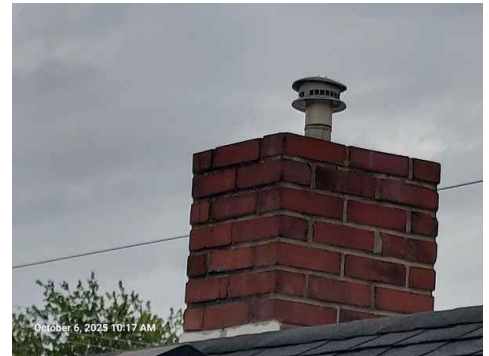
#### 4.3.1 Chimneys & Vent Stacks

Chimney was noted as rusted, weathered, or in need of maintenance at the time of the inspection. Recommend having the chimney maintained by cleaning, repainting, or resealing the chimney.

Contact a qualified handyman.

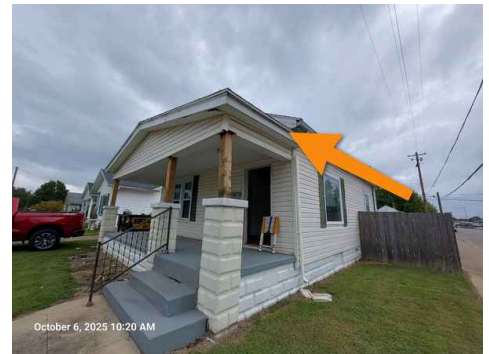
#### 4.4.1 Gutters & Downspouts

### GUTTER(S) - MISSING / DAMAGED

Missing or damaged gutters were noted at the time of the inspection. This can result in excessive moisture in the soil at the foundation, which can lead to moisture intrusion or damage to the foundation. Recommend further evaluation & correction by a qualified contractor.

Contact a qualified gutter contractor

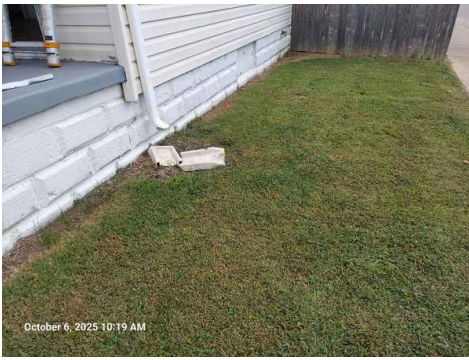
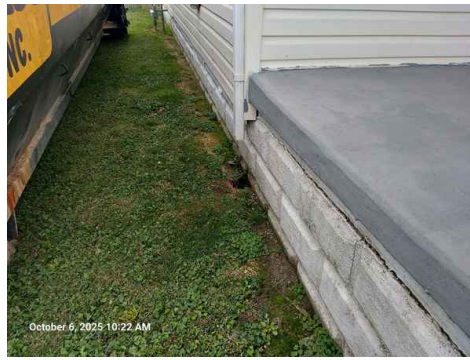
#### 4.4.2 Gutters & Downspouts

### DOWNSPOUT(S) - MISSING / IMPROPER EXTENSION

One or more downspouts were noted as having missing or improperly installed splash block(s) at the time of the inspection. Downspout extensions are used to divert water away from the foundation. Recommend further evaluation & correction by a qualified contractor.

Contact a qualified professional.

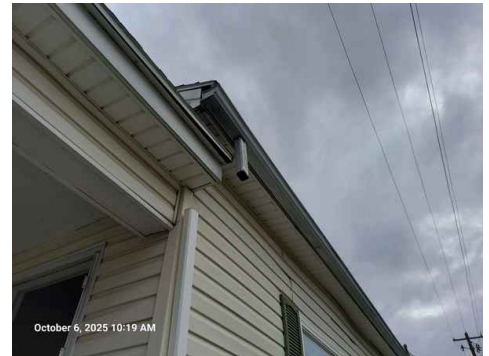
#### 4.4.3 Gutters & Downspouts

##### **DOWNSPOUT(S) - DISCONNECTED / GAPS**

One or more downspout(s) were noted as disconnected or having gaps at the time of the inspection. Improperly connected downspout(s) can lead to moisture intrusion around foundation. Recommend further evaluation & correction by a qualified contractor.

Contact a qualified gutter contractor

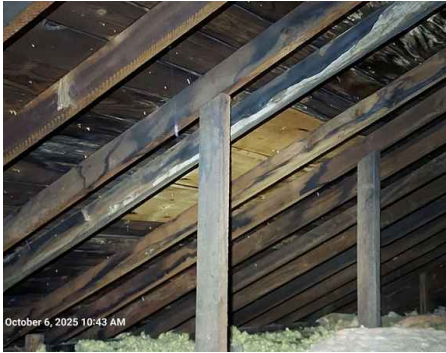
## Roof Structure: Previous Repairs Observed

Previous repairs were noted at the time of the inspection. The inspector cannot guarantee the function or longevity of any repairs, and if any concerns are present recommend further evaluation by a qualified contractor.

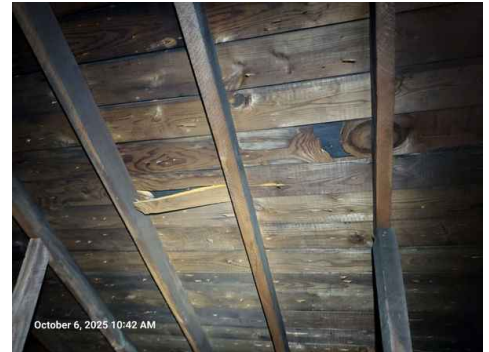
#### **SHEATHING - DAMAGED**

Cracks / hole(s) or damaged areas of roof sheathing were noted at the time of inspection. Damaged areas of roof sheathing should typically be replaced before the roof covering were installed. Recommend further evaluation & correction by a qualified contractor.

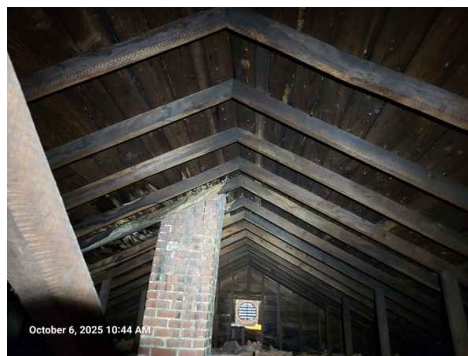
### 5.2.2 Roof Structure

#### **RAFTERS - COLLAR TIES MISSING**

Collar ties were noted as missing on rafters in the upper third of the attic space at time of the inspection. Collar ties (a horizontal 2x4) are typically installed on every other set of rafters to resist wind uplift. Recommend monitoring for signs of movement & further evaluation if conditions change.

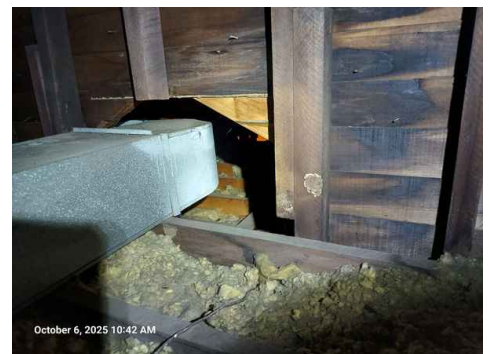
### 5.4.1 Insulation

#### **INSULATION - MISSING / OUT OF PLACE**

Attic insulation was noted as missing or out of place in some areas at the time of the inspection. This will result in energy loss. Recommend further evaluation & correction by a qualified contractor.

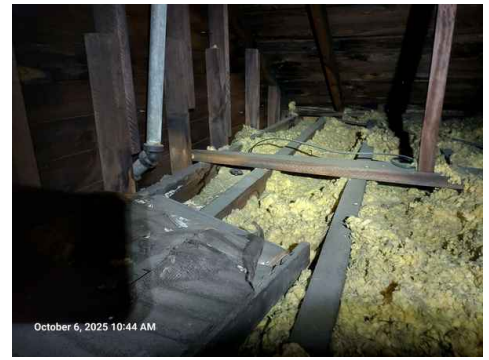
#### 5.4.2 Insulation

Insulation was noted as disturbed, sparse or compacted in some areas in the attic at the time of the inspection. This may be insulation being moved around so that work could've be done or so that a person could safely traverse the attic space. Recommend further evaluation & correction by a qualified contractor.

Contact a qualified insulation contractor.

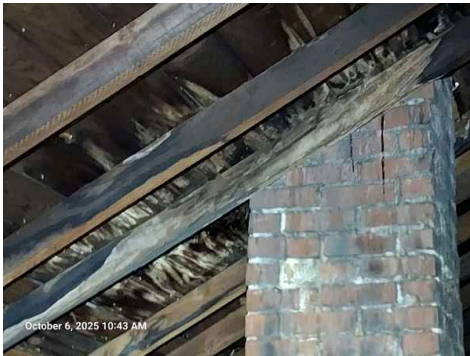
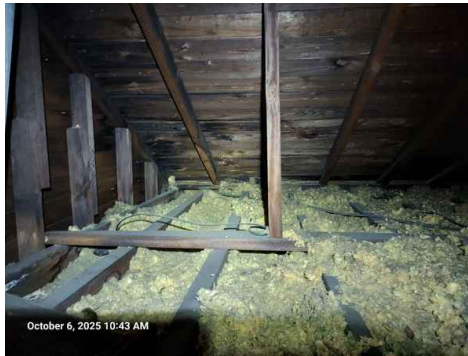
#### 5.5.1 Evidence of Leaks

### LEAKS - INACCESSIBLE

Evidence of leaking was viewed at the time of inspection. The stains were not readily accessible to test with a moisture meter and the inspector was unable to determine how long ago they occurred. Recommend further evaluation & correction by a qualified contractor.

Contact a qualified professional.

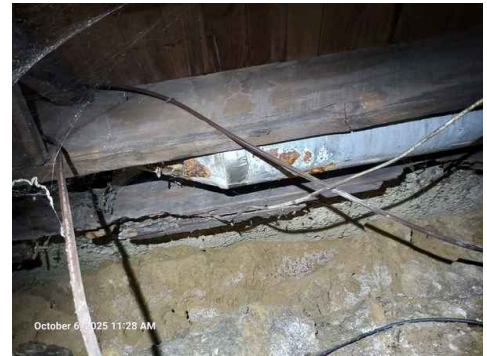
#### **DUCTWORK - DAMAGED**

One or more sections of ductwork were noted as damaged at the time of inspection. Recommend further evaluation & correction by a qualified contractor.

Contact a qualified HVAC professional.

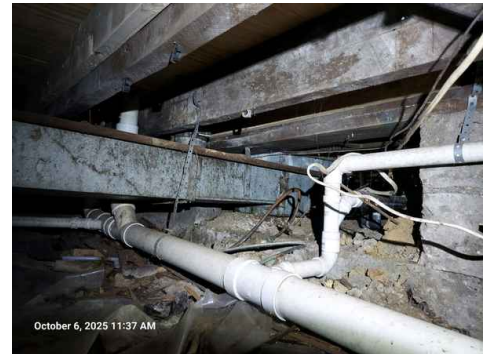
### 6.4.2 Ductwork

One or more sections of ductwork were noted as being in contact with the ground at the time of inspection. This can allow moisture and pests to enter the ductwork. Recommend further evaluation & correction by a qualified contractor.

Contact a qualified HVAC professional.

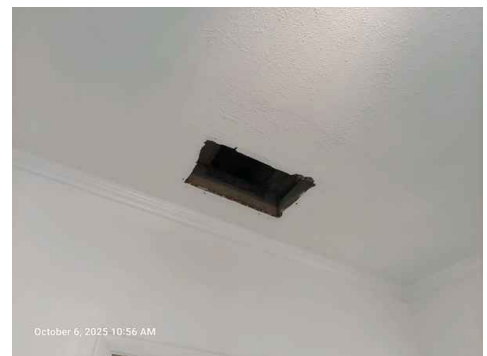
### 6.4.3 Ductwork

#### **REGISTER(S) - MISSING OR DAMAGED**

One or more registers were noted as missing or damaged at the time of inspection. Recommend further evaluation & correction by a qualified contractor.

Contact a qualified HVAC professional.

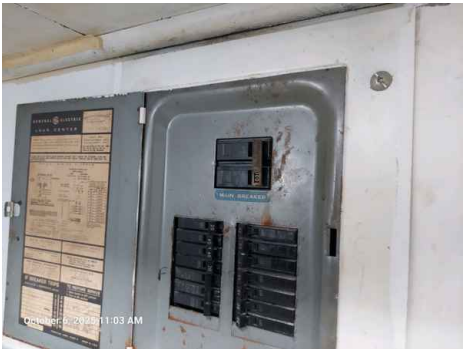
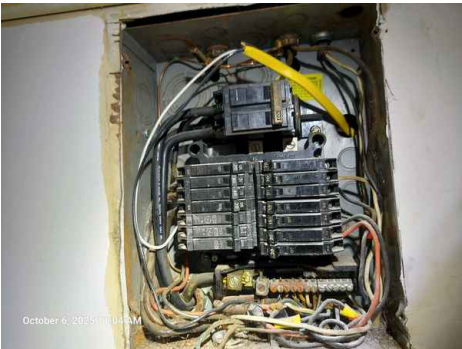
**Electrical Service : No Significant Defects Observed**

Power was supplied to the home via service conductors. The meter and protective conduit appeared to be in satisfactory condition. No deficiencies were observed at visible portions unless otherwise noted in this report.

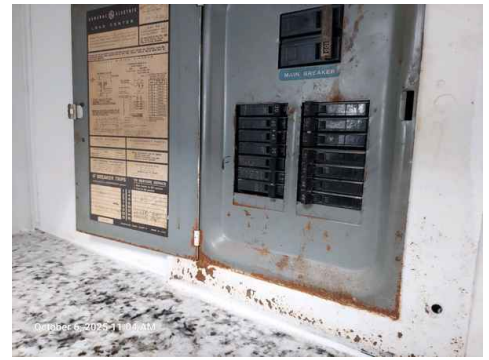
Panel noted not have clear/complete labeling at the time of inspection. All fuse or breaker panels are required to have an accurate listing of what the circuits are connected to. An unsafe condition can exist if the homeowner turns off a breaker, believing to have killed the power on the circuit, only to find that they tripped the wrong breaker. Additionally, the inspector is not able to determine if breakers are properly sized for appliances if the panel is not labeled. Recommend further evaluation & correction by a qualified contractor.

Contact a qualified electrical contractor.

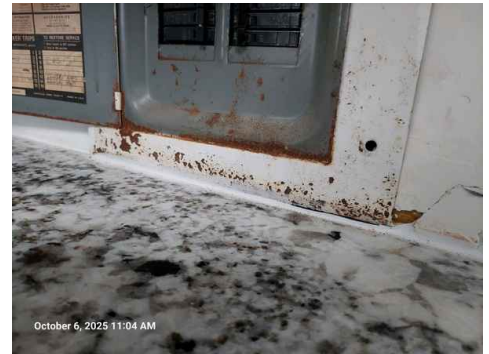
Panel box exterior was noted as weathered or rusted at the time of inspection. Recommend further evaluation and maintenance be performed to ensure continued life of the box.

Contact a qualified electrical contractor.

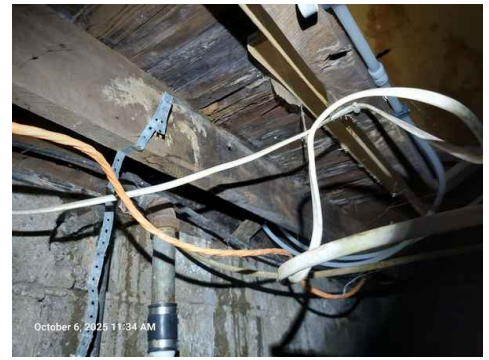
Improperly secured electrical wiring was noted in one or more areas at the time of inspection. All electrical wiring should be properly secured to framing members to protect it from damage. Recommend further evaluation & correction by a qualified contractor.

Contact a qualified electrical contractor.

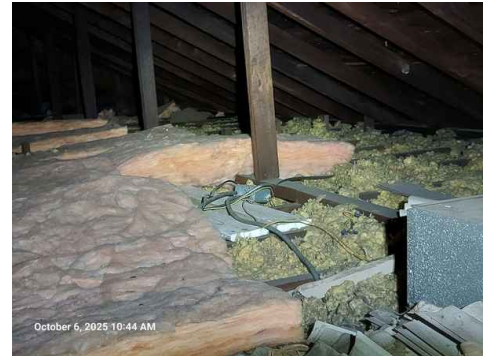
One or more junction boxes were noted as being loose or improperly secured at the time of inspection. All junction boxes used to contain splices in branch wiring should be securely mounted to framing to ensure splices are not damaged. Recommend further evaluation & correction by a qualified contractor.

Contact a qualified electrical contractor.

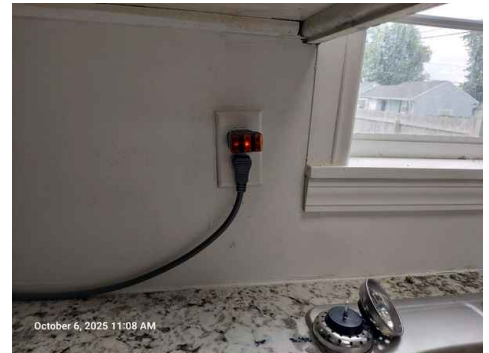
One or more outlets noted to be improperly wired as indicated by an outlet tester at the time of inspection. Recommend further evaluation & correction by a qualified contractor.

Contact a qualified electrical contractor.

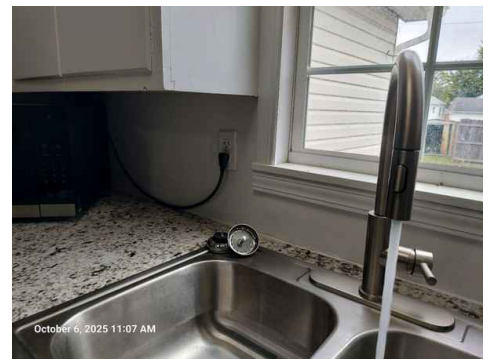
Ground Fault Circuit Interrupter (GFCI) protected receptacles were noted as not installed in some areas where they are required at the time of inspection. While GFCI protection may not have been required by code when the house was built, this is now considered a safety hazard. Recommend further evaluation & correction by a qualified contractor.

Contact a qualified electrical contractor.

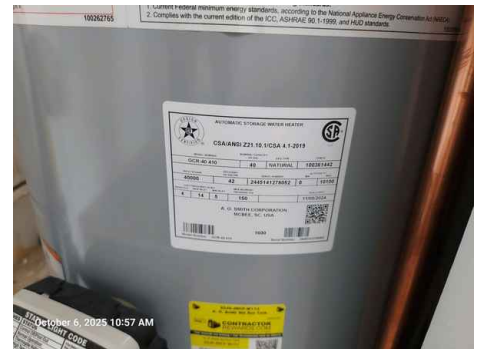
**Water Heater: Manufacturer**

A.O. Smith

**Water Heater: Manufacture Date**

2024

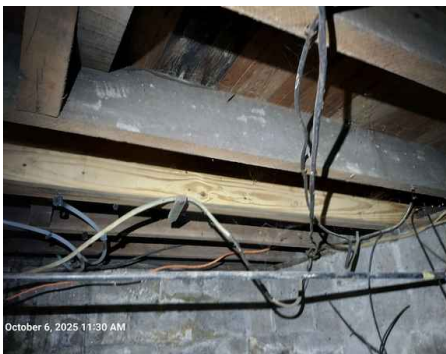
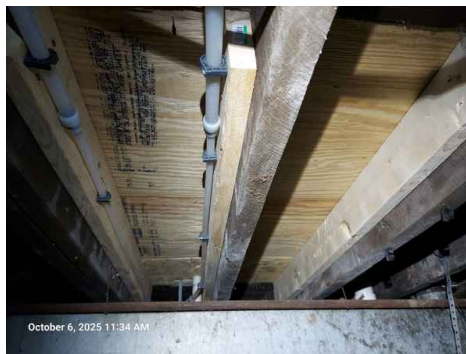
## Subfloor: Previous Repairs Observed

Previous repairs were noted at the time of the inspection. The inspector cannot guarantee the function or longevity of any repairs, and if any concerns are present recommend further evaluation by a qualified contractor.

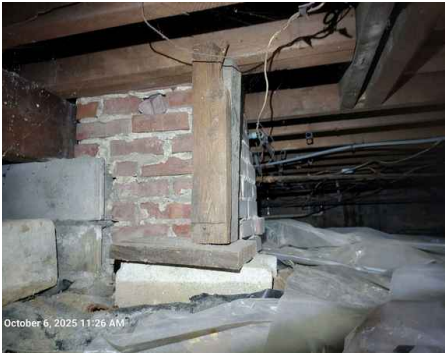
## Walls, Beams, & Columns: Additional Support

Additional support(s) have been added to the foundation in an attempt to reinforce the floor framing at the time of inspection. This is typical in older homes. Inspector was unable to determine the structural integrity of the repair. Recommend inquiring with seller and obtaining paperwork from the seller to determine if there is any warranty on the foundation repairs if applicable.

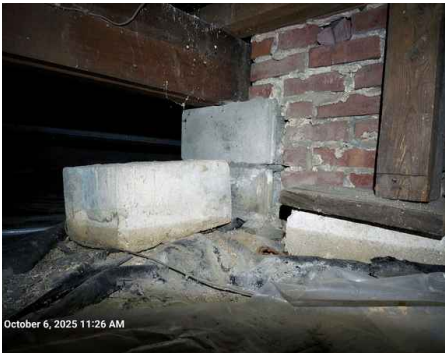
## Walls, Beams, & Columns: Previous Repairs Observed

Previous repairs were noted at the time of the inspection. The inspector cannot guarantee the function or longevity of any repairs, and if any concerns are present recommend further evaluation by a qualified contractor.

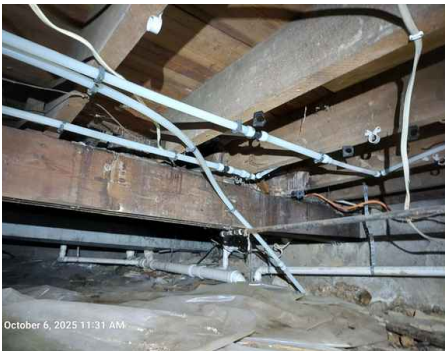
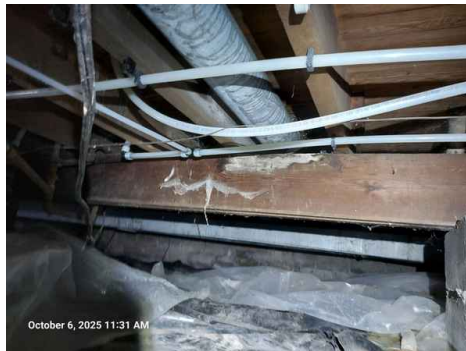
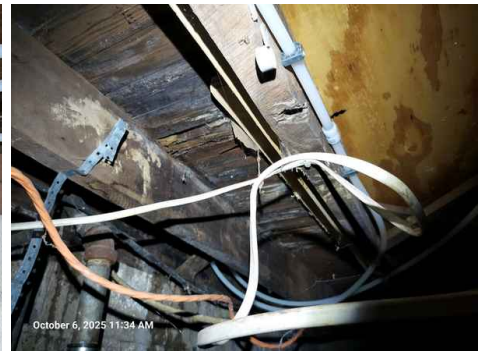
## Evidence of Leaks: Leaks - Dry

Multiple Locations

Evidence of leaking was viewed at the time of inspection. A moisture meter indicated that the stains were dry at the time of inspection.

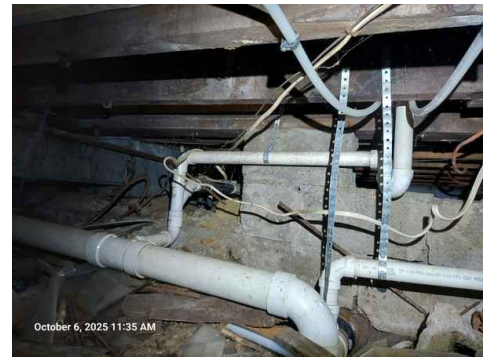
**LIMITED ACCESS TO FOUNDATION AREAS**

Portion selected of the foundation were noted as inaccessible at the time of inspection. This may be for various reasons including but not limited to standing water, vermin, belongings, low clearances, ductwork, and/or plumbing.

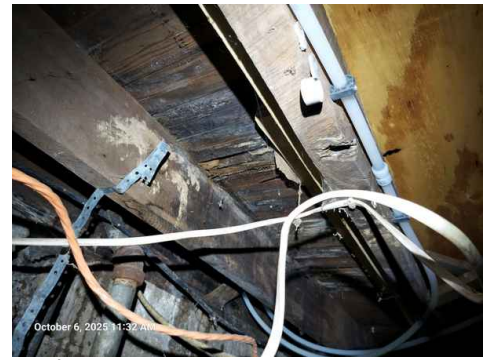
### SUBFLOOR - DAMAGED

Damage was noted to the subfloor at the time of inspection. This damage may allow pest intrusion or promote weak spots in the flooring. Recommend further evaluation & correction by a qualified contractor.

Contact a qualified professional.

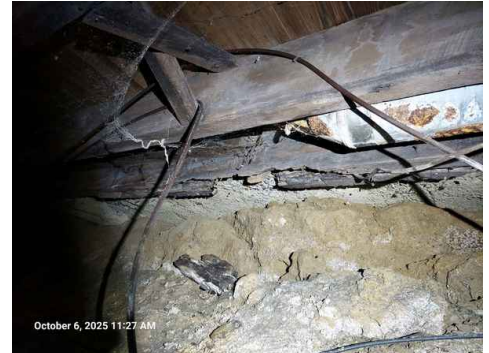
## FRAMING - DAMAGED / CRACKED JOIST(S)

One or more damaged or cracked floor joist(s) were noted at the time of inspection. It is recommended that these be braced to prevent further damage. Recommend further evaluation & correction by a qualified contractor.

Contact a qualified professional.

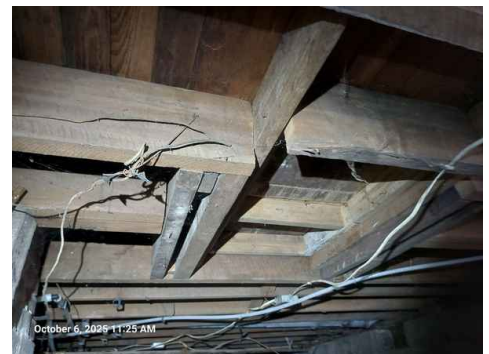
### 13.2.3 Subfloor

Floor joist(s) noted with lack of proper support at the time of inspection. All joists should have 1.5" (wood / metal), 3.5"(masonry) bearing/support under the end. In older homes this condition is very common around obstructions such as staircases, fireplaces, etc. Recommend further evaluation & correction by a qualified contractor.

Contact a qualified professional.

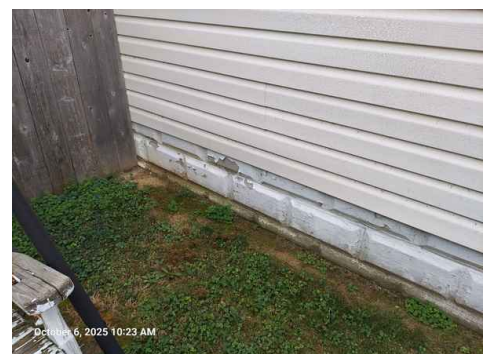
## FOUNDATION WALL(S) - MAINTENANCE NEEDED

Foundation walls noted in need of regular maintenance including caulking, painting, and cleaning. Recommend regular maintenance to prevent unwanted deterioration.

Contact a handyman or DIY project

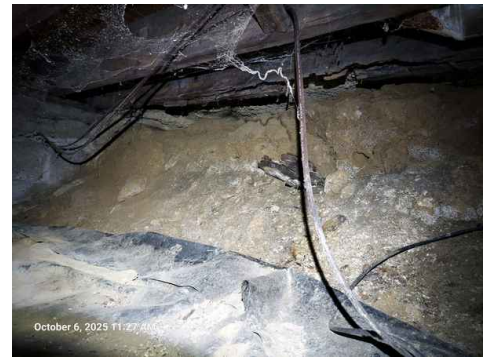
## FOUNDATION WALL(S) - EROSION

Evidence of erosion under the foundation was noted at the time of inspection. Determining the extent of the erosion is beyond the scope of this inspection. Recommend further evaluation & correction by a qualified contractor.

Contact a foundation contractor.

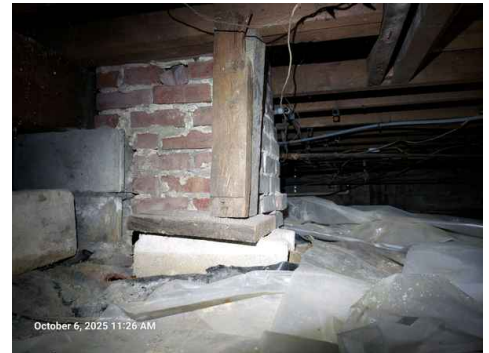
## COLUMN(S) - IMPROPER SUPPORT(S)

One or more columns or supports were noted as improper at the time of inspection. All structural supports should be attached in proper locations and have a proper footer underneath. Recommend further evaluation & correction by a qualified contractor.

Contact a foundation contractor.

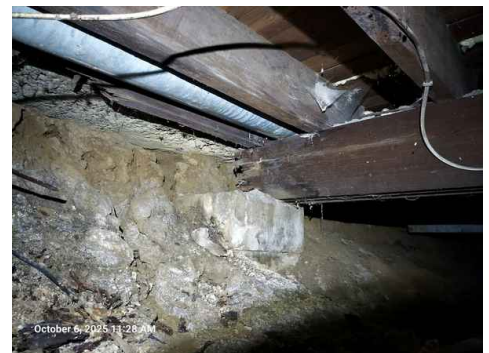
## BEAM(S) - DAMAGED

One or more foundation beams noted as damaged at the time of inspection. Damaged beams may cause further structural problems. Recommend further evaluation & correction by a qualified contractor.

Contact a foundation contractor.

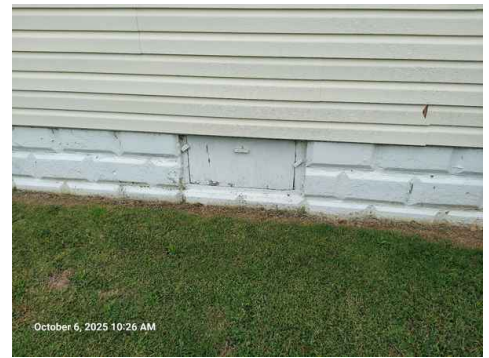
## ACCESS - IMPROPER MATERIAL

Crawlspace access door noted as made of an inappropriate material at the time of inspection. Crawlspace access door should be made of treated wood, metal, or appropriate plastics with a complete seal around the opening. Recommend further evaluation & correction by a qualified contractor.

Contact a foundation contractor.

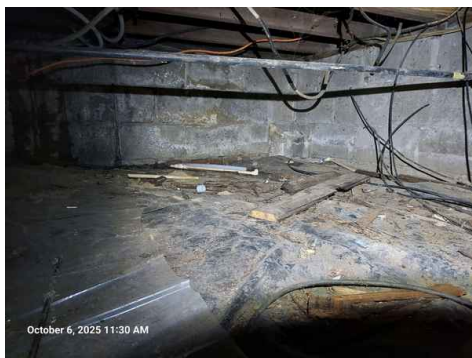
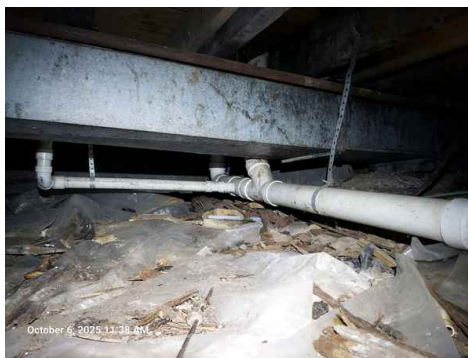
### **CRAWLSPACE - DEBRIS**

There is an excessive amount of debris / trash noted in the crawlspace at the time of inspection. This may attract pests and make it difficult for any, if necessary, work to be done. Recommend removal of debris and trash.

Contact a handyman or DIY project

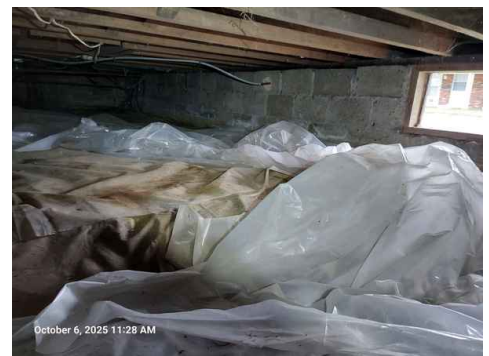
#### 13.4.3 Crawlspace

Multiple layers of vapor barrier were noted at the time of inspection. This also includes excessive overlapping. Only one layer of vapor barrier should be present and overlapping should not exceed 12 inches because moisture can get trapped between the two layers. Recommend further evaluation & correction by a qualified contractor.

Contact a foundation contractor.

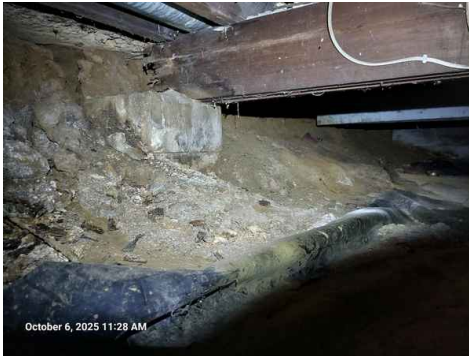
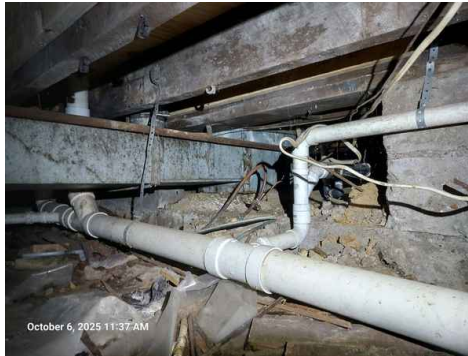
### **VAPOR BARRIER - MISSING / DAMAGED / IMPROPER**

The vapor barrier was noted as missing, damaged, or improper at some locations in the crawlspace at the time of inspection. The vapor barrier is used to prevent excessive humidity / moisture in the crawlspace. Recommend further evaluation & correction by a qualified contractor.

Contact a foundation contractor.

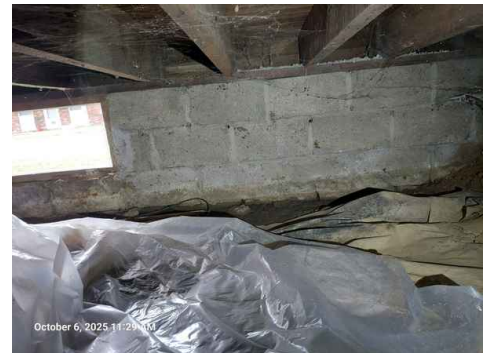
### GROUND - MUDDY

Crawlspace ground was noted as muddy at the time of inspection. This may indicate moisture is having difficulty draining and drying out. Recommend further evaluation & correction by qualified contractor.

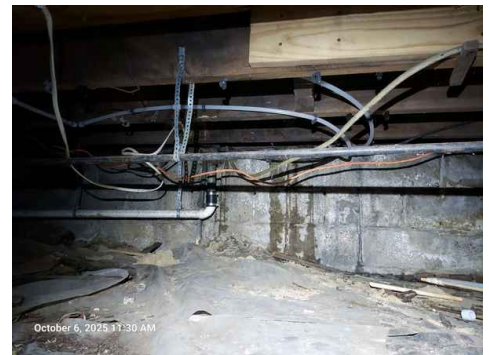
### LEAKS - ACTIVE

Evidence of leaking was viewed and moisture was present at the time of inspection. Recommend further evaluation & correction by a qualified contractor.

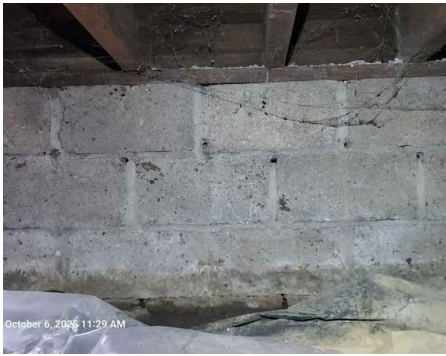
### Pest Activity: Treatment Mark(s)

Suspected treatment marks noted on sections of patios, walkways, or foundations. Recommend inquiring with sellers about previous treatments and obtaining paperwork if possible.

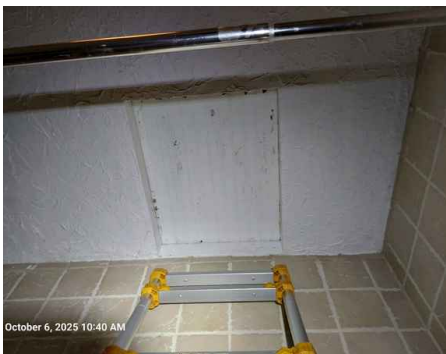
## Lead: Suspected Lead - Testing Recommended

Areas in the structure were noted to be suspected lead at the time of inspection. In 1978, the federal government banned consumer uses of lead-based paint, but some states banned it even earlier. RHI recommend have a swab test performed to tell wether lead paint has been properly encapsulated. Any following photos are examples of areas we at the minimum recommend having tested.

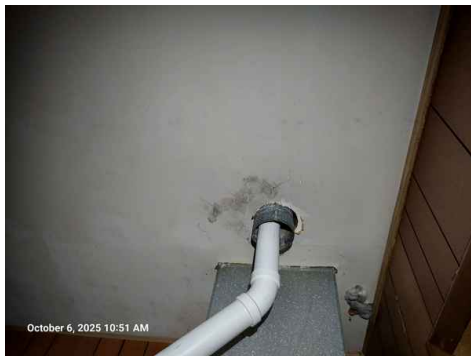
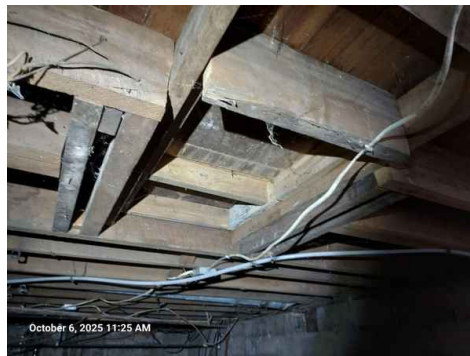
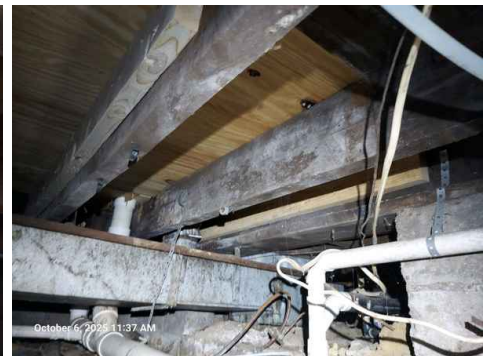
**SUSPECTED FUNGAL GROWTH - NOT TESTED**

Utility Room

Crawlspace

Contact a qualified mold remediation contractor

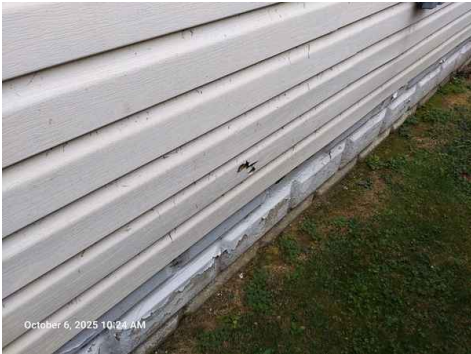
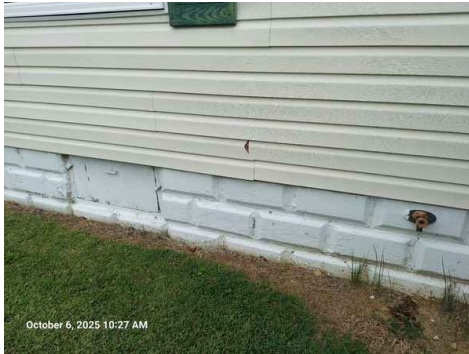
### 2.1.5 Siding **SIDING - DAMAGE**

#### MULTIPLE LOCATIONS

Damage to siding was noted at one or more locations at the time of inspection. Recommend further evaluation & correction by a qualified contractor.

Recommendation  
Contact a qualified siding specialist.

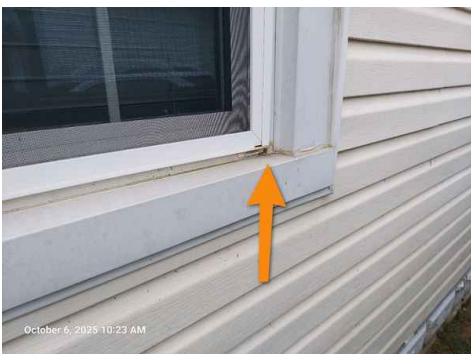
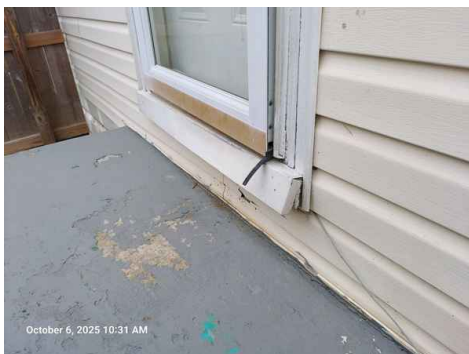
North

Trim was noted as loose at one or more locations at the time of inspection. This can allow for potential moisture & pest intrusion. Recommend further evaluation & correction by a qualified contractor.

Recommendation  
Contact a qualified siding specialist.

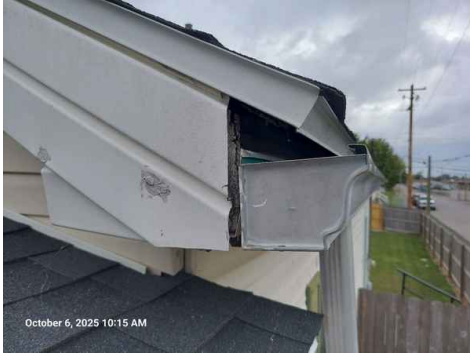
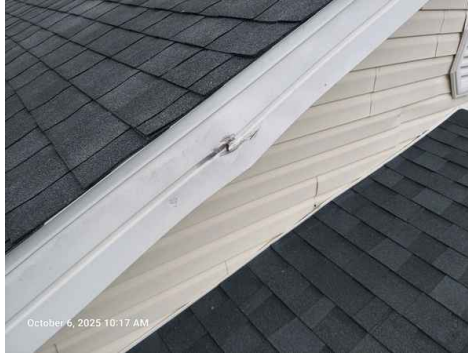
#### TRIM - MISSING / DAMAGED

Trim was noted as missing or damaged at one or more locations at the time of inspection. This includes conditions such as wood rot, exposed structure, etc. Recommend further evaluation & correction by a qualified contractor.

Contact a qualified siding specialist.

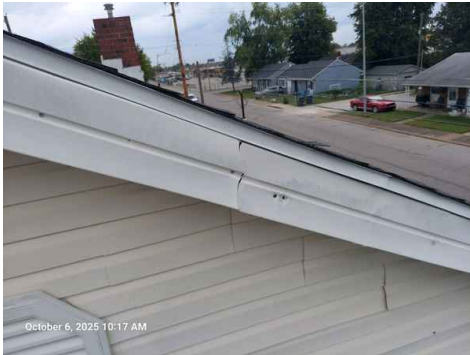
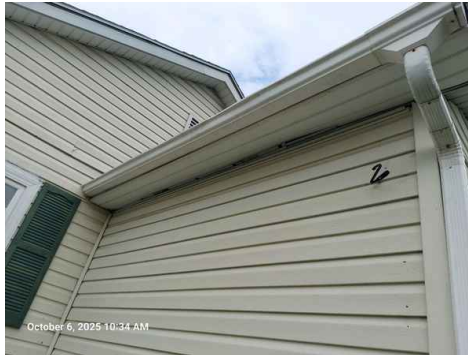
#### TRIM - IMPROPER OVERLAP / INSTALLATION

Trim was noted as improperly overlapped or installed at one or more locations at the time of inspection. This can allow for potential moisture & pest intrusion. Recommend further evaluation & correction by a qualified contractor.

Contact a qualified siding specialist.

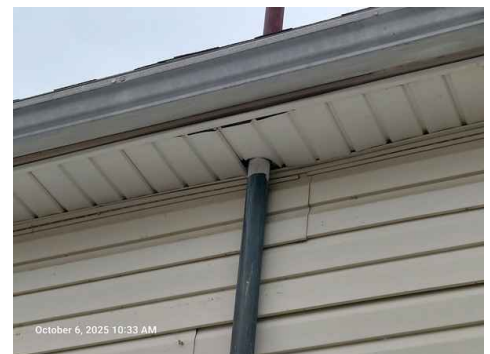
#### SOFFIT(S) - UNSEALED PENETRATIONS

Unsealed penetrations were noted at one or more locations at the time of inspection. Openings, spray foam, or other forms of unsealed penetrations leaves the structure exposed to potential moisture damage & pest intrusion. Recommend further evaluation & correction by a qualified contractor.

Contact a qualified siding specialist.

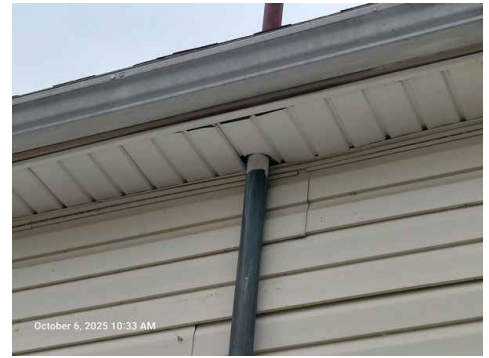
##### **SOFFIT(S) - LOOSE**

Soffit was noted as loose at one or more locations at the time of inspection. This can allow for potential moisture & pest intrusion. Recommend further evaluation & correction by a qualified contractor.

Contact a qualified siding specialist.

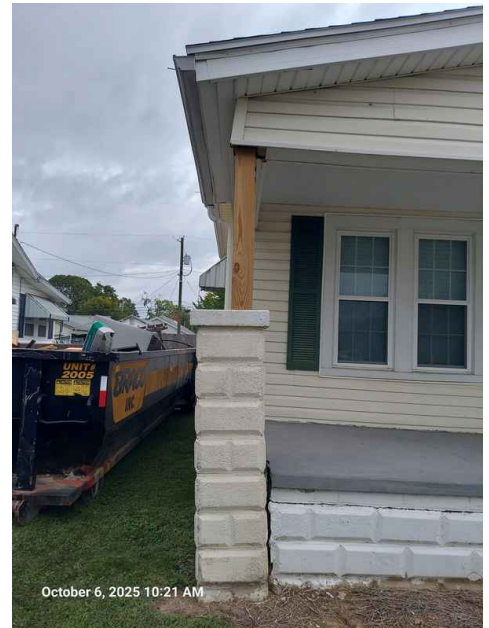
#### 2.4.2 Exterior Doors

##### **DOOR(S) - BINDING**

One or more exterior doors were noted as binding on flooring or jamb at the time of inspection. This could be due to loose hardware, out of square frame, etc. Recommend further evaluation & correction by a qualified contractor.

Recommendation  
Contact a qualified door repair/installation contractor.

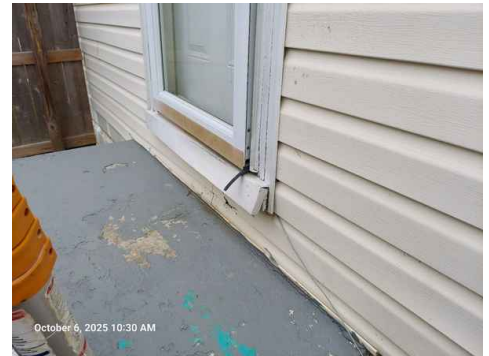
#### 3.2.1 Grading / Drainage

### GRADING - EROSION NEAR FOUNDATION

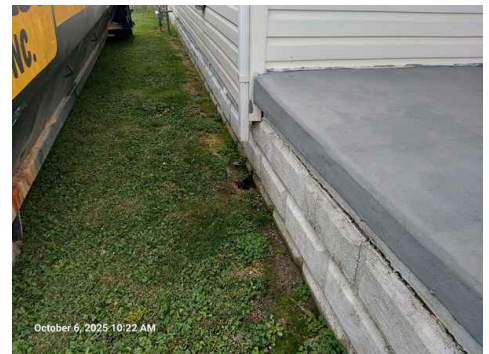
Soil near the foundation was noted as eroded at one or more locations at the time of inspection. Ongoing erosion could compromise the structural integrity of the foundation. Recommend further evaluation & correction by a qualified contractor.

Recommendation  
Contact a qualified grading contractor.

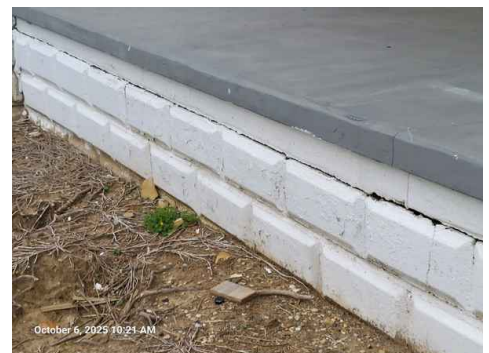
### PORCH - CRACKING

Larger cracks were noted on the porch at the time of inspection. While some cracking is typical on almost every porch, the cracking present was of a size/configuration that would indicate some portions of the porch have settled or been damaged. Recommend further evaluation & correction by a qualified contractor.

Recommendation  
Contact a qualified professional.

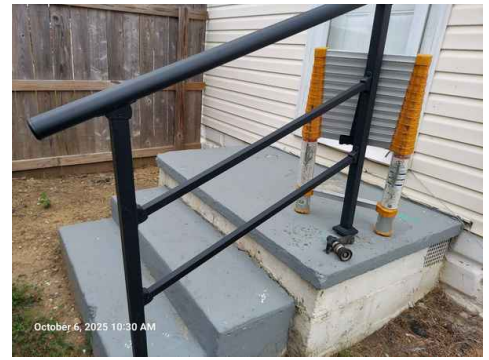
### HANDRAIL - LOOSE

Handrail on staircase was noted as loose at the time of inspection. Whenever four or more stair risers are present a handrail is required to be in place and in good condition for the safety of those using the stairs. Recommend further evaluation & correction by a qualified contractor.

Recommendation  
Contact a qualified professional.

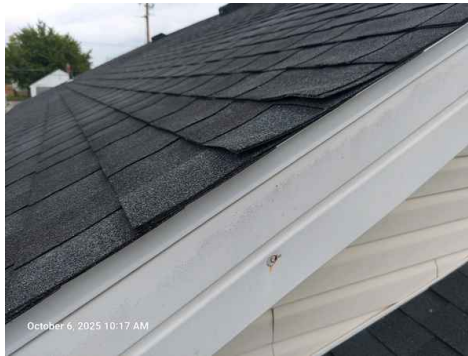
### SHINGLES - LIFTED SHINGLE(S)

One or more shingles appear to be lifted at the time of inspection. This could be due to a variety of reasons, such as nail pops, etc. Recommend further evaluation & correction by a qualified contractor.

Recommendation  
Contact a qualified roofing professional.

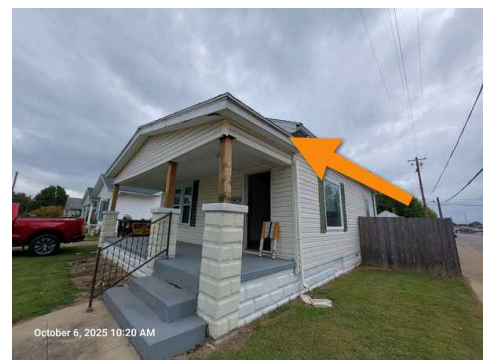
### GUTTER(S) - MISSING / DAMAGED

Missing or damaged gutters were noted at the time of the inspection. This can result in excessive moisture in the soil at the foundation, which can lead to moisture intrusion or damage to the foundation. Recommend further evaluation & correction by a qualified contractor.

Recommendation  
Contact a qualified gutter contractor

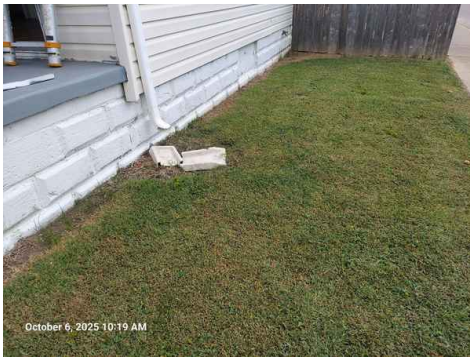
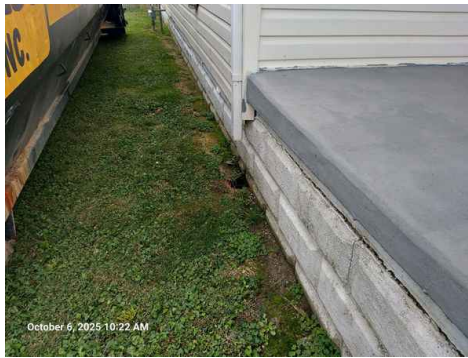
### DOWNSPOUT(S) - MISSING / IMPROPER EXTENSION

One or more downspouts were noted as having missing or improperly installed splash block(s) at the time of the inspection. Downspout extensions are used to divert water away from the foundation. Recommend further evaluation & correction by a qualified contractor.

Recommendation  
Contact a qualified professional.

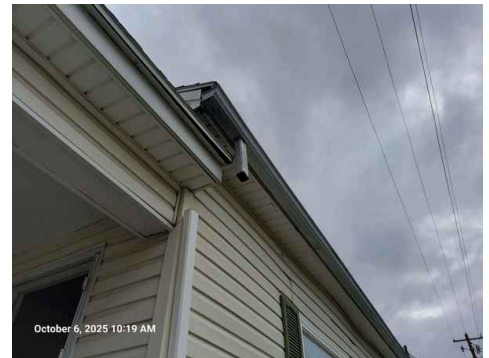
##### **DOWNSPOUT(S) - DISCONNECTED / GAPS**

One or more downspout(s) were noted as disconnected or having gaps at the time of the inspection. Improperly connected downspout(s) can lead to moisture intrusion around foundation. Recommend further evaluation & correction by a qualified contractor.

Recommendation  
Contact a qualified gutter contractor

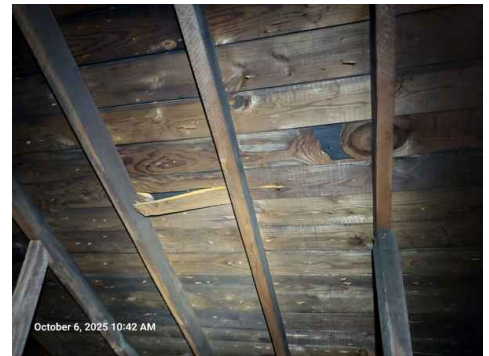
##### **SHEATHING - DAMAGED**

Cracks / hole(s) or damaged areas of roof sheathing were noted at the time of inspection. Damaged areas of roof sheathing should typically be replaced before the roof covering were installed. Recommend further evaluation & correction by a qualified contractor.

Recommendation  
Contact a qualified roofing professional.

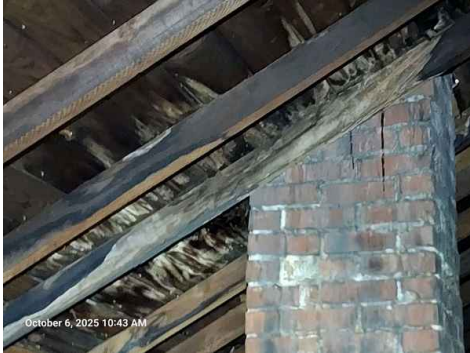
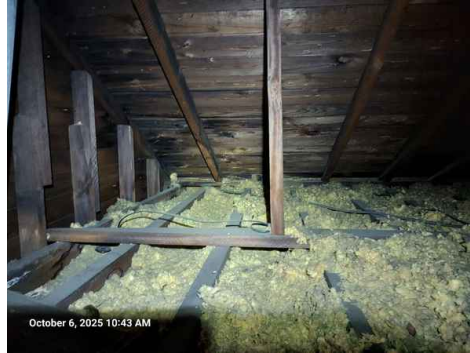
### 5.5.1 Evidence of Leaks **LEAKS - INACCESSIBLE**

Evidence of leaking was viewed at the time of inspection. The stains were not readily accessible to test with a moisture meter and the inspector was unable to determine how long ago they occurred. Recommend further evaluation & correction by a qualified contractor.

Recommendation  
Contact a qualified professional.

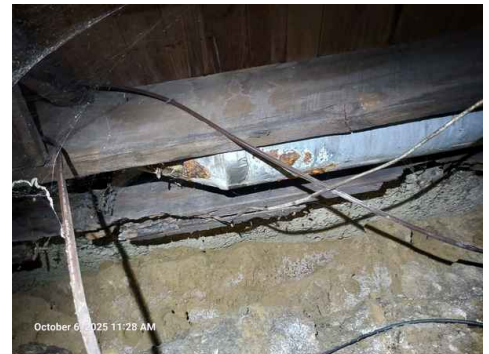
### 6.4.1 Ductwork **DUCTWORK - DAMAGED**

One or more sections of ductwork were noted as damaged at the time of inspection. Recommend further evaluation & correction by a qualified contractor.

Recommendation  
Contact a qualified HVAC professional.

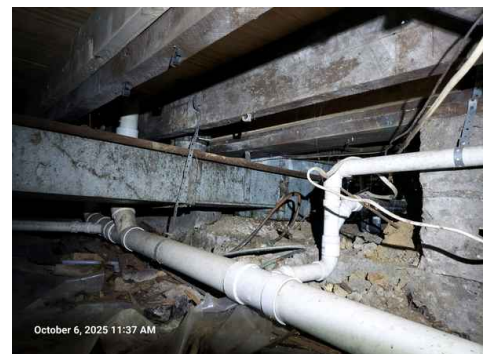
### 6.4.2 Ductwork **DUCTWORK - GROUND CONTACT**

One or more sections of ductwork were noted as being in contact with the ground at the time of inspection. This can allow moisture and pests to enter the ductwork. Recommend further evaluation & correction by a qualified contractor.

Recommendation  
Contact a qualified HVAC professional.

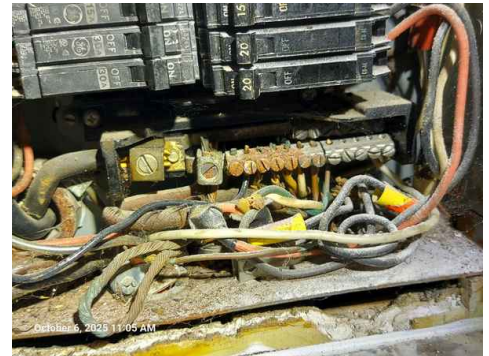
##### **PANEL - CORROSION**

Corrosion was viewed inside the distribution panel at the time of inspection. This is typically caused by water entry or moisture condensing inside the panel. Moisture inside electrical panels can create hazardous conditions. Recommend further evaluation & correction by a qualified contractor.

Contact a qualified electrical contractor.

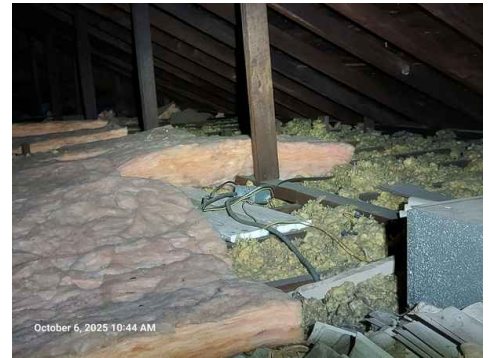
### **JUNCTION BOX(ES) - LOOSE / IMPROPERLY SECURED**

One or more junction boxes were noted as being loose or improperly secured at the time of inspection. All junction boxes used to contain splices in branch wiring should be securely mounted to framing to ensure splices are not damaged. Recommend further evaluation & correction by a qualified contractor.

Contact a qualified electrical contractor.

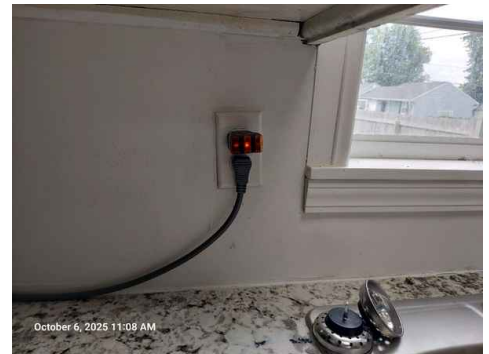
### **OUTLET(S) - IMPROPERLY WIRED**

One or more outlets noted to be improperly wired as indicated by an outlet tester at the time of inspection. Recommend further evaluation & correction by a qualified contractor.

Contact a qualified electrical contractor.
