**SELLER'S RESIDENTIAL REAL ESTATE SALES DISCLOSURE**

2501 N Lafayette Ave

Evansville

IN 47711

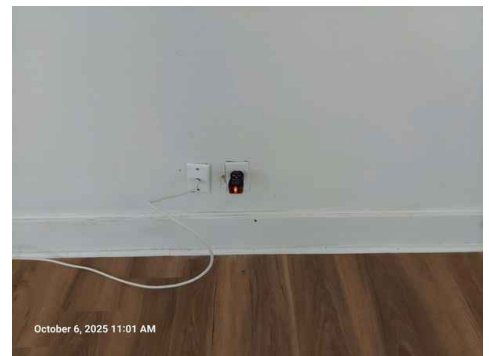
### **OUTLET(S) - 3-PRONG NON-GROUNDED OUTLET(S)**

One or more open grounds were noted on 3-prong type electrical receptacles at the time of inspection. This could be due to potential older wiring not having grounding conductors. The 3-prong receptacles give the impression that there are equipment grounding conductors when none are present. Recommend further evaluation & correction by a qualified contractor.

Contact a qualified electrical contractor.

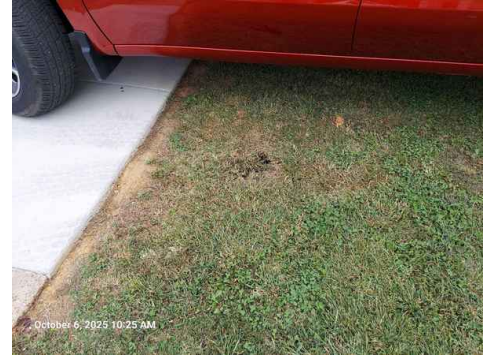
#### METER - LID MISSING OR DAMAGED

The water meter head was noted as damaged or missing at the time of inspection. This could pose as a tripping hazard. Recommend further evaluation & correction by a qualified contractor.

Contact a qualified plumbing contractor.

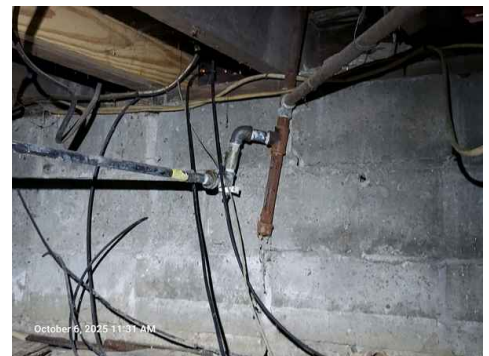
#### GAS LINE(S) - CORROSION / RUST

One or more gas lines were corroded at the time of the inspection. This can lead to gas leaks if left unattended. Recommend further evaluation & correction by a qualified contractor.

Contact a qualified plumbing contractor.

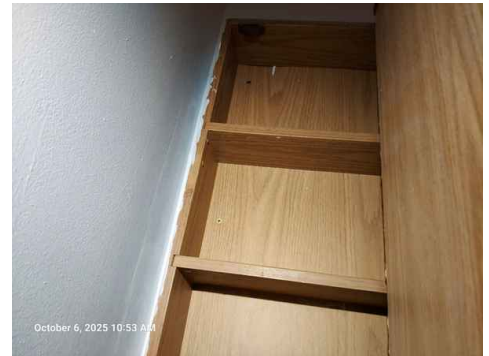
Cabinets were noted as being improperly mounted at the time of inspection. Recommend further evaluation & correction by a qualified contractor.

Recommendation  
Contact a qualified cabinet contractor.

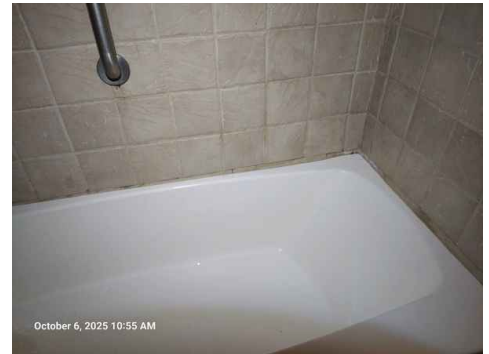
### SHOWER TILE - MISSING / DETERIORATED GROUT

The grout was noted as missing or deteriorated at the time of the inspection. This may allow for water penetration or further damage. Recommend further evaluation & correction by a qualified contractor.

Recommendation  
Contact a qualified tile contractor

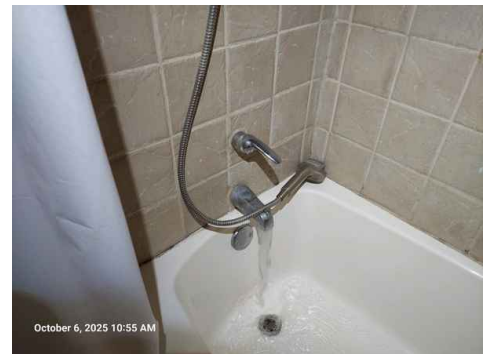
### FIXTURE - LEAKING

One or more tub / shower fixtures were noted as leaking at the time of the inspection. Recommend further evaluation & correction by a qualified contractor.

Recommendation  
Contact a qualified plumbing contractor.

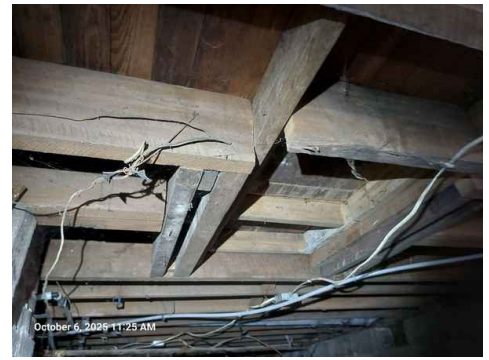
### 13.3.2 Walls, Beams, & Columns

## FOUNDATION WALL(S) - EROSION

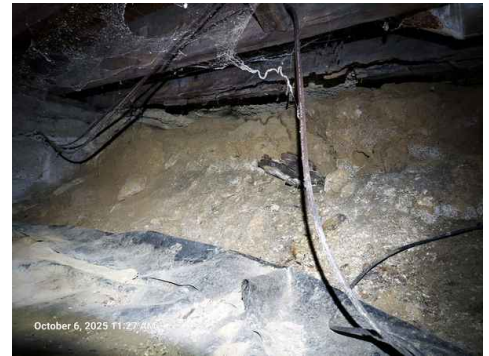
### 13.3.3 Walls, Beams, & Columns

## FOUNDATION WALL(S) - POTENTIAL MOVEMENT

Structural / Safety Hazard

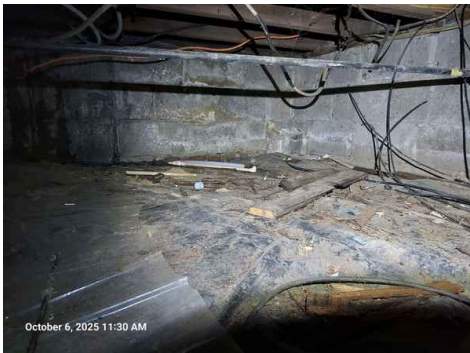
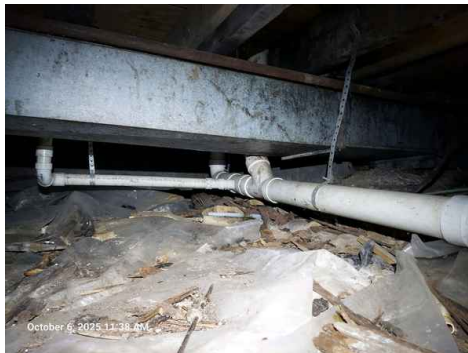
There is an excessive amount of debris / trash noted in the crawlspace at the time of inspection. This may attract pests and make it difficult for any, if necessary, work to be done. Recommend removal of debris and trash.

Contact a handyman or DIY project

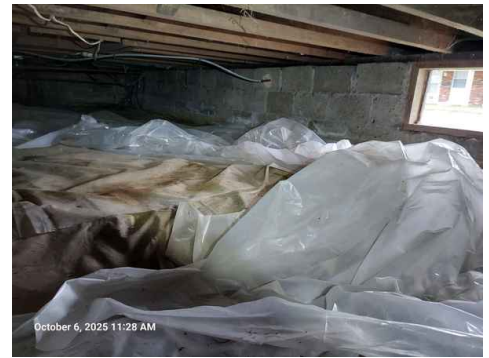
#### VAPOR BARRIER - MULTIPLE LAYERS

Multiple layers of vapor barrier were noted at the time of inspection. This also includes excessive overlapping. Only one layer of vapor barrier should be present and overlapping should not exceed 12 inches because moisture can get trapped between the two layers . Recommend further evaluation & correction by a qualified contractor.

Contact a foundation contractor.

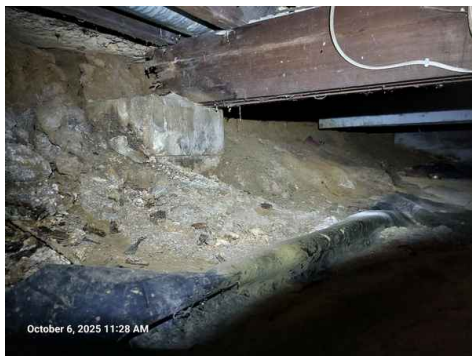
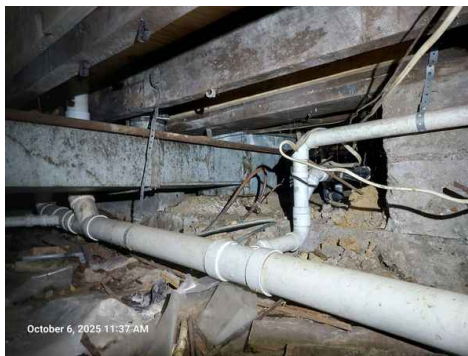
### VAPOR BARRIER - MISSING / DAMAGED / IMPROPER

The vapor barrier was noted as missing, damaged, or improper at some locations in the crawlspace at the time of inspection. The vapor barrier is used to prevent excessive humidity / moisture in the crawlspace. Recommend further evaluation & correction by a qualified contractor.

Contact a foundation contractor.

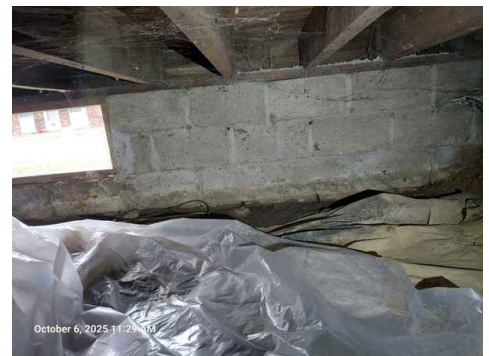
#### 13.6.1 Evidence of Leaks

### LEAKS - ACTIVE

Recommendation  
Contact a qualified professional.

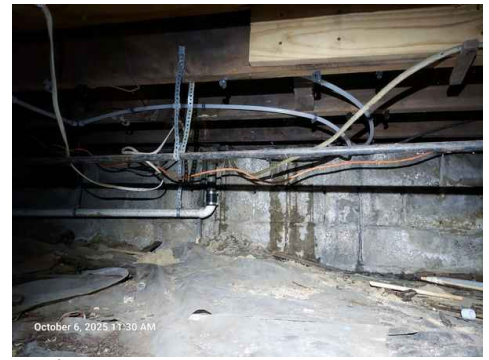
Evidence of leaking was viewed and moisture was present at the time of inspection. Recommend further evaluation & correction by a qualified contractor.

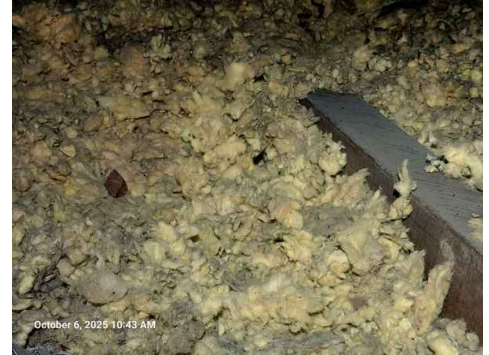
#### 14.2.1 Animal Activity **RODENT ACTIVITY**

Evidence of rodent activity was noted at the time of inspection. It is common for rodents to enter areas during cold weather. The inspector is unable to determine how recent the activity might be. Recommend further evaluation & removal by a wildlife removal company.

Recommendation  
Contact a qualified pest control specialist.

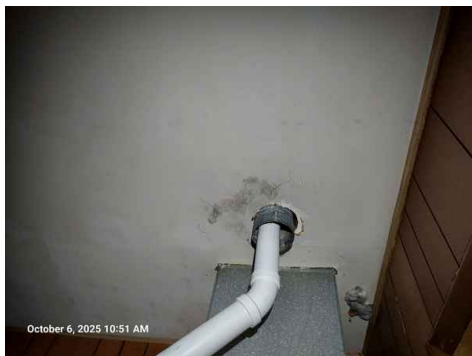
Utility Room

Suspected fungal growth was noted at the time of the inspection. Some types of mold can have negative health effects but proper remediation of any mold may eliminate negative side effects. Recommend further evaluation & correction by a qualified contractor. RHI can take a mold sample to have lab analysis performed to confirm this for an addition charge.

Recommendation  
Contact a qualified mold remediation contractor

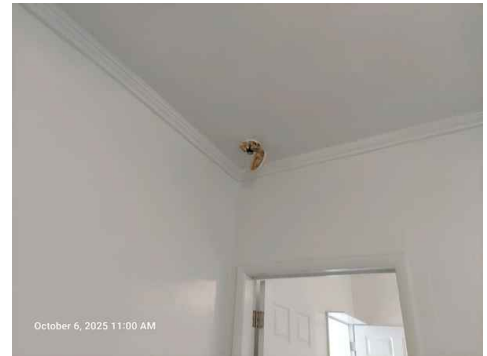
One or more smoke alarms noted as appearing to be older than 10 years at the time of the inspection. Smoke alarms are not intended to last longer than 10 years and may not be able to sense smoke even if the audible alarm still responds to a test. Recommend further evaluation & correction by a qualified contractor.

Recommendation  
Contact a qualified electrical contractor.
