PZD-0 - INDEX OF DOCUMENTS FOR PLANNING & ZONING; SPECIAL PERMITS

Re: Letter of Intent for Special Certificate of Appropriateness for Historic Property at 67 NE 44 Street, Miami, FL

**Certified Arborist Assessment
67 NE 44 St, Miami, Florida
NLE Project No. 52724001**

BUENA VISTA RESIDENCE

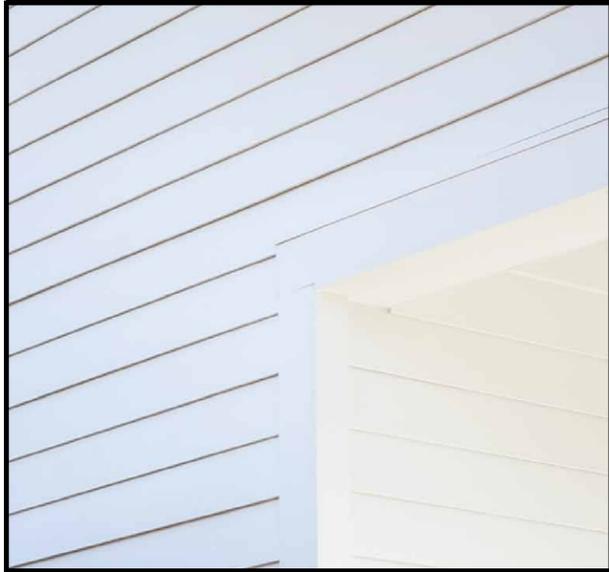
1- WOOD SIDING (COLOR TO MATCH EXISTING CONDITION)

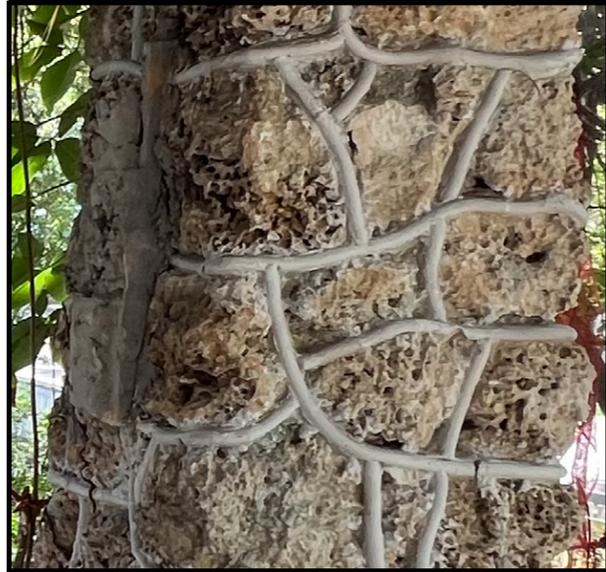
2- OOLITE STONE TO MATCH EXISTING CONDITION

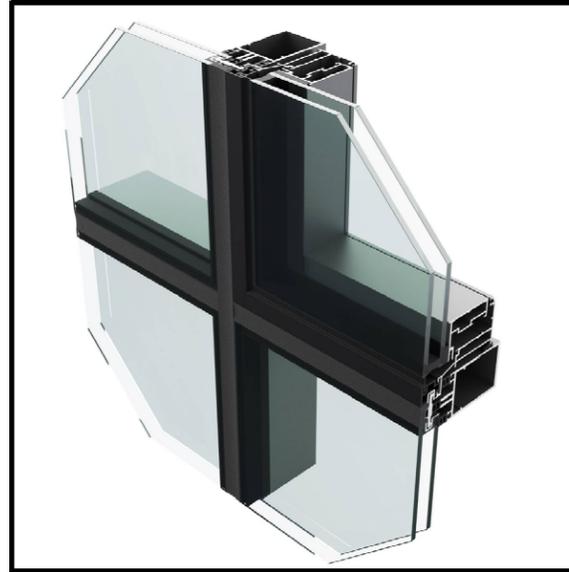
3- DARK GRAY PAINTED MULLIONS

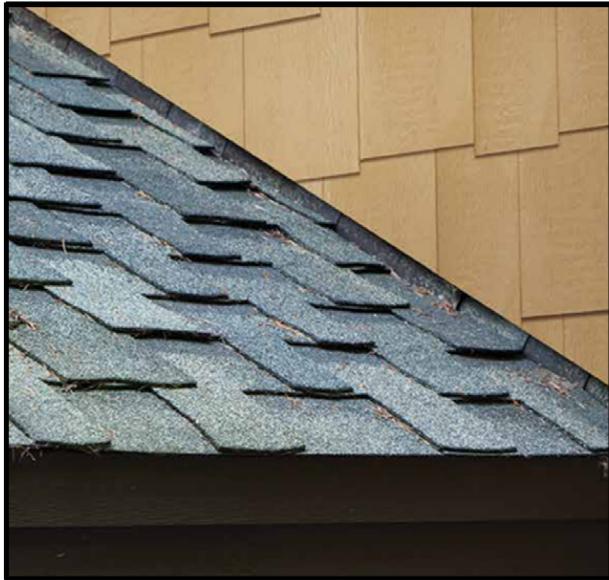
5- ASPHALT SHINGLE ROOF TO MATCH EXISTING

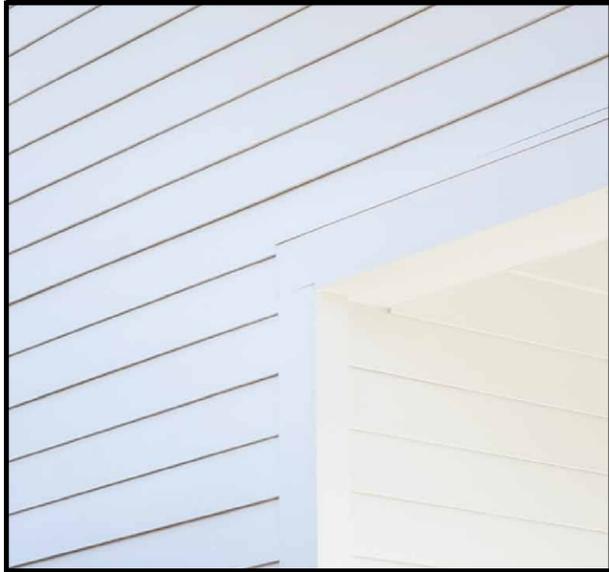
1- WOOD SIDING (COLOR TO MATCH EXISTING CONDITION)

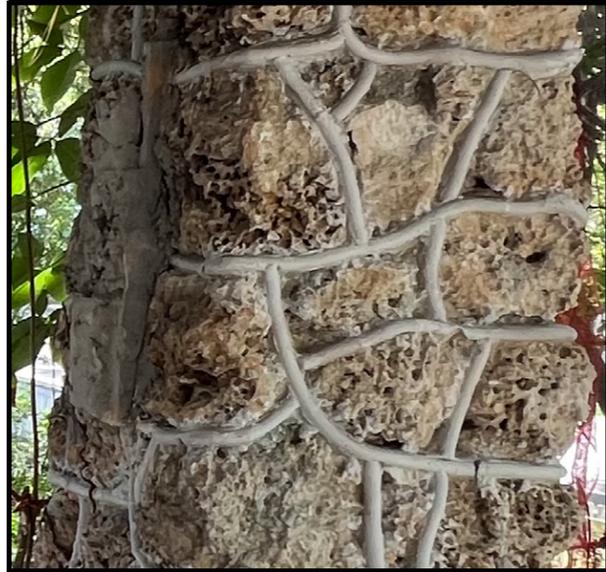
2- OOLITE STONE TO MATCH EXISTING CONDITION

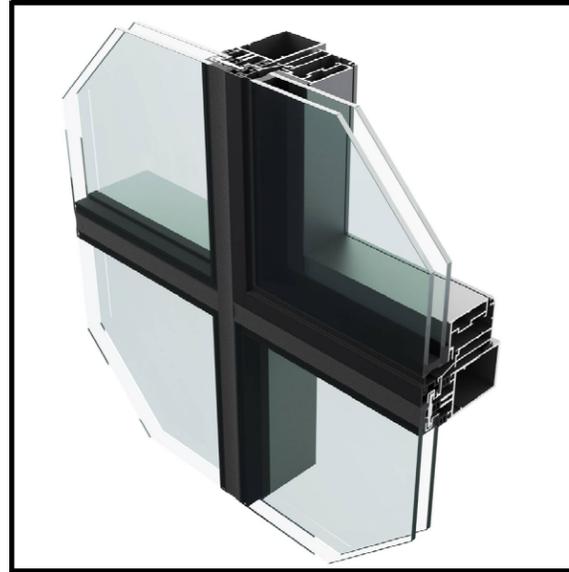
3- DARK GRAY PAINTED MULLIONS

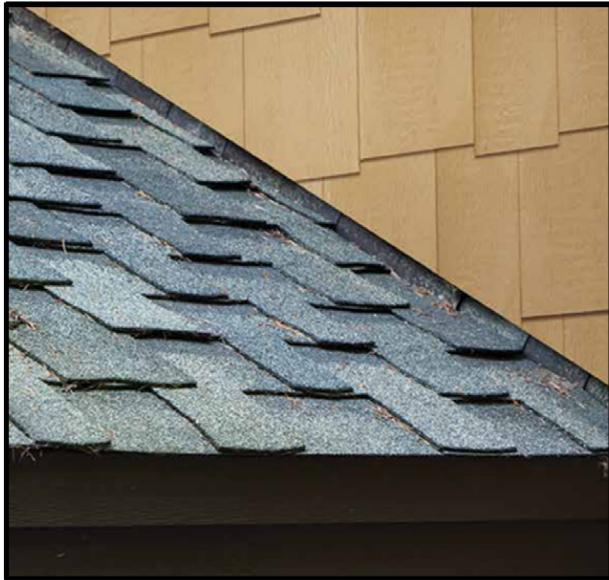
5- ASPHALT SHINGLE ROOF TO MATCH EXISTING

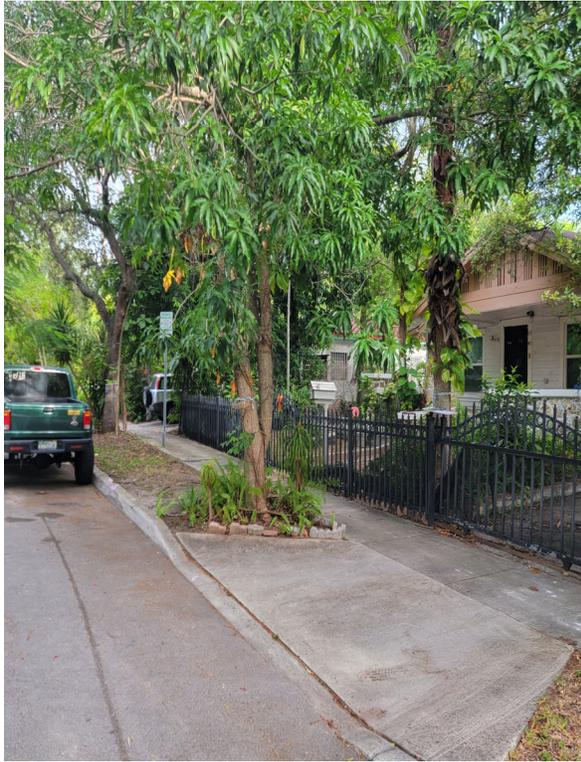
Tree 1 mango
(*Mangifera indica*)
13 inch DBH, Good condition
40 foot height, 38 foot spread

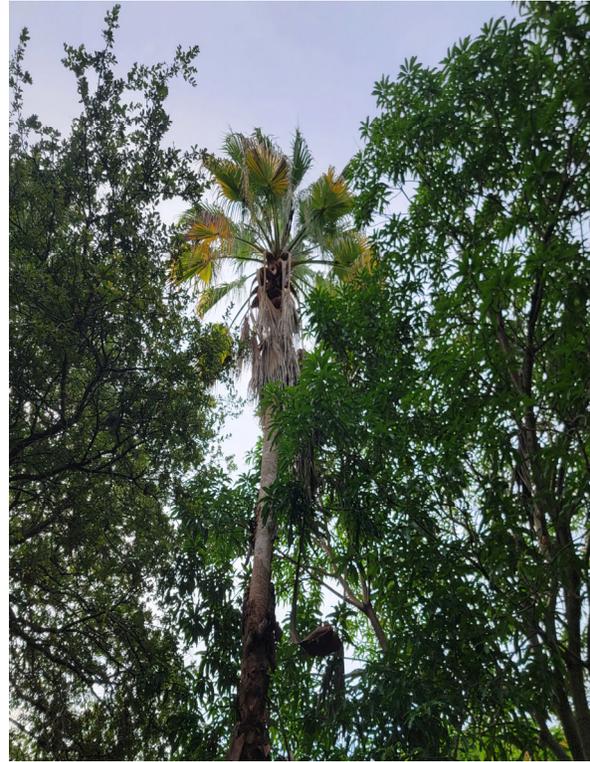
Tree 2 Chinese fan palm
(*Livistona chinensis*)
11 inch DBH Fair condition
50 foot height, 16 foot spread

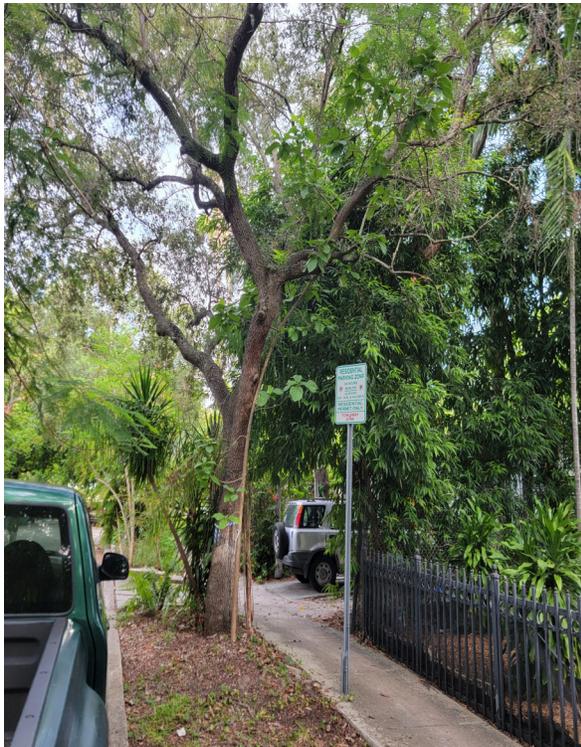
Tree 3 live oak
(*Quercus virginiana*)
18 inch DBH, Good condition
45 foot height, 50 foot spread

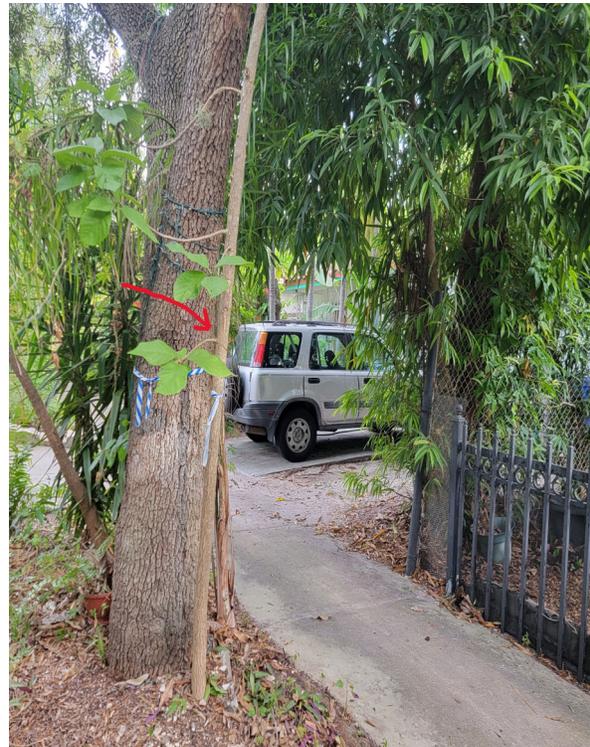
Tree 4 orange geiger
(*Cordia sebestena*)
2 inch DBH Fair condition
18 foot height, 12 foot spread

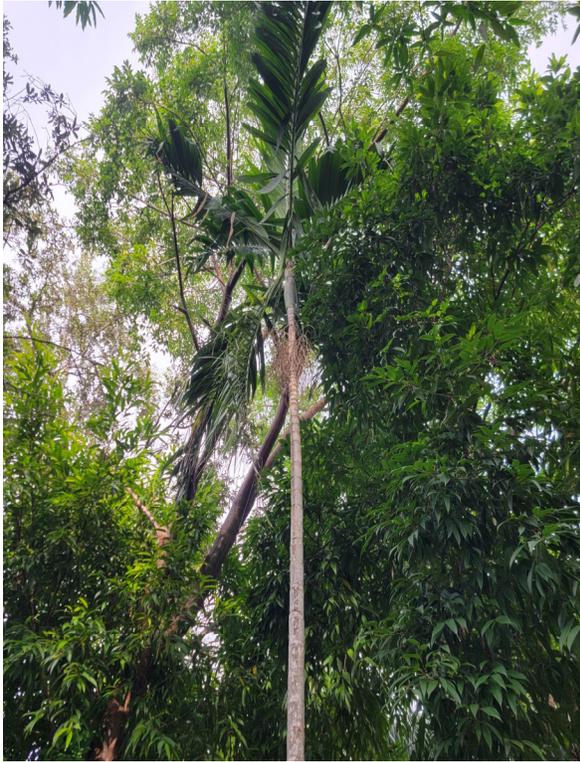
Tree 5 solitaire palm
(*Ptychosperma elegans*)
3 inch DBH, Good condition
28 foot height, 12 foot spread

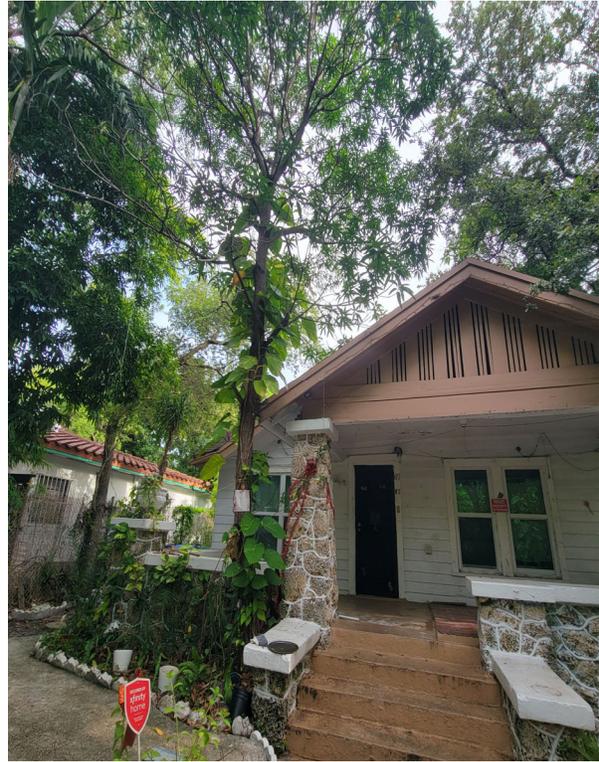
Tree 6 mango
(*Mangifera indica*)
10 inch DBH Good condition
40 foot height, 28 foot spread

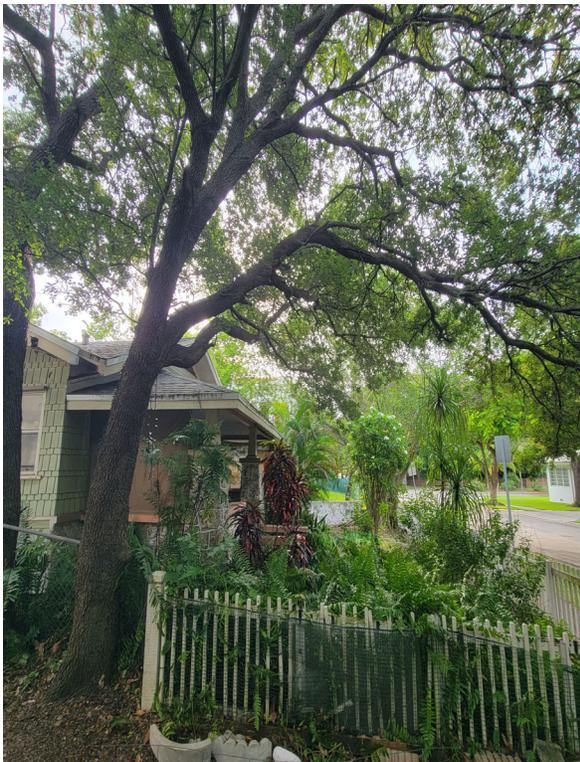
Tree 7 live oak
(*Quercus virginiana*)
17 inch DBH, Fair condition
48 foot height, 45 foot spread

fence through trunk

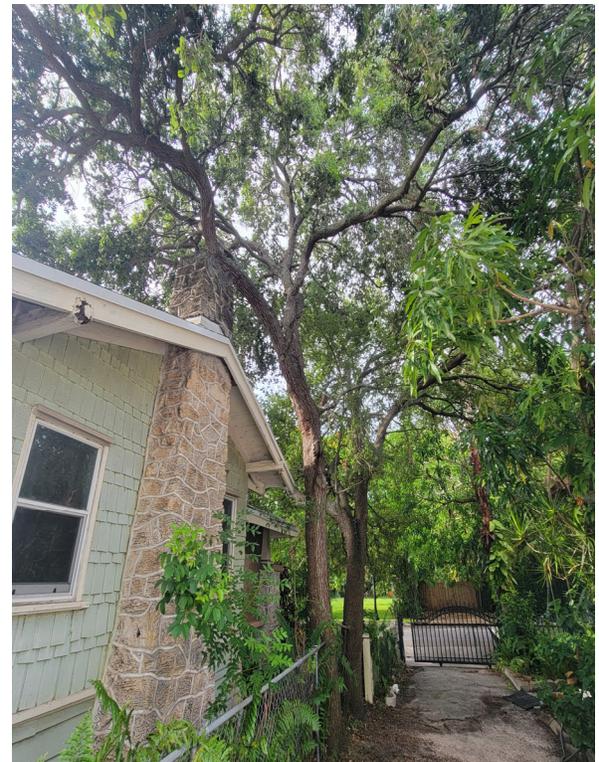
Tree 8 live oak
(*Quercus virginiana*)
15 inch DBH Good condition
48 foot height, 42 foot spread

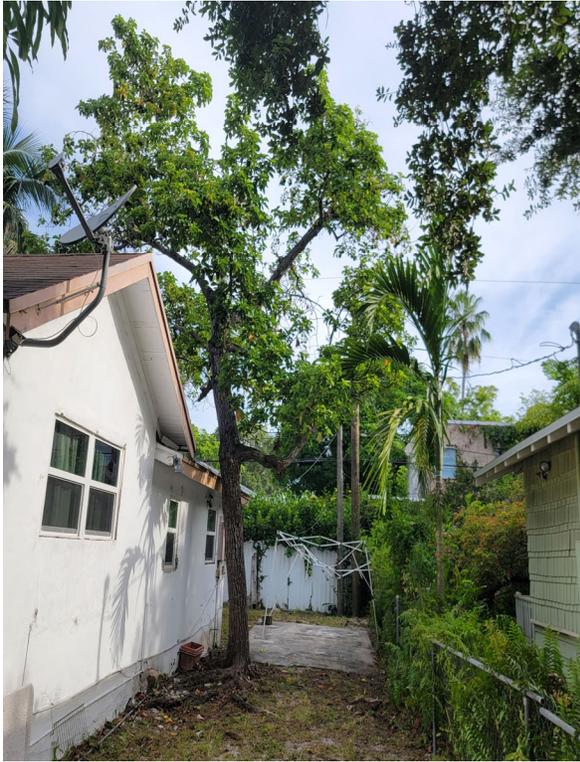
Tree 9 avocado
(Persea americana)
14 inch DBH, Fair condition
38 foot height, 32 foot spread

crown dieback

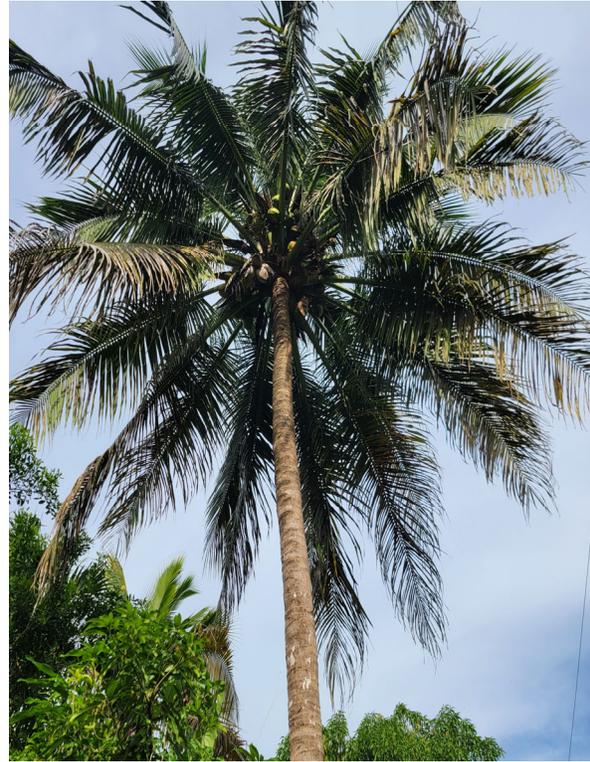
Tree 10 coconut palm
(Cocos nucifera)
11 inch DBH Good condition
45 foot height, 18 foot spread

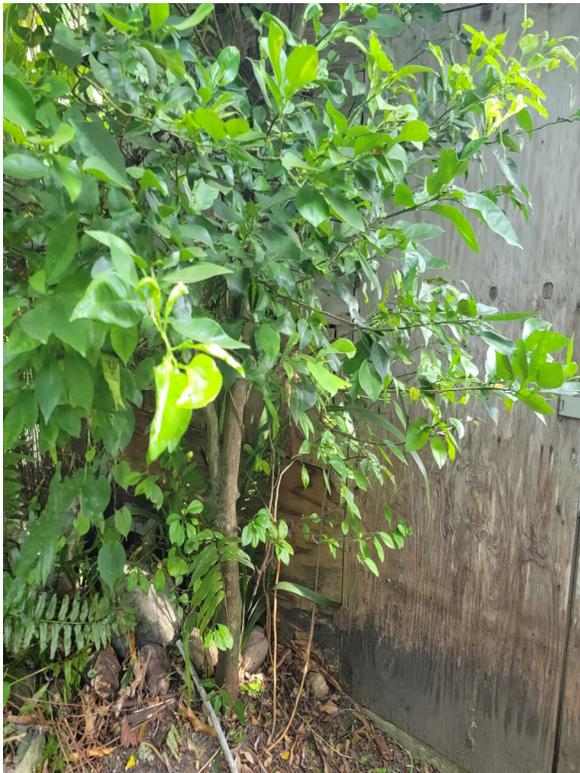
Tree 11 citrus
(Citrus sp.)
4 inch DBH, Fair condition
12 foot height, 10 foot spread

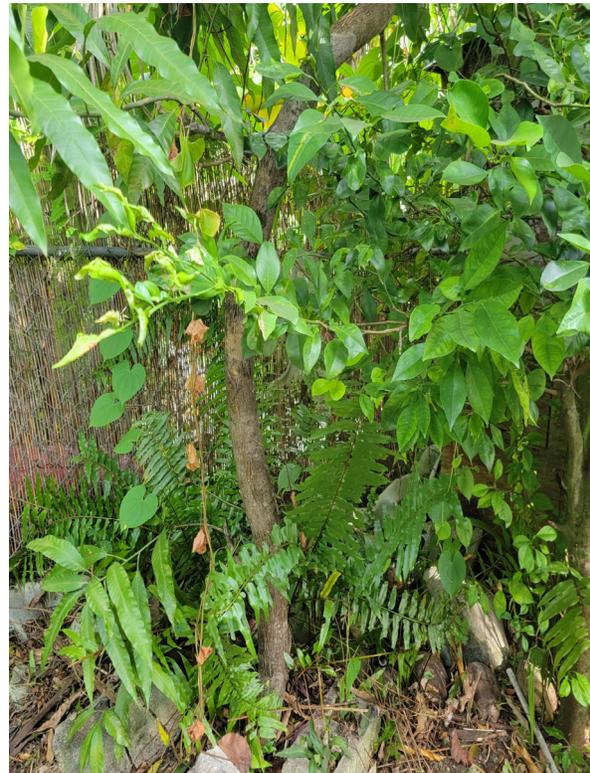
Tree 12 mango
(Mangifera indica)
4 inch DBH Fair condition
12 foot height, 10 foot spread

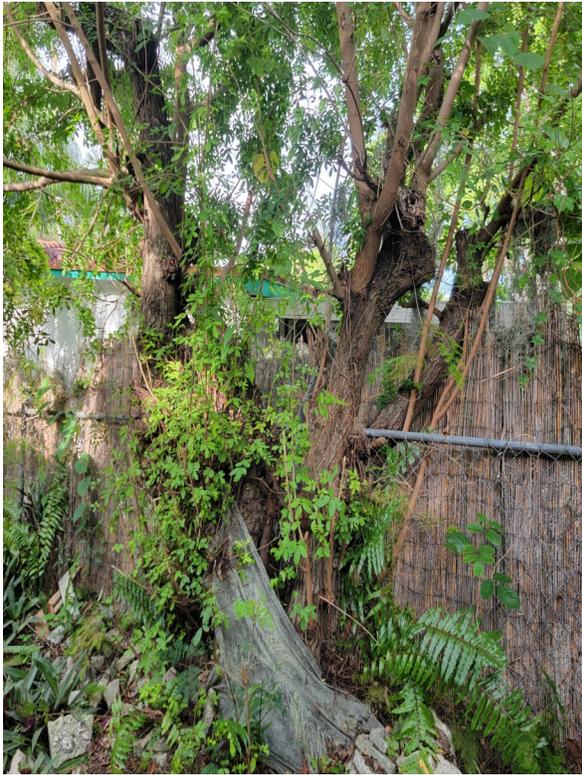
Tree 13 Brazilian pepper
(*Schinus terebinthifolius*)
21 inch DBH, Fair condition
28 foot height, 28 foot spread

in fence

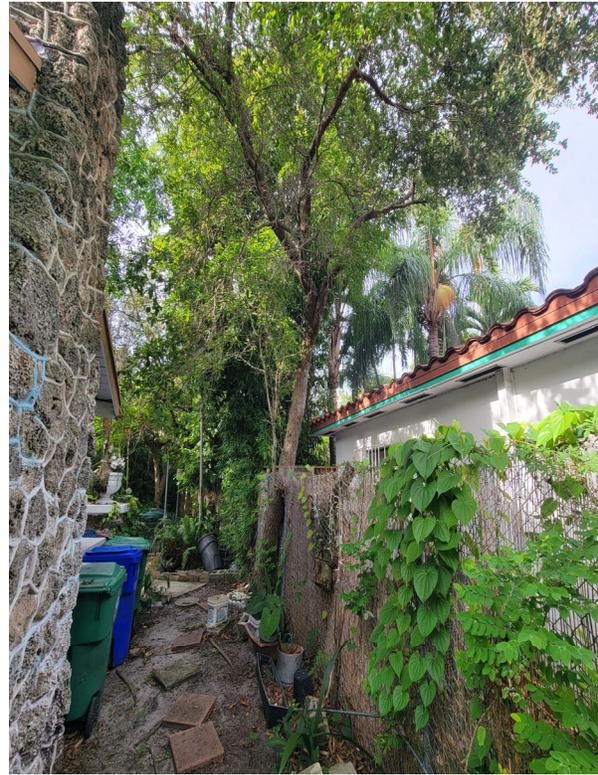
Tree 14 live oak
(*Quercus virginiana*)
11 inch DBH Poor condition
35 foot height, 30 foot spread

fence through trunk

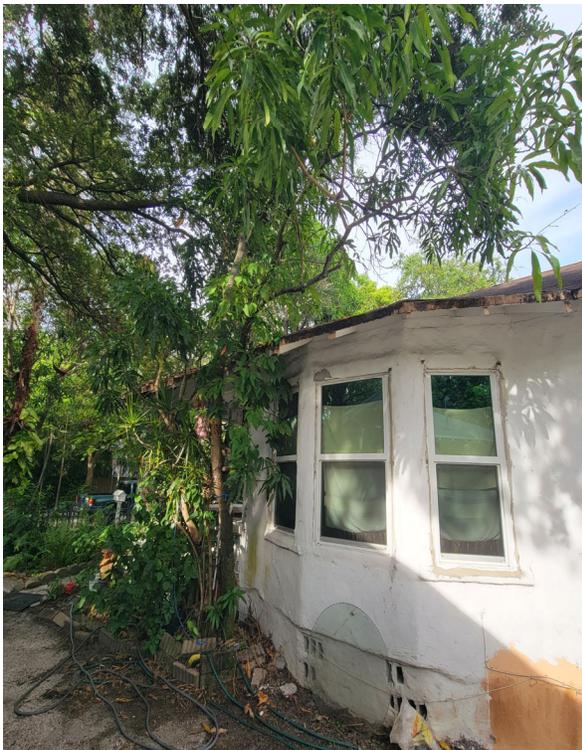
Tree 15 mango
(*Mangifera indica*)
7 inch DBH, Fair condition
30 foot height, 26 foot spread

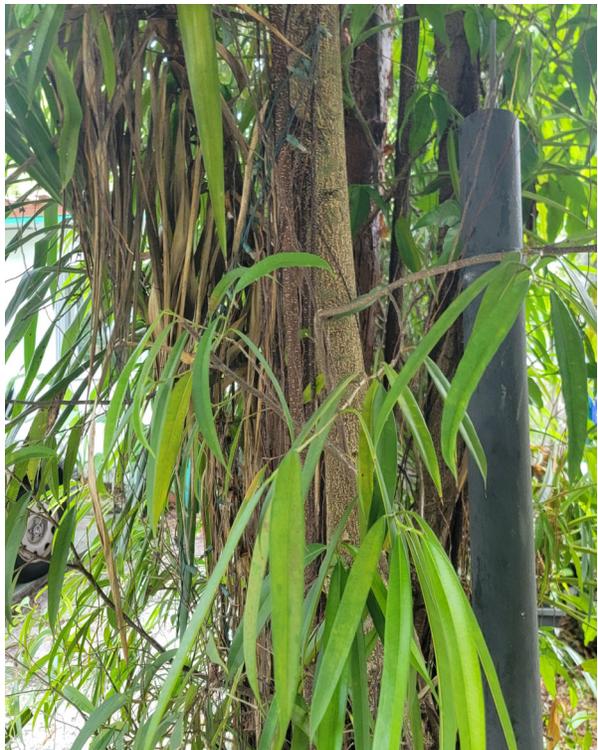
Tree ADJ1 ficus alii
(*Ficus maclellandii*)
4 inch DBH Fair condition
20 foot height, 20 foot spread

off site

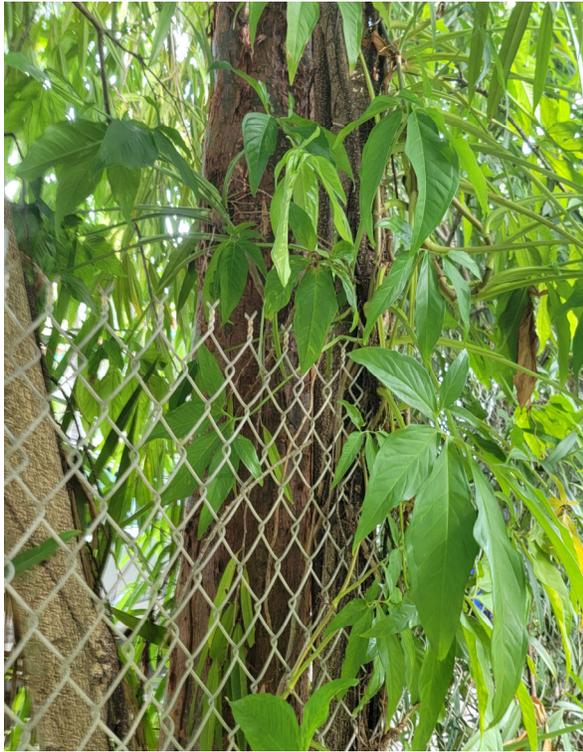
Tree ADJ2 gumbo limbo
(*Bursera simaruba*)
14 inch DBH, Fair condition
30 foot height, 26 foot spread

off site

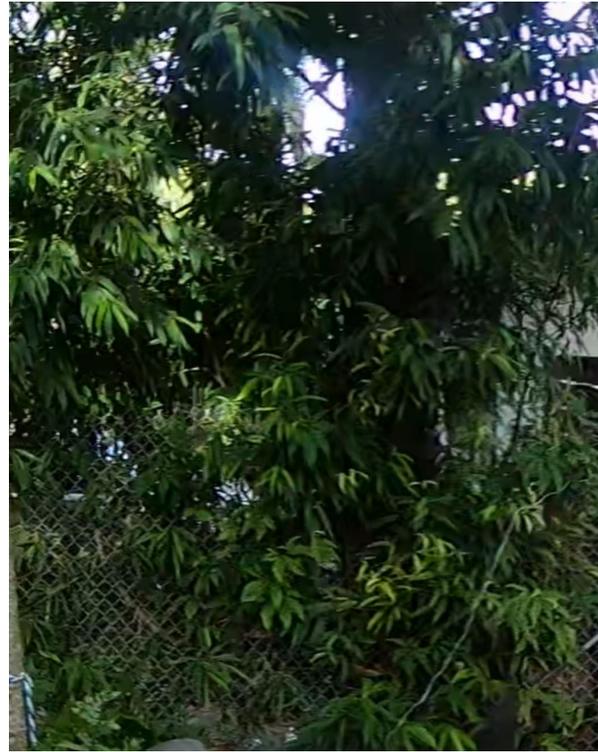
Tree ADJ3 ficus alii
(*Ficus maclellandii*)
11 inch DBH Fair condition
26 foot height, 20 foot spread

off site

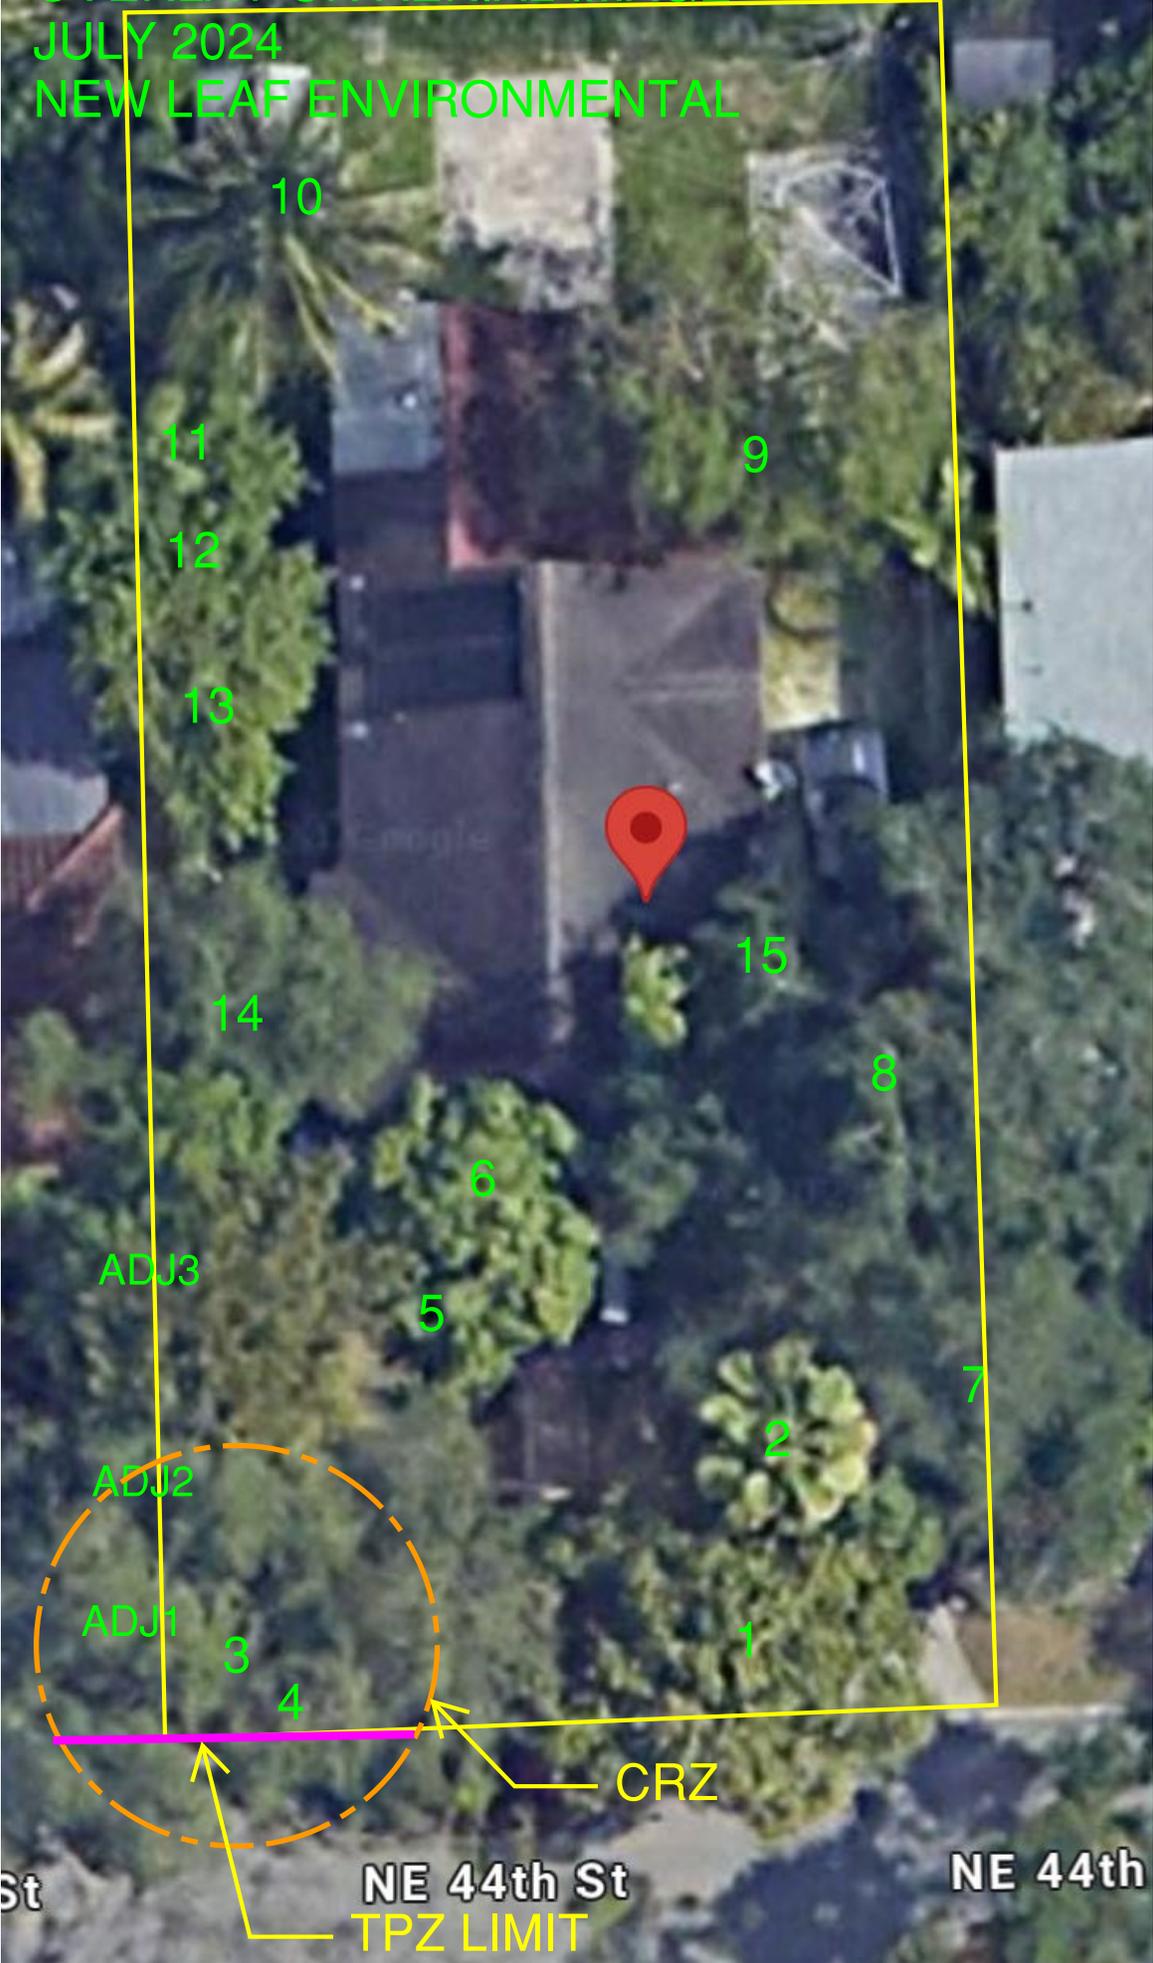
TREE MAP 67 NE 44 ST
OVERLAY ON AERIAL IMAGE
JULY 2024
NEW LEAF ENVIRONMENTAL

NE 44th St
TPZ LIMIT

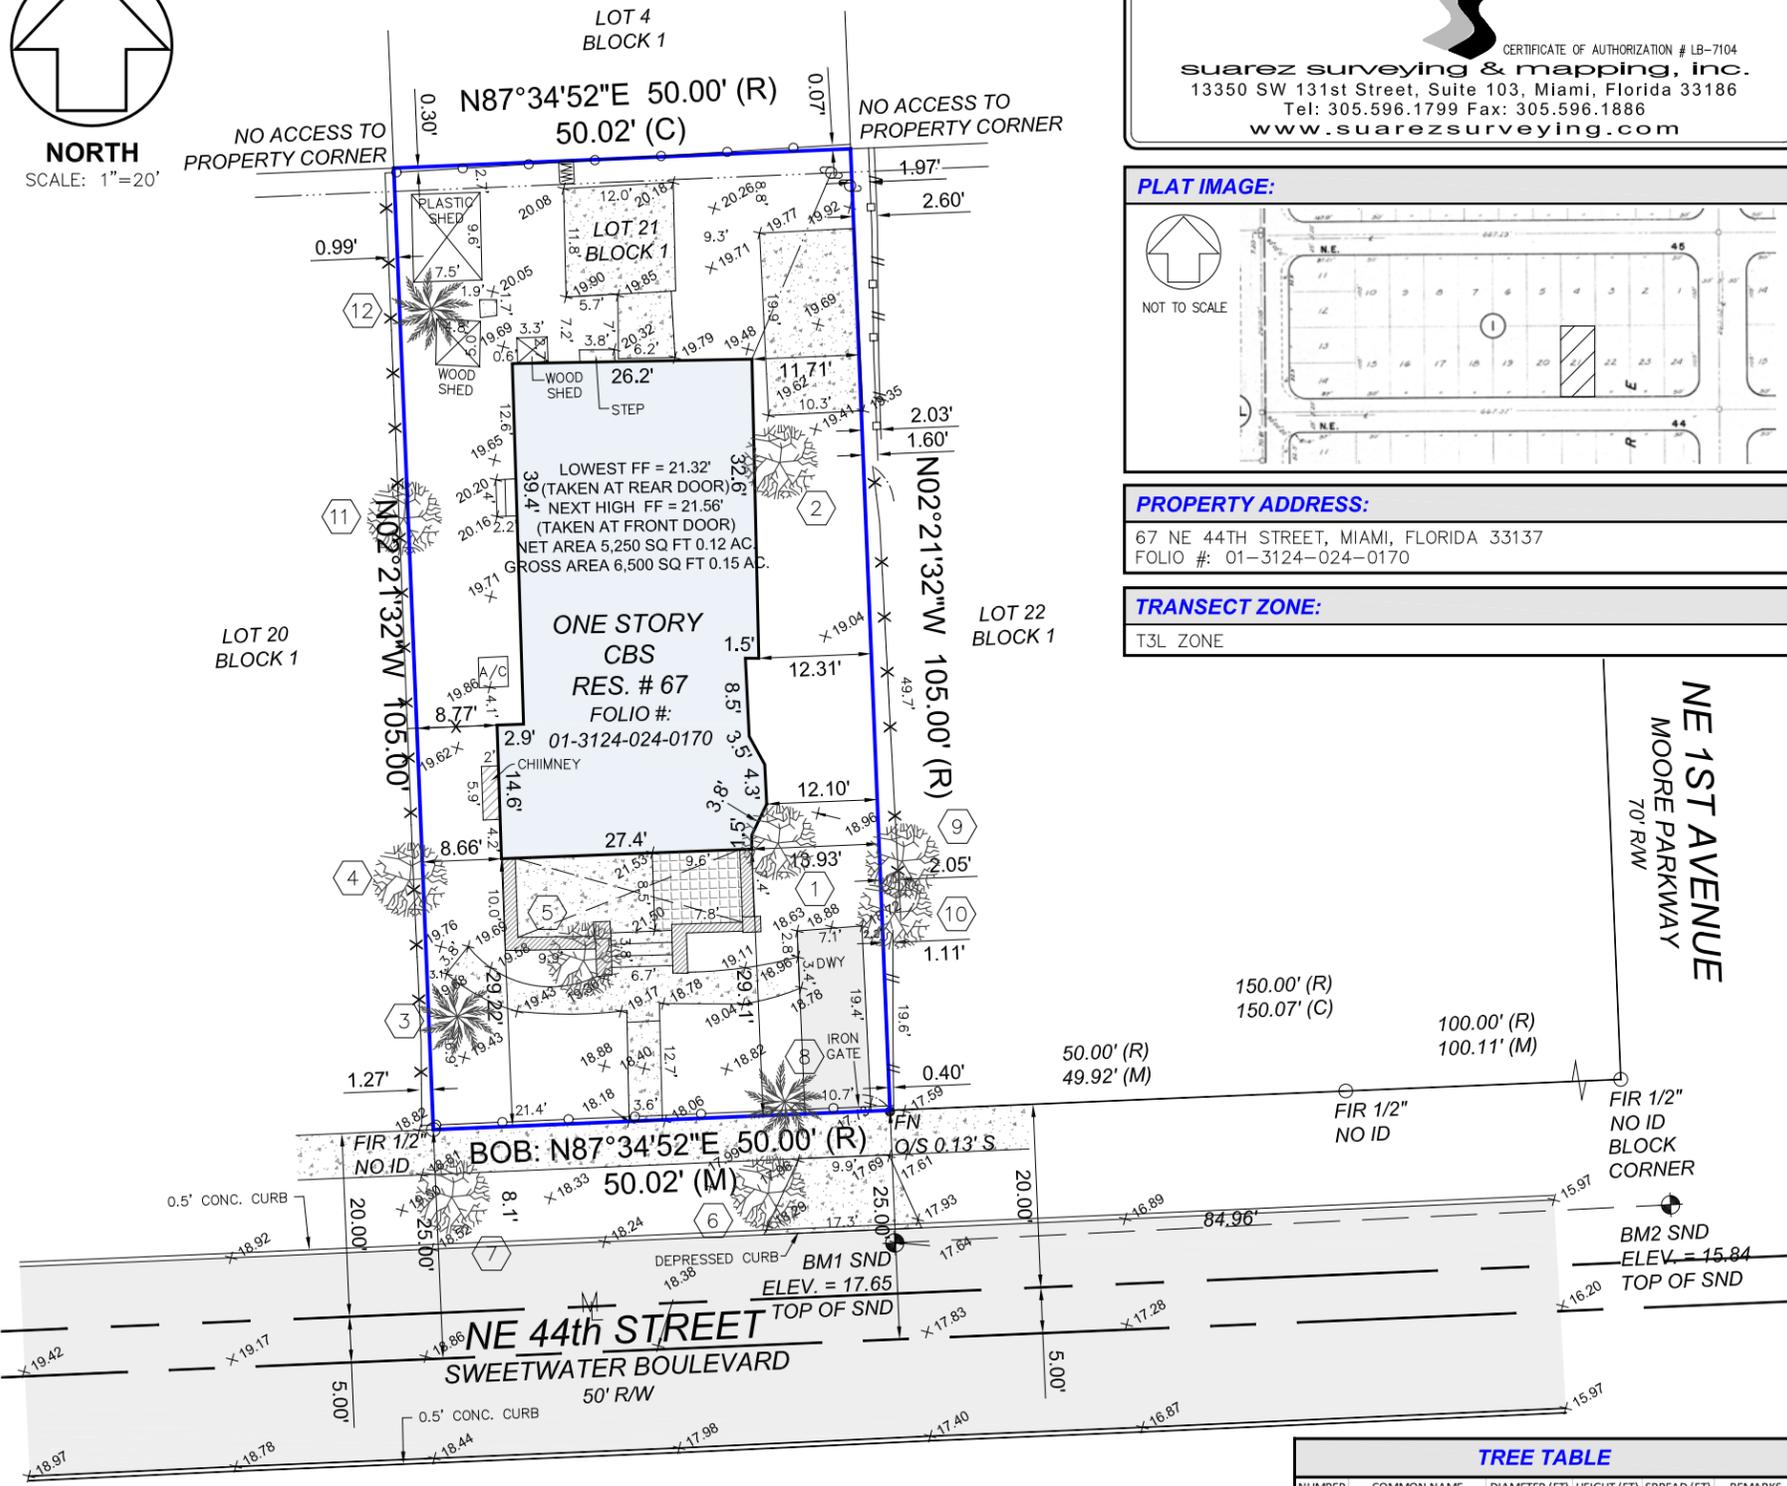
MAP OF BOUNDARY, TOPOGRAPHIC, & TREE SURVEY

SCALE: 1"=20'
