RHI HOME INSPECTIONS

## INSPECTION REPORT

15245 Shakespeare Dr  
Evansville, IN 47725

03/12/2026

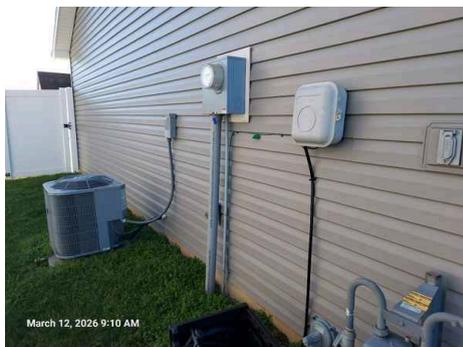
Underground, North

Location and type of service entry for electricity to the structure.

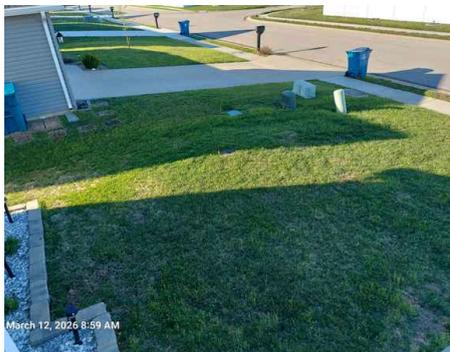
Public, Yard Near Structure

Listed here is the source and location of the water meter or well head if known and located at the time of inspection.

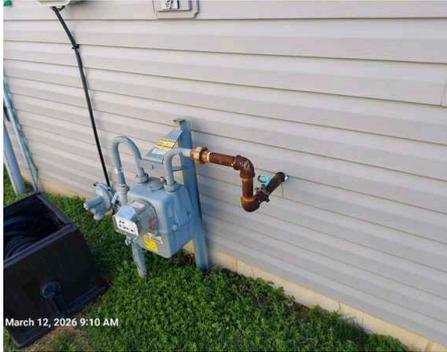
Natural Gas, North

The type of fuel systems and the location of the meter and tank if located. Some systems may have underground tanks, these tanks are outside the scope of a home inspection.

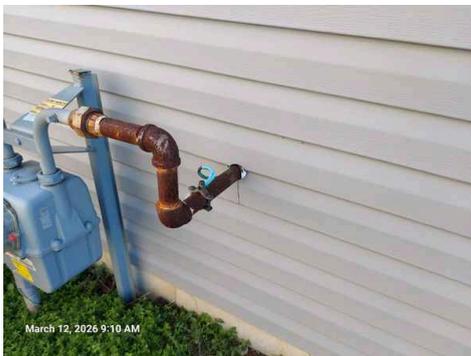
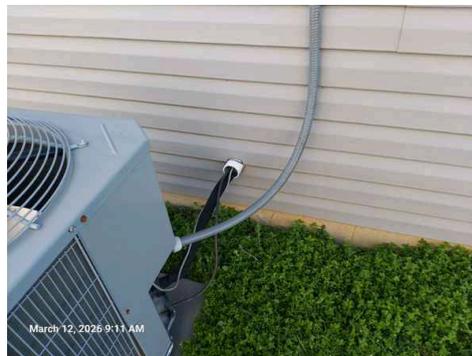
Unsealed penetrations were noted at one or more locations at the time of inspection. Openings, spray foam, or other forms of unsealed penetrations leaves the structure below exposed to potential damage & pest intrusion. Recommend further evaluation & correction by a qualified contractor. [Defect Explained](#)

Contact a qualified professional.

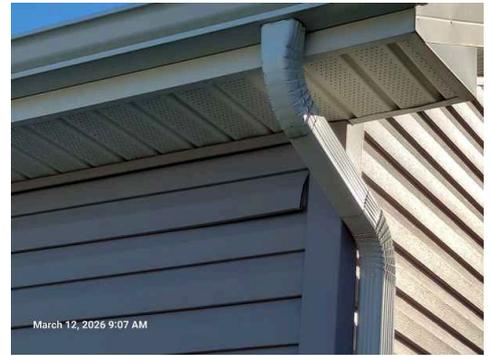
South West

##### **SIDING - LOOSE**

One or more sections of siding were noted as loose at the time of inspection. This could be due to missing or improper fasteners, damaged, etc. Recommend further evaluation & correction by a qualified contractor.

Contact a qualified siding specialist.

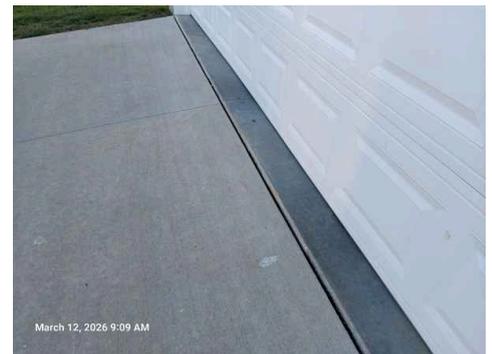
### CONCRETE - MISSING / DETERIORATING EXPANSION FILLER

Expansion gap filler was noted as missing or deteriorated in one or more locations at the time of inspection. This expansion filler is used to help prevent moisture from making its way under concrete and near the structure. Recommend further evaluation & correction by qualified contractor. [Defect Explained](#)

Contact a qualified professional.

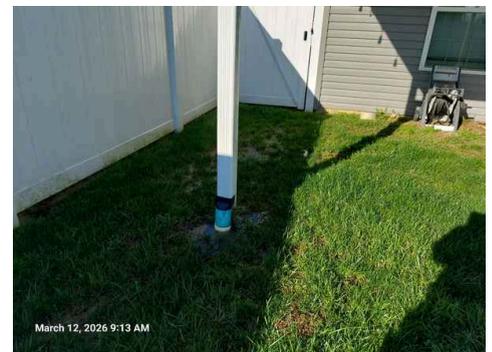
3.2.1 Grading / Drainage

Evidence of poor drainage was noted at one or more locations around the structure at the time of inspection. It appears that water may pool at some locations when it rains. Recommend further evaluation & correction by a qualified contractor.

Recommend monitoring.

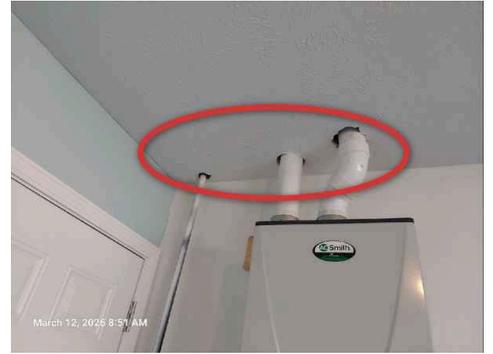
Openings or gaps were noted in the ceilings between the garage and living space at the time of inspection. This creates a safety concern due to the lack of complete fire protection. Recommend further evaluation & correction by a qualified contractor. [Defect Explained](#)

Contact a qualified professional.

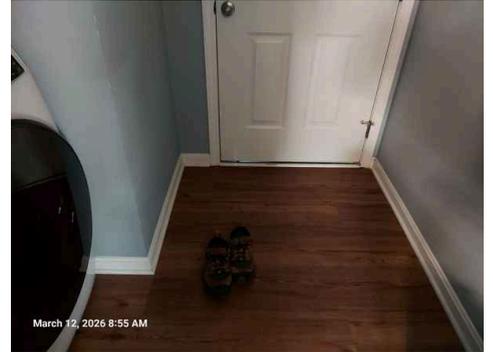
#### 4.2.1 Fire Door(s)

### **FIRE DOOR - LIGHT AROUND DOOR IN FRAME**

Light noted to be seen around the door at the time of inspection. Recommend further evaluation & correction by a qualified contractor.

Contact a qualified door repair/installation contractor.

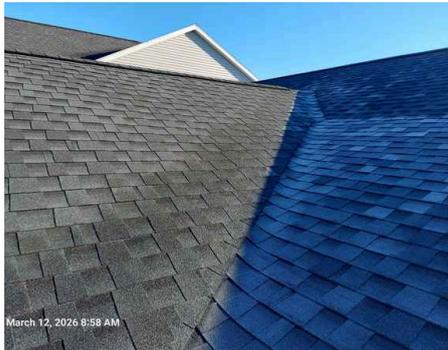
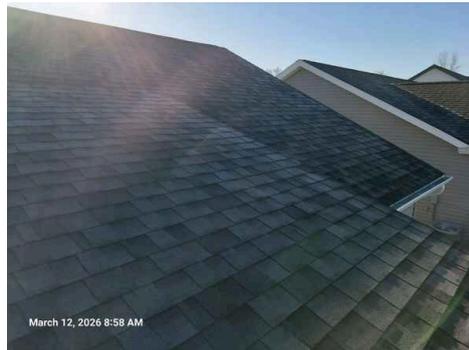
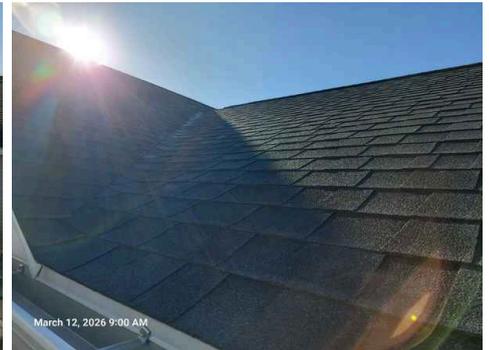
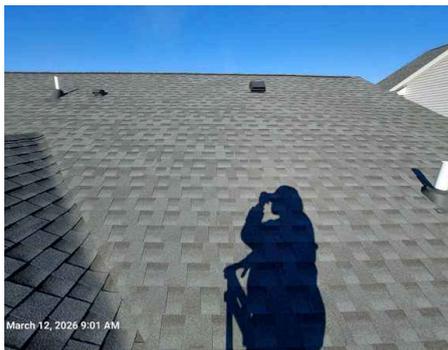
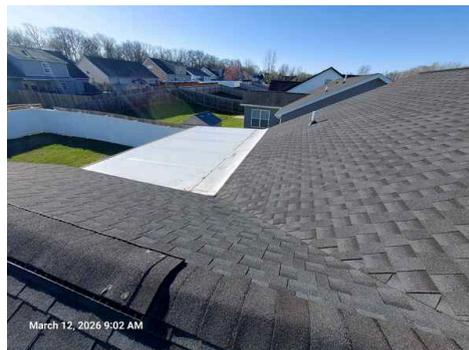
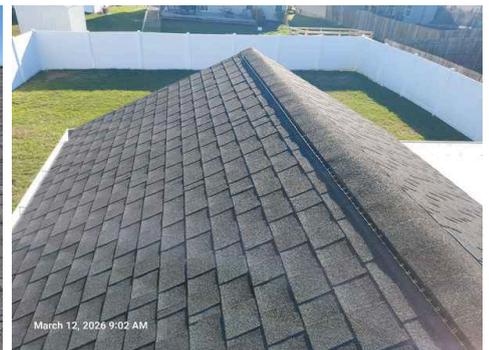
### Roof Coverings: General Photo(s)

Roof appeared to be in the first third of service life

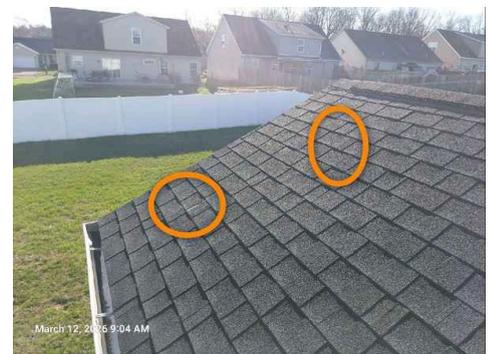
East

#### **SHINGLES - MISSING / DAMAGED**

Shingles were noted as missing or damaged in one or more locations at the time of inspection. Recommend further evaluation & correction by a qualified contractor.

Contact a qualified roofing professional.

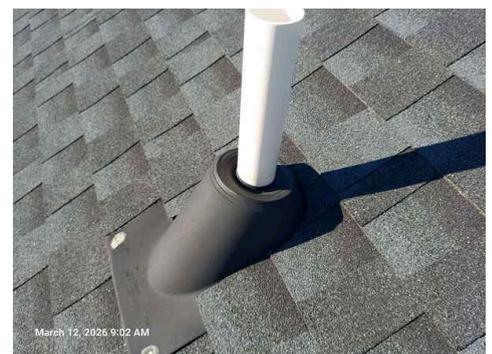
### 5.2.1 Flashings & Boots

Vent boot is installed in a way that it holds water around the pipe. Recommend repair to prevent leak.

Contact a qualified professional.

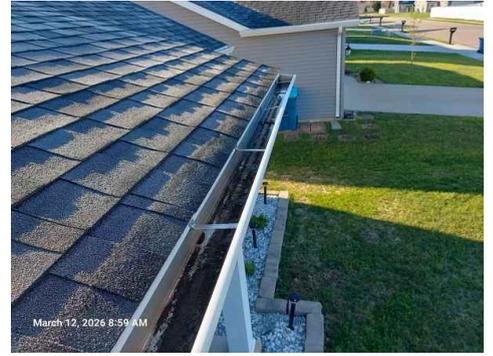
## 5.4.1 Gutters &amp; Downspouts

Gutters noted as holding water at the time of the inspection. This could be due to debris in gutters, clogged downspouts, improperly sloped gutters, or some other condition which would prevent proper drainage. Recommend further evaluation & correction by a qualified contractor.

Contact a qualified professional.

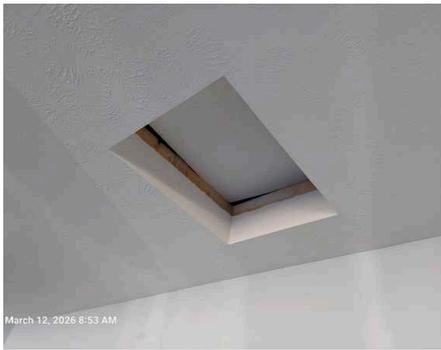
**Roof Structure: Type**  
Engineered Trusses, OSB Decking

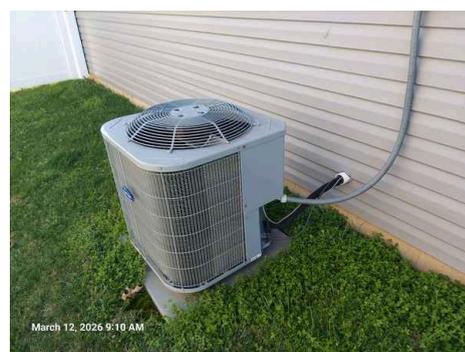
**AC / Heat Pump Unit: Location**  
North

**AC / Heat Pump Unit: Manufacturer**  
Carrier

**AC / Heat Pump Unit: Manufacture Date**  
2020

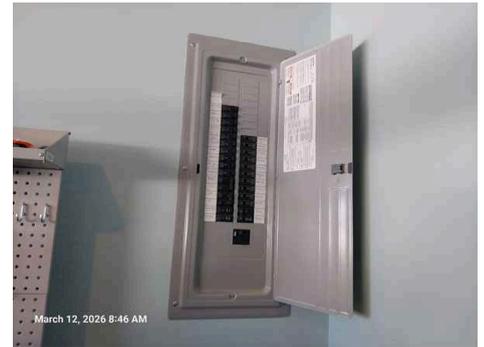
**Main Distribution Panel(s): Main Panel Location**  
Garage

**Main Distribution Panel(s): Panel Type**  
Circuit Breaker

**Main Distribution Panel(s): Panel Capacity**  
200 AMP

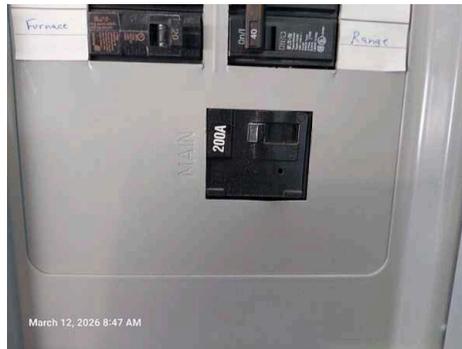
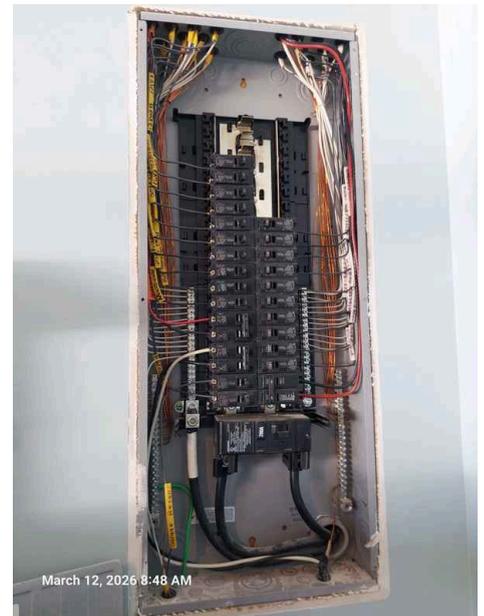
**Main Distribution Panel(s): Manufacturer**  
Siemens

**Main Distribution Panel(s): Service Conductors**  
Copper

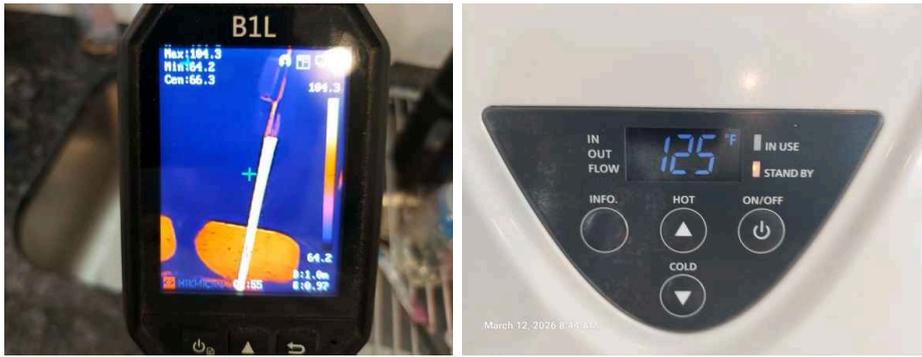
## Water Heater: TPR Valve Drains Inside

The TPR (temperature and pressure relief) valve did not drain into an open drain at the time of inspection. In the event of a discharge this may cause moisture damage to flooring and building materials.

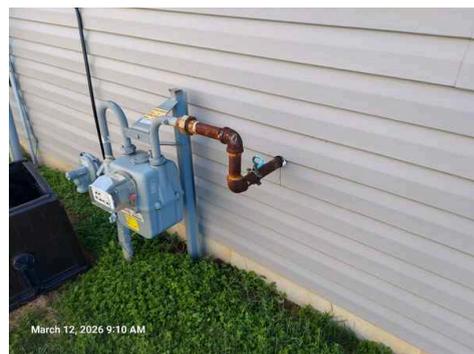
### 9.2.2 Fuel System

#### **GAS LINE(S) - CORROSION / RUST**

Contact a qualified plumbing contractor.

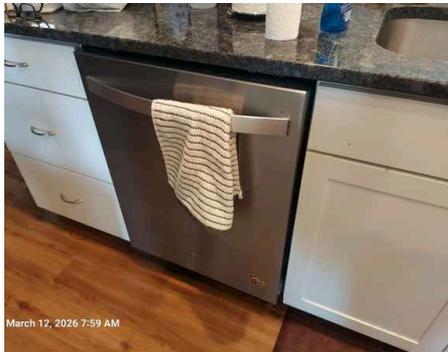
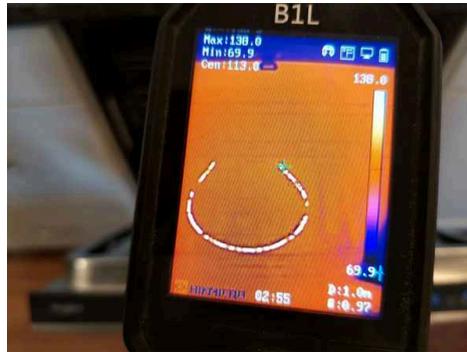
### Dishwasher: General Photo(s)

The dishwasher was operated by running a wash cycle, and was functional at the time of inspection. No leaks or water was present at the base of the unit at the completion of the cycle. The unit's efficiency of cleaning dishes is not tested for. No deficiencies were observed with the unit unless otherwise noted in this report.

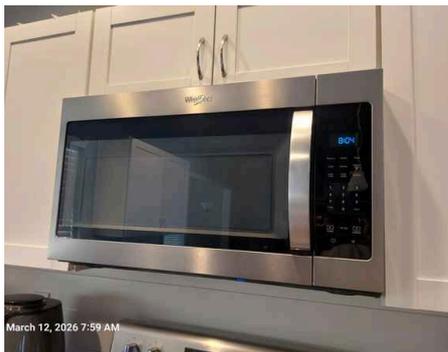
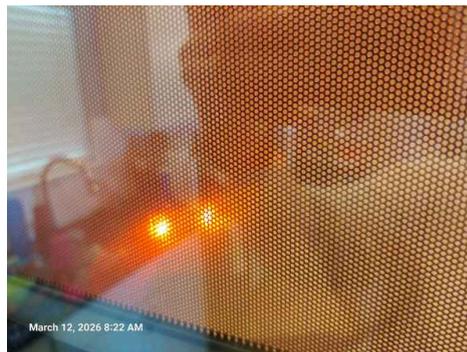
### Built-in Microwave: General Photo(s)

The microwave was operated by operating with normal controls, and was functional at the time of inspection. No deficiencies were observed with the unit unless otherwise noted in this report.

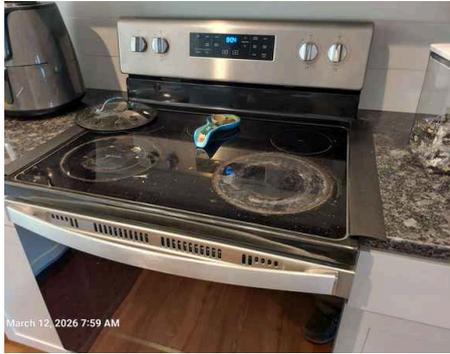
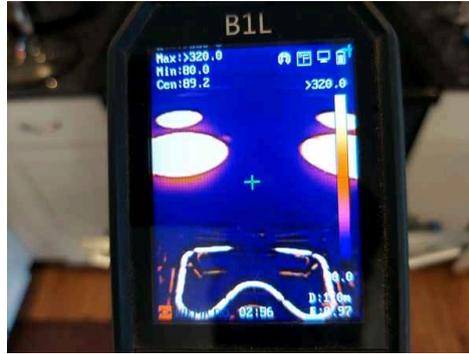
### Cooking Appliances & Ventilation: General Photo(s)

Recirculating, Microwave

If the exhaust fan is noted as the microwave, all associated defects will be noted in the Microwave section of the report.

The cooking appliance and exhaust systems were operated by operating with normal controls, and were functional at the time of inspection. No deficiencies were observed with the unit unless otherwise noted in this report.

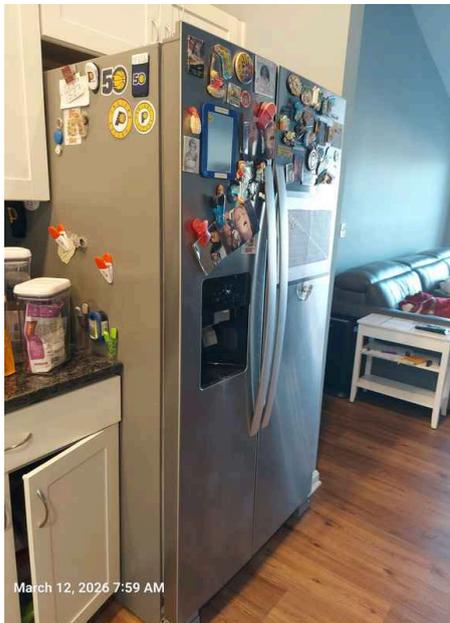
### Refrigerator: General Photo(s)

The refrigerator was operated by operating with normal controls, and was functional at the time of inspection. No deficiencies were observed with the unit unless otherwise noted in this report.

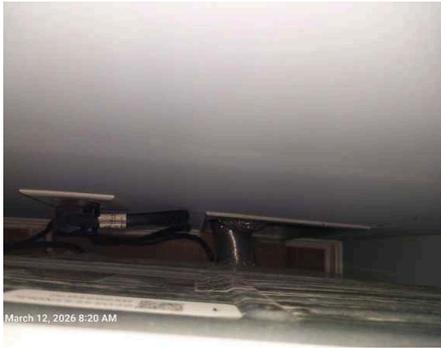
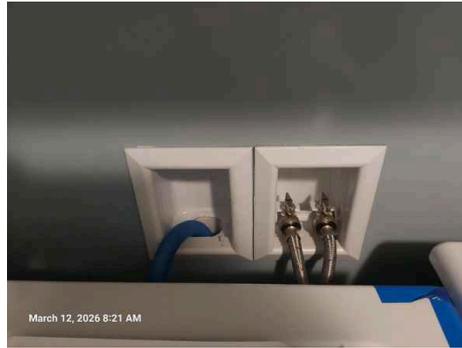
### Dryer Connections: Hook-Up Type Washer Hook-Ups: General Electric Photos

The washer and dryer are not fixed appliances and therefore not part of the home inspection. The comments in this section pertain to the hookups themselves.

Dryer vents were inspected for functionality, leaks, and damage. No reportable defects were viewed at the time of the inspection.

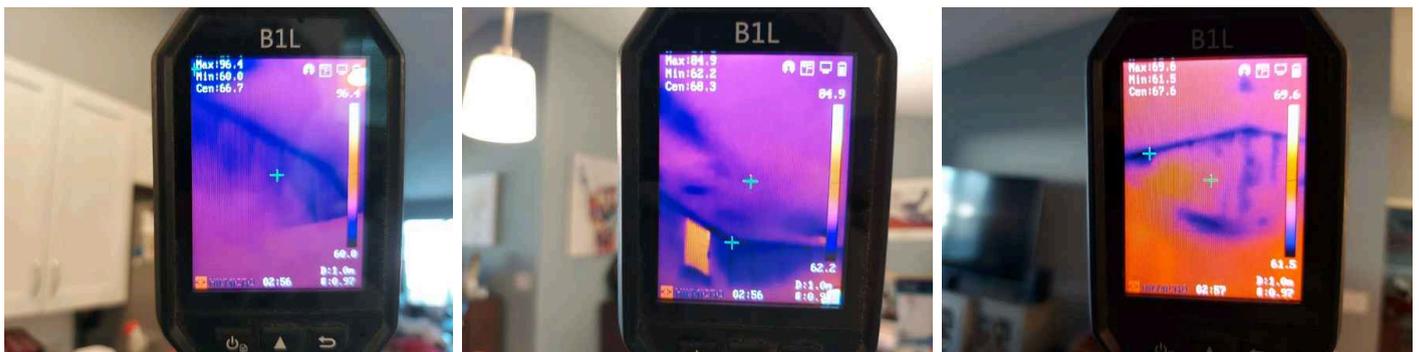
### Thermal Scan

A basic scan of the house was performed with an infrared camera to check for leaks, missing insulation, and overheated electrical conductors. This scan does not ensure the inspector will find all defects that may be hidden in walls or ceilings. Any specific defects that were found pertaining to specific components will be noted in their respective areas of the report.
