SUMMARY

15245 Shakespeare Dr, Evansville, IN
47725
Catrina Brown
03/12/2026

Rowdy Abbott
HI02100086, F282058
RHI Home Inspections
8127740804
office@yourrhi.com

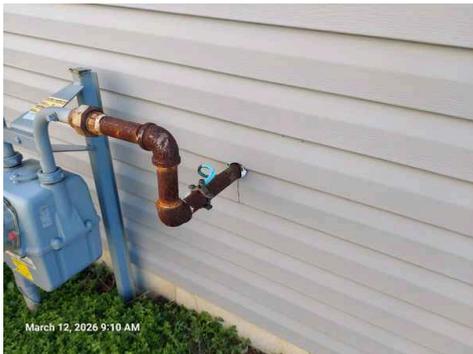
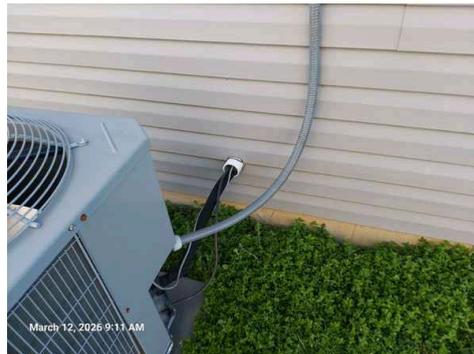
2.1.1 Siding

SIDING - UNSEALED PENETRATIONS

MULTIPLE LOCATIONS

Unsealed penetrations were noted at one or more locations at the time of inspection. Openings, spray foam, or other forms of unsealed penetrations leaves the structure below exposed to potential damage & pest intrusion. Recommend further evaluation & correction by a qualified contractor. [Defect Explained](#)

Corrected

Recommendation

Contact a qualified professional.

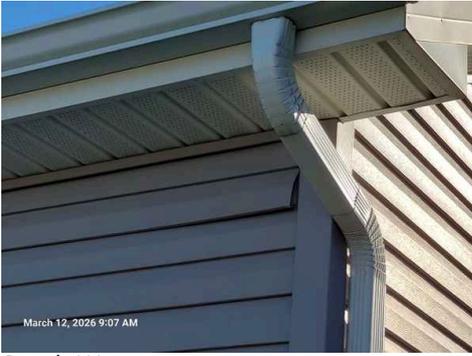
2.1.2 Siding

SIDING - LOOSE

One or more sections of siding were noted as loose at the time of inspection. This could be due to missing or improper fasteners, damaged, etc. Recommend further evaluation & correction by a qualified contractor.

South West

Corrected

Recommendation

Contact a qualified siding specialist.

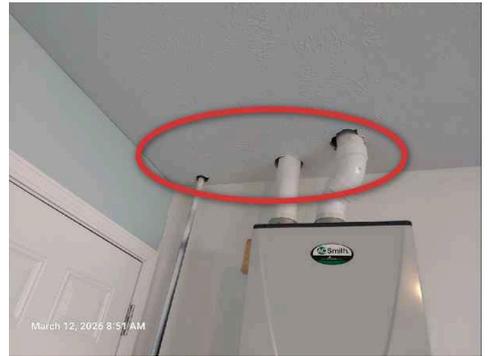
4.1.1 Walls, Ceiling, & Firewalls
CEILING(S) - BREACH IN FIRE BARRIER

MULTIPLE LOCATIONS

Openings or gaps were noted in the ceilings between the garage and living space at the time of inspection. This creates a safety concern due to the lack of complete fire protection. Recommend further evaluation & correction by a qualified contractor. [Defect Explained](#)

Corrected

Recommendation
 Contact a qualified professional.

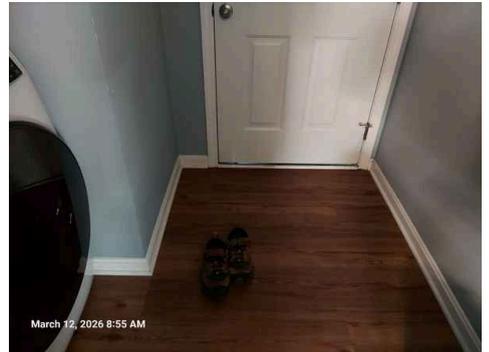
4.2.1 Fire Door(s)
FIRE DOOR - LIGHT AROUND DOOR IN FRAME

Light noted to be seen around the door at the time of inspection. Recommend further evaluation & correction by a qualified contractor.

Corrected

Recommendation
 Contact a qualified door repair/installation contractor.

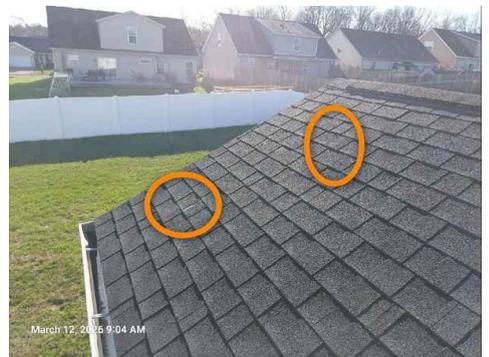
5.1.1 Roof Coverings
SHINGLES - MISSING / DAMAGED

Shingles were noted as missing or damaged in one or more locations at the time of inspection. Recommend further evaluation & correction by a qualified contractor.

East

Corrected

Recommendation
 Contact a qualified roofing professional.

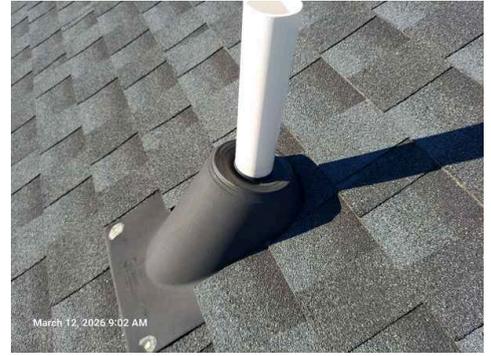
5.2.1 Flashings & Boots

VENT BOOT - HOLDS WATER OR HAS DEPRESSION

Vent boot is installed in a way that it holds water around the pipe. Recommend repair to prevent leak.

Corrected

Recommendation
Contact a qualified professional.

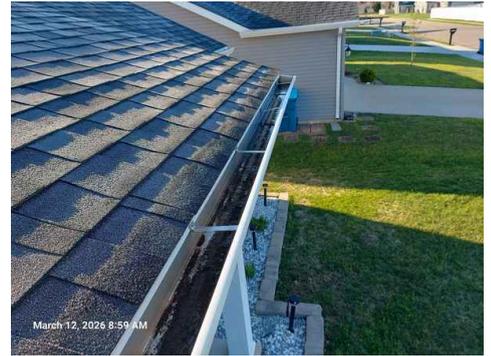
5.4.1 Gutters & Downspouts

GUTTER(S) - HOLDING WATER

FRONT ENTRY

Gutters noted as holding water at the time of the inspection. This could be due to debris in gutters, clogged downspouts, improperly sloped gutters, or some other condition which would prevent proper drainage. Recommend further evaluation & correction by a qualified contractor.

Corrected

Recommendation
Contact a qualified professional.

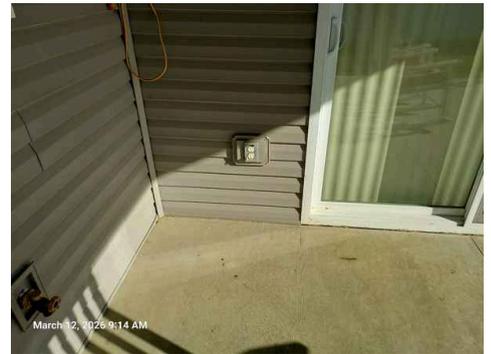
8.5.1 Outlets

OUTLET(S) - MISSING OR DAMAGED WEATHERPROOF COVER(S)

One or more exterior receptacle covers noted as missing or damaged at the time of inspection. Outlets on the exterior of the property should be protected with a weather resistant cover. Recommend further evaluation & correction by a qualified contractor.

Corrected

Recommendation
Contact a qualified electrical contractor.

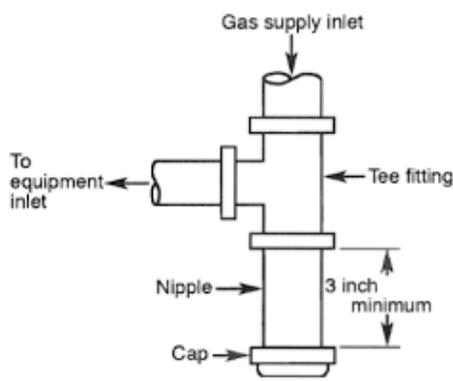
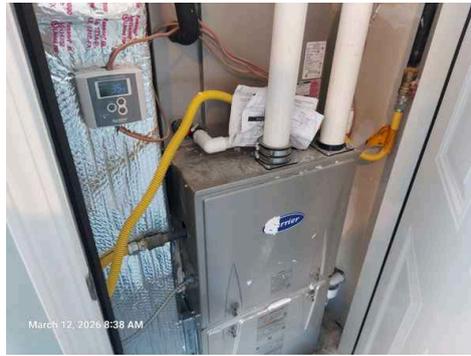
9.2.1 Fuel System

GAS LINE(S) - MISSING / IMPROPER SEDIMENT TRAP

A missing or improper sediment trap configuration was noted in the fuel line at the time of the inspection. The gas line should be installed to dead end over the trap rather than have the trap in line. This trap should be the lowest point in the line. The trap serves to capture sediment before it enters the appliance and its absence may clog a valve or cause an equipment malfunction. Recommend further evaluation & correction by a qualified contractor.

CenterPoint + HVAC guy say not an issue

Builder Correcting

Recommendation
Contact a qualified plumbing contractor.

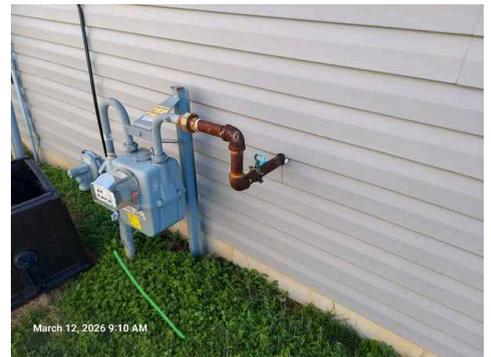
9.2.2 Fuel System

GAS LINE(S) - CORROSION / RUST

One or more gas lines were corroded at the time of the inspection. This can lead to gas leaks if left unattended. Recommend further evaluation & correction by a qualified contractor.

Recommendation
Contact a qualified plumbing contractor.

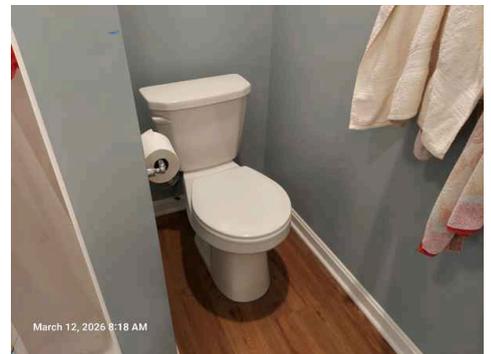
11.4.1 Toilets

TOILET - LOOSE AT FLOOR

One or more toilets were noted as loose at floor at the time of the inspection. This allows the toilet to move and can damage the wax ring under the toilet. The wax ring must have a snug, secure fit in order to keep from leaking. This type of damage is not always visible or accessible to the inspector. Recommend further evaluation & correction by a qualified contractor. [Defect Explained](#)

Corrected

Recommendation
Contact a qualified plumbing contractor.
