SUMMARY
2068 Cass Ave, Evansville, IN 47714
Elijah Folsom
04/08/2026

Von Lamey
InterNACHI Certified Professional
Inspector, IAC2 Certified Mold Inspector,
NRSB Certified Radon Measurement
Specialist
Precision Home Inspections
812-480-5126
precisionhomein@gmail.com

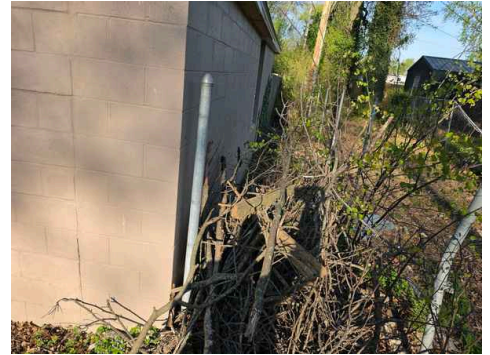
2.1.1 General
DEBRIS

Debris located near exterior walls. This can harbor pests and allow moisture to become trapped on or near the exterior surface. Recommend a qualified handyman remove debris.

Recommendation
Contact a handyman or DIY project

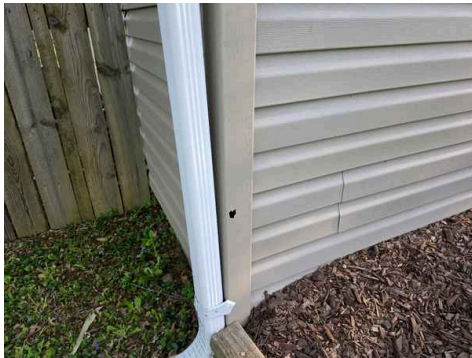
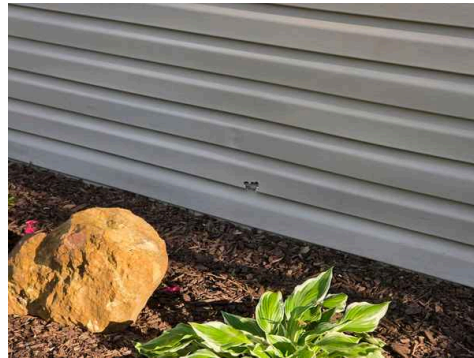
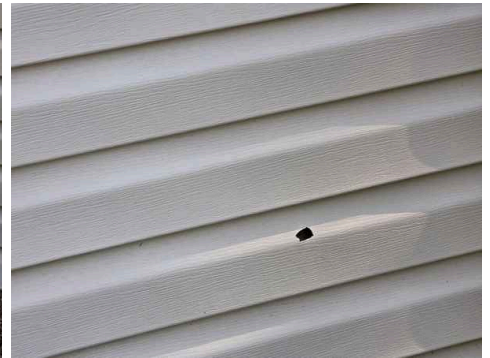
2.2.1 Siding, Flashing & Trim
GENERAL DAMAGE

General damage to siding material was visible at the time of the inspection. This may allow moisture and/or pest intrusion. Recommend a qualified contractor repair or replace.

Recommendation
Contact a qualified professional.

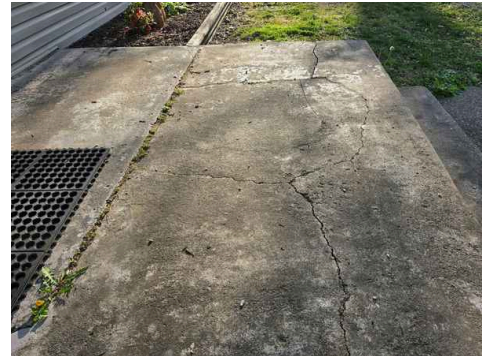
2.4.1 Decks, Balconies, Porches & Steps
PORCH CRACKING - MINOR

Porch surface was cracked at the time of the inspection. Recommend sealing cracks in concrete to prevent expansion or further moisture intrusion.

Recommendation
 Contact a handyman or DIY project

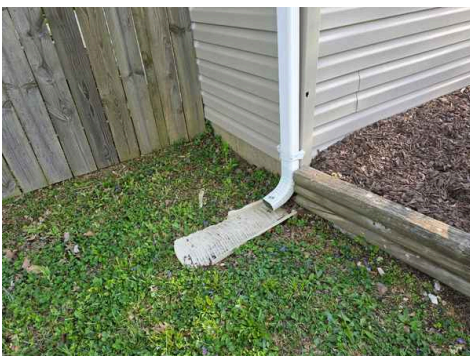
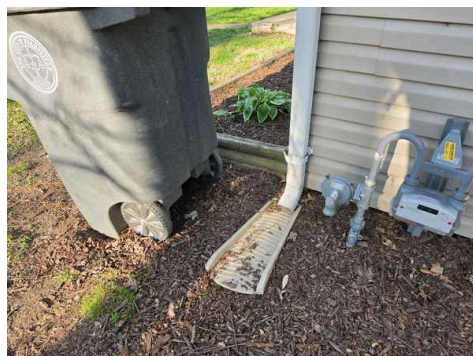
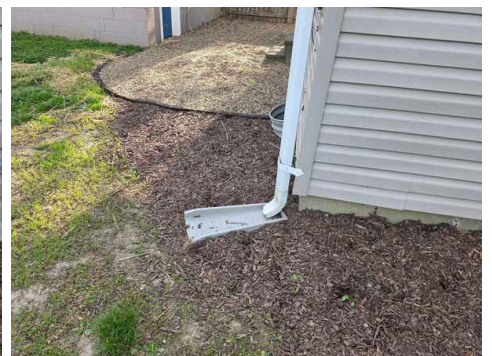
2.6.1 Vegetation, Grading & Drainage
DOWNSPOUTS DRAIN TOO CLOSE TO STRUCTURE
 BOTH SIDES

Downspouts drained close to the structure. This can cause water to become trapped around the foundation and may create foundation issues. Recommend downspout extensions to divert water at least 6 feet away from the foundation.

Recommendation
 Contact a handyman or DIY project

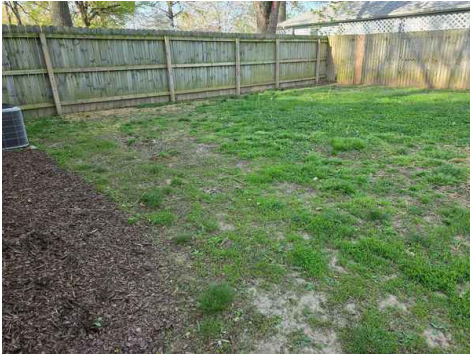
2.6.2 Vegetation, Grading & Drainage
POOLING

There was evidence of pooling. This can cause moisture to be trapped near the foundation or deteriorate areas where pooling occurs. Recommend a qualified landscaper install proper drainage.

Recommendation
 Contact a qualified landscaping contractor

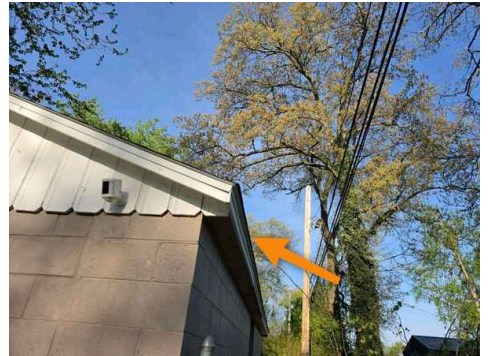
2.6.3 Vegetation, Grading & Drainage
NO DRAINAGE/GUTTER SYSTEM

There was no drainage system present at the property. This can allow run off near the foundation and may cause structural issues. Recommend a qualified gutter contractor install gutter/drainage system.

On back side of garage

Recommendation
Contact a qualified gutter contractor

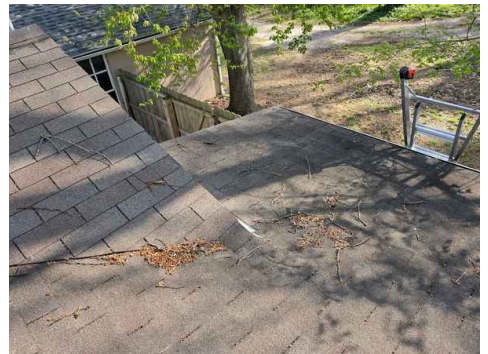
3.1.1 Coverings
TREE DEBRIS

Roof had tree debris on the surface. Debris can trap moisture on the asphalt shingle and reduce life expectancy. Recommend having debris removed from roof surface.

Recommendation
Contact a handyman or DIY project

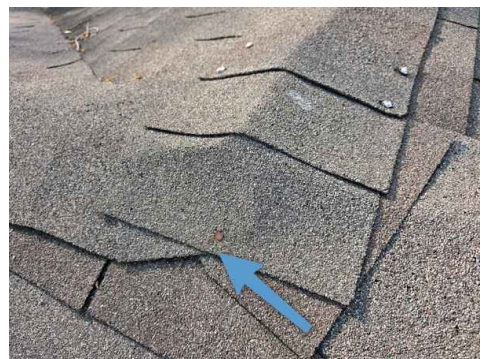
3.1.2 Coverings
EXPOSED FASTENERS

Exposed fastener(s) were identified on roof shingle(s) or vents at the time of the inspection. This can lead to moisture intrusion to the roof decking. Recommend a qualified roofing contractor repair.

Recommendation
Contact a qualified roofing professional.

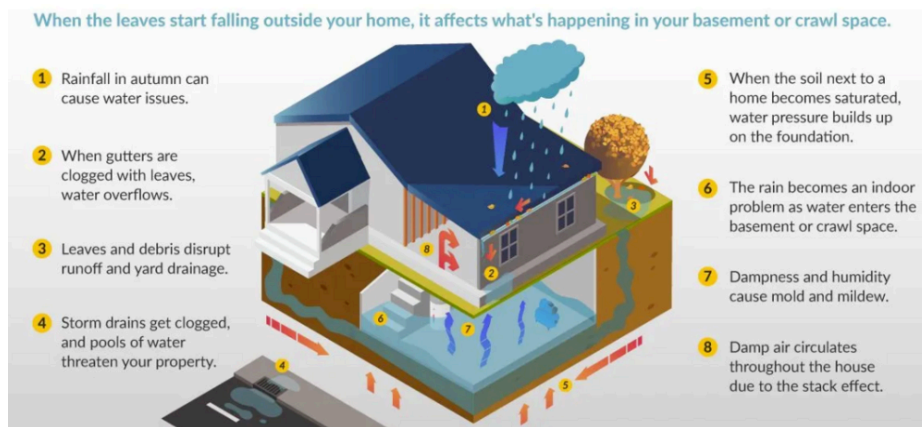
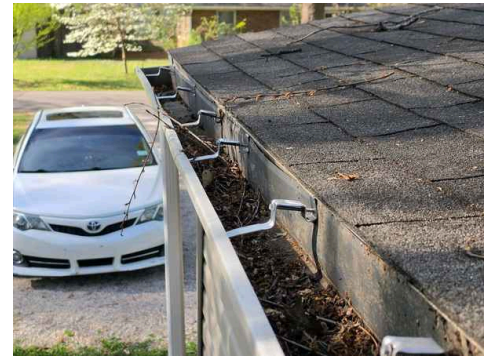
3.2.1 Roof Drainage Systems
DEBRIS

Debris had accumulated in the gutters. Recommend cleaning to facilitate water flow.

Recommendation
Contact a handyman or DIY project

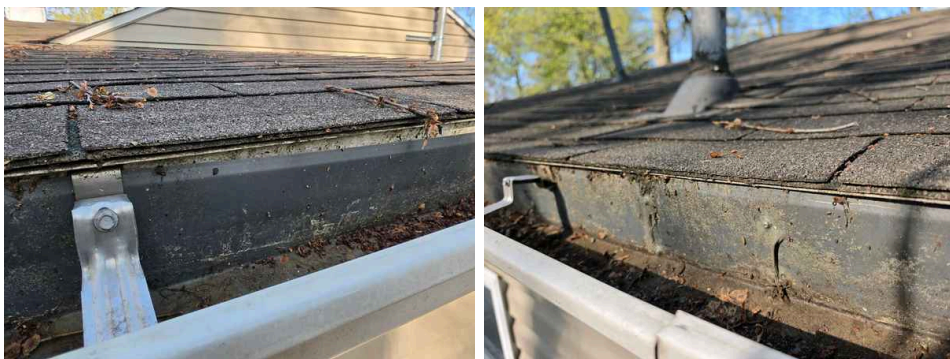
3.3.1 Flashings
DRIP EDGE IMPROPERLY INSTALLED
Seller Correcting

Drip edge installed behind gutters. This may allow water behind the gutter onto the fascia. Recommend a qualified roofing contractor repair.

Recommendation
Contact a qualified roofing professional.

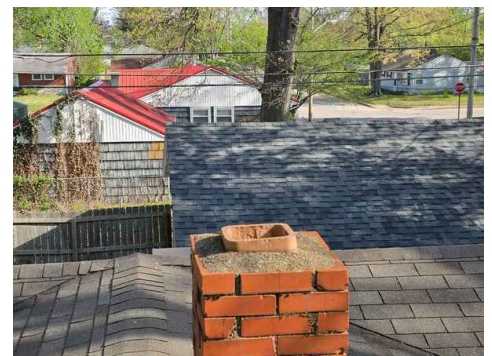
3.4.1 Skylights, Chimneys & Other Roof Penetrations
CHIMNEY CAP MISSING

No chimney cap was observed. This is important to protect from moisture intrusion and protect the chimney. Recommend a qualified roofing or chimney contractor install.

Recommendation
Contact a qualified roofing professional.

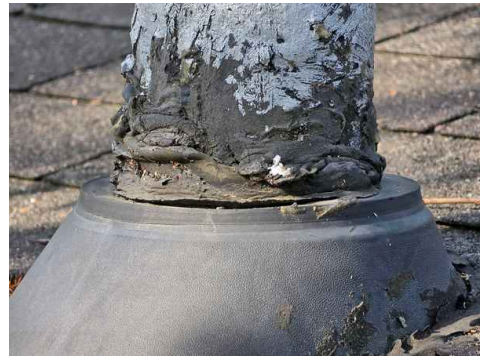
3.4.2 Skylights, Chimneys & Other Roof Penetrations

SEALANT DETERIORATED

Sealant showed signs of cracking. This can lead to moisture intrusion. Recommend a qualified roofing contractor repair.

Contact a qualified roofing professional.

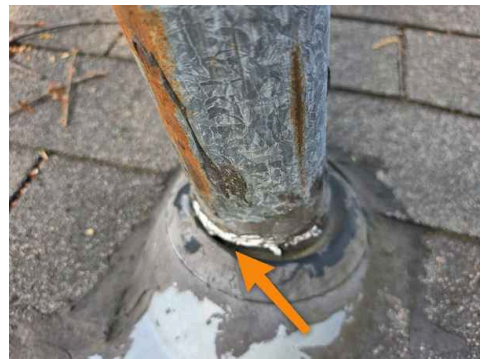
3.4.3 Skylights, Chimneys & Other Roof Penetrations

PLUMBING VENT BOOT DAMAGED

Plumbing vent boot was damaged at the time of the inspection. This may cause roof leaks and damage to roof decking. Recommend a qualified roofing contractor repair or replace.

Contact a qualified roofing professional.

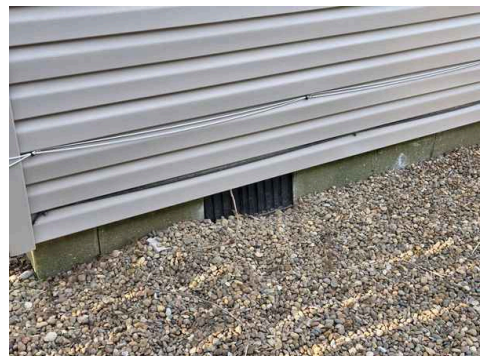
4.2.1 Crawlspace

CRAWLSPACE VENTS INADEQUATE CLEARANCE

Crawlspace vent observed to not have adequate clearance. This may cause water intrusion. Recommend a qualified contractor evaluate and repair.

Contact a qualified professional.

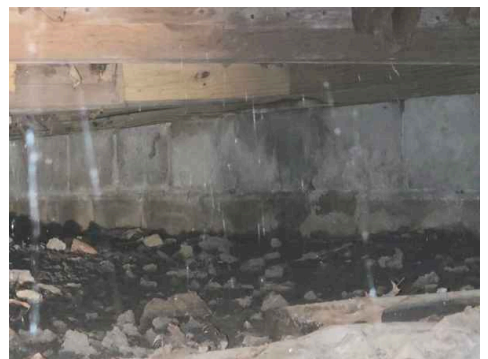
4.3.1 Vapor Retarders

MISSING COVERAGE

Areas were missing vapor retarder or had been pulled back. Recommend a qualified contractor install additional vapor retarder or redistribute to help prevent moisture buildup.

Contact a qualified professional.

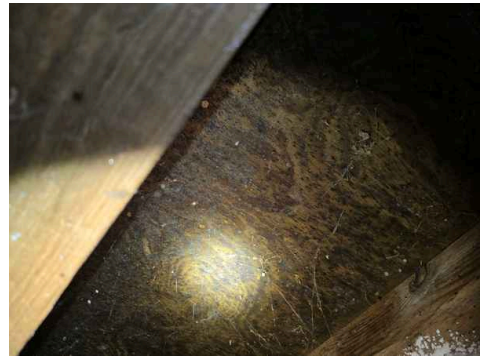
4.6.1 Ceiling Structure
ORGANIC GROWTH

Observed signs of organic growth on one or more areas of the ceiling structure. Recommend identifying source or moisture intrusion and sending samples to a lab for testing.

Recommendation
Contact a qualified mold inspection professional.

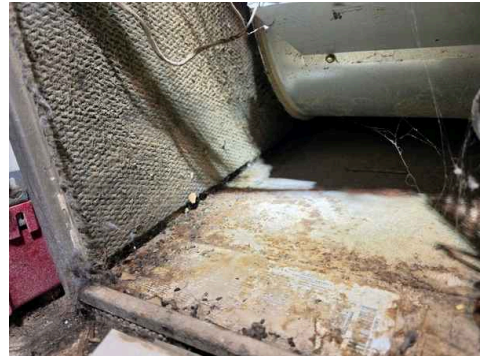
5.1.1 Equipment
CORROSION

Furnace was corroded in one or more areas. This could be the result of condensation or improper venting, which the source would need to be identified. Recommend a HVAC contractor evaluate and repair.

Recommendation
Contact a qualified HVAC professional.

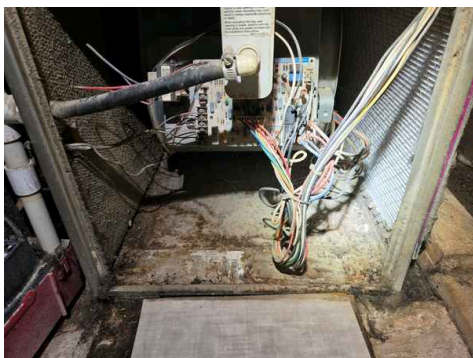
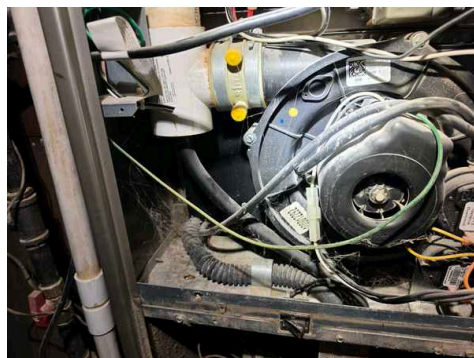
5.1.2 Equipment
NEEDS SERVICED/CLEANING

Furnace should be cleaned and serviced annually. Recommend a qualified HVAC contractor clean, service and certify furnace.

Recommendation
Contact a qualified HVAC professional.

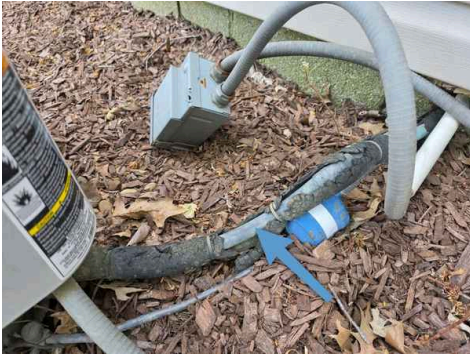
6.1.1 Cooling Equipment
INSULATION MISSING OR DAMAGED

Missing or damaged insulation on refrigerant line can cause energy loss and condensation.

Recommendation
Contact a handyman or DIY project

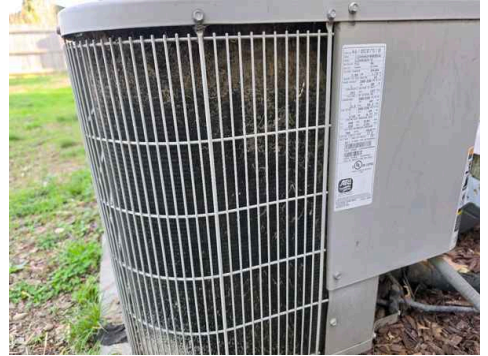
Seller Correcting
 6.1.2 Cooling Equipment **NEEDS SERVICED/CLEANING**

Exterior air conditioning unit was in need of service/cleaning. Recommend a qualified HVAC professional service.

Recommendation
 Contact a qualified HVAC professional.

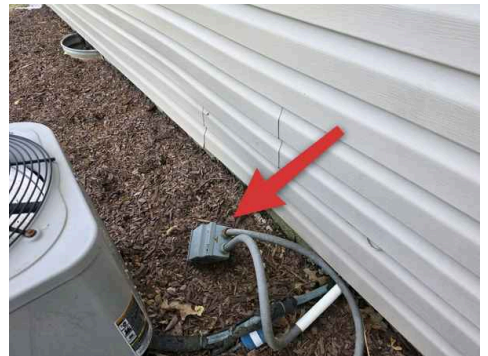
Seller Correcting
 6.1.3 Cooling Equipment **ELECTRICAL BOX NOT SECURED**

Electrical box for air conditioning unit was not secured. This may cause damage to electrical components. Recommend a qualified electrical or HVAC contractor repair.

Recommendation
 Contact a qualified electrical contractor.

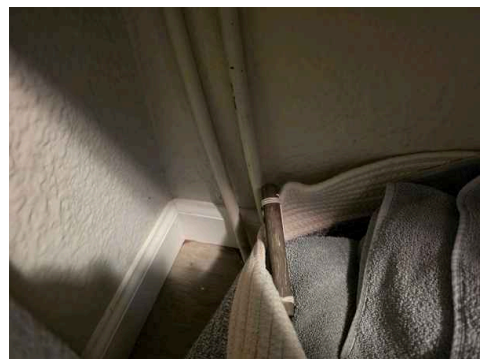
None exists. Shut off at street/city.
 7.1.1 Main Water Shut-off Device **NO VISIBLE/ACCESSIBLE SHUT-OFF**

There was no visible/accessible main water shut-off identified. This is an important device to be able to shut off water to the home in an emergency. Recommend a qualified plumbing contractor evaluate and remedy.

Recommendation
 Contact a qualified plumbing contractor.

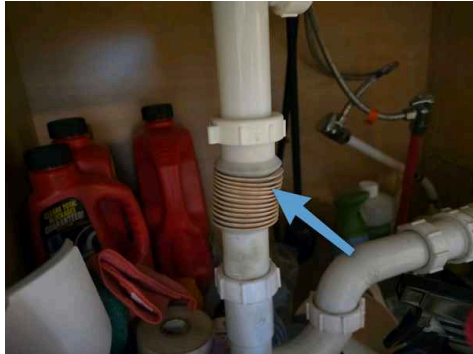
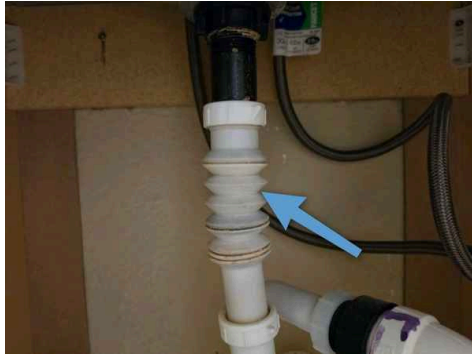
7.2.1 Drain, Waste, & Vent Systems

IMPROPER PIPE MATERIAL

The drain pipe was of an improper type. The pipe was flexible which can cause the drain to back up. Recommend a qualified plumbing contractor replace.

Contact a qualified plumbing contractor.

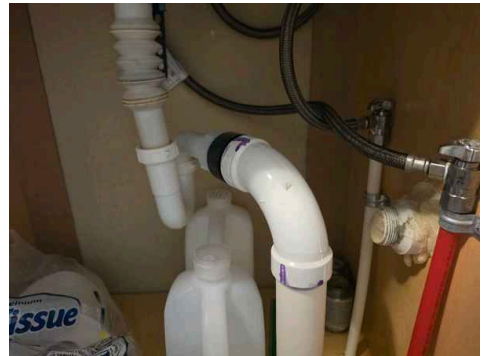
7.2.2 Drain, Waste, & Vent Systems

S-TRAP

Observed S-trap(s) under plumbing drains. This is a safety hazard and may cause dangerous gasses to be released. Recommend a qualified plumbing contractor repair.

Contact a qualified plumbing contractor.

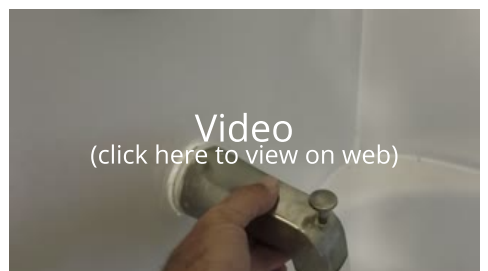
7.3.1 Water Supply, Distribution Systems & Fixtures

PLUMBING HARDWARE LOOSE

One or more pieces of plumbing hardware were loose. Recommend securing/tightening plumbing hardware to help prevent damage and/or leaks.

Contact a qualified plumbing contractor.

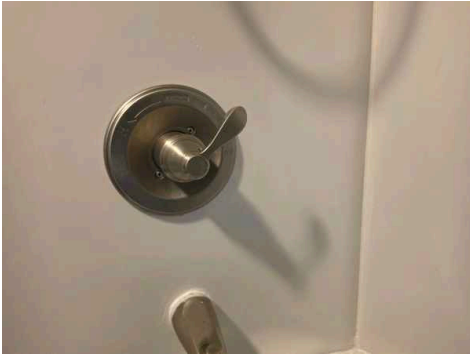
7.3.2 Water Supply, Distribution Systems & Fixtures

HOT/COLD REVERSE

Hot and cold was reversed at the time of the inspection. Recommend a qualified handyman repair.

Contact a handyman or DIY project

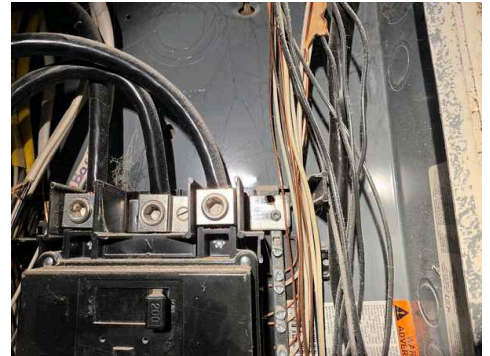
8.2.1 Main & Subpanels, Service & Grounding, Main Overcurrent Device

IMPROPER OR NO BONDING

Improper bonding at the time of the inspection. This is a safety hazard. Recommend a qualified electrical contractor evaluate and remedy.

Contact a qualified electrical contractor.

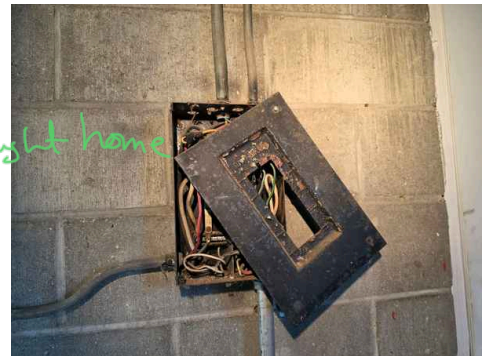
8.2.2 Main & Subpanels, Service & Grounding, Main Overcurrent Device

Panel box required service. Excess debris, missing grommets, cover damage and corrosion were observed. Panel was inactive but should be properly removed, secured and/or housed. Recommend a qualified electrical contractor repair.

Contact a qualified electrical contractor.

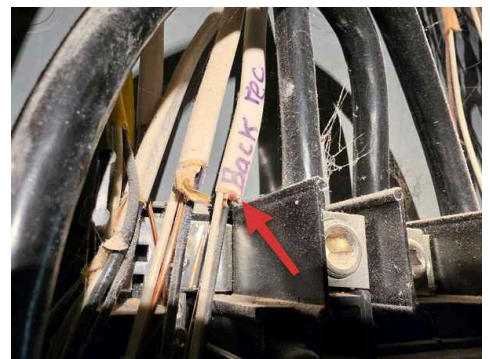
8.3.1 Branch Wiring Circuits, Breakers & Fuses

EXPOSED WIRES

Exposed wires present at the time of the inspection. This may create a shock hazard. Exposed wires, whether inactive or energized, should be covered or capped. Recommend a qualified electrical contractor repair.

Contact a qualified electrical contractor.

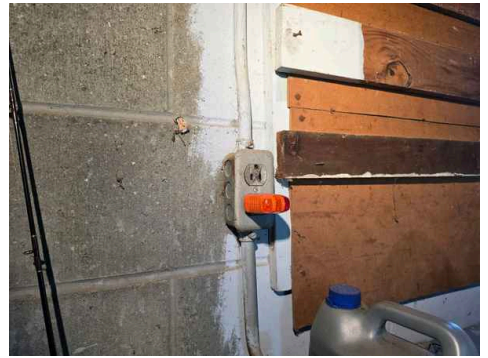
8.4.1 Lighting Fixtures, Switches & Receptacles

OUTLETS INOPERABLE

Outlet had no power running to it at the time of the inspection. Recommend a qualified electrical contractor repair.

Contact a qualified electrical contractor.

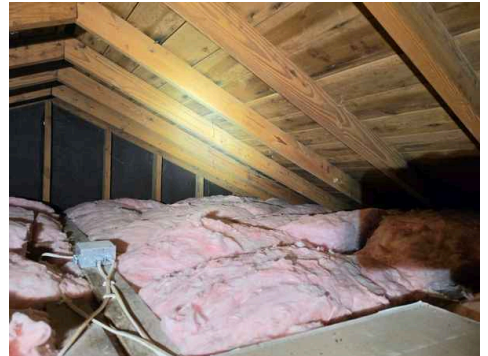
9.1.1 Attic Insulation

INSUFFICIENT INSULATION

Insulation depth was inadequate. Recommend a qualified insulation contractor install additional insulation.

Contact a qualified insulation contractor.

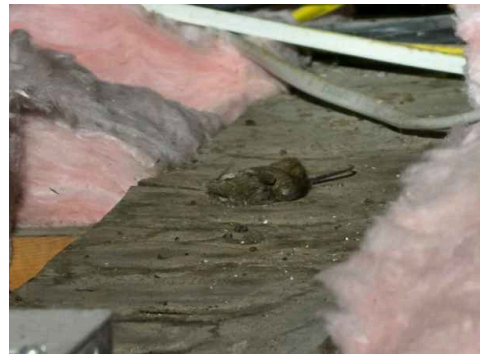
9.1.2 Attic Insulation

PEST ACTIVITY

Evidence of pest activity in attic insulation at the time of the inspection. Recommend pest control company evaluate and remedy.

Contact a qualified pest control specialist.

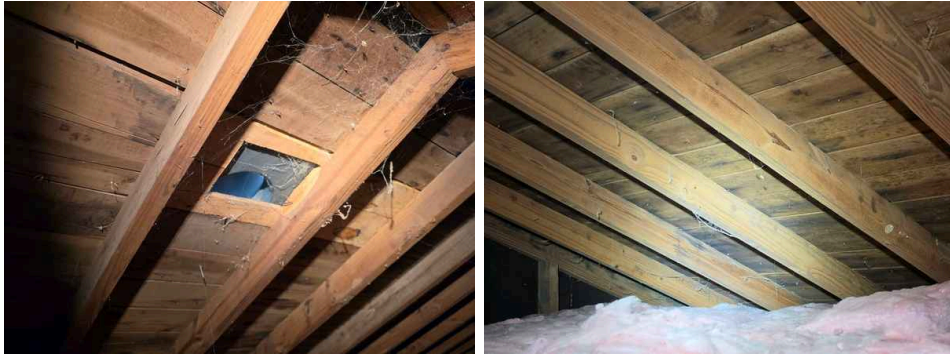
9.2.1 Ventilation

ATTIC VENTILATION INSUFFICIENT

Attic ventilation was insufficient at time of the inspection. The only ventilation openings were passive vents. Gable, Ridge, and/or Soffit vents were not observed to allow for proper airflow. Recommend a qualified contractor repair.

Contact a qualified professional.

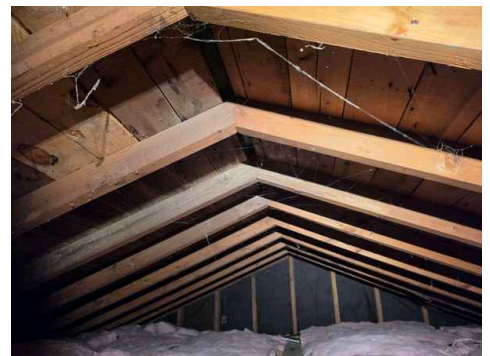
9.4.1 Roof Decking

MISSING COLLAR TIES

Rafters were missing collar ties. Collar ties help prevent separation from the ridge beam. Recommend a qualified contractor repair.

Recommendation
Contact a qualified professional.

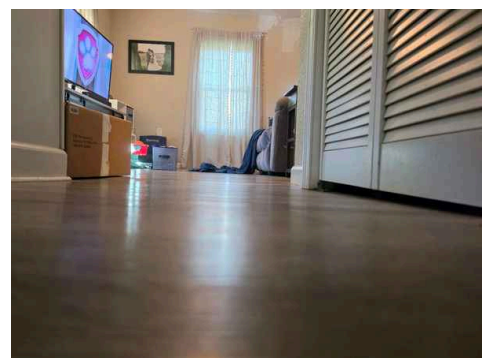
10.3.1 Floors

FLOOR AREAS NOT LEVEL

There were areas of the floor that were not level at the time of the inspection. Recommend a qualified contractor determine the cause of uneven floors and repair.

Recommendation
Contact a qualified flooring contractor

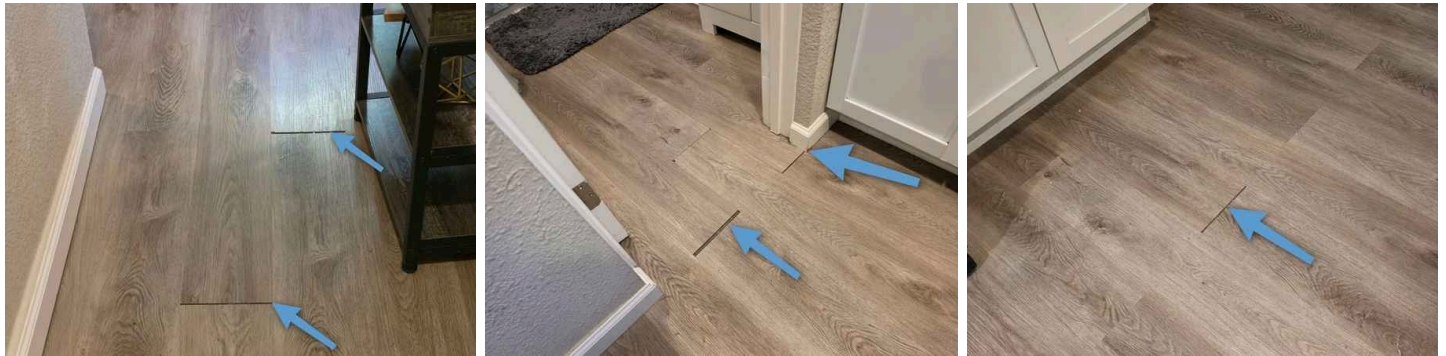
10.3.2 Floors

IMPROPER INSTALLATION

One or more areas of floor coverings were installed improperly. Recommend a qualified flooring contractor repair or replace.

Recommendation
Contact a qualified flooring contractor

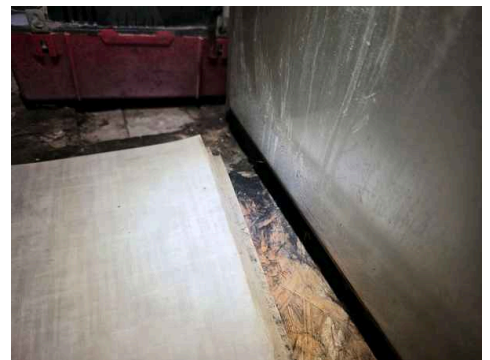
10.3.3 Floors

ORGANIC GROWTH

Evidence of organic growth growing near moisture intrusion. Recommend a qualified contractor evaluate and recommend repairs.

Recommendation
Contact a qualified professional.

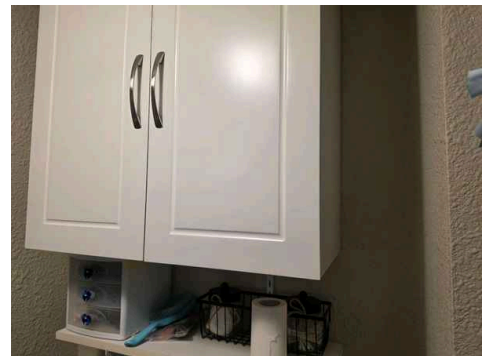
10.6.1 Countertops & Cabinets

CABINETS NOT SECURED

Cabinet was not secured to the floor or wall. This may pose a safety hazard as the cabinet could fall on occupant. Recommend a handyman secure cabinet properly.

Recommendation
Contact a handyman or DIY project

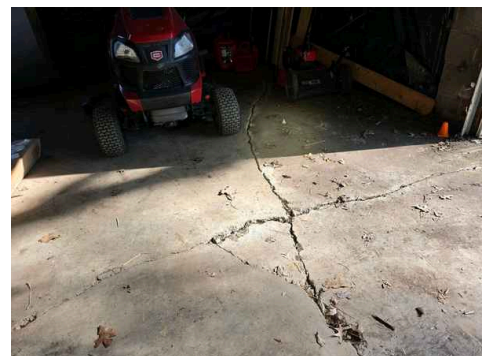
12.2.1 Floor

CRACKING - MAJOR

Cracking observed at the garage floor. Recommend a qualified concrete contractor evaluate and repair.

Recommendation
Contact a qualified concrete contractor.

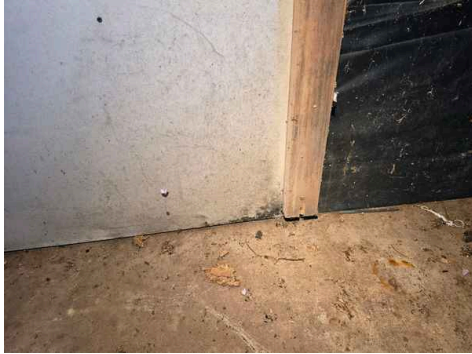
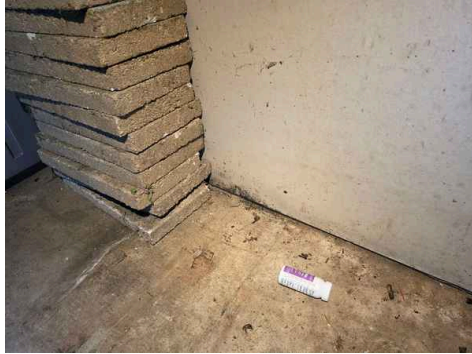
12.3.1 Walls

ORGANIC GROWTH

Evidence of organic growth was observed. Recommend a qualified mold inspector test and drywall contractor replace damaged drywall.

Contact a qualified mold inspection professional.

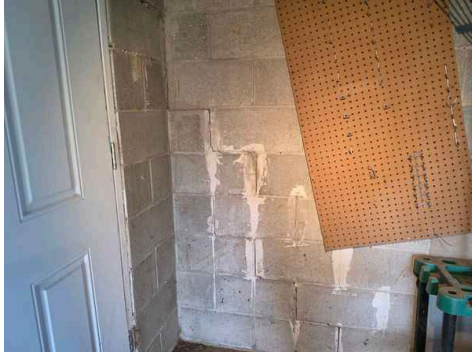
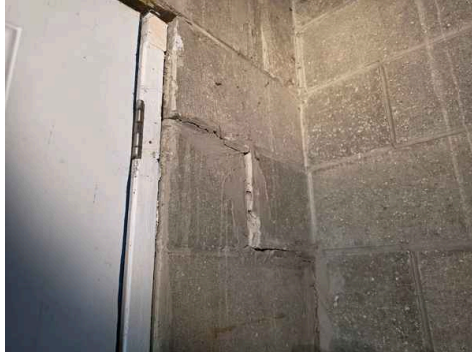
12.3.2 Walls

CRACKING - MAJOR

Cracking identified on garage masonry block. Recommend a qualified foundation contractor repair.

Contact a foundation contractor.
