PRECISION HOME INSPECTIONS

RESIDENTIAL REPORT

2068 Cass Ave
Evansville, IN 47714

04/08/2026

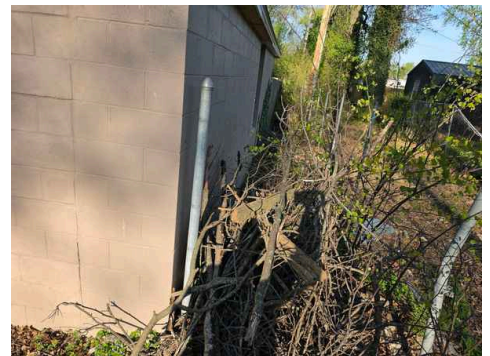
2.1.1 General

Debris located near exterior walls. This can harbor pests and allow moisture to become trapped on or near the exterior surface. Recommend a qualified handyman remove debris.

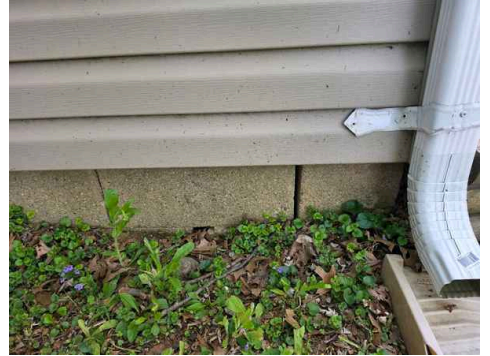
Areas of the exterior siding had missing mortar between bricks. This could lead to moisture intrusion and deterioration of the structure. Recommend a qualified masonry contractor repair.

Contact a qualified masonry professional.

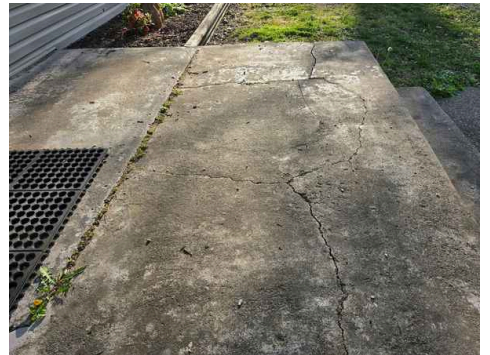
2.4.1 Decks, Balconies, Porches & Steps

PORCH CRACKING - MINOR

Porch surface was cracked at the time of the inspection. Recommend sealing cracks in concrete to prevent expansion or further moisture intrusion.

Contact a handyman or DIY project

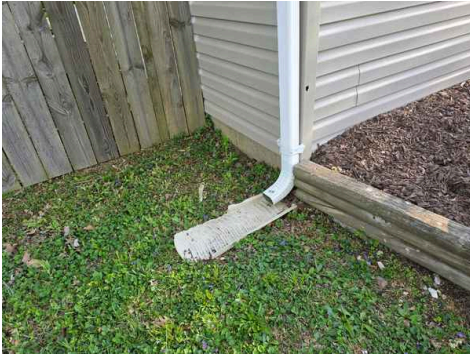
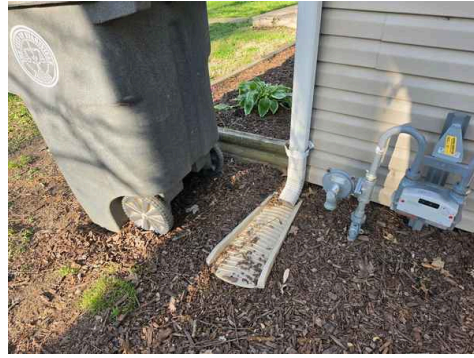
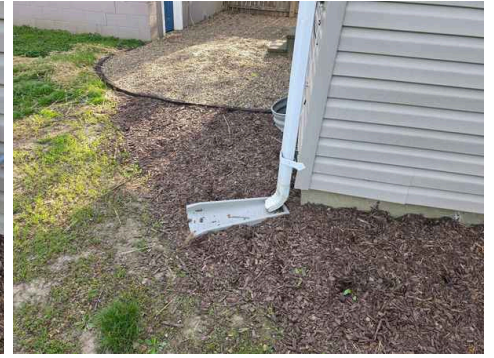
2.6.1 Vegetation, Grading & Drainage

Downspouts drained close to the structure. This can cause water to become trapped around the foundation and may create foundation issues. Recommend downspout extensions to divert water at least 6 feet away from the foundation.

Contact a handyman or DIY project

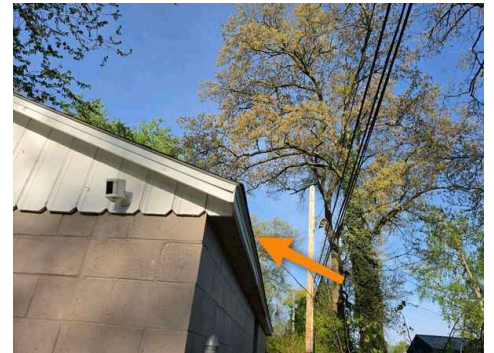
There was no drainage system present at the property. This can allow run off near the foundation and may cause structural issues. Recommend a qualified gutter contractor install gutter/drainage system.

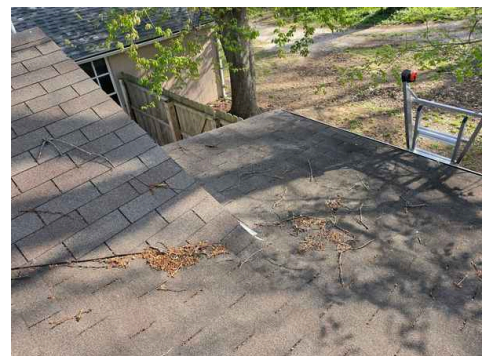
3.1.1 Coverings

Roof had tree debris on the surface. Debris can trap moisture on the asphalt shingle and reduce life expectancy. Recommend having debris removed from roof surface.

Contact a handyman or DIY project

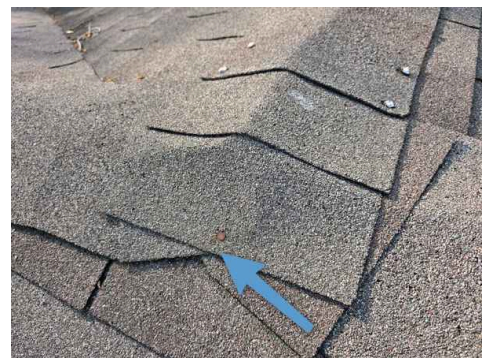
3.1.2 Coverings

EXPOSED FASTENERS

Exposed fastener(s) were identified on roof shingle(s) or vents at the time of the inspection. This can lead to moisture intrusion to the roof decking. Recommend a qualified roofing contractor repair.

Contact a qualified roofing professional.

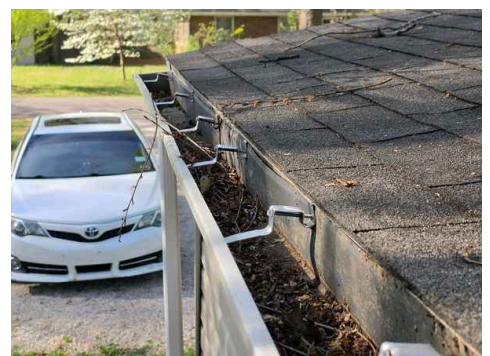
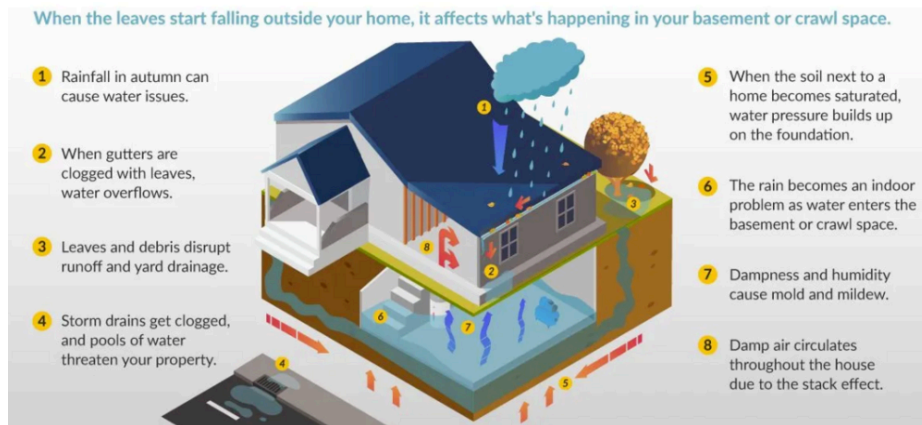
3.2.1 Roof Drainage Systems

DEBRIS

Debris had accumulated in the gutters. Recommend cleaning to facilitate water flow.

Contact a handyman or DIY project

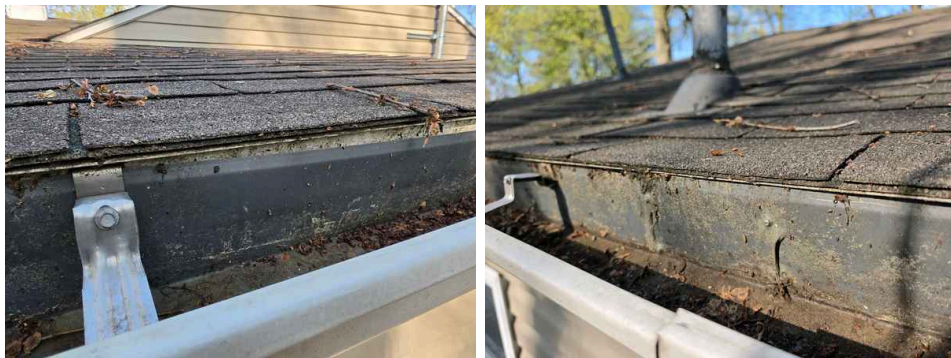
DRIP EDGE IMPROPERLY INSTALLED

Drip edge installed behind gutters. This may allow water behind the gutter onto the fascia. Recommend a qualified roofing contractor repair.

Contact a qualified roofing professional.

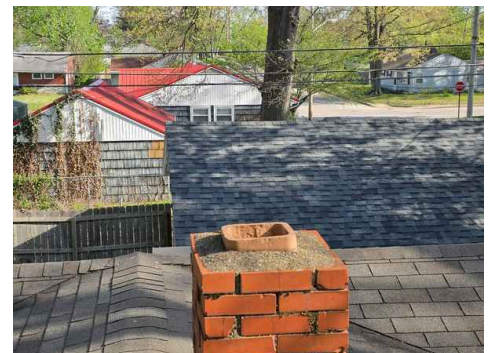
3.4.1 Skylights, Chimneys & Other Roof Penetrations

CHIMNEY CAP MISSING

No chimney cap was observed. This is important to protect from moisture intrusion and protect the chimney. Recommend a qualified roofing or chimney contractor install.

Contact a qualified roofing professional.

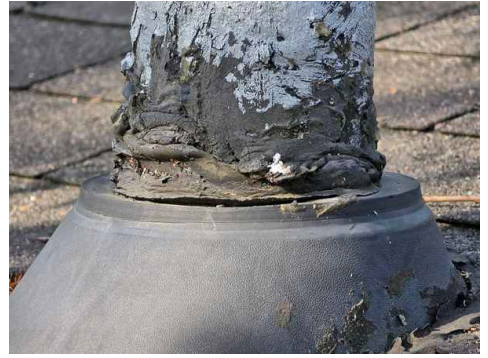
3.4.2 Skylights, Chimneys & Other Roof Penetrations

SEALANT DETERIORATED

Sealant showed signs of cracking. This can lead to moisture intrusion. Recommend a qualified roofing contractor repair.

Contact a qualified roofing professional.

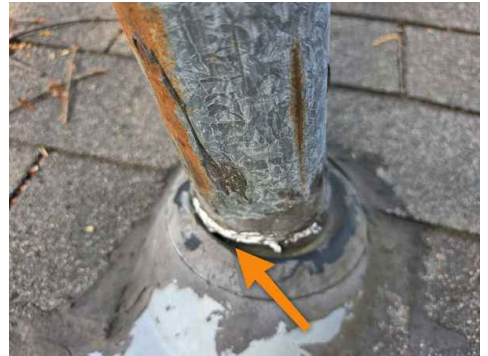
3.4.3 Skylights, Chimneys & Other Roof Penetrations

PLUMBING VENT BOOT DAMAGED

Plumbing vent boot was damaged at the time of the inspection. This may cause roof leaks and damage to roof decking. Recommend a qualified roofing contractor repair or replace.

Contact a qualified roofing professional.

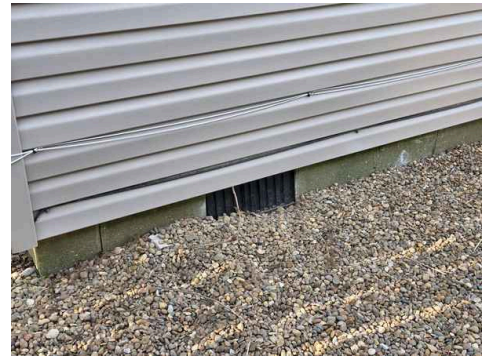
CRAWLSPACE VENTS INADEQUATE CLEARANCE

Crawlspace vent observed to not have adequate clearance. This may cause water intrusion. Recommend a qualified contractor evaluate and repair.

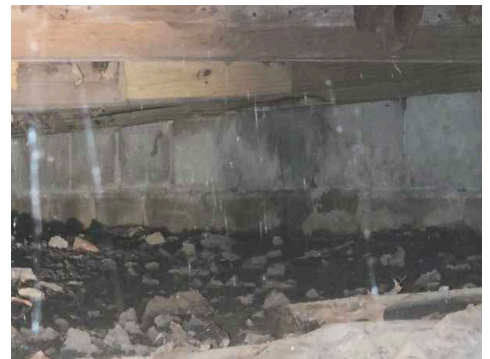
4.3.1 Vapor Retarders

MISSING COVERAGE

Areas were missing vapor retarder or had been pulled back. Recommend a qualified contractor install additional vapor retarder or redistribute to help prevent moisture buildup.

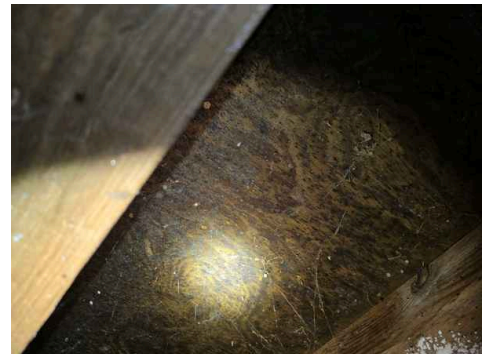
4.6.1 Ceiling Structure

ORGANIC GROWTH

Observed signs of organic growth on one or more areas of the ceiling structure. Recommend identifying source or moisture intrusion and sending samples to a lab for testing.

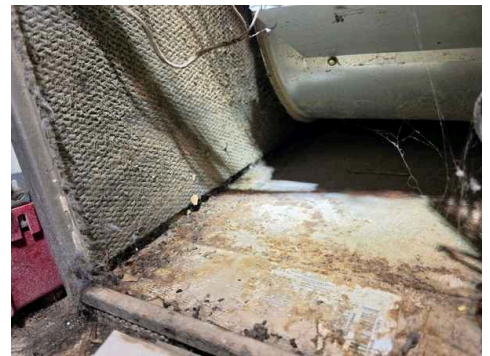
5.1.1 Equipment

CORROSION

Furnace was corroded in one or more areas. This could be the result of condensation or improper venting, which the source would need to be identified. Recommend a HVAC contractor evaluate and repair.

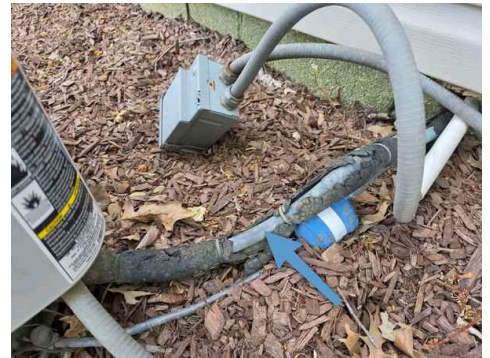
6.1.1 Cooling Equipment

INSULATION MISSING OR DAMAGED

Missing or damaged insulation on refrigerant line can cause energy loss and condensation.

Contact a handyman or DIY project

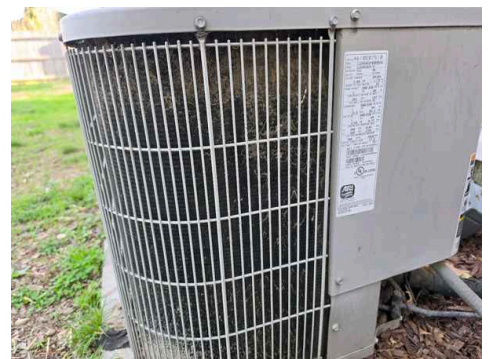
6.1.2 Cooling Equipment

NEEDS SERVICED/CLEANING

Exterior air conditioning unit was in need of service/cleaning. Recommend a qualified HVAC professional service.

Contact a qualified HVAC professional.

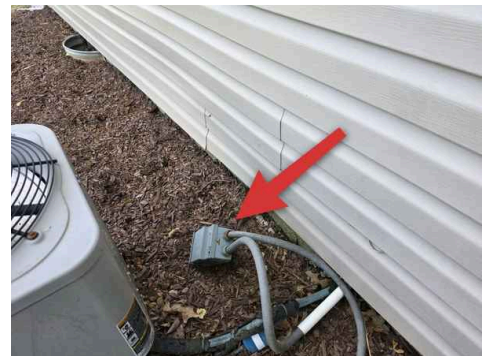
6.1.3 Cooling Equipment

ELECTRICAL BOX NOT SECURED

Electrical box for air conditioning unit was not secured. This may cause damage to electrical components. Recommend a qualified electrical or HVAC contractor repair.

Contact a qualified electrical contractor.

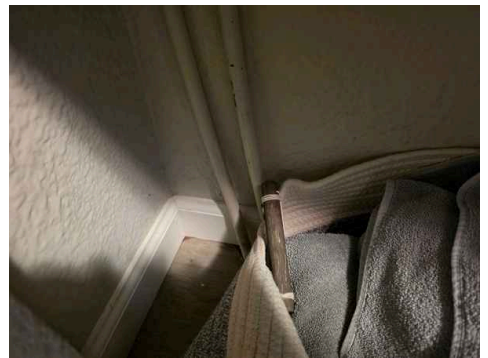
There was no visible/accessible main water shut-off identified. This is an important device to be able to shut off water to the home in an emergency. Recommend a qualified plumbing contractor evaluate and remedy.

Contact a qualified plumbing contractor.

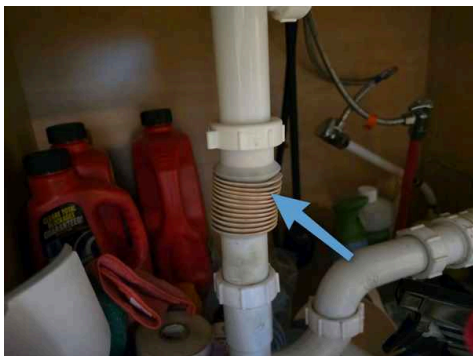
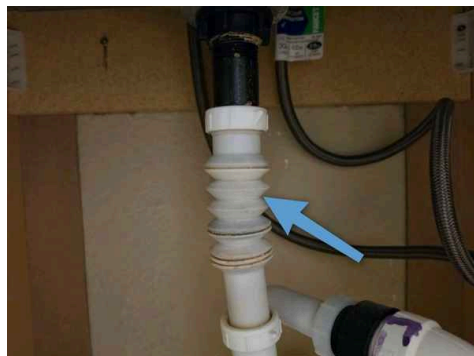
7.2.1 Drain, Waste, & Vent Systems

IMPROPER PIPE MATERIAL

The drain pipe was of an improper type. The pipe was flexible which can cause the drain to back up. Recommend a qualified plumbing contractor replace.

Contact a qualified plumbing contractor.

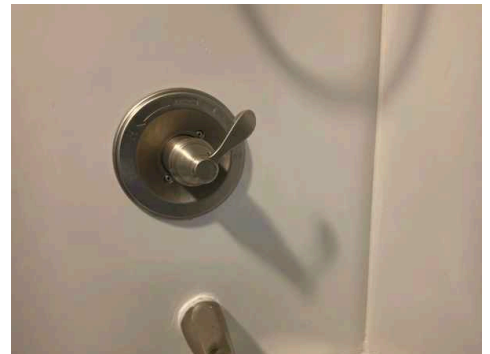
7.3.2 Water Supply, Distribution Systems & Fixtures

Hot and cold was reversed at the time of the inspection. Recommend a qualified handyman repair.

Contact a handyman or DIY project

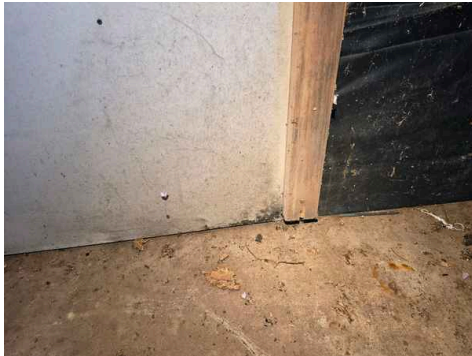
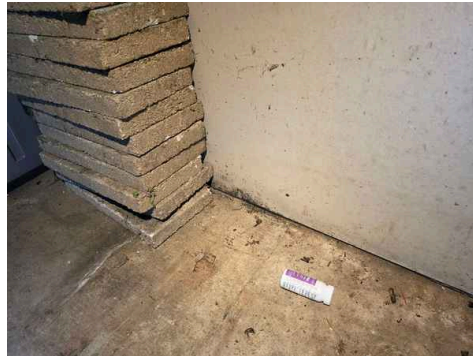
12.3.1 Walls

ORGANIC GROWTH

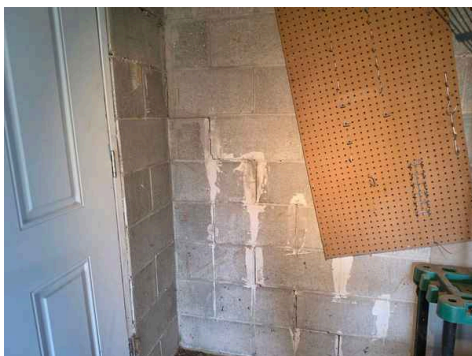
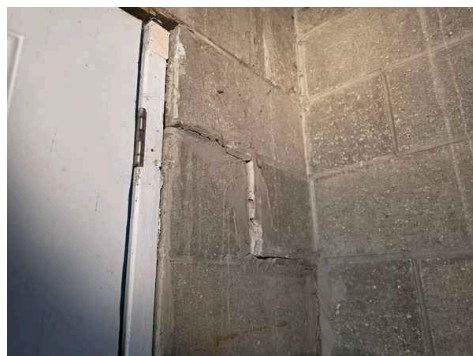
12.3.2 Walls

CRACKING - MAJOR
