RHI HOME INSPECTIONS

## INSPECTION REPORT

9845 Monte Wy  
Newburgh, IN 0

03/30/2026

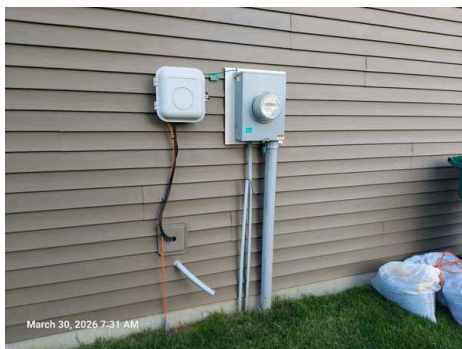
Underground, East

Location and type of service entry  
for electricity to the structure.

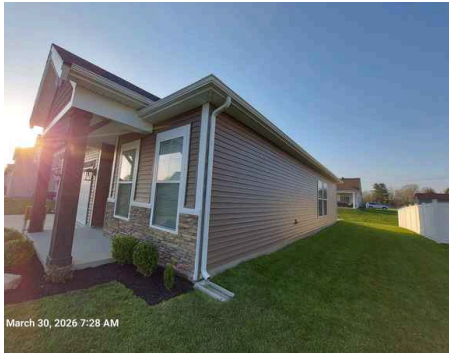
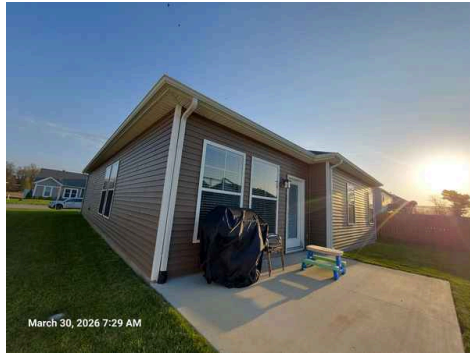
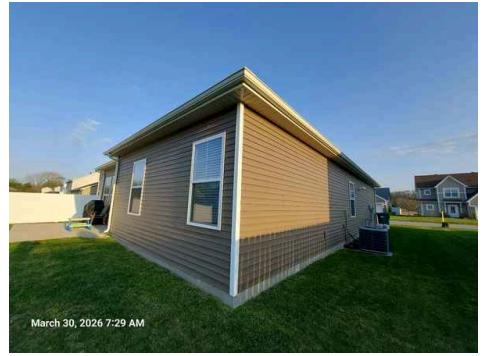
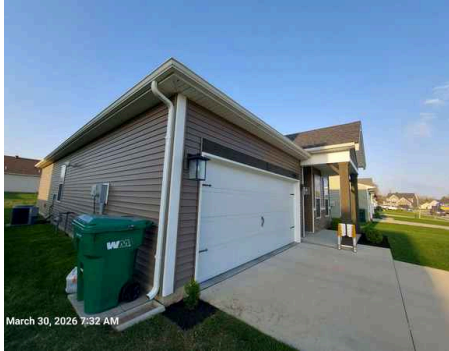
### Elevation Photos

Photos of around the structure at the time of inspection.

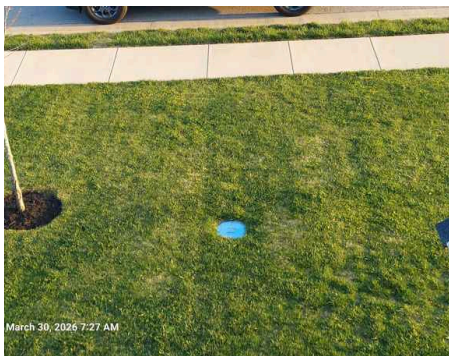
Public, Yard Near Street

Listed here is the source and location of the water meter or well head if known and located at the time of inspection.

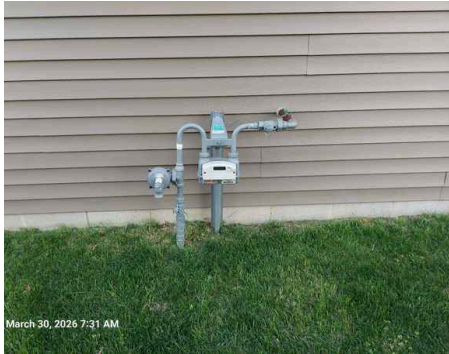
Natural Gas, East

The type of fuel systems and the location of the meter and tank if located. Some systems may have underground tanks, these tanks are outside the scope of a home inspection.

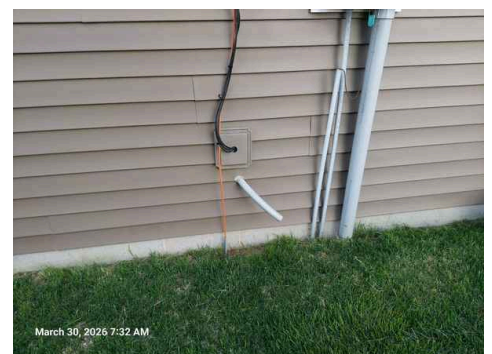
Unsealed penetrations were noted at one or more locations at the time of inspection. Openings, spray foam, or other forms of unsealed penetrations leaves the structure below exposed to potential damage & pest intrusion. Recommend further evaluation & correction by a qualified contractor. [Defect Explained](#)

Contact a qualified professional.

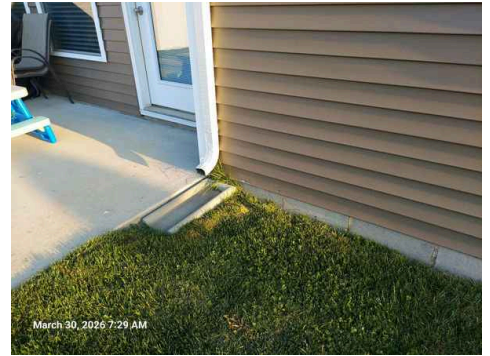
## 2.1.3 Siding

Deficiencies
**SIDING - MINOR DAMAGE**

Minor damage to siding was noted at one or more locations at the time of inspection. Recommend further evaluation & correction by a qualified contractor.

Contact a qualified siding specialist.

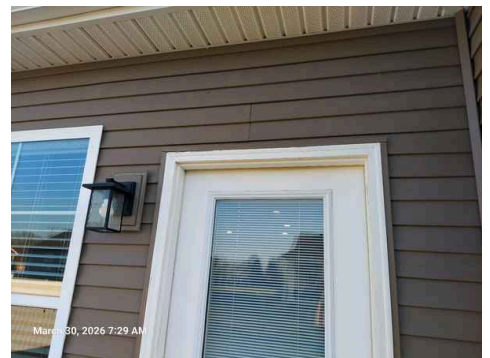
## 2.2.1 Fascia, Soffit, Trim, &amp; Columns

Maintenance / Recommendations
**TRIM - MAINTENANCE NEEDED**

Regular maintenance is required to keep property in good condition, which includes but is not limited to cleaning, caulking, sealing & painting. Recommend surfaces be washed & properly cleaned, gaps or holes be filled, & exposed surfaces, weathering, or peeling paint properly prepped & sealed or repainted as needed.

Contact a qualified professional.

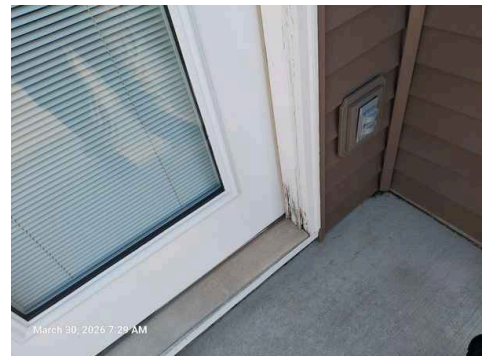
## 2.2.2 Fascia, Soffit, Trim, &amp; Columns

Deficiencies
**TRIM - MISSING / DAMAGED**

Trim was noted as missing or damaged at one or more locations at the time of inspection. This includes conditions such as wood rot, exposed structure, etc. Recommend further evaluation & correction by a qualified contractor.

Contact a qualified siding specialist.

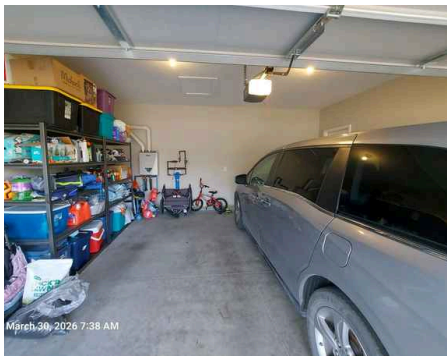
### Garage Photos

Photos taken of the garage to show its condition during the home inspection.

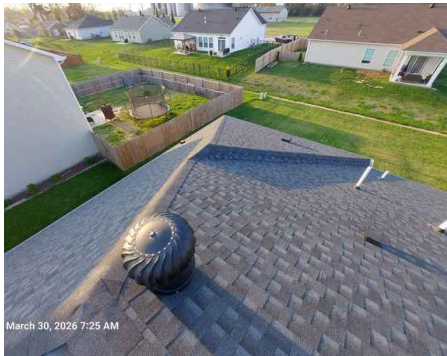
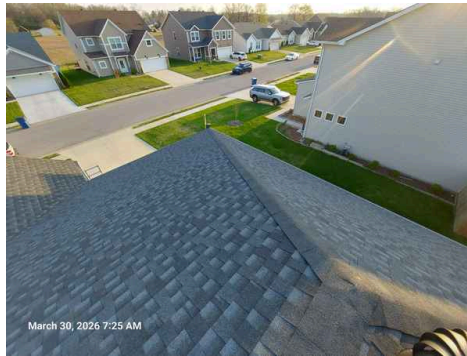
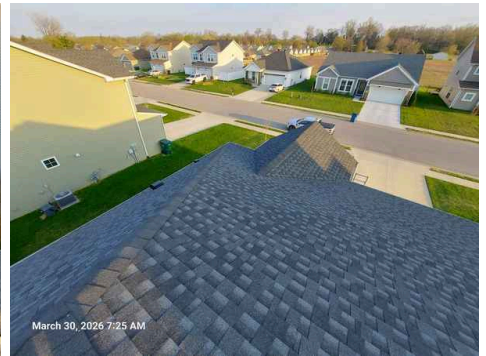
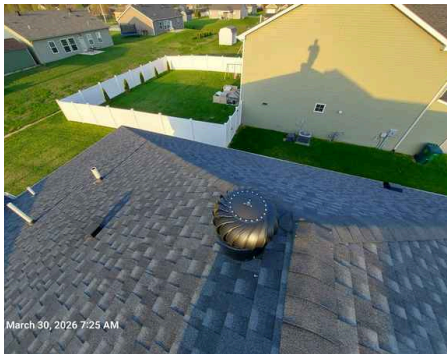
#### Roof Coverings: General Photo(s)

Roof appeared to be in the first third of service life

#### Roof Coverings: No Significant Defects Observed

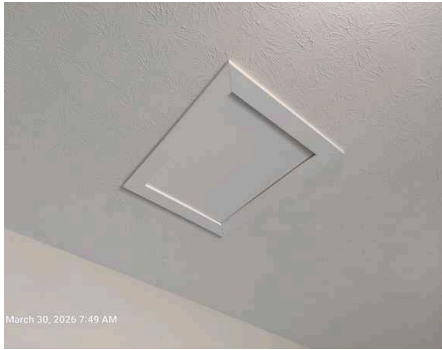
**Attic Access: Type**  
Ceiling Scuttle

**Attic Access: Location(s)**  
Garage, Ceiling

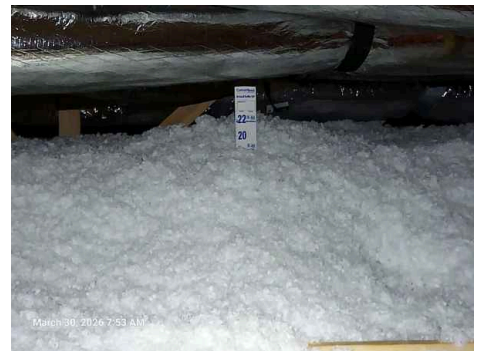
**Insulation: Insulation Type**  
Loose Fill, Fiberglass

**Insulation: Approx. Depth**  
>14"

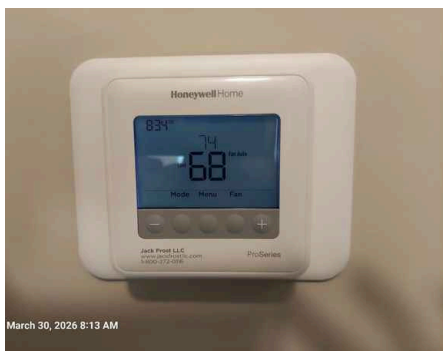
**Thermostats: Location**  
Hallway

Thermostat(s) appeared to operate normally.

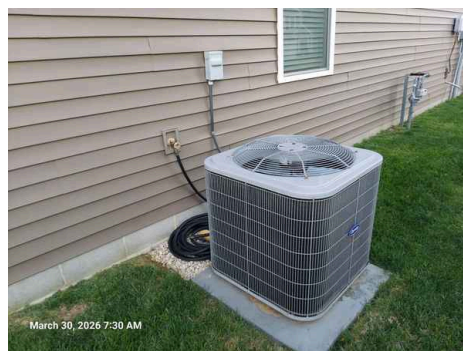
**AC / Heat Pump Unit: Location**  
East

**AC / Heat Pump Unit: Manufacturer**  
Carrier

**AC / Heat Pump Unit: Manufacture Date**  
2022

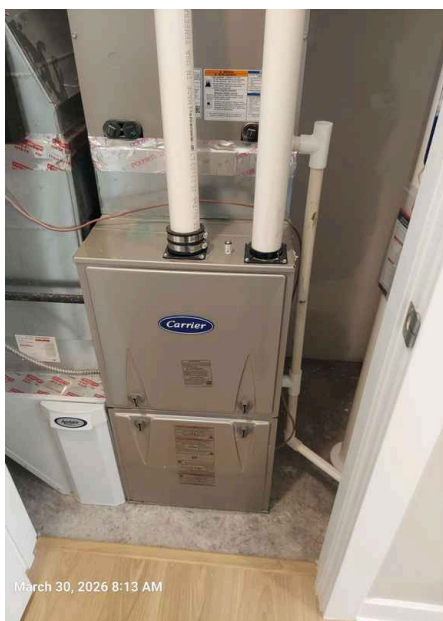
**Heating Unit: Location**  
Hallway, Closet

**Heating Unit: Manufacturer**  
Carrier

**Heating Unit: Manufacture Date**  
2022

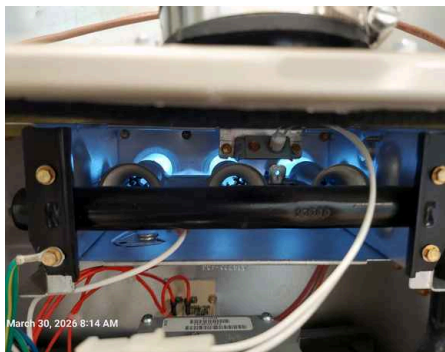
### Heating Unit: Energy Source

Appliance in operation

Gas Furnace

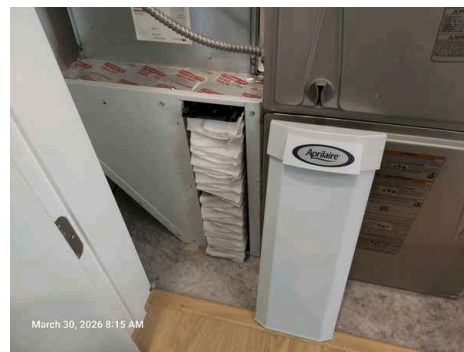
### Heating Unit: Filter Location

Next to Unit, Cut into Ductwork

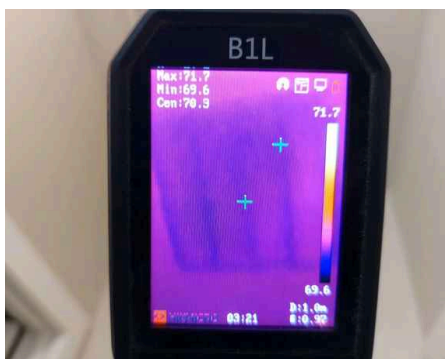
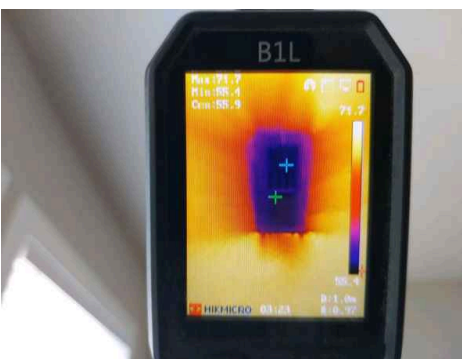
An infrared camera was used to show the system responded to normal operating controls, at the time of inspection. These images are not intended to show the exact temperature differential produced or the efficiency of the system; which lies beyond the scope of a home inspection. HVAC thermometers (wet bulb) are required for accurate readings, and measurement points would be carried out at a different location by an HVAC contractor. Typical temperature differentials between return and supply air is 14 - 20 degrees in cooling mode. Several factors can affect these numbers, such as, but not limited to: indoor ambient air temperature, exterior ambient air temperature, humidity, cleanliness of the air filter and evaporator, etc. Heat pump setting was

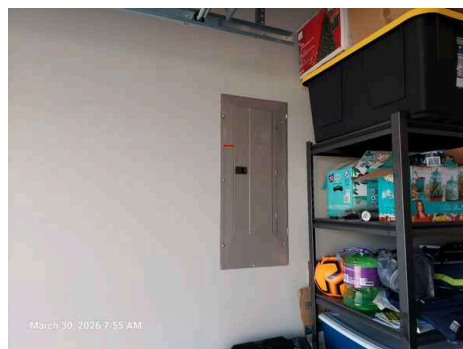
**Main Distribution Panel(s): Main Panel Location**  
Garage

**Main Distribution Panel(s): Panel Type**  
Circuit Breaker

**Main Distribution Panel(s): Panel Capacity**  
200 AMP

**Main Distribution Panel(s): Manufacturer**  
Eaton

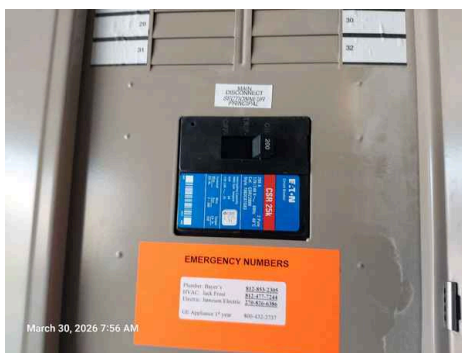
**Main Distribution Panel(s): Service Conductors**  
Aluminum Multi-Strand

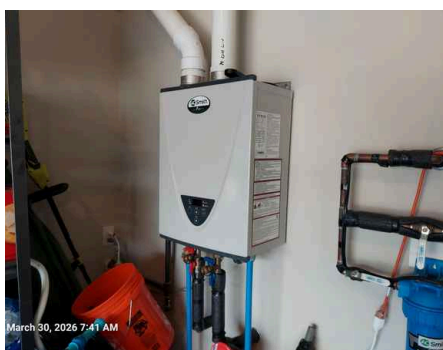
**Water Heater: Location**  
Garage

**Water Heater: Capacity**  
Tankless

**Water Heater: Manufacturer**  
A.O. Smith

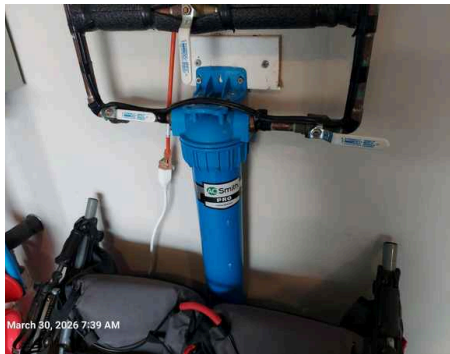
### Service: Inline Filter

An inline filter was viewed. This type of filter will require regular replacement, at least a couple of times per year.

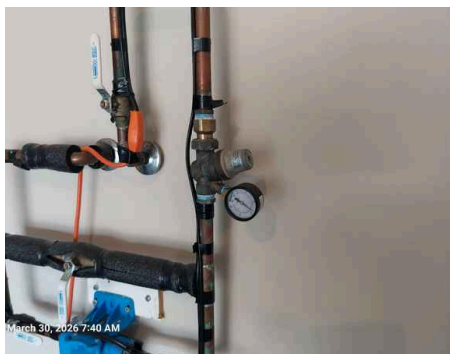
### Service: Water Pressure Regulator Valve

Water pressure regulator valve noted as installed at the time of the inspection.

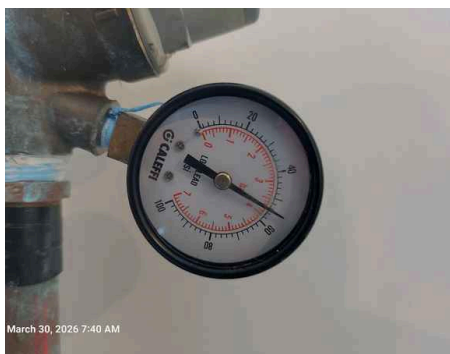
### Service: Water Pressure Adequate

The water pressure tested between 40 and 80 psi. This is the generally accepted range for correct water pressure. Water pressure that is too high can cause valves on plumbing fixtures to fail.

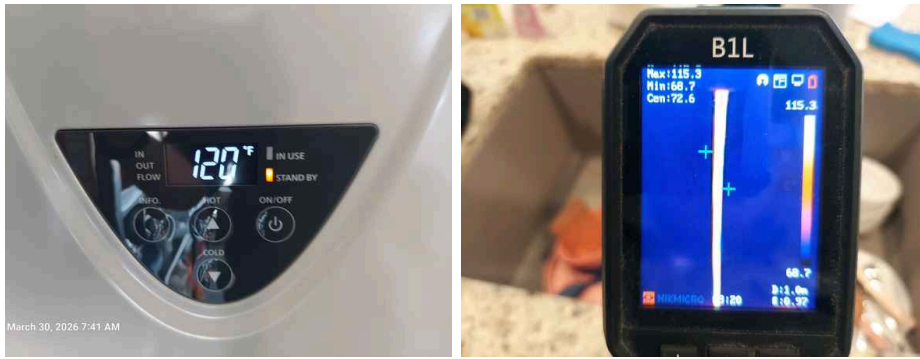
## Water Heater: TPR Valve Drains Inside

The TPR (temperature and pressure relief) valve did not drain into an open drain at the time of inspection. In the event of a discharge this may cause moisture damage to flooring and building materials.

Contact a qualified plumbing contractor.

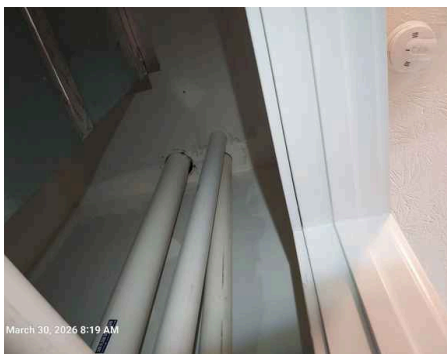
Furnace closet

**Evidence of Leaks: Dry Leaks**

Evidence of leaking was viewed at the time of inspection. A moisture meter indicated that the stains were dry at the time of inspection.

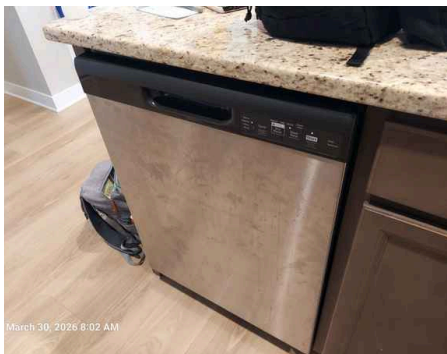
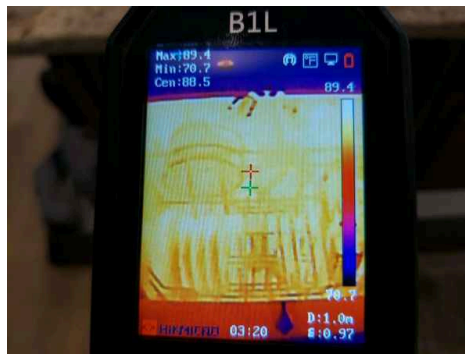
### Dishwasher: General Photo(s)

The dishwasher was operated by running a wash cycle, and was functional at the time of inspection. No leaks or water was present at the base of the unit at the completion of the cycle. The unit's efficiency of cleaning dishes is not tested for. No deficiencies were observed with the unit unless otherwise noted in this report.

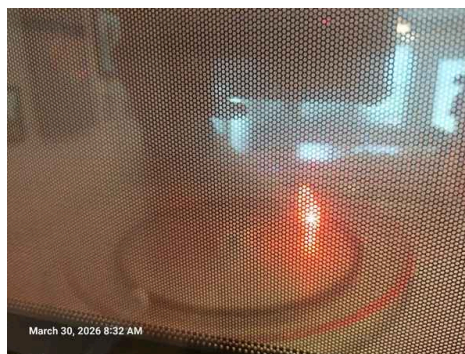
### Built-in Microwave: General Photo(s)

The microwave was operated by operating with normal controls, and was functional at the time of inspection. No deficiencies were observed with the unit unless otherwise noted in this report.

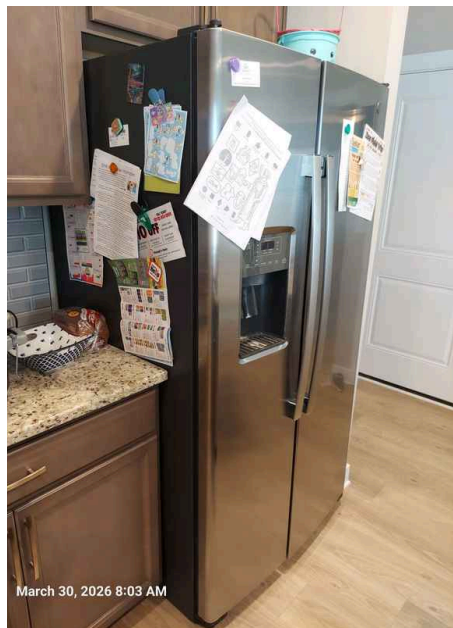
### Refrigerator: General Photo(s)

The refrigerator was operated by operating with normal controls, and was functional at the time of inspection. No deficiencies were observed with the unit unless otherwise noted in this report.

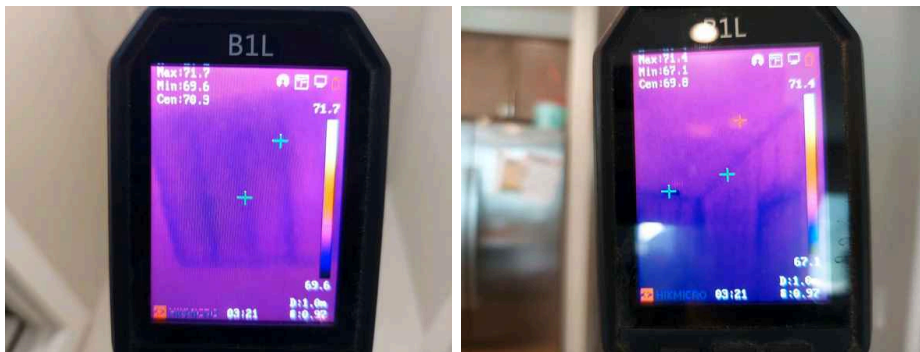
### Thermal Scan

A basic scan of the house was performed with an infrared camera to check for leaks, missing insulation, and overheated electrical conductors. This scan does not ensure the inspector will find all defects that may be hidden in walls or ceilings. Any specific defects that were found pertaining to specific components will be noted in their respective areas of the report.

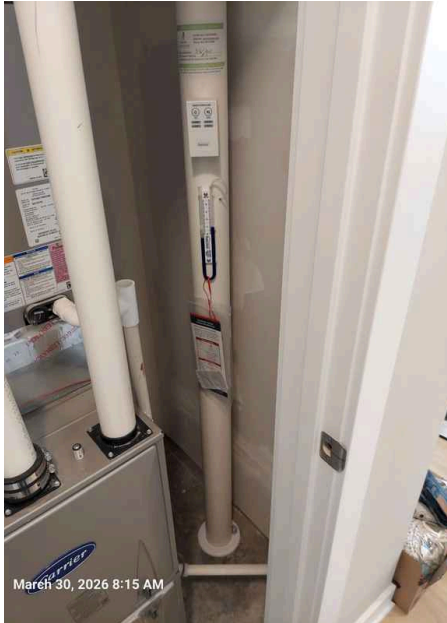
A radon mitigation system was currently installed at the time of the inspection. The EPA recommends re-testing for radon every two years. This will ensure the mitigation system is fulfilling its intended function. RHI can perform this test for you when the time comes.

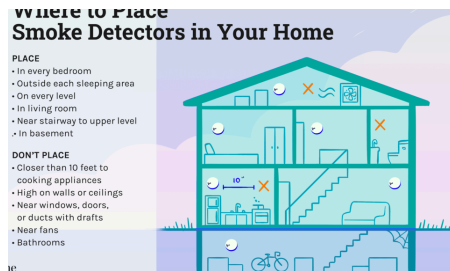
Hallways, Bedrooms

It is recommended that smoke alarms be installed inside each bedroom, outside each sleeping area and on every level of the home, including the basement.
