YOUR INSPECTION REPORT

1879 Highland Ave E
Twin Falls, ID 83301

Triple A Realty LLC
MAY 14, 2026

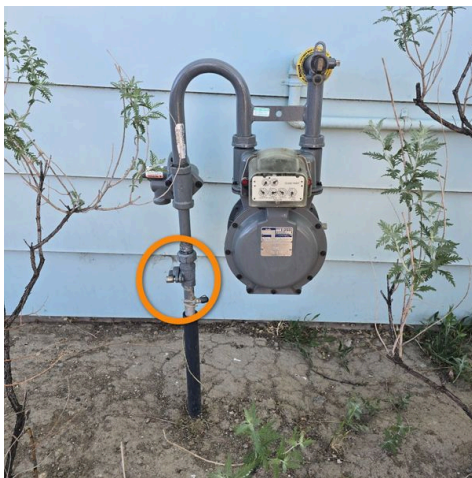
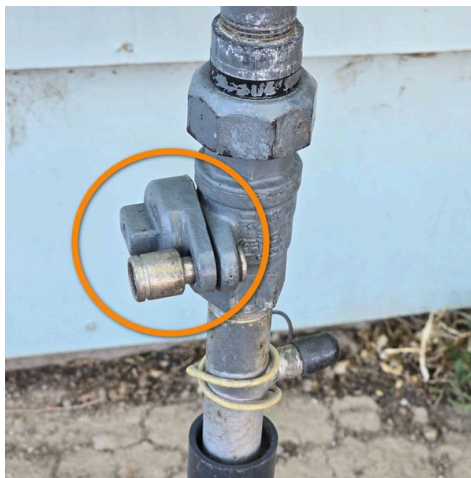
Main Fuel Valve Location

Gas Valve OFF and LOCKED at the time of the inspection. Close Up View

The location of the main gas valve is noted here for your information.

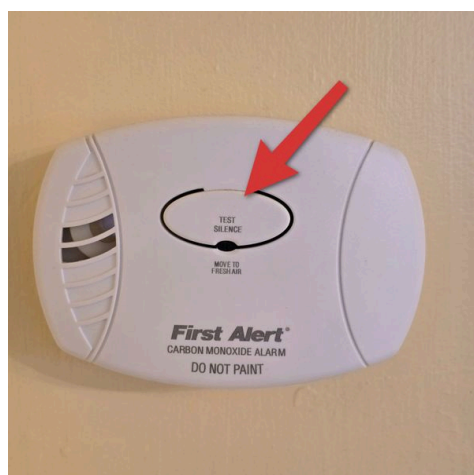
3.2.1 Carbon Monoxide Detectors

No Response from Carbon Monoxide Detector at noted locations.

No Response

Failed to respond to the TEST BUTTON

Replace batteries & re-test if newer than 10 years or replace as needed to restore proper function.

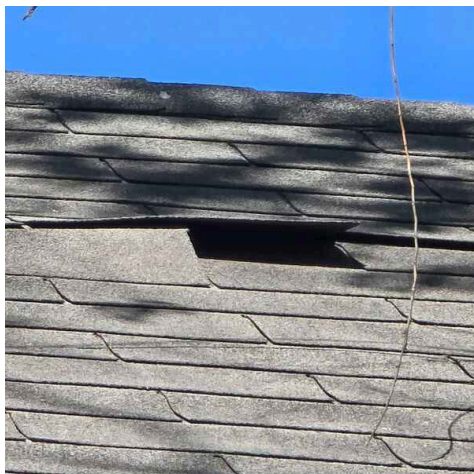
About Here

Minor damage observed to the shingles at noted locations.

Although minor, repairs are recommended.

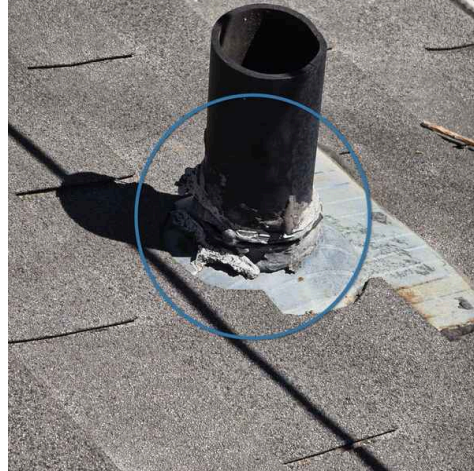
Plumbing Vent Flashings

Properly installed flashings in good condition require little, if any sealant to perform. This does not mean they *will leak* but these types of applications require regular inspection and maintenance and may still not perform well. I recommend consulting with a roofing contractor. See location tags, pictures and comments for more information.

Recommend monitoring.

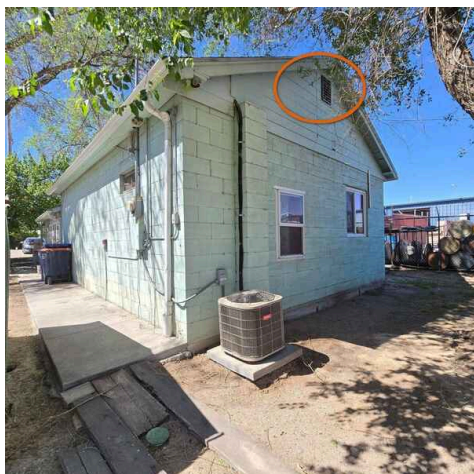
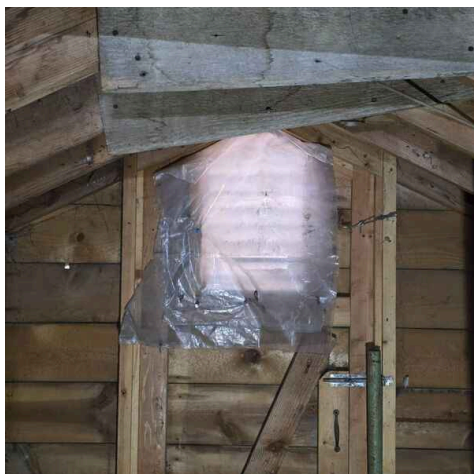
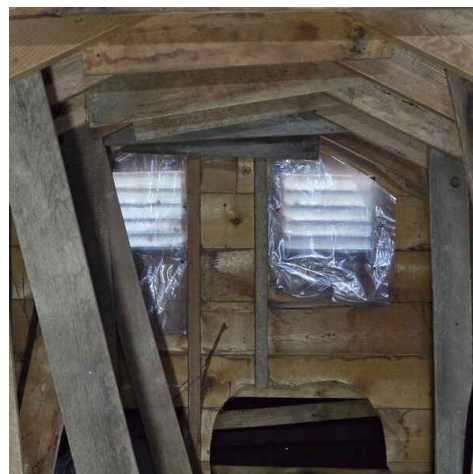
5.1.2 Attic Ventilation

Gable Vents at noted locations appear to be obstructed.

Attic ventilation may not be adequate to ensure heat and moisture are evacuated from the attic. Recommend obstructions be cleared or additional ventilation added.

Gable Vents are covered with plastic in the Attic

Contact a qualified professional.

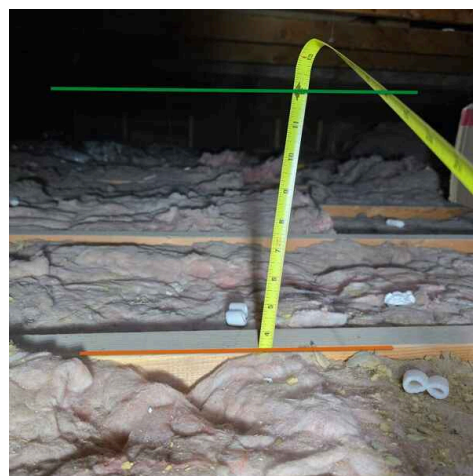
5.2.1 Attic Insulation

Attic Insulation appears to be less than the *currently recommended* rating of R38.

There was about 3 1/2" of insulation present at the time of the inspection

Current & Recommended Insulation Depth

Contact a qualified insulation contractor.

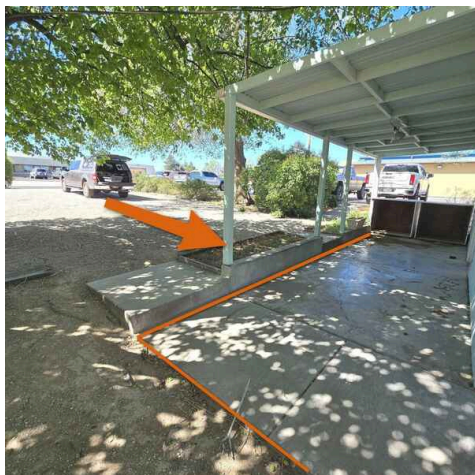
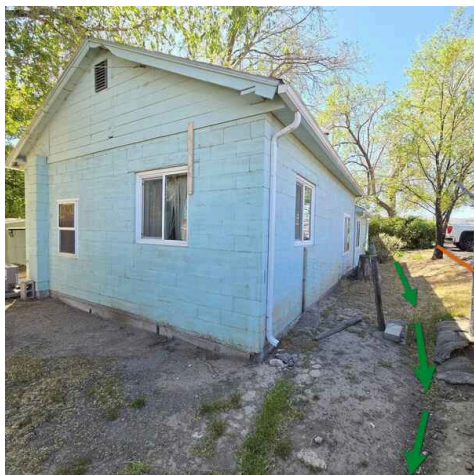
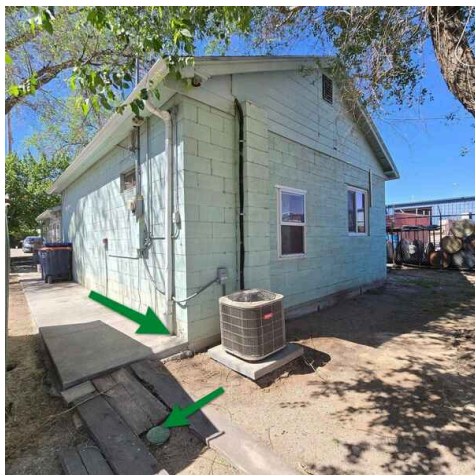
6.7.1 Vegetation, Grading & Drainage.

Direction of slope: Elevation drop at front of house from driveway.

This view shows the yard at the east side is higher than the sidewalk and foundation.

The adjacent lot is higher than the house. A valley has been dug to help water flow to the downhill (north) side of the lot.

An underground drain system has been installed for the rain gutters on the east side, which leads to a pop-up drain on the downhill (north) side of the house.

Recommend monitoring.

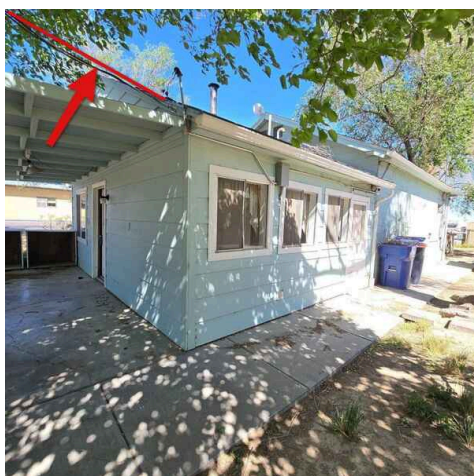
Here

Less than 10'

Contact a qualified electrical contractor.

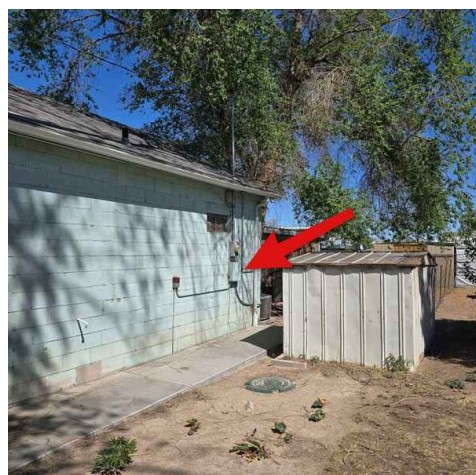
9.2.1 Main Panel, Service & Grounding, Main Overcurrent Device

This is actually just a junction box now, but the cover is not secured, and when opened, open electrical connections are easily accessible. Add dead front cover, or make inaccessible without tools recommended.

Contact a qualified electrical contractor.

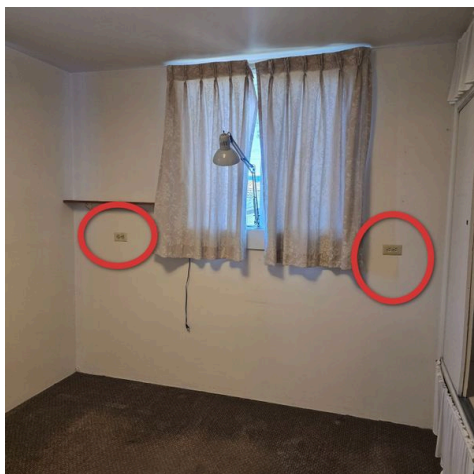
NW Bedroom

Tester Indicates Reverse Polarity

Contact a qualified electrical contractor.

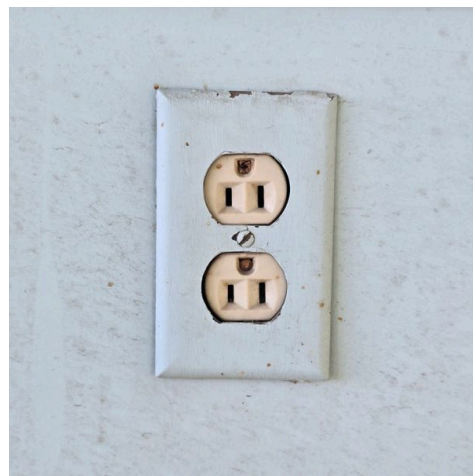
Here

Weatherproof Receptacle Cover

Contact a qualified professional.

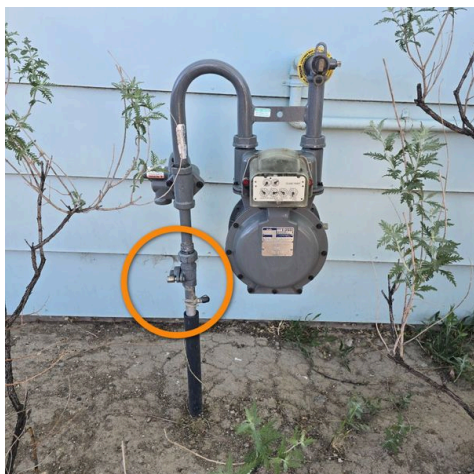
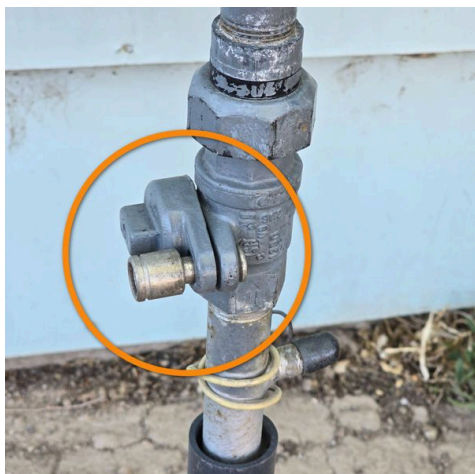
EXTERIOR SW

Gas was off at the main. Recommend local utility company turn on and check all gas appliances prior to deadlines.

Main Gas Valve OFF at the time of the inspection

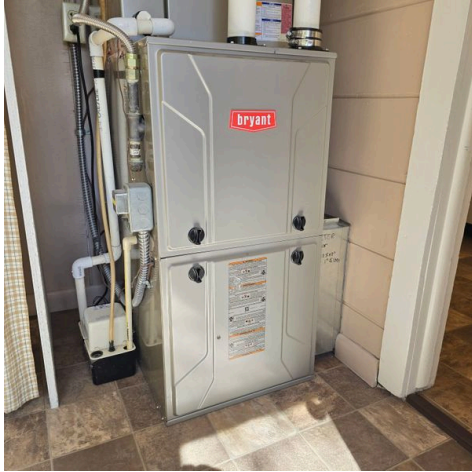
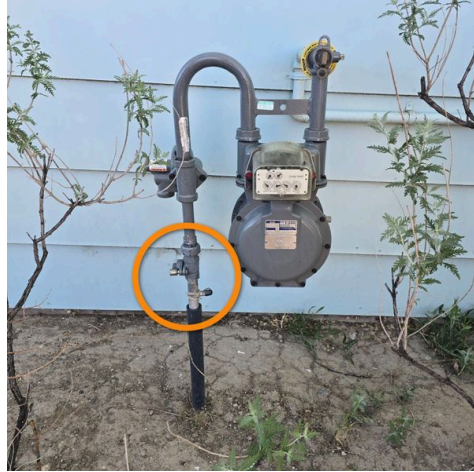
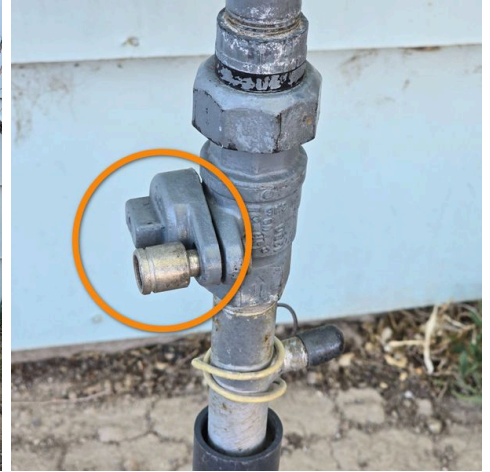
The Furnace was visually inspected, but NOT TESTED. Gas OFF at the time of the inspection

Gas OFF

Contact a qualified heating and cooling contractor
