Repairs Based on Home Pre-Inspection on 4.20.2026

RESIDENTIAL INSPECTION

1093 SE St Patrick Ct
Port Orchard, WA 98367

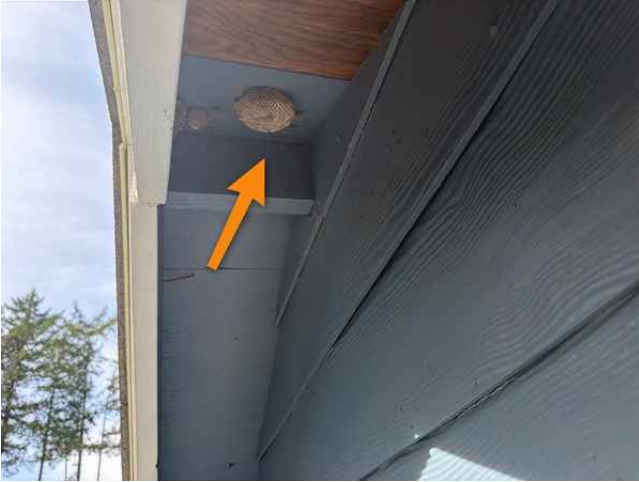
4.26.1 – Pests. Two wasp/hornet nests were removed when the roof was cleaned.

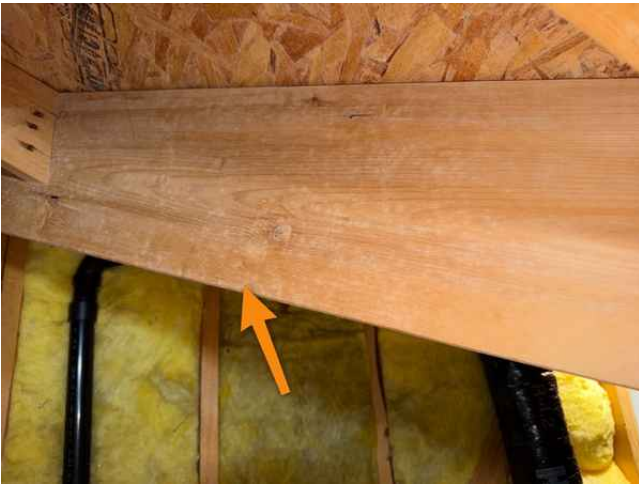
5.10.1/7.4.1 - Mold-like growth. This is old on dry wood, and the cause was rectified when the roof was re-done and is documented in pictures by Patriot Roofing. The surface was wiped clean with bleach.

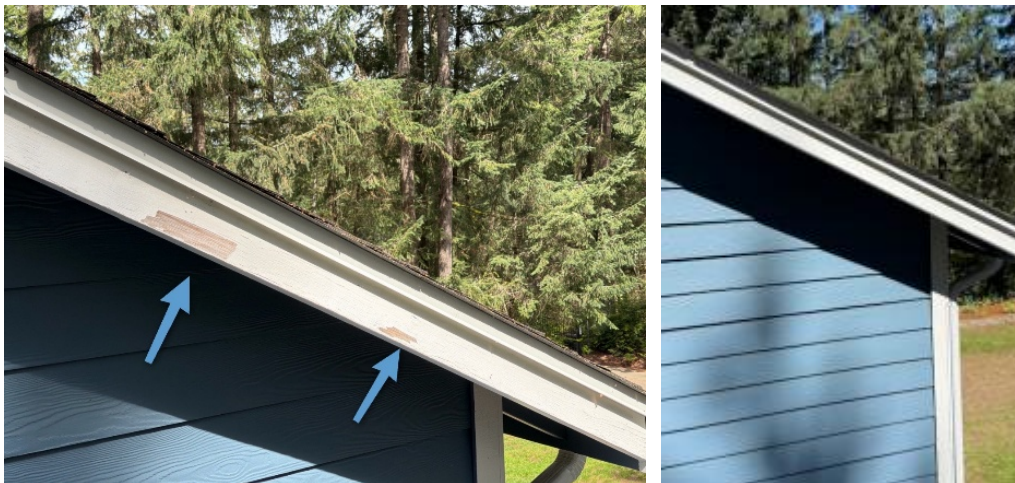
4.7.1 – Exterior Trim Paint. Trim was scraped and repainted.

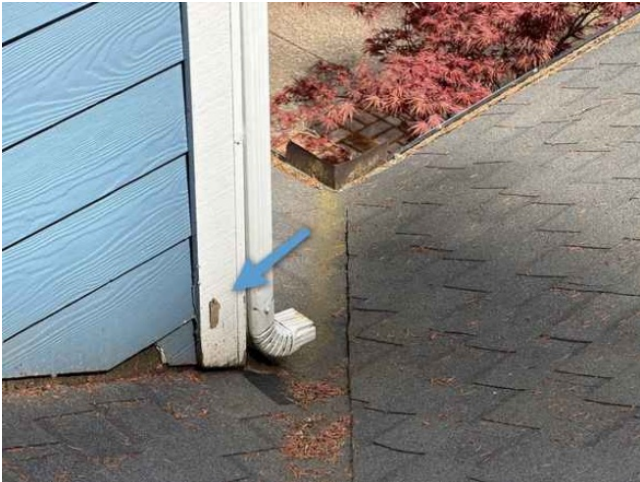
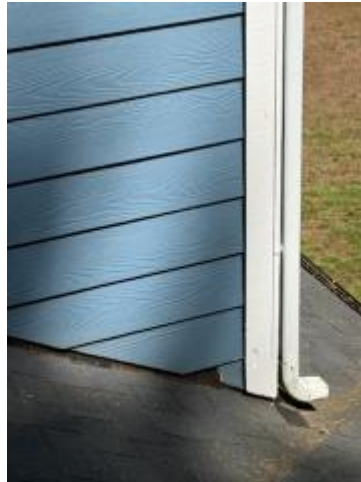
4.7.1 – Exterior Trim Paint. Trim was scraped and repainted

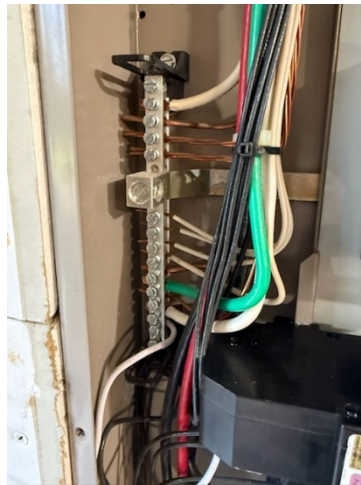
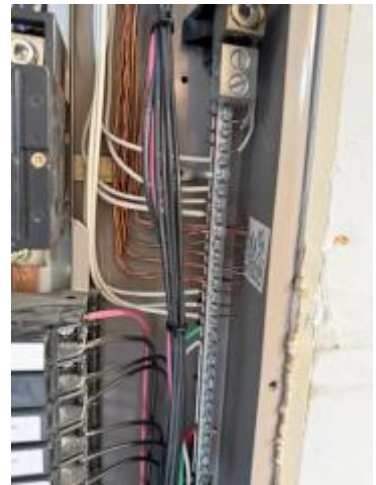
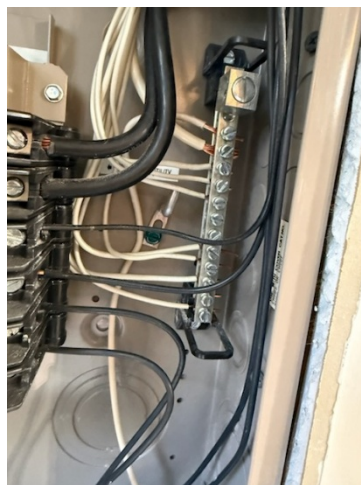
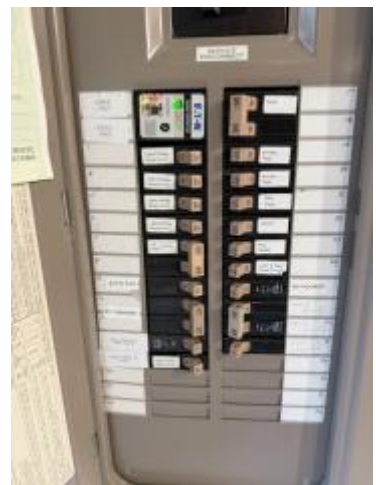
11.6.1 – Multiple neutrals under one lug. This was repaired by a licensed electrician. Surge Protection was moved to the top of the panel, and the panel was re-labeled.

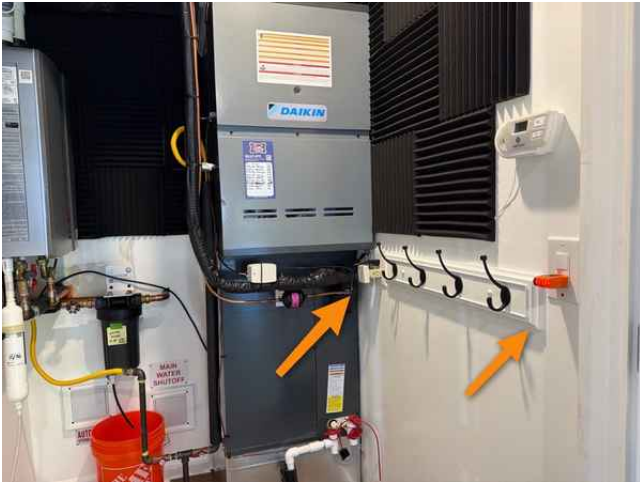
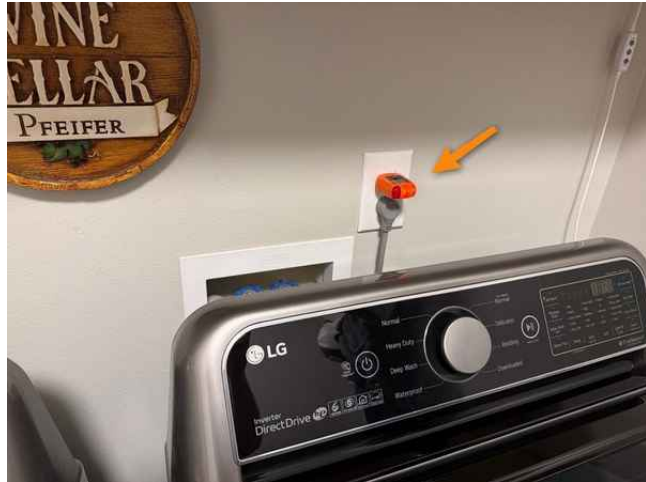
11.9.1 – Receptacles: GFCI. Per a licensed electrician, a GFCI is not required in the Mechanical Room. GFCI outlets were not required in these areas when the home was built (Grandfathered).

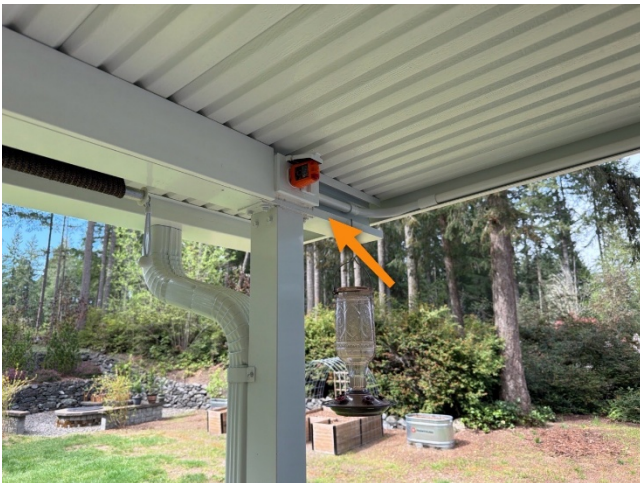
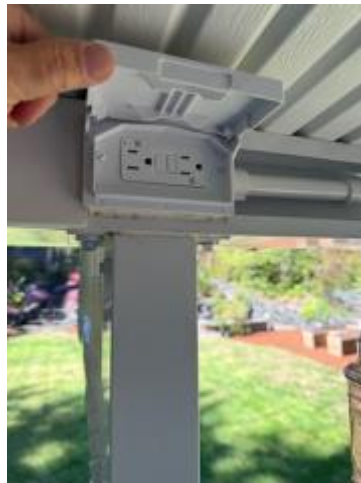
11.9.2 – Receptacles (Exterior) GFCI. Exterior outlet was replaced with a GFCI.

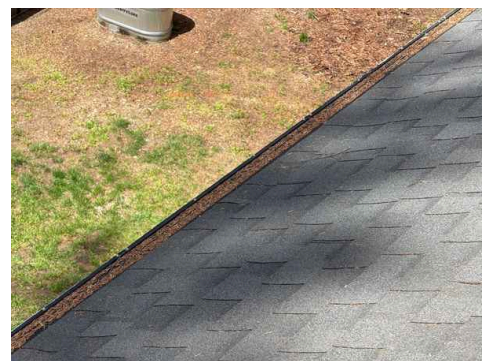
GUTTER PROTECTION SYSTEM

The gutters were equipped with a screen or gutter protection system, which limited visibility and prevented a complete evaluation of the gutter interiors and drainage conditions at the time of inspection. As a result, the presence of debris, blockages, or concealed defects could not be fully determined. Recommend periodic maintenance and monitoring, and further evaluation by a qualified contractor if drainage concerns are observed.

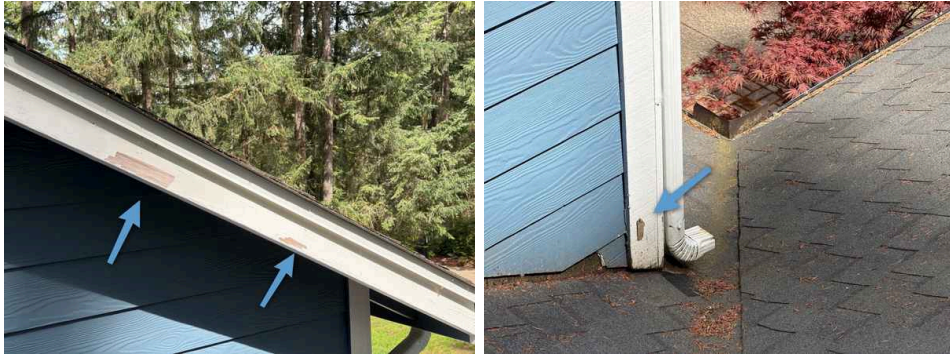
4.7.2 Exterior Trim

The soffit needed routine painting maintenance. Recommend a professional painter repair/paint as needed.

Recommendation

Contact a qualified painting contractor.

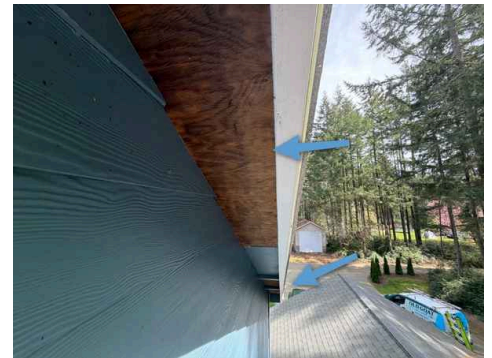
4.26.1 Pests

WASPS: MULTIPLE NESTS

Wasp nests visible at various points around the home exterior should be removed.

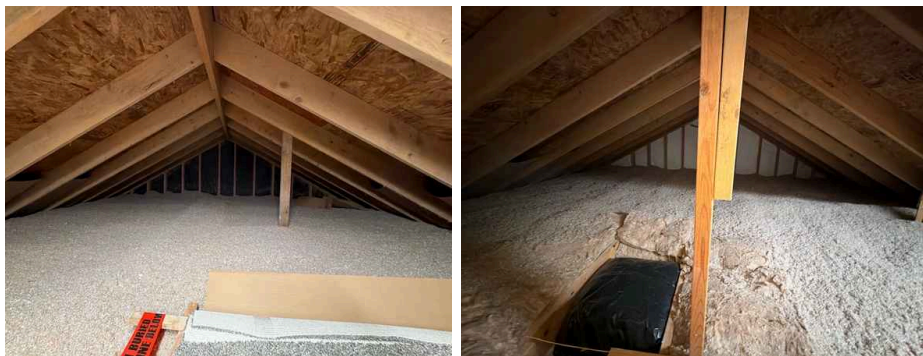
Conventional Roof Framing: Conventional roof framing

The garage roof structure was built using conventional framing methods (rafters and ridge).

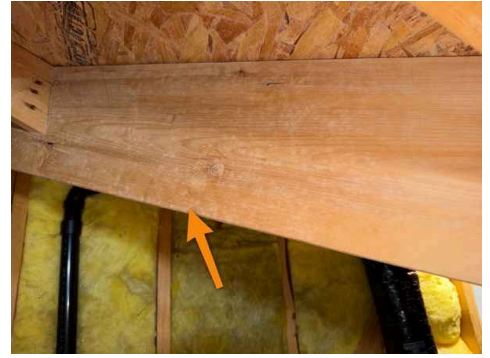
Mold-like growth was observed on the framing and sheathing in the garage attic during inspection. This indicates moisture accumulation in the attic space, which can compromise structural integrity and create potential health concerns. A mold remediation specialist should evaluate the extent of the growth, identify the moisture source, and recommend appropriate treatment and ventilation improvements.

Recommendation

Contact a qualified professional.

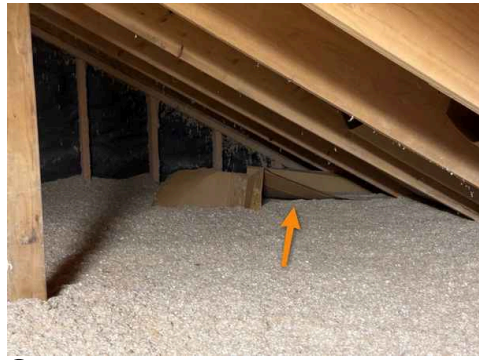
The soffit baffles had fallen from the joists, risk of improper ventilation. Recommend a licensed contractor properly install the baffles at the eaves ensuring proper ventilation.

Recommendation

Contact a qualified professional.

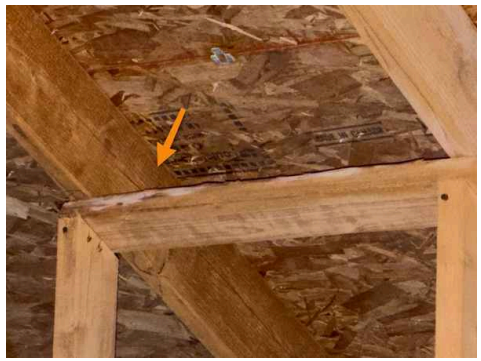
7.4.1 Conventional Roof Framing

Mold-like growth was observed on the roof framing and/or sheathing during inspection. Mold growth indicates moisture intrusion and can compromise structural integrity and air quality. A qualified mold professional should evaluate the extent of growth, identify moisture sources, and recommend appropriate remediation and repairs to prevent further damage.

Recommendation

Contact a qualified professional.

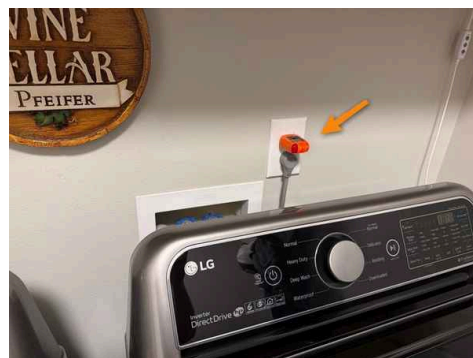
No ground fault circuit interrupter (GFCI) protection of laundry room electrical receptacles was provided in the laundry room at the time of inspection. Good electrical safety practice recommends that electrical receptacles located within 6 feet of a plumbing fixture be provided with ground fault circuit interrupter (GFCI) protection. This can be achieved relatively inexpensively. You should consult with a qualified electrical contractor to discuss options and costs.

Recommendation

Contact a qualified electrical contractor.

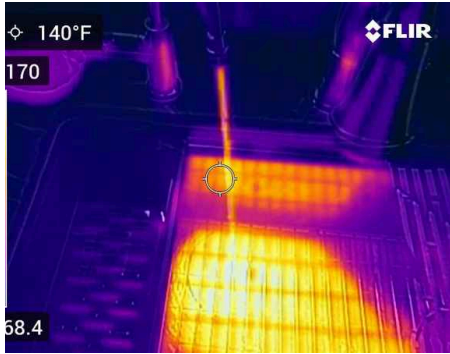
Kitchen Sink: Instant Hot Water Dispenser Present

An instant hot water dispenser was observed at the kitchen sink. This is a point-of-use water heating system that provides hot water on demand for the sink, typically used for beverages, cooking, and cleaning tasks. The system is a convenience feature separate from the main water heater.

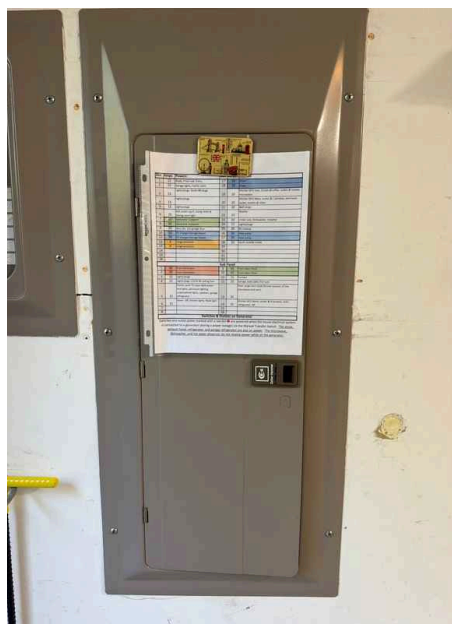
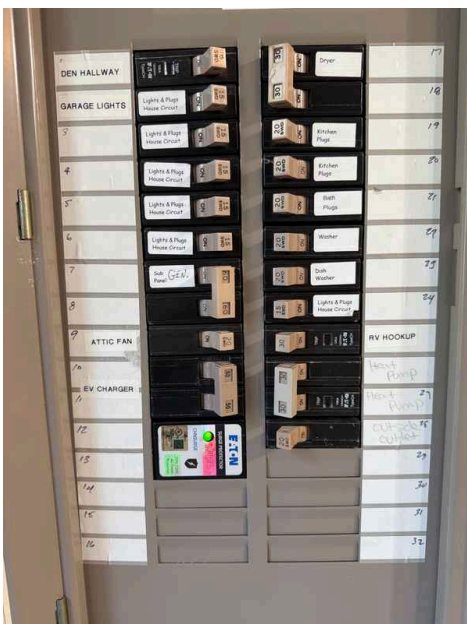
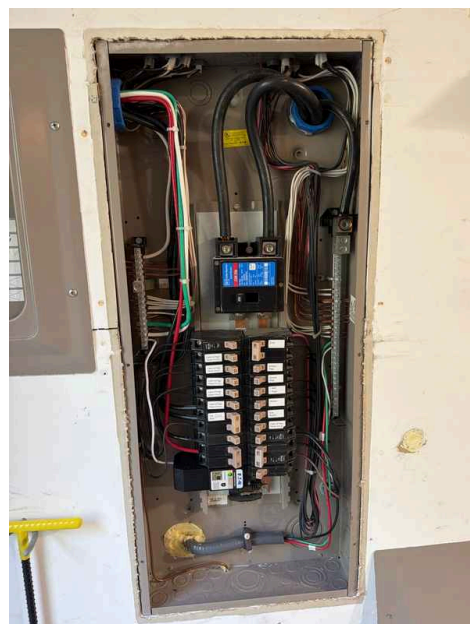
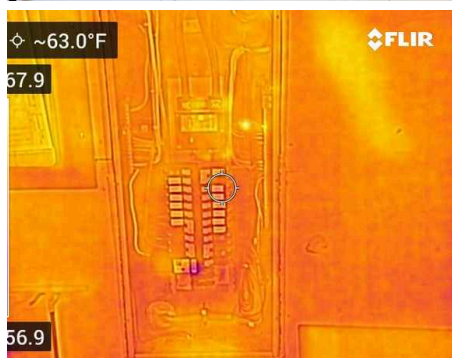
Service Panel: Service panel brand

Service Grounding and Bonding: Ground and neutrals on same bus bar, OK

In the electrical service panel, equipment grounding and neutral conductors terminated on the same bus bar. This is not a concern.

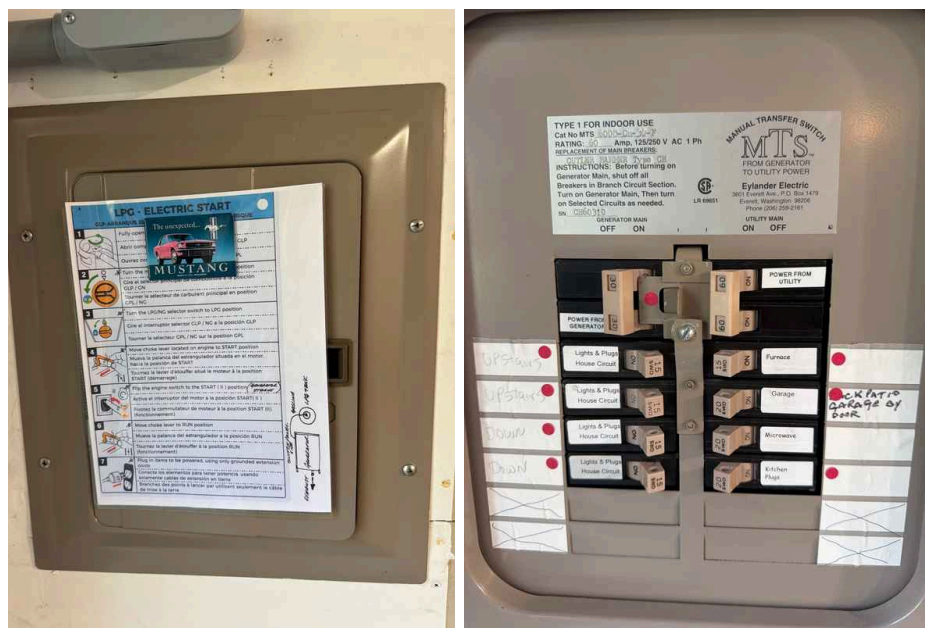
Sub-Panel: Sub-panel brand

Sub-Panel Grounding & Bonding: Neutral & grounds isolated

The neutral and grounding conductors were electrically isolated from each other in this sub-panel. This is a proper condition.

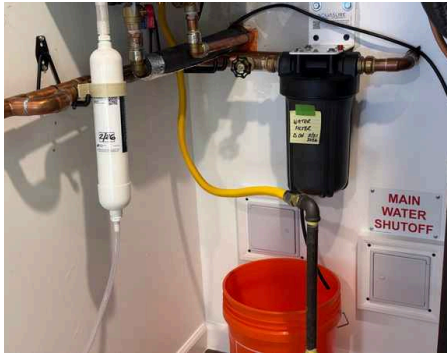
Water Filter: Whole house canister filter, not identified

The home contained a canister-type whole-house water filter installed. Canisters can contain different filters designed to address various types of water quality problems. Identification of the type of filter installed in the canister requires research that exceeds the scope of the General Home Inspection. Contact the filter manufacturer to learn more about the problems it is designed to alleviate, and its limitations and maintenance requirements.

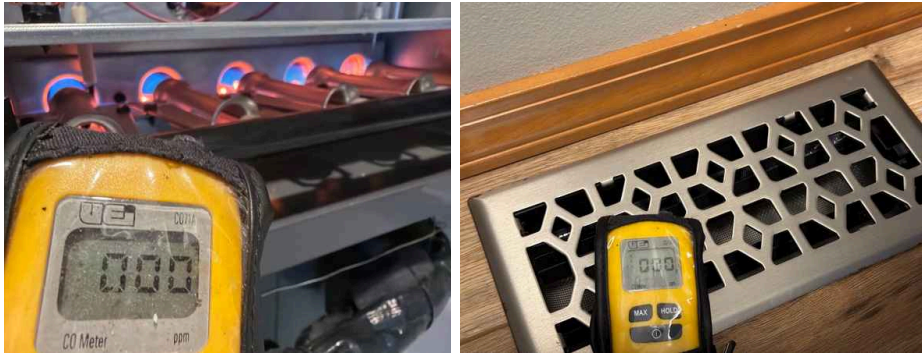
No carbon monoxide was detected. Recommend regular monitoring with proper carbon monoxide detectors. Consult a licensed HVAC technician as needed.

Tester: UEI Instruments carbon monoxide tester.

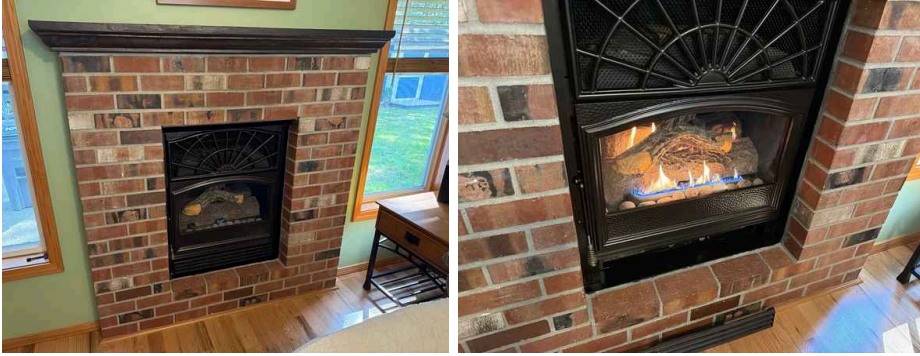
Fireplace: Fireplace Type

Gas-fired
