### SUMMARY

14EFloridaSt, Evansville, IN 47711

RHI Home Inspections

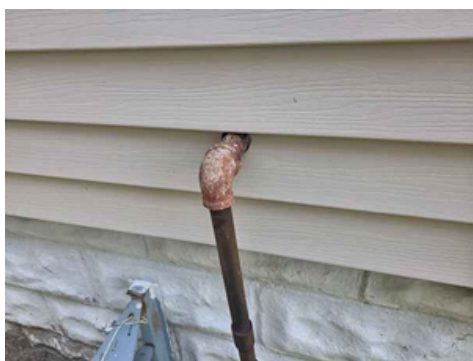
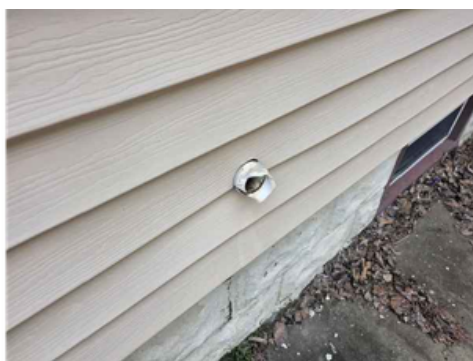
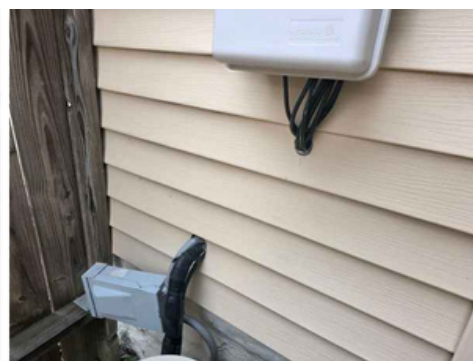
#### 2.1.2 Siding

#### SIDING - UNSEALED PENETRATIONS

Unsealed penetrations were noted at one or more locations at the time of inspection. Openings, spray foam, or other forms of unsealed penetrations leaves the structure below exposed to potential damage & pest intrusion. Recommend further evaluation & correction by a quali ed contractor. [Defect Explained](#)

Contact a quali ed professional.

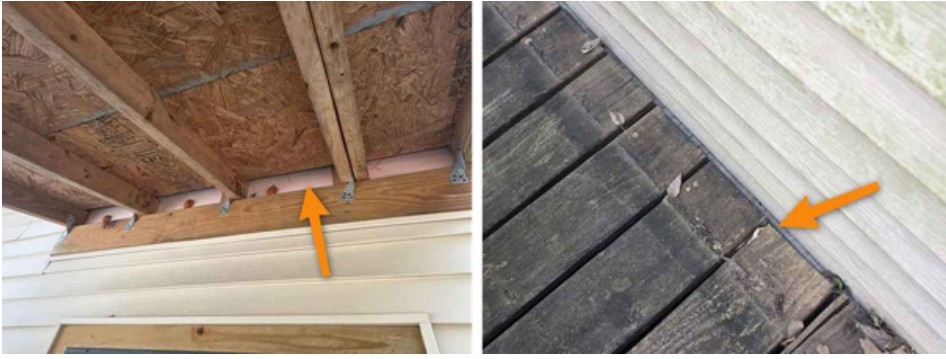
#### 2.1.3 Siding

#### SIDING - IMPROPER OVERLAP / GAPS / INSTALLATION

Siding was noted as improperly overlaps at the time of inspection. This can include gaps, improper o sets, missing channel around openings, etc., & can lead to potential moisture or pest intrusion. Recommend further evaluation & correction by quali ed professional.

Contact a quali ed siding specialist.

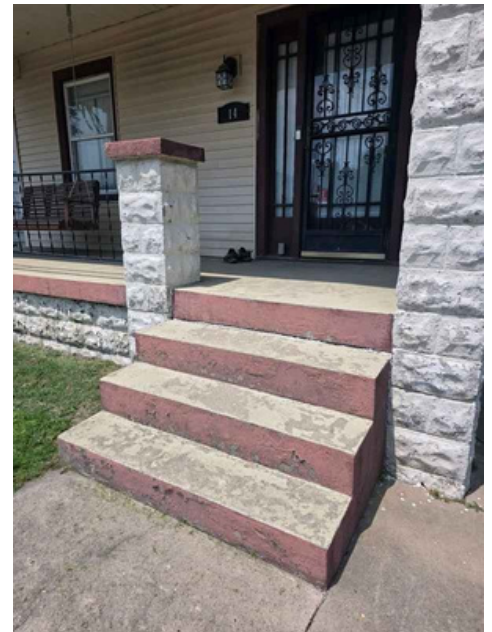
3.5.1 Stairs, Ramps, & Railings  
**HANDRAIL - MISSING OR DAMAGED**

Handrail on staircase was noted as missing damage t the time of inspection. Whenever four or more stair risers are present a handrail is required to be in place and in good condition for the safety of those using the stairs. Recommend further evaluation & correction by a quali ed contractor.

Recommendation  
 Contact a quali ed professional.

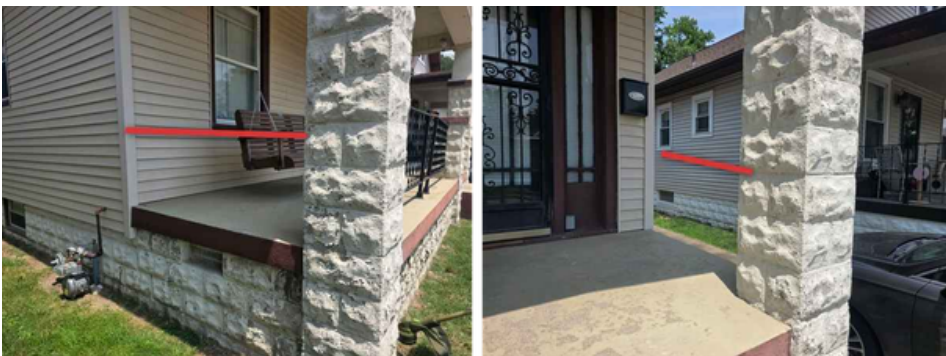
3.5.2 Stairs, Ramps, & Railings  
**GUARDRAIL - MISSING / DAMAGED**

Guardrail was noted as missing or damaged at the time of inspection. A guardrail should be placed at the side of any staircase or where there is a drop of 30" or more. Recommend further evaluation & correction by a quali ed contractor.

Recommendation  
 Contact a quali ed professional.

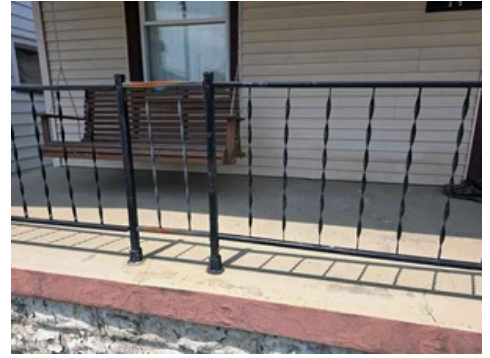
3.5.3 Stairs, Ramps, & Railings

**GUARDRAIL - LOOSE**

Guardrail was noted as loose at the time of inspection. Recommend further evaluation & correction by a qualified contractor.

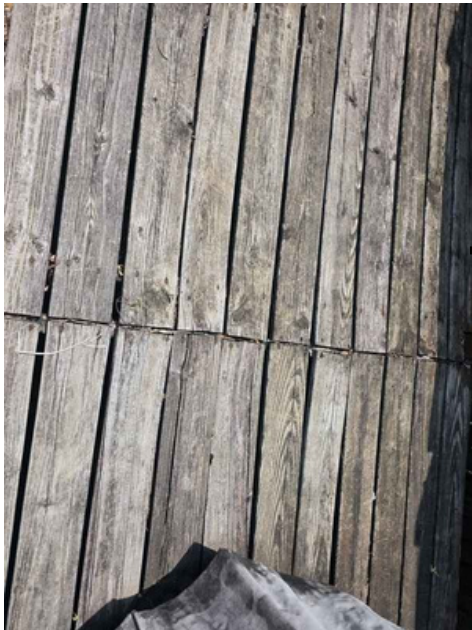
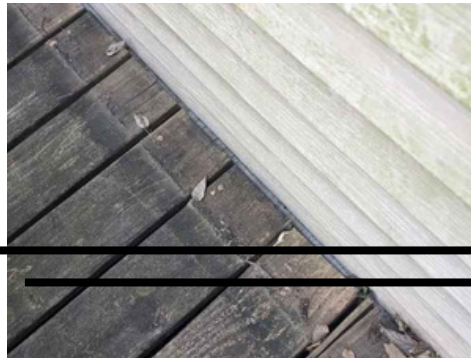
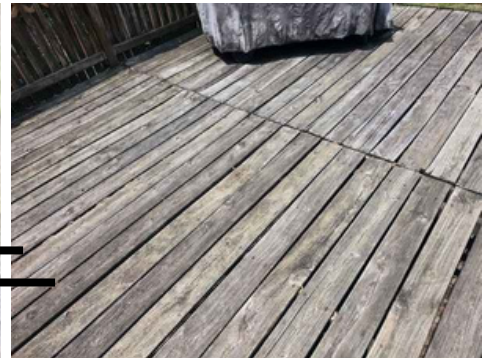
The deck was noted as appearing to be at or nearing the end of its service life at the time of inspection. More defects could be present & hidden by other conditions of the deck. Recommend further evaluation & correction by a qualified contractor.

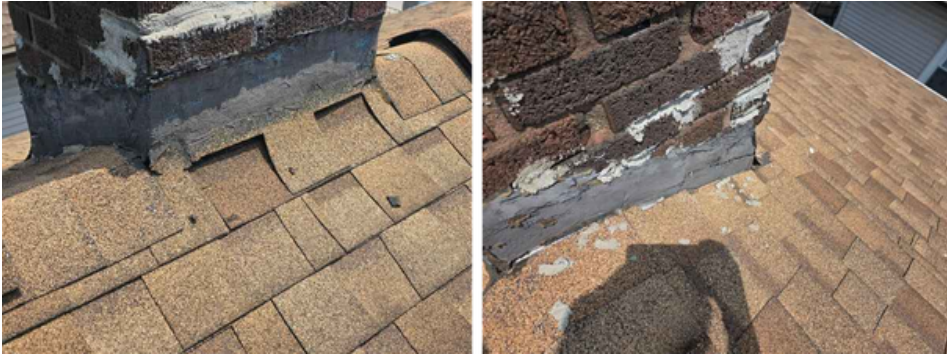
5.2.1 Flashings & Boots

**FLASHING(S) - MISSING / DAMAGED**

Roof flashing(s) were noted as missing or damaged at one or more locations at the time of the inspection. Recommend further evaluation & correction by a qualified contractor.

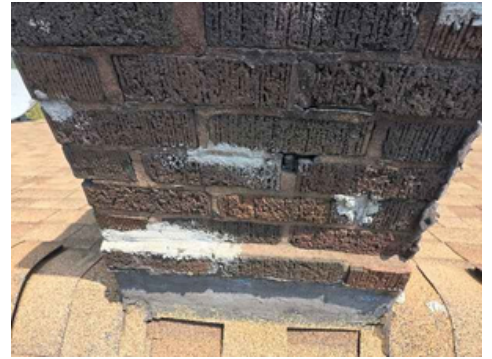
5.3.1 Chimneys & Vent Stacks

**CHIMNEY - SPALLING**

Spalling (Deterioration) of masonry and mortar joints noted at the time of the inspection. Recommend further evaluation & correction by a quali ed contractor.

Contact a quali ed chimney contractor.

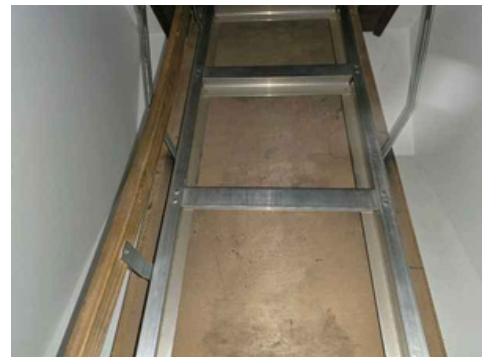
6.1.1 Attic Access

**ATTICACCESS - NOT INSULATED**

Attic access was noted as not insulated at the time of inspection. This can cause energy loss. Recommend further evaluation & correction by a quali ed contractor.

Contact a quali ed insulation contractor.

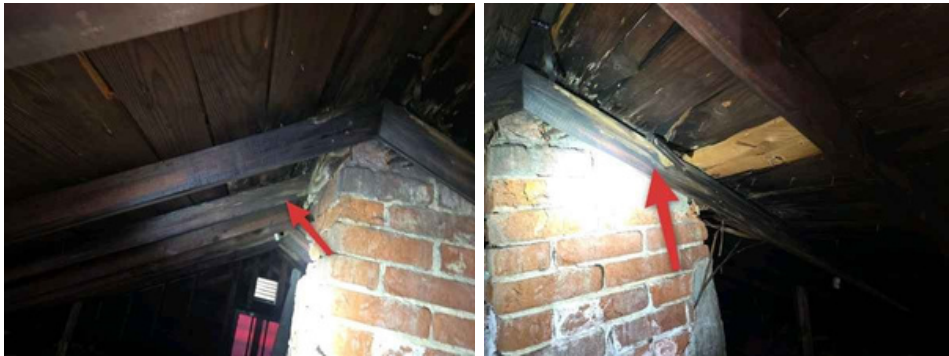
**RAFTERS - DAMAGED**

Damaged rafter(s) were noted in the attic at the time of inspection. Recommend further evaluation & correction by a quali ed contractor.

Contact a quali ed carpenter.

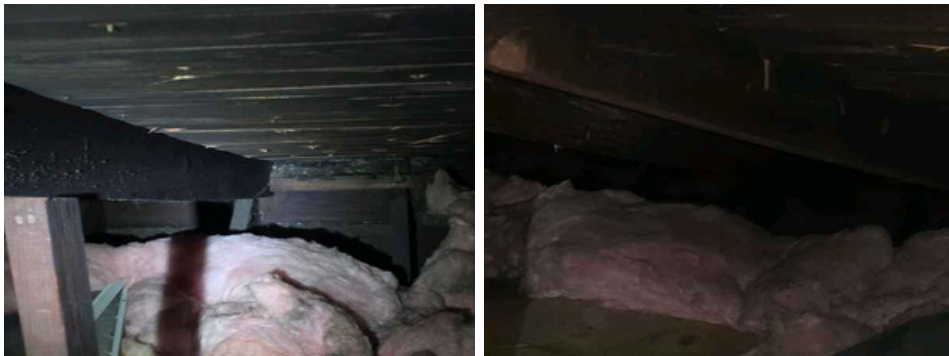
6.4.1 Insulation

**INSULATION - MISSING / OUT OF PLACE**

Attic insulation was noted as missing or out of place in some areas at the time of the inspection. This will result in energy loss. Recommend further evaluation & correction by a quali ed contractor.

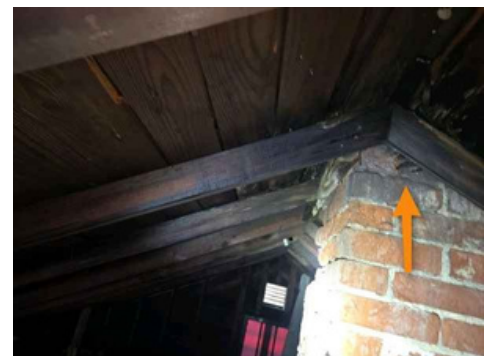
6.5.1 Evidence of Leaks

**LEAKS - ACTIVE**

Evidence of leaking was viewed and moisture was present at the time of inspection. Recommend further evaluation & correction by a quali ed contractor.

Contact a quali ed roo ng professional.

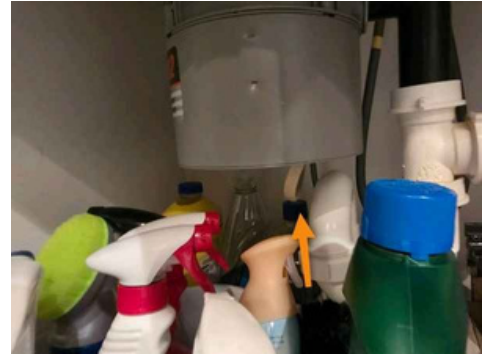
8.4.1 Branch Wiring

**WIRING - EXPOSED WIRING**

Unprotected electrical wiring was noted at one or more locations at the time of inspection. Wiring in storage or living areas should be protected in conduit to keep it from being damaged. Wiring on the exterior of home should be rated for exterior exposure or protected by exterior rated conduit. Recommend further evaluation & correction by a qualified contractor.

Contact a qualified electrical contractor.

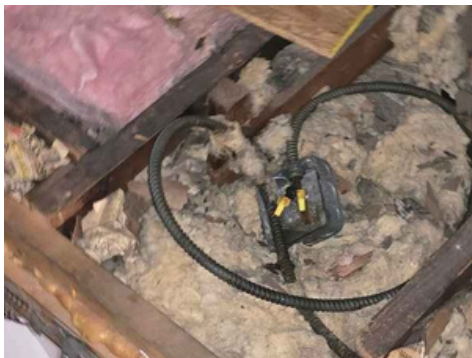
### 8.4.2 Branch Wiring

#### JUNCTIONBOX(ES) - MISSING OR DAMAGED COVERS

One or more missing or damaged covers were noted on junction boxes for electrical wiring at the time of inspection. Recommend further evaluation & correction by a qualified contractor.

Contact a qualified electrical contractor.

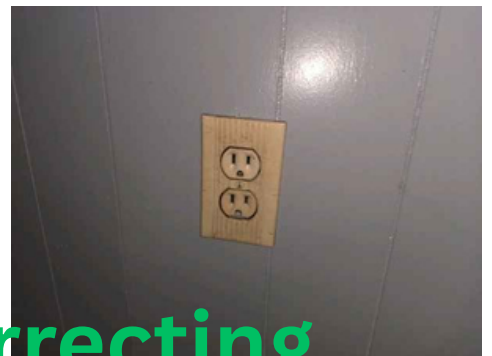
### 8.5.1 Outlets

#### OUTLET(S) - DAMAGED / WORN / OBSTRUCTED

One or more damaged, worn, obstructed outlet(s) were noted at the time of inspection. Damaged or worn outlets can result in arcing and a potential fire when an electronic device or appliance is plugged into the outlet, making this a safety hazard. Recommend further evaluation & correction by a qualified contractor. [Defect Explained](#)

Contact a qualified electrical contractor.

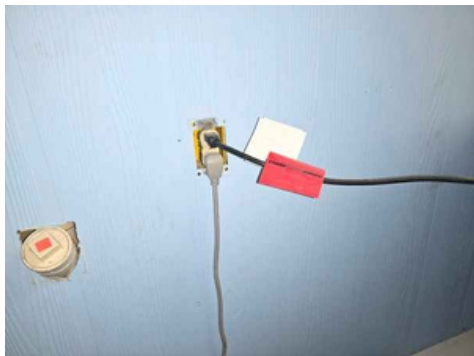
#### OUTLET(S) - MISSING OR DAMAGED COVER PLATE(S)

One or more outlet cover plates were noted as missing or damaged at the time of inspection. Outlet covers are intended to protect occupants from the live electrical wiring in the box. Recommend further evaluation & correction by a qualified contractor. [Defect Explained](#)

Contact a qualified electrical contractor.

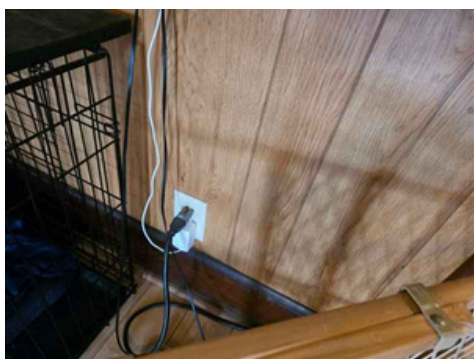
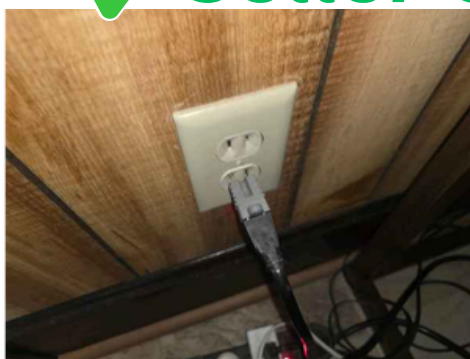
3 prong to 2 prong adapter noted to be in use at the time of inspection. A plug adapter or modified 3 prongs should never be used. Equipment made with three prongs require the 3rd prong for grounding purposes. Equipment requiring a ground should be plugged into an outlet that is properly wired with a ground connection. Recommend further evaluation & correction by a qualified contractor.

Recommendation  
Contact a qualified electrical contractor.

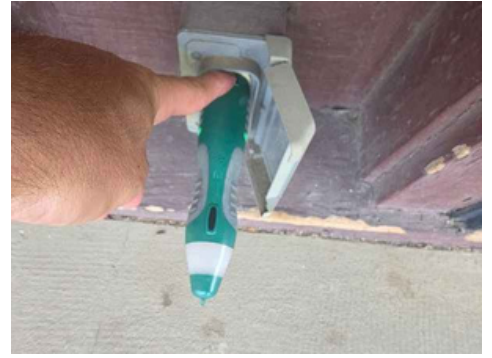
8.5.5 Outlet  
GFCIS - MISSING OR IMPROPERLY WIRED

Ground Fault Circuit Interrupter (GFCI) protected receptacles were noted as not installed or defective in some areas where they are required at the time of inspection. While GFCI protection may not have been required by code when the house was built, this is now considered a safety hazard. Recommend further evaluation & correction by a qualified contractor.

Contact a qualified electrical contractor.

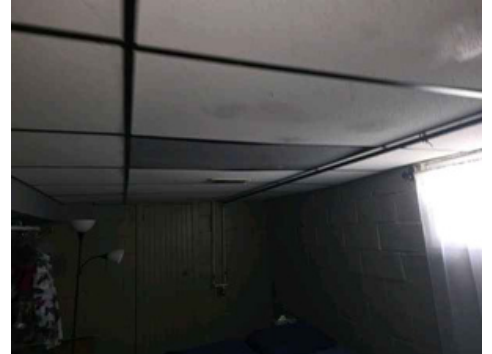
### 8.6.1 Light Fixtures, Switches & Fans LIGHT(S) - MISSING / INOPERABLE

Lights were noted as missing or inoperable at one or more locations at the time of inspection. It is possible that the bulbs are blown or missing, the inspector does not verify this thus cannot verify if it is the bulb or the fixture that is the issue. Recommend further evaluation & correction by a qualified contractor.

Contact a qualified electrical contractor.

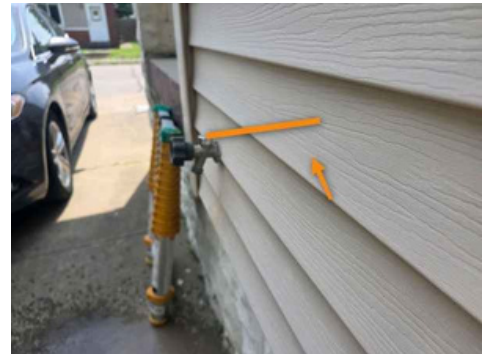
### 9.3.1 Hose Bibs / Spigots SPIGOT - IMPROPERLY INSTALLED

One or more hose spigots were noted as being improperly installed, such as sideways, reverse sloped, etc. at the time of the inspection. Recommend further evaluation & correction by a qualified contractor.

Back of spigot in wall should be flush than front.

Contact a qualified plumbing contractor.

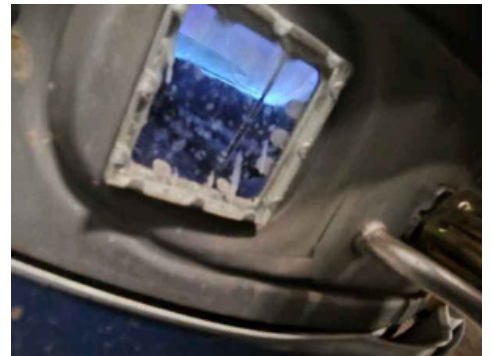
### 9.4.1 Water Heater MISSING GLASS - DAMAGED/MISSING

Missing or broken viewing (sight) glass on a gas water heater can cause improper combustion, potential flame rollout, and pilot light failure. Recommend further evaluation and proper repair by a qualified professional.

Contact a qualified professional.

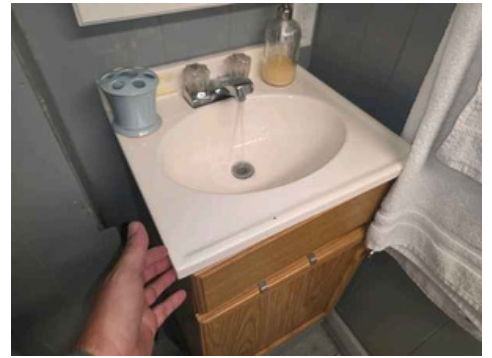
## 11.2.1 Cabinets &amp; Counters

**COUNTER(S) - IMPROPERLY MOUNTED**

Counter(s) were noted as being improperly mounted at the time of inspection. Recommend further evaluation & correction by a qualified contractor.

Contact a qualified cabinet contractor.

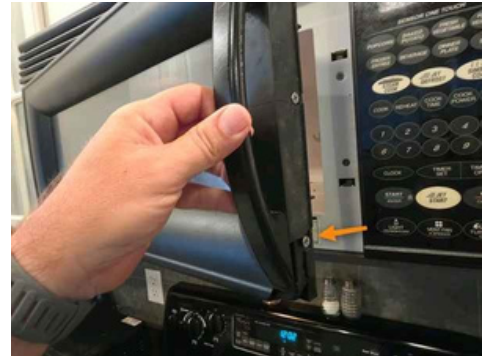
## 12.4.1 Built-in Microwave

**MICROWAVE - MISSING / DAMAGED PARTS**

One or more parts on the microwave were noted as missing or damaged at the time of the inspection. This could be parts such as the control display, door gasket, handle, etc. Recommend further evaluation & correction by a qualified contractor.

Contact a qualified appliance repair professional.

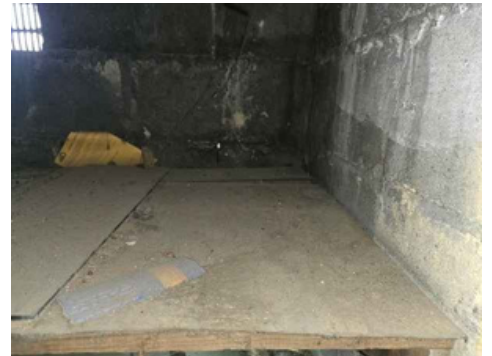
## 14.3.2 Walls, Beams, &amp; Columns

**FOUNDATION WALL(S) - GAPS TO EXTERIOR**

Unsealed gaps to the exterior were noted at the time of inspection. These gaps should be properly filled to prevent moisture and pest intrusion. Recommend further evaluation & correction by a qualified contractor.

Contact a qualified professional.

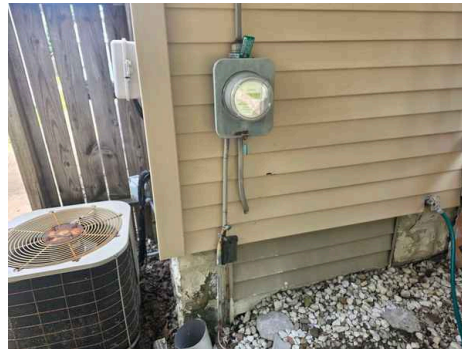
Overhead

Location and type of service entry for electricity to the structure.

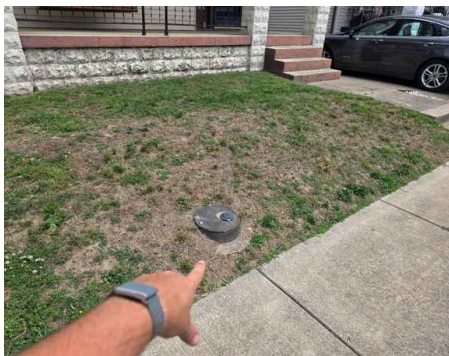
### Water Meter / Well Head Location

Public

Listed here is the source and location of the water meter or well head if known and located at the time of inspection.

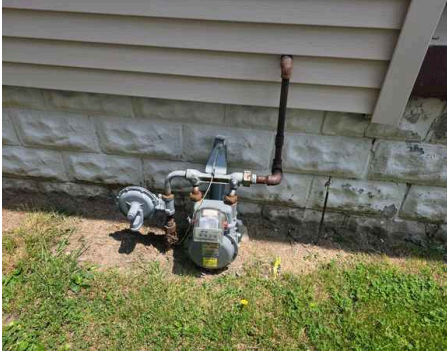
### Natural Gas

The type of fuel systems and the location of the meter and tank if located. Some systems may have underground tanks, these tanks are outside the scope of a home inspection.

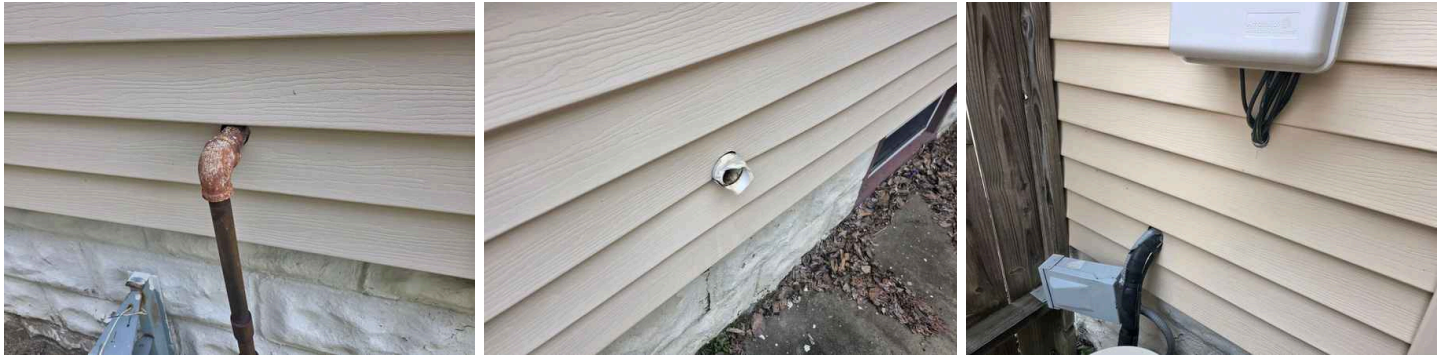
2.1.2 Siding

Unsealed penetrations were noted at one or more locations at the time of inspection. Openings, spray foam, or other forms of unsealed penetrations leaves the structure below exposed to potential damage & pest intrusion. Recommend further evaluation & correction by a qualified contractor. [Defect Explained](#)

Contact a qualified professional.

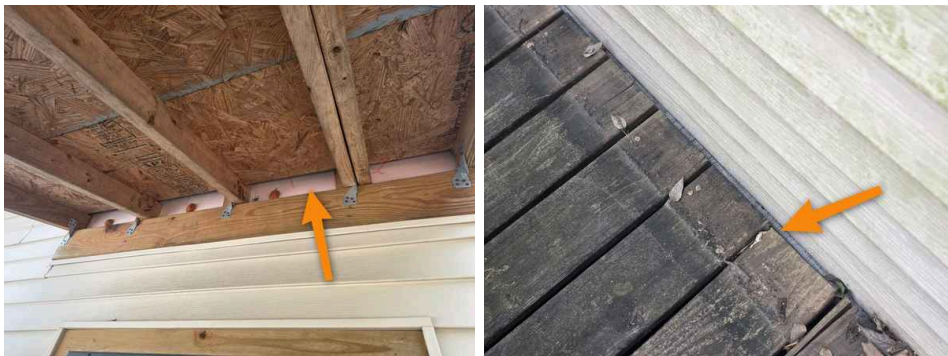
### 2.1.3 Siding

#### **SIDING - IMPROPER OVERLAP / GAPS / INSTALLATION**

Siding was noted as improperly overlaps at the time of inspection. This can include gaps, improper offsets, missing channel around openings, etc., & can lead to potential moisture or pest intrusion. Recommend further evaluation & correction by qualified professional.

Contact a qualified siding specialist.

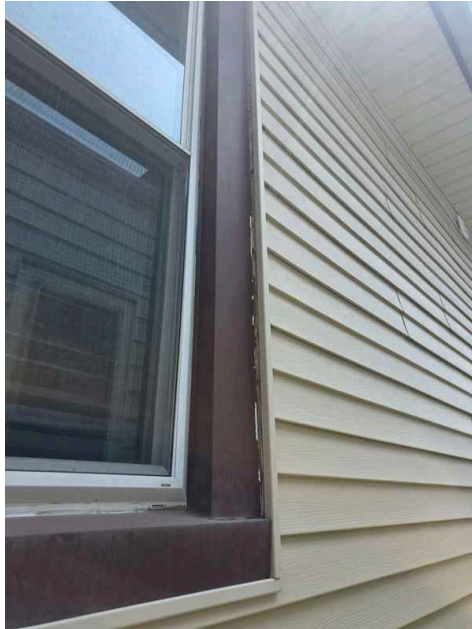
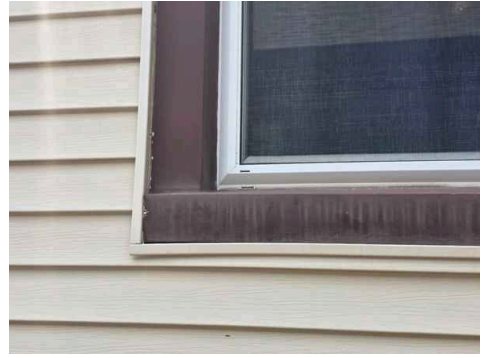
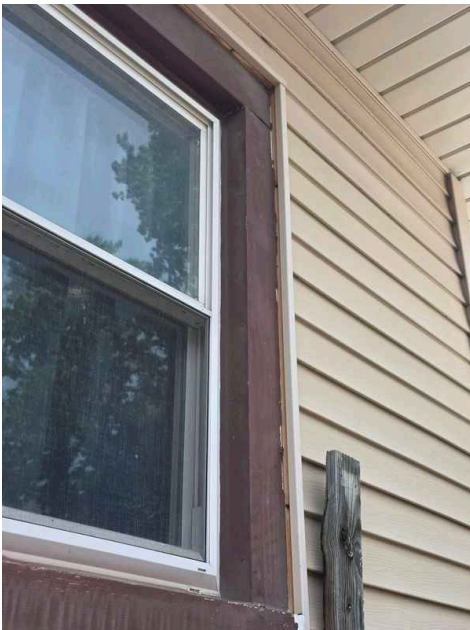
### 2.2.1 Fascia, Soffit, Trim, & Columns

#### **TRIM - MAINTENANCE NEEDED**

Regular maintenance is required to keep property in good condition, which includes but is not limited to cleaning, caulking, sealing & painting. Recommend surfaces be washed & properly cleaned, gaps or holes be filled, & exposed surfaces, weathering, or peeling paint properly prepped & sealed or repainted as needed.

Contact a qualified professional.

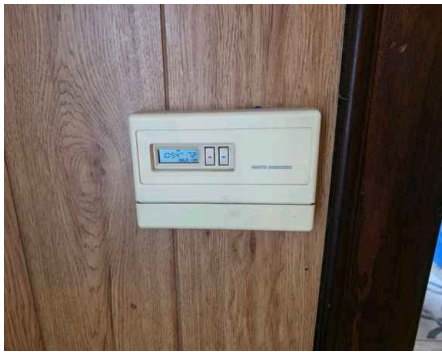
**Thermostats: Location**  
Dining Room

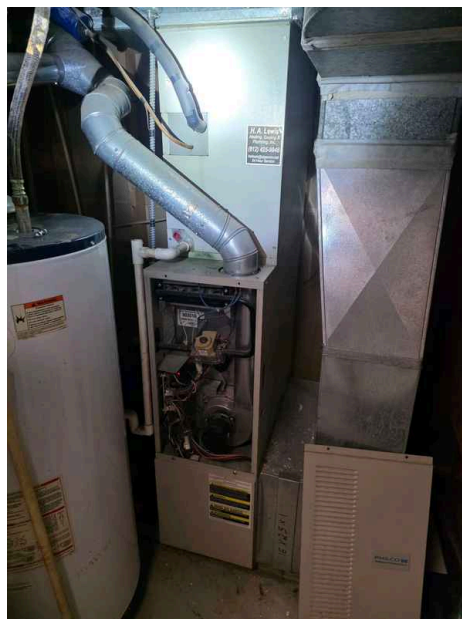
**Heating Unit: Location**  
Basement

**Heating Unit: Manufacturer**  
Philco

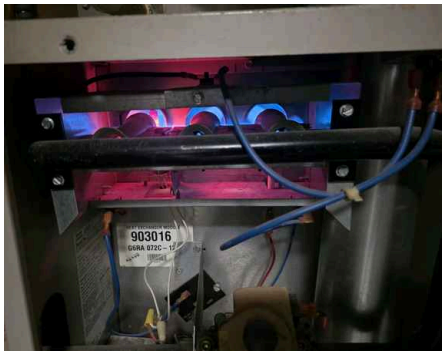
Appliance in operation

Gas Furnace

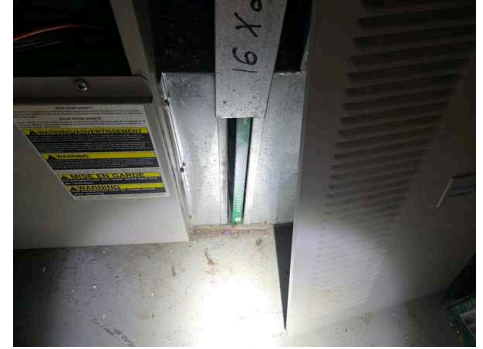
**Heating Unit: Filter Location**  
Next to Unit

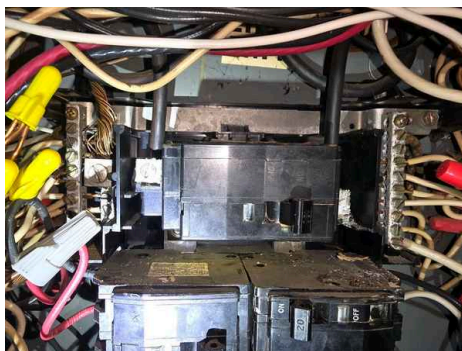
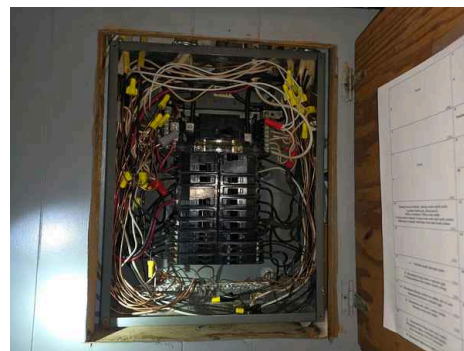
**Main Distribution Panel(s): Panel Capacity**  
100 AMP

**Main Distribution Panel(s): Manufacturer**  
Square D

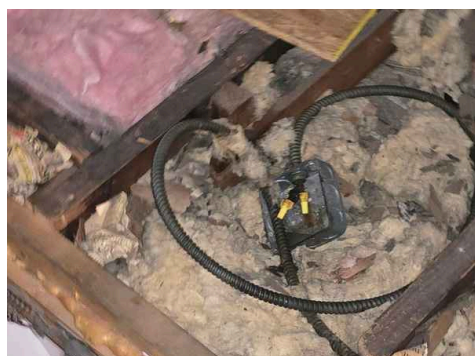
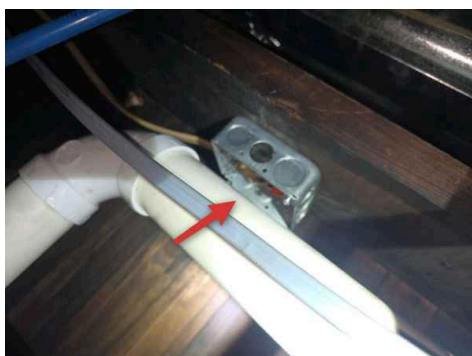
8.4.2 Branch Wiring

### JUNCTION BOX(ES) - MISSING OR DAMAGED COVERS

One or more missing or damaged covers were noted on junction boxes for electrical wiring at the time of inspection. Recommend further evaluation & correction by a qualified contractor.

Contact a qualified electrical contractor.

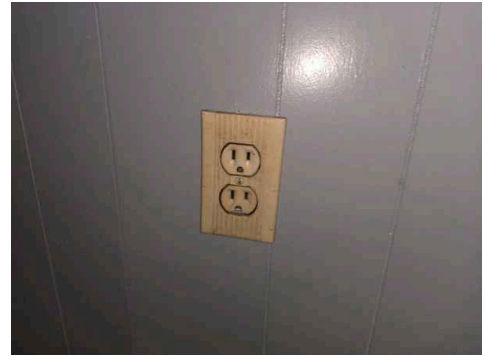
## 8.5.1 Outlets

Structural / Safety Hazard
**OUTLET(S) - DAMAGED / WORN / OBSTRUCTED**

One or more damaged, worn, obstructed outlet(s) were noted at the time of inspection. Damaged or worn outlets can result in arcing and a potential fire when an electronic device or appliance is plugged into the outlet, making this a safety hazard. Recommend further evaluation & correction by a qualified contractor. [Defect Explained](#)

Contact a qualified electrical contractor.

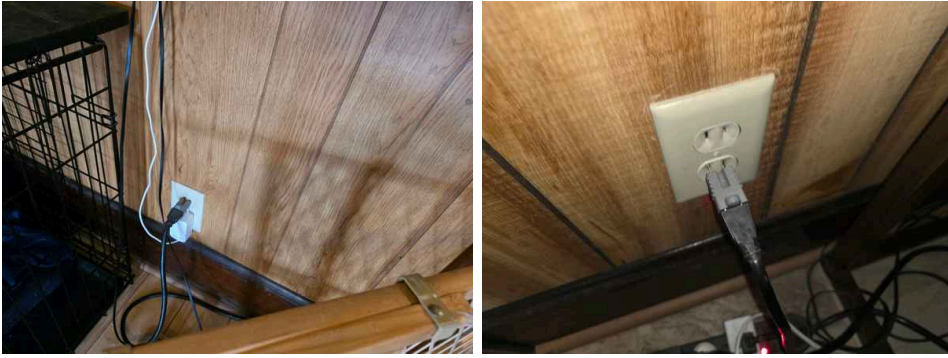
Deficiencies
**OUTLET(S) - 3 PRONG ADAPTER(S)**

3 prong to 2 prong adapter noted to be in use at the time of inspection. A plug adapter or modified 3 prongs should never be used. Equipment made with three prongs require the 3rd prong for grounding purposes. Equipment requiring a ground should be plugged into an outlet that is properly wired with a ground connection. Recommend further evaluation & correction by a qualified contractor.

Contact a qualified electrical contractor.

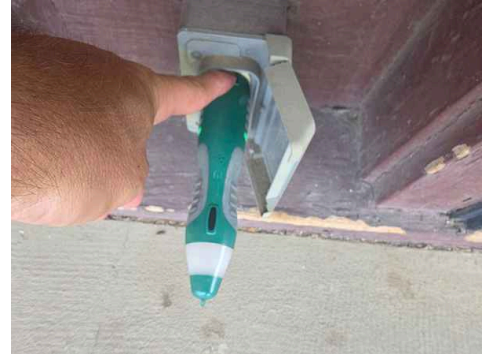
### 8.5.5 Outlets

#### **GFCIS - MISSING OR IMPROPERLY WIRED**

Ground Fault Circuit Interrupter (GFCI) protected receptacles were noted as not installed or defective in some areas where they are required at the time of inspection. While GFCI protection may not have been required by code when the house was built, this is now considered a safety hazard. Recommend further evaluation & correction by a qualified contractor.

Contact a qualified electrical contractor.

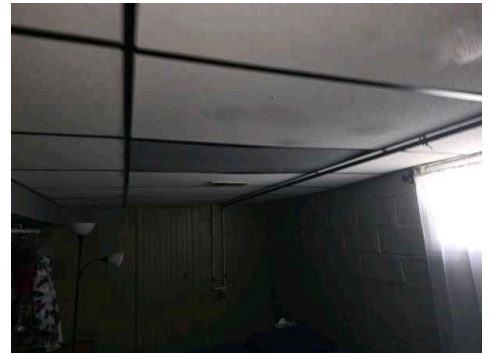
### 8.6.1 Light Fixtures, Switches & Fans

#### **LIGHT(S) - MISSING / INOPERABLE**

Lights were noted as missing or inoperable at one or more locations at the time of inspection. It is possible that the bulbs are blown or missing, the inspector does not verify this thus cannot verify if it is the bulb or the fixture that is the issue. Recommend further evaluation & correction by a qualified contractor.

Contact a qualified electrical contractor.

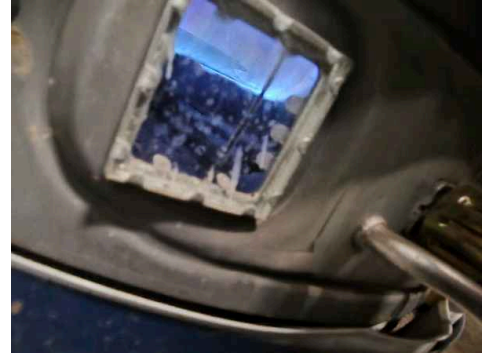
**MISSING GLASS -  
DAMAGED/MISSING**

Missing or broken viewing (sight) glass on a gas water heater can cause improper combustion, potential flame rollout, and pilot light failure. Recommend further evaluation and proper repair by a qualified professional.

Contact a qualified professional.

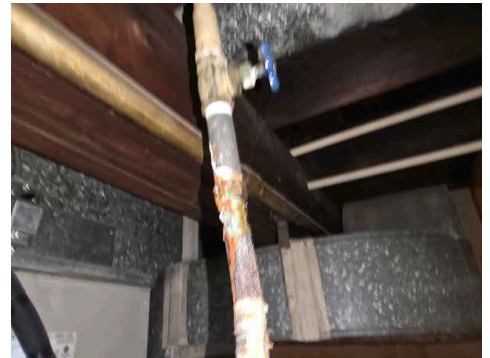
## 9.5.1 Supply Lines

**LINE(S) - CORROSION  
VIEWED**

Corrosion was noted on supply line(s) at the time of the inspection. No leaks found at the time of inspection. Recommend monitoring.

Recommend monitoring.

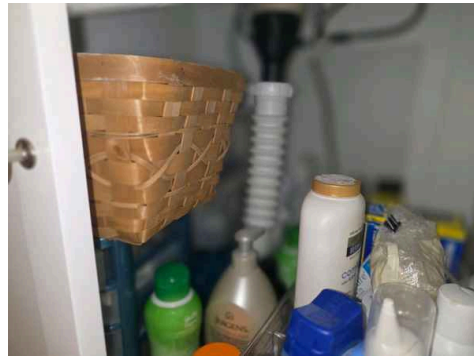
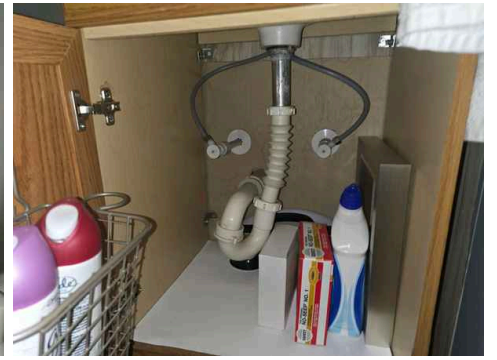
### 11.3.1 Sinks

#### DRAIN LINE(S) - FLEX LINE

Contact a qualified plumbing contractor.

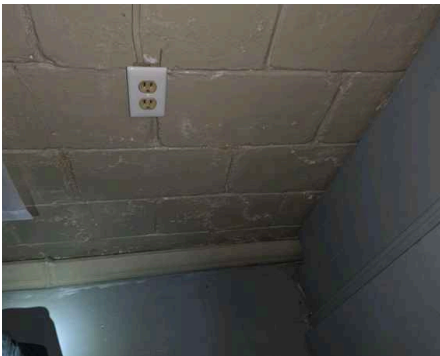
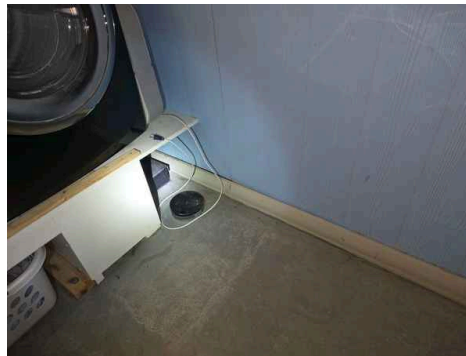
### Foundation: Interior Drainage System

The foundation appears to have had an interior drainage system added at some point. This system is there to help remove water from foundation.

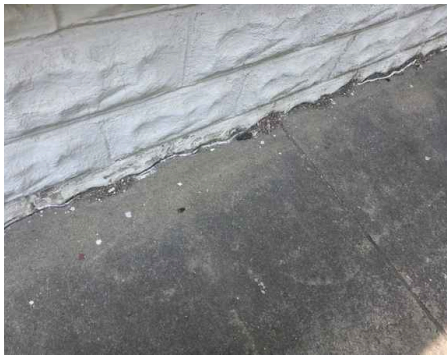
### **Pest Activity: Treatment Mark(s)**

Suspected treatment marks noted on sections of patios, walkways, or foundations. Recommend inquiring with sellers about previous treatments and obtaining paperwork if possible.

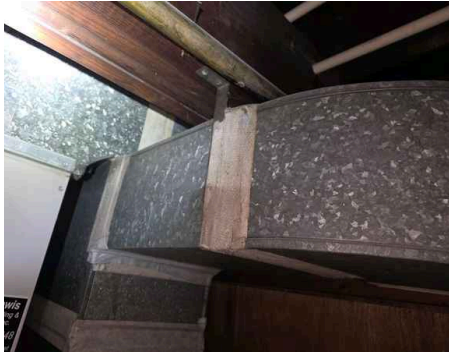
Suspected asbestos noted. Asbestos was widely used prior to the 1980s and is commonly found in older structures. Please note determining the existence of environmental hazards like asbestos is beyond the scope of this inspection.

You may want to obtain further evaluation by a licensed asbestos abatement contractor or have the suspected asbestos sealed by a professional. RHI can perform testing to confirm the presence of asbestos for an additional charge.

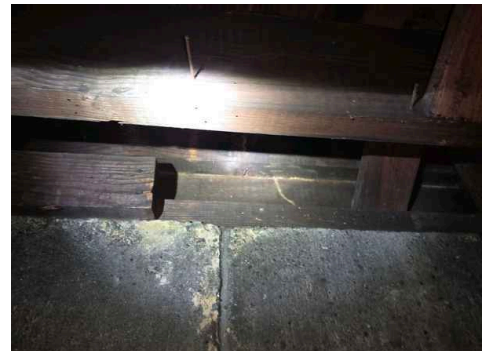
### EXTENT OF DAMAGE

Inspector is unable to determine extent of any damage caused by pest activity in and around the home. Recommend further evaluation & correction by a qualified contractor.
