YOUR INSPECTION REPORT

1750 4550 N
Buhl, ID 83316

Triple A Realty LLC
APRIL 29, 2026

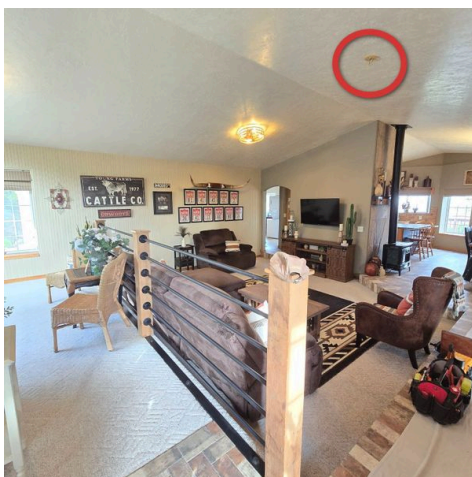
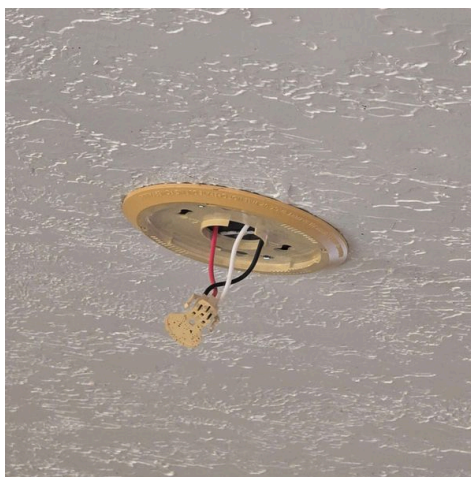
Living Room Example

REMOVED DEVICE, OR MISSING BATTERIES

One or more *Smoke Detectors* have been intentionally removed or are missing batteries.

Close Up View Example

I recommend functional smoke detectors be present and test confirmed at *all currently required locations prior to occupancy*. If you don't know when the batteries were last changed, change them now. If the device is 10 years old or more, replace it.

Contact a qualified professional.

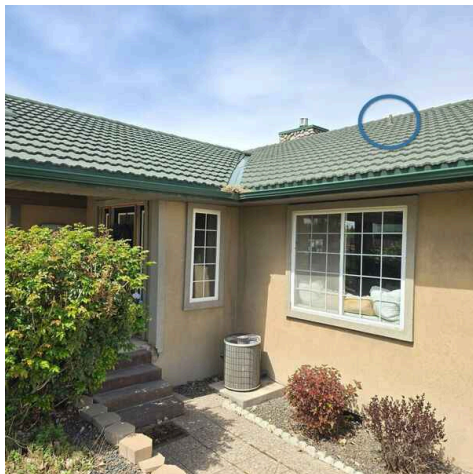
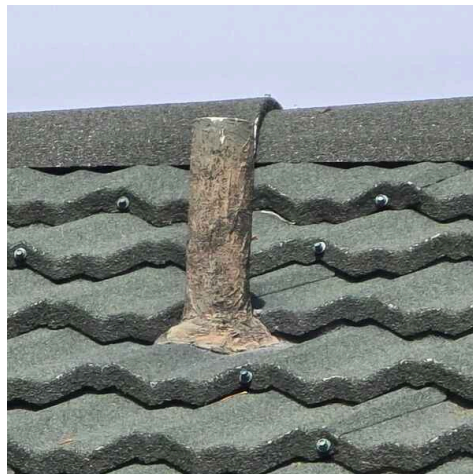
Location Example

Properly installed flashings in good condition require little, if any sealant to perform.

This does not mean they *will leak* but these types of applications require regular inspection and maintenance and may still not perform well. I recommend consulting with a roofing contractor.

Close Up View Example

Recommend monitoring.

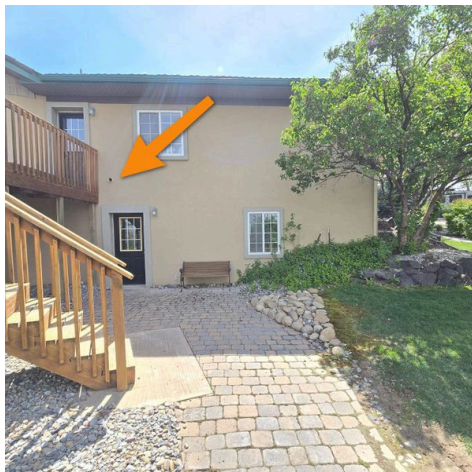
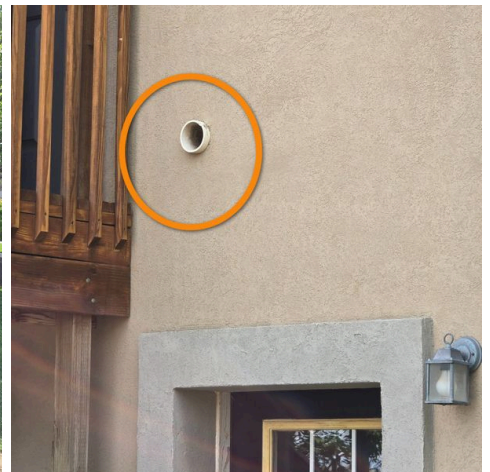
Dryer Vent

MISSING OR DAMAGED EXTERIOR VENT TERMINATION

Missing or damaged exterior termination devices at noted location(s).
System may not function properly, or this may allow water or pest intrusion.
Recommend correction.
See pictures, location tags & comments for more information.

Contact a qualified HVAC professional.

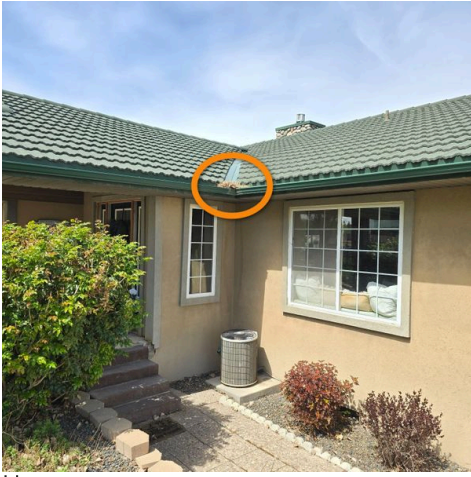
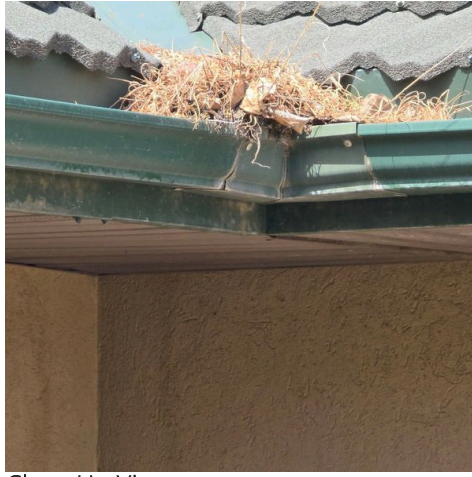
Here

Close Up View

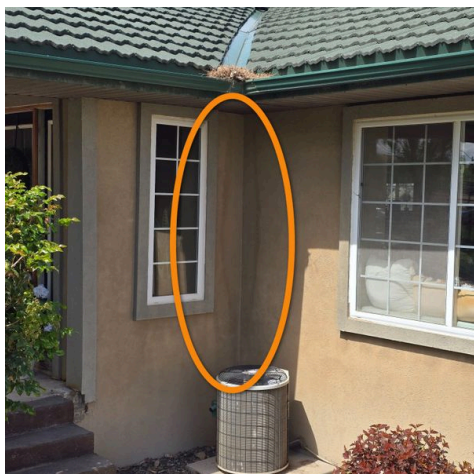
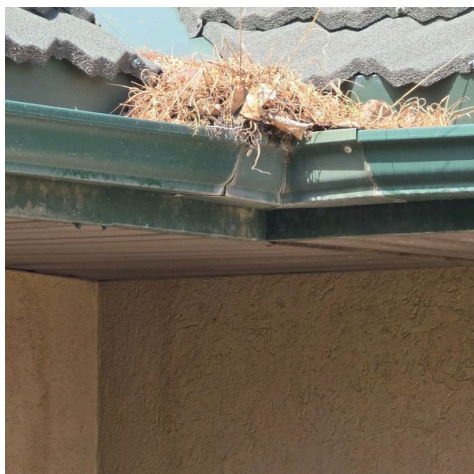
Here

6.4.1 Siding, Flashing & Trim

It is possible, even likely, the debris in the rain gutter caused water to back up into the soffit

Contact a qualified professional.

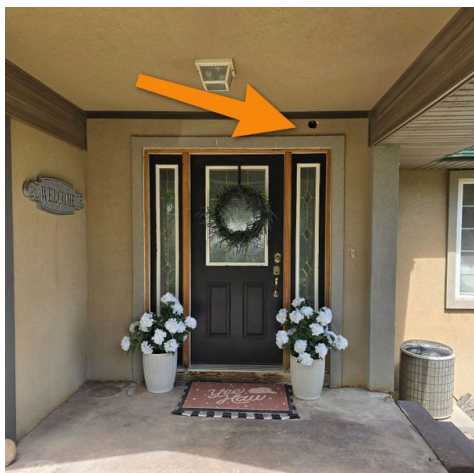
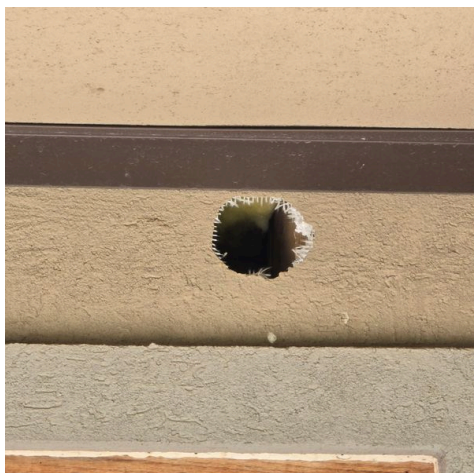
Here

6.4.2 Siding, Flashing & Trim

Close Up View

Contact a qualified professional.

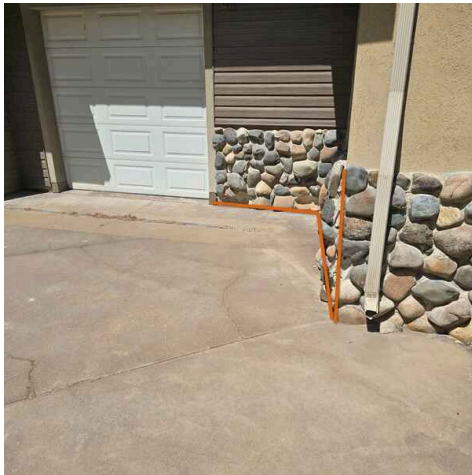
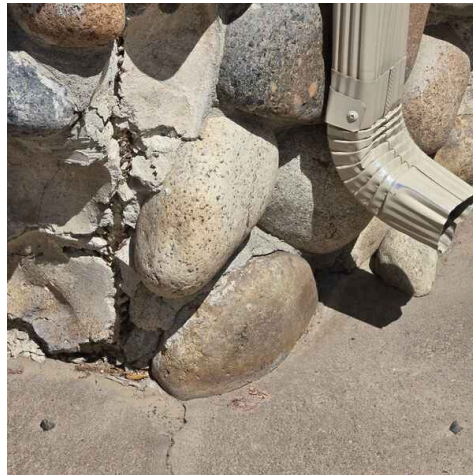
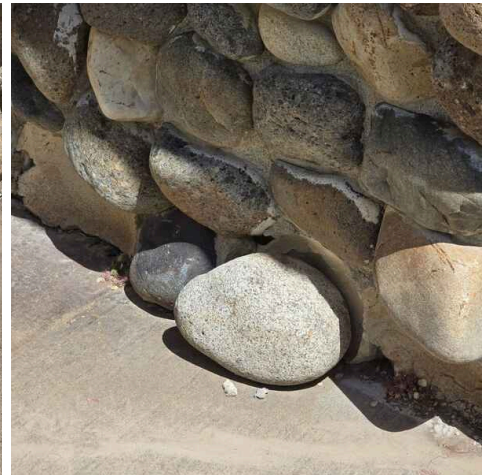
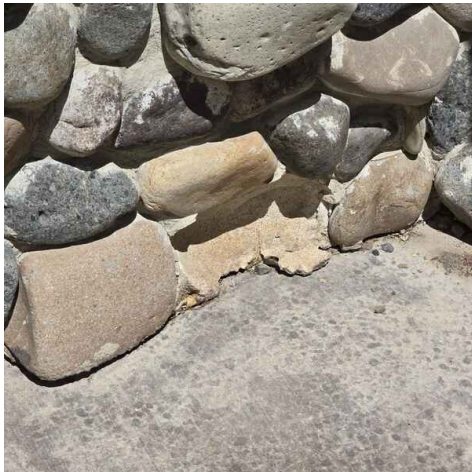
6.4.3 Siding, Flashing & Trim

Storm water from the gutter system is likely the influence.

A Closer Look: Cracking and stone delamination

Contact a qualified professional.

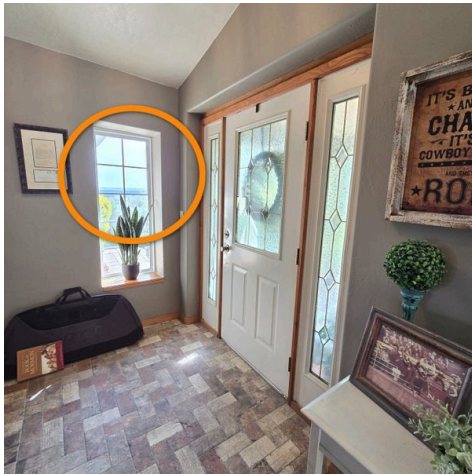
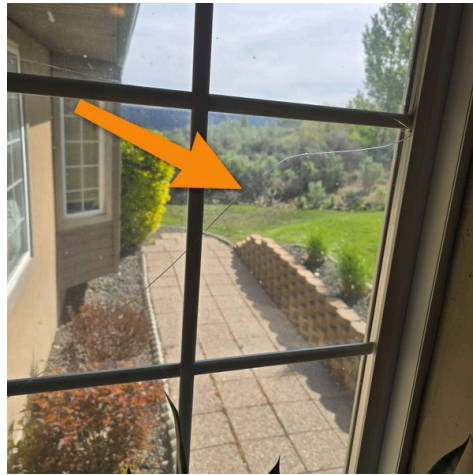
Here

6.5.1 Windows (Exterior)

Close Up View

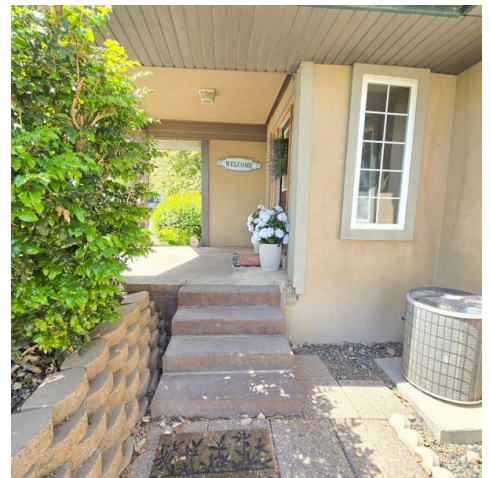
6.7.1 Attached Structures, Stairs and Railings

4 Risers Present, a handrail is recommended

Contact a qualified professional.

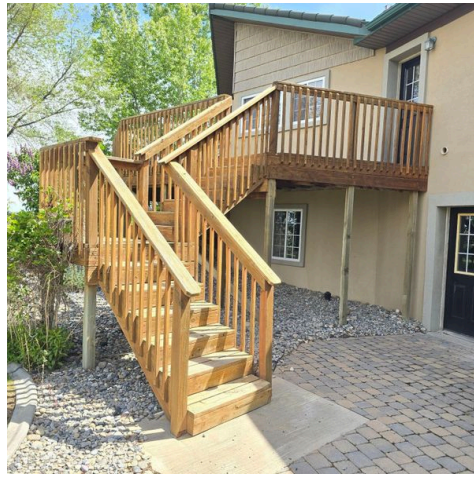
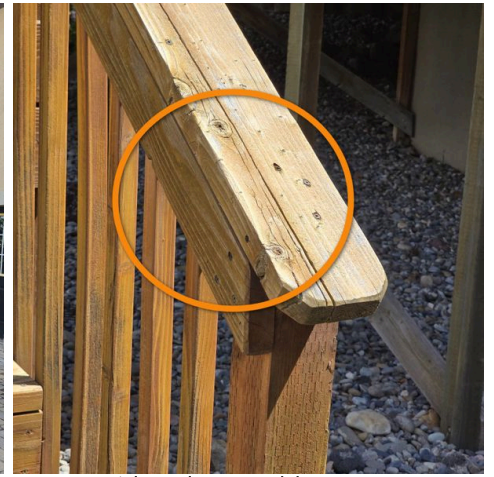
Here

6.7.2 Attached Structures, Stairs and Railings

Not considered graspable

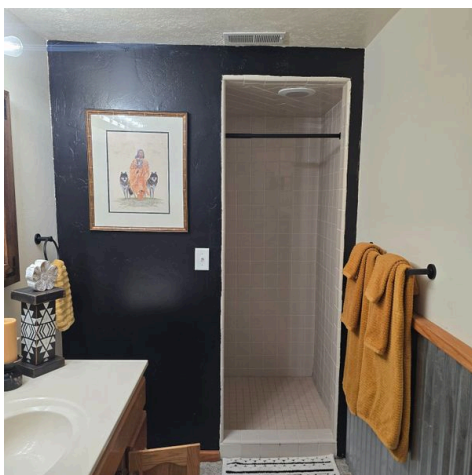
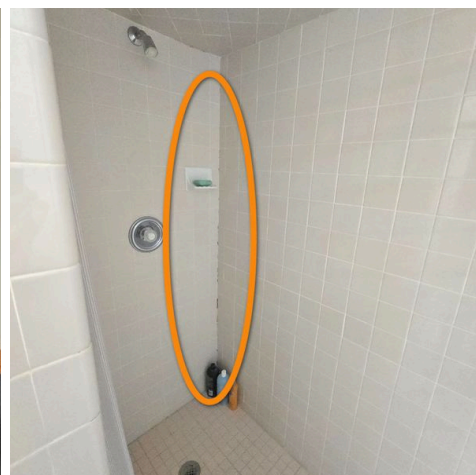
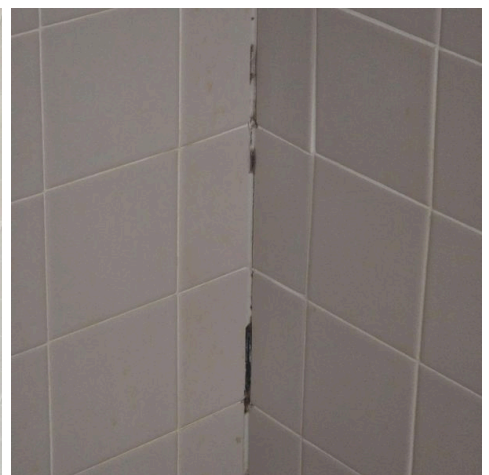
Basement Bathroom

7.4.1 Walls

Close Up View Example

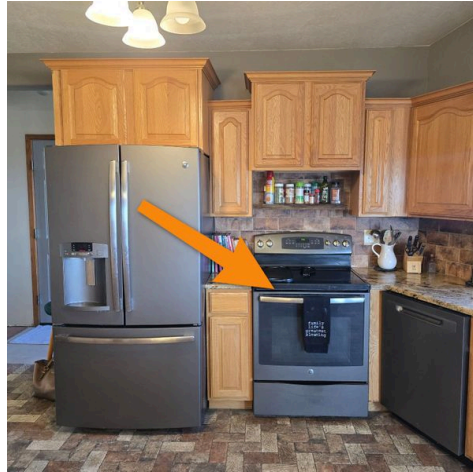
No Anti-Tip Bracket Installed

Contact a qualified professional.

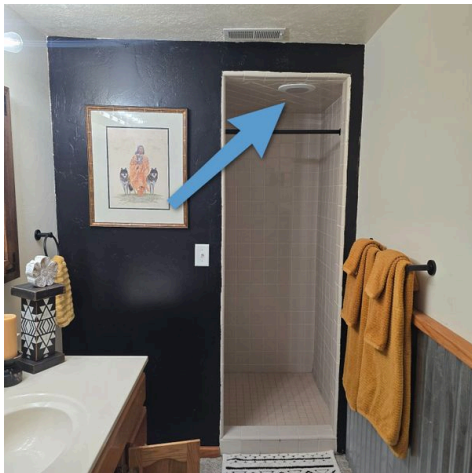
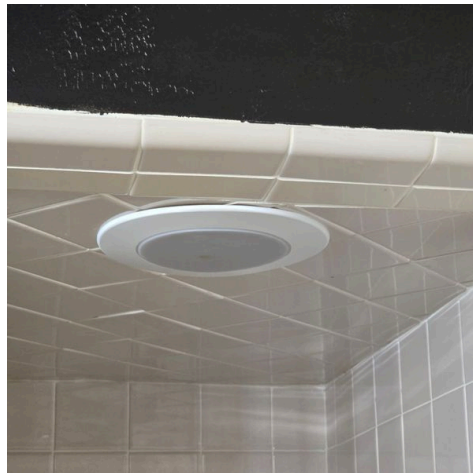
Basement Bathroom

A Closer Look

Contact the seller for more info

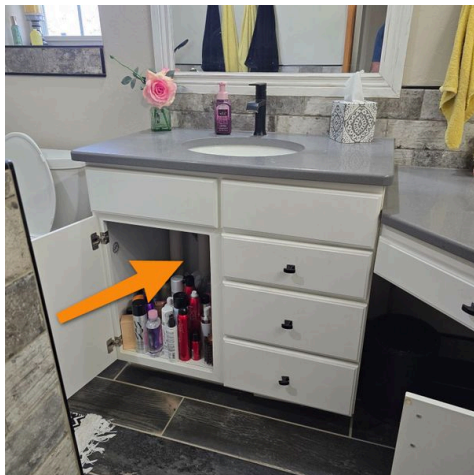
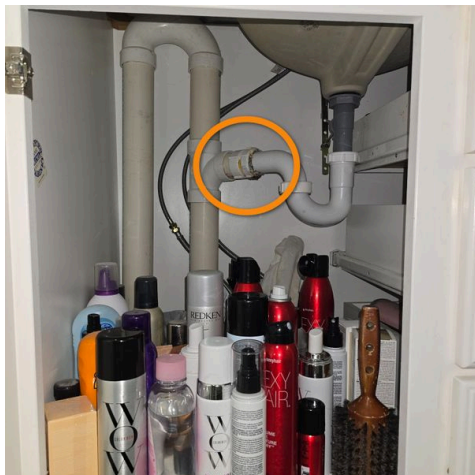
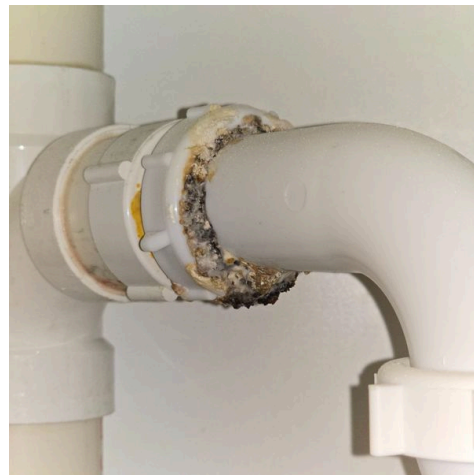
Main Floor Primary Bathroom

10.2.1 Drain, Waste, & Vent Systems

A Closer Look

Close Up View

Contact a qualified plumbing contractor.

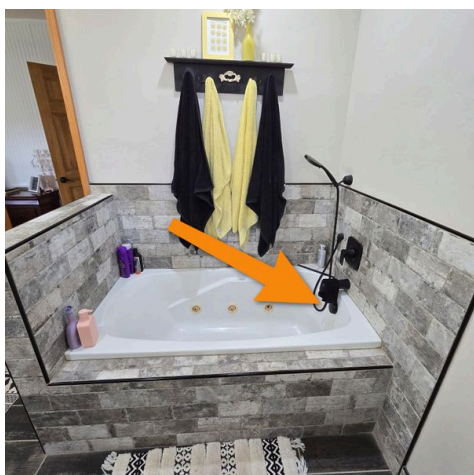
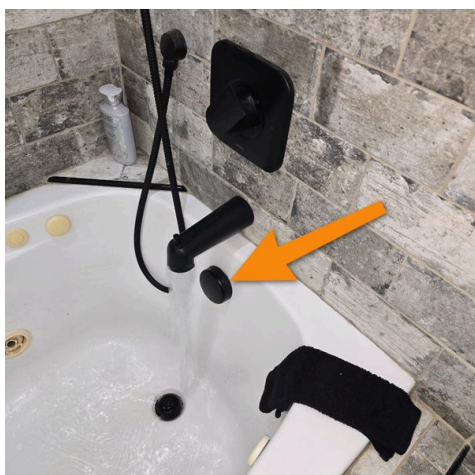
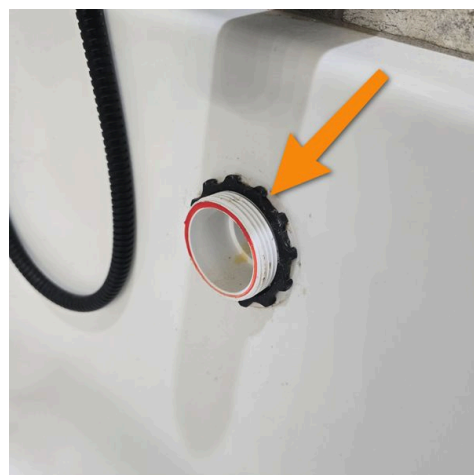
Here

10.2.2 Drain, Waste, & Vent Systems

Compression Nut Cracked

Compression Nut Cracked: Overflow Seal Jeopardized

Contact a qualified plumbing contractor.

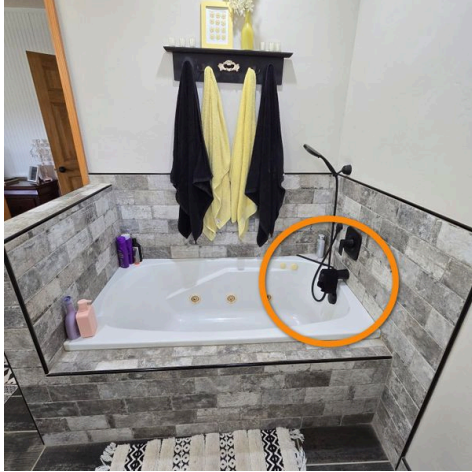
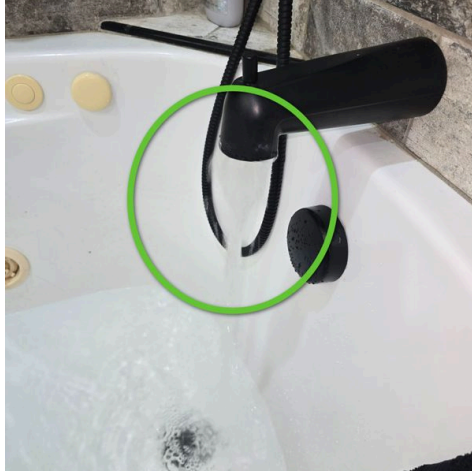
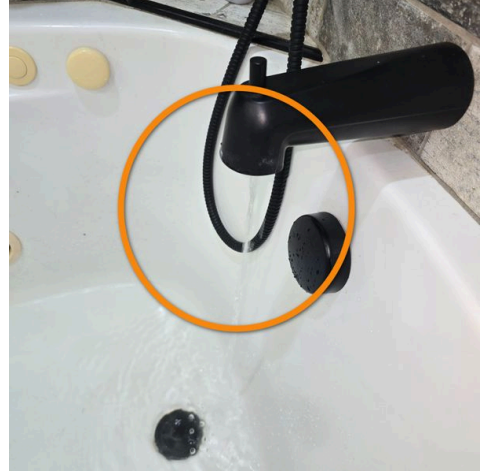
Test Location

10.6.1 Well System

Normal Water Flow Initially

Water Flow almost completely stops before well kicks in

Contact a qualified well service contractor.

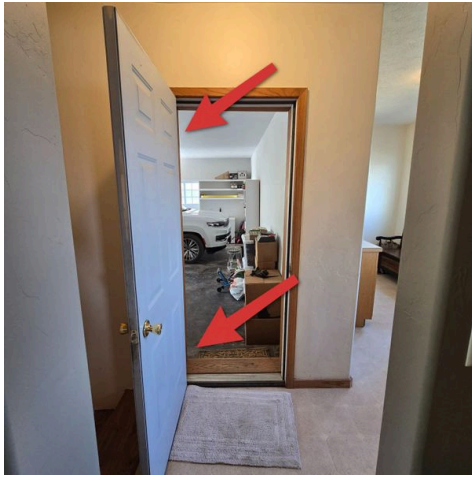
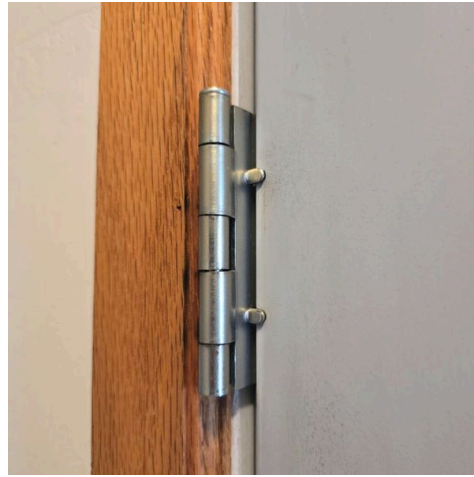
No Self-Closing Hinges Present

Close Up View Example

Contact a handyman or DIY project
