SUMMARY

11051KahreCt, Evansville, IN 47710
Pat Johns
06/29/2026

Brandon Riecken
F253527
RHI Home Inspections
8127740804
o ce@yourrhi.com

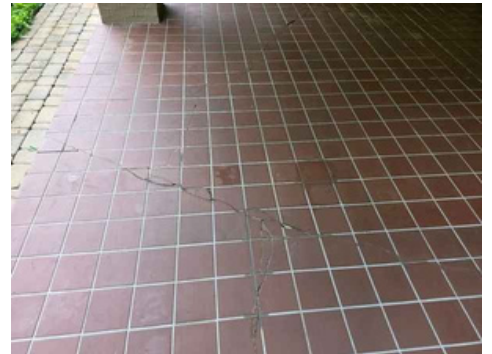
3.1.1 Driveways, Walkways & Patios PATIO(S) - CRACKING

Larger cracks were noted on the patio at the time of inspection. While some cracking is typical on almost every patio, the cracking present was of a size/con guration that would indicate some portions of the patio have settled or been damaged. Recommend further evaluation & correction by a quali ed contractor.

Recommendation
Contact a quali ed concrete contractor.

As Is

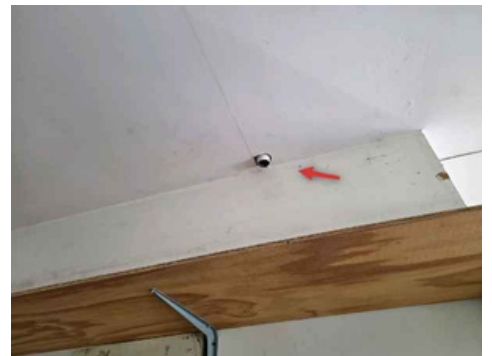
4.1.2 Walls, Ceiling, & Firewalls CEILING(S) - BREACHINFIRE BARRIER

Openings or gaps were noted in the ceilings between the garage and living space at the time of inspection. This creates a safety concern due to the lack of complete re protection. Recommend further evaluation & correction by a quali ed contractor. [Defect Explained](#)

Recommendation
Contact a quali ed professional.

✓ Seller Correcting

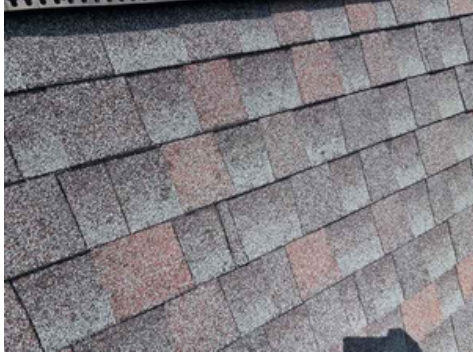
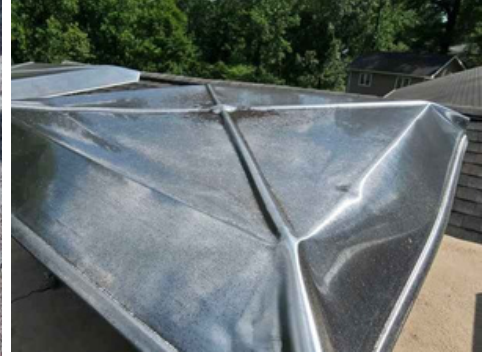
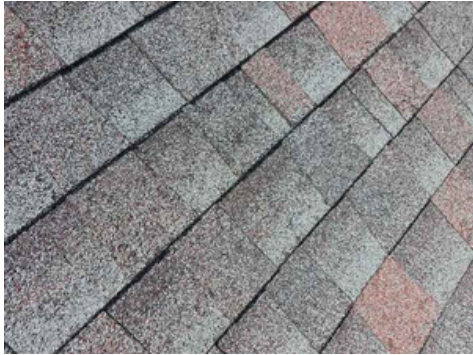
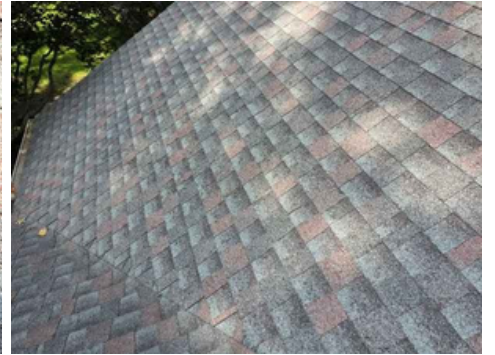
5.1.2 Roof Coverings SHINGLES - HAIL DAMAGE

Roof inspected by 3 roofers (The Way, Chapman, & Boss). New roof not needed - See Attached statement from The Way.

Shingles were noted as having potential hail damage in one or more locations at the time of inspection. Recommend further evaluation & correction by a quali ed contractor.

Recommendation
Contact a qualified roofing professional.

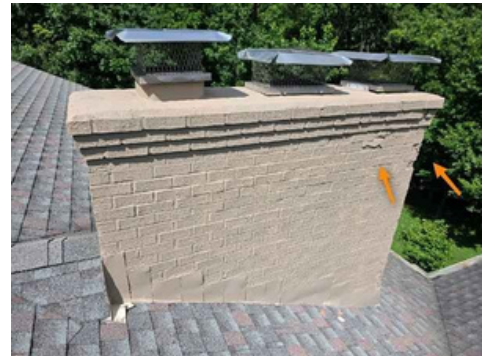
5.3.1 Chimneys & Vent Stacks
CHIMNEY - SPALLING

Spalling (Deterioration) of masonry and mortar joints noted at the time of the inspection. Recommend further evaluation & correction by a qualified contractor.

Recommendation
Contact a qualified chimney contractor.

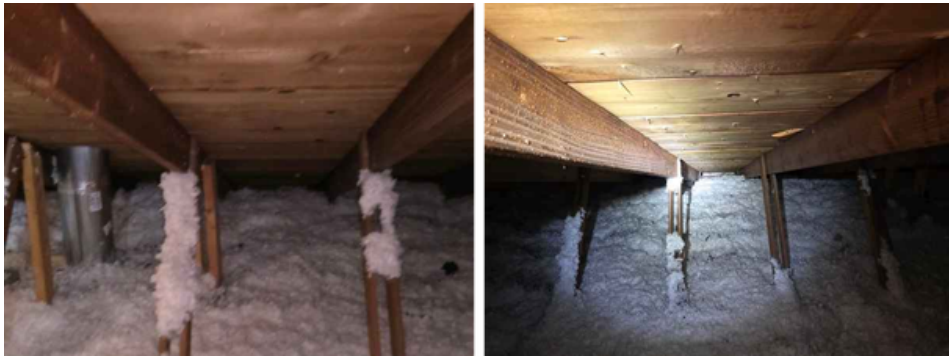
6.3.1 Ventilation
ATTIC VENT(S) - MISSING / OUT OF PLACE BAFFLES

So t vent ba es were noted as missing or out of place at the time of inspection. This condition can cause drafting of insulation or allow insulation to su ocate so t vents. Recommend further evaluation & correction by a qualified contractor.

Recommendation
Contact a qualified professional.

✓ Seller Correcting

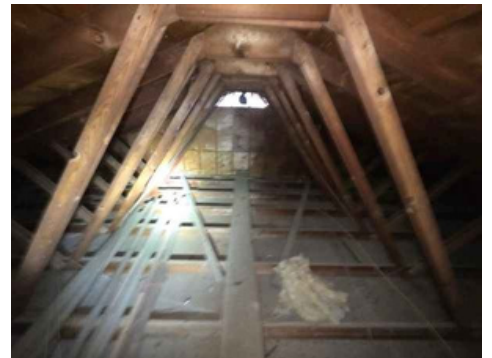
6.3.2 Ventilation

ATTICVENT(S) - RIDGE VENTS & GABLE VENTS

Ridge vents and gable vents were noted in the attic at the time of inspection. Too many exhaust vents work against each other. In situations where ridge vents and gable vents are used in combination, we see the gable vents act as the so t vents would: drawing in the air, which moves up and out through the ridge vent. This creates a layer of stagnant air near the attic oor that allows moisture and heat to combine. This layer of air traps heat in the living space as well as trapping moisture that condenses in the cooler winter months. Recommend further evaluation & correction by a quali ed contractor.

Contact a quali ed professional.

✓ Seller Correcting

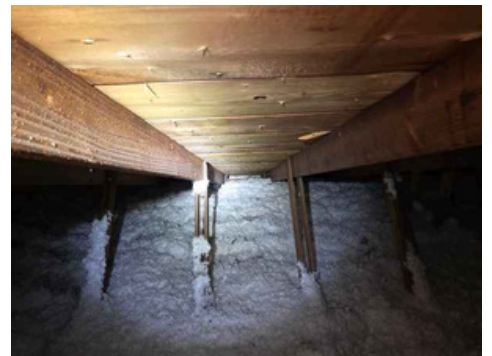
INSULATION - MISSING / OUT OF PLACE

Attic insulation was noted as missing or out of place in some areas at the time of the inspection. This will result in energy loss. Recommend further evaluation & correction by a quali ed contractor.

Contact a quali ed insulation contractor.

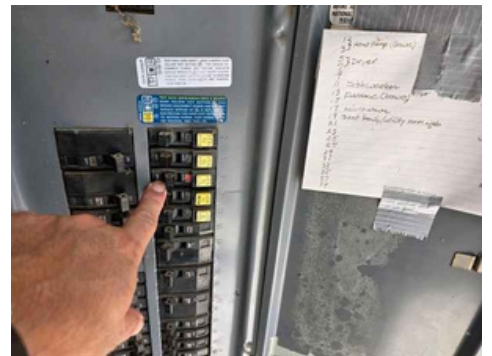
One or more tripped breakers were noted in the panel at the time of inspection. The inspector will not reset an o or tripped breaker because we cannot determine why the breaker tripped or was turned o and resetting it could become a re hazard. Recommend further evaluation & correction by a quali ed contractor.

Recommendation
Contact a quali ed electrical contractor.

Seller Correcting

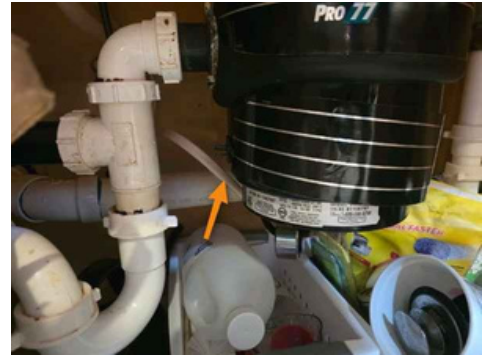
Unprotected electrical wiring was noted at one or more locations at the time of inspection. Wiring in storage or living areas should be protected in conduit to keep it from being damaged. Wiring on the exterior of home should be rated for exterior exposure or protected by exterior rated conduit. Recommend further evaluation & correction by a qualified contractor.

Recommendation
Contact a qualified electrical contractor.

✓ Seller Correcting

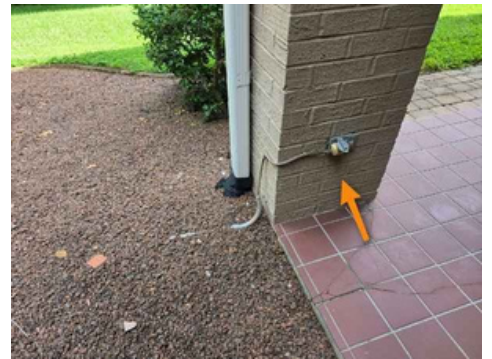
10.6.2 Branch Wiring

WIRING - IMPROPER EXTENSION CORD

Improper use of an extension cord was noted at the time of inspection. Extension cords should not be used to supply permanent power to an appliance / fixture or be routed through walls, doors or partitions. Recommend further evaluation & correction by a qualified contractor.

AS IS - Heavy Duty Extension Cord in Conduit provides electric to shed. Not dangerous. Can be unplugged.

Recommendation
Contact a qualified electrical contractor.

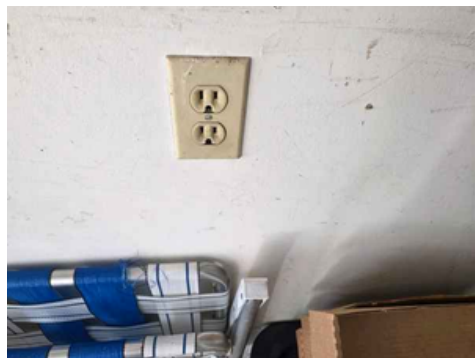
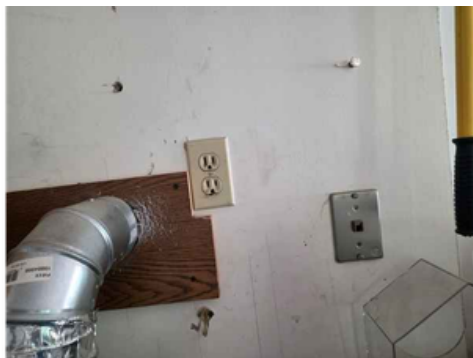
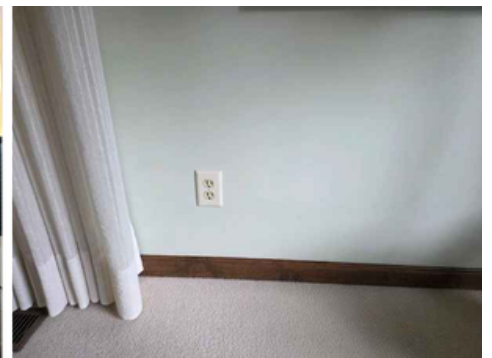
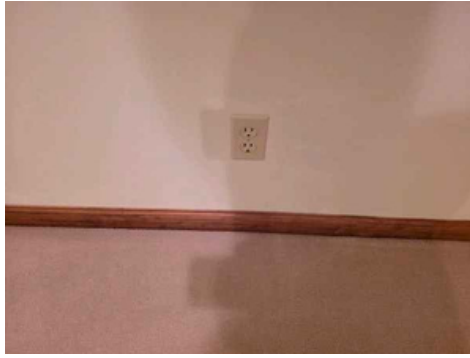
10.7.1 Outlets

OUTLET(S) - DAMAGED / WORN / OBSTRUCTED

One or more damaged, worn, obstructed outlet(s) were noted at the time of inspection. Damaged or worn outlets can result in arcing and a potential fire when an electronic device or appliance is plugged into the outlet, making this a safety hazard. Recommend further evaluation & correction by a qualified contractor.

✓ Electrician says not dangerous.

Recommendation
Contact a qualified electrical contractor.

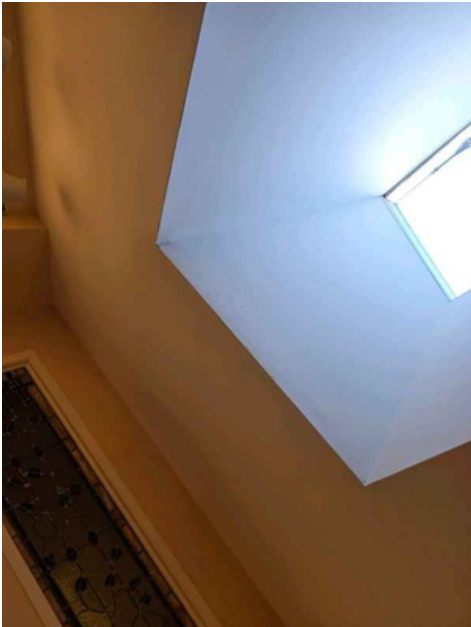
Suspected fungal growth was noted at the time of the inspection. Some types of mold can have negative health effects but proper remediation of any mold may eliminate negative side effects. Recommend further evaluation & correction by a qualified contractor. RHI can take a mold sample to have lab analysis performed to confirm this for an additional charge.

**Seller Correcting**

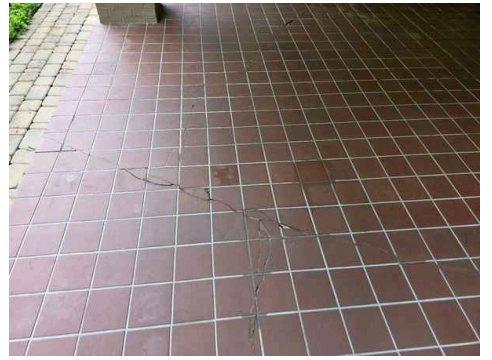
**PATIO(S) - CRACKING**

Larger cracks were noted on the patio at the time of inspection. While some cracking is typical on almost every patio, the cracking present was of a size/configuration that would indicate some portions of the patio have settled or been damaged. Recommend further evaluation & correction by a qualified contractor.

Contact a qualified concrete contractor.

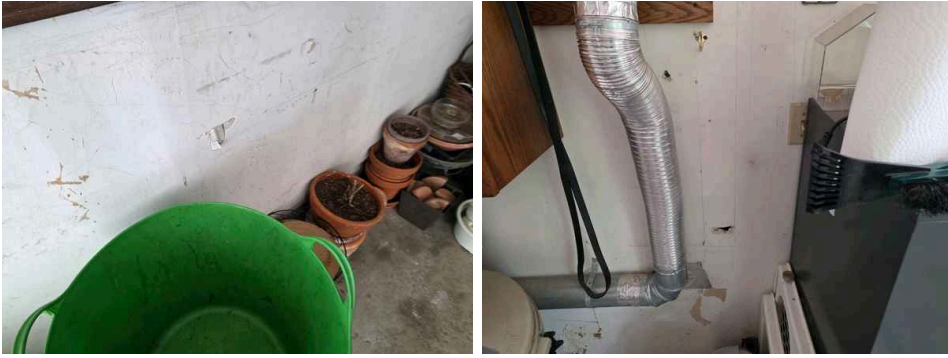
4.1.2 Walls, Ceiling, & Firewalls

CEILING(S) - BREACH IN FIRE BARRIER

Recommendation

Contact a qualified professional.

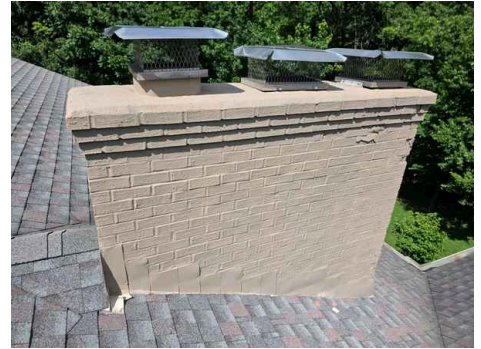
Roof Coverings: Materials
Architectural Asphalt Shingles

Chimneys & Vent Stacks: Type of Chimney
Masonry

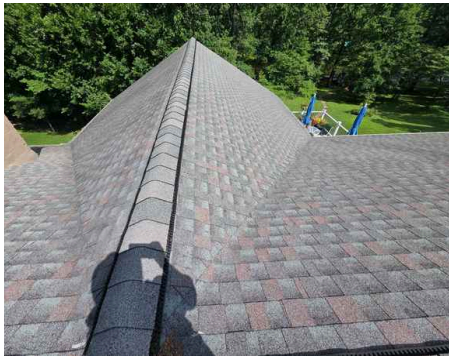
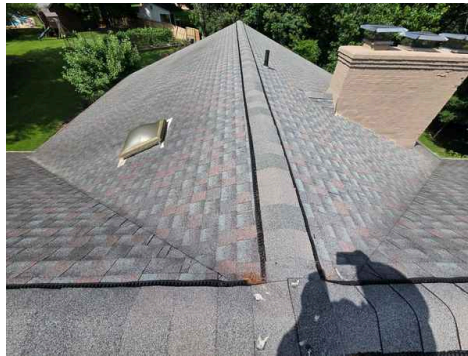
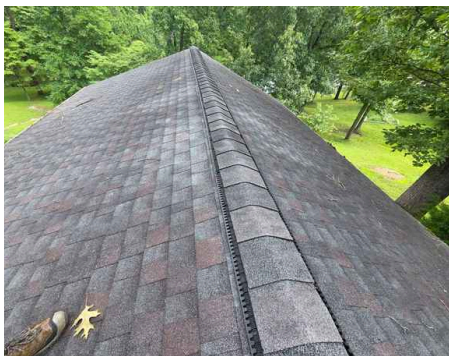
Roof Coverings: General Photo(s)

Roof appeared to be in the middle third of service life

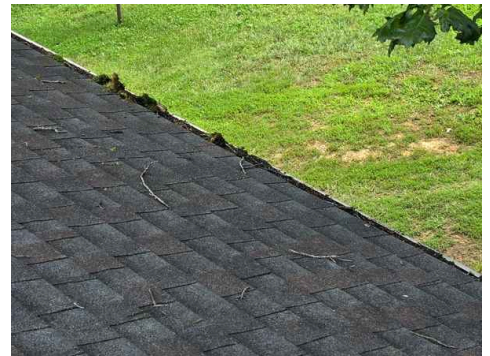
5.1.2 Roof Coverings

SHINGLES - HAIL DAMAGE

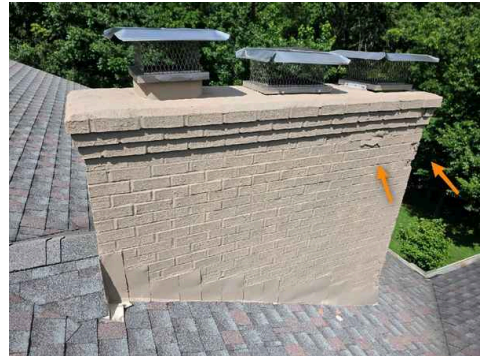
5.3.1 Chimneys & Vent Stacks

CHIMNEY - SPALLING

Spalling (Deterioration) of masonry and mortar joints noted at the time of the inspection. Recommend further evaluation & correction by a qualified contractor.

Recommendation

Contact a qualified chimney contractor.

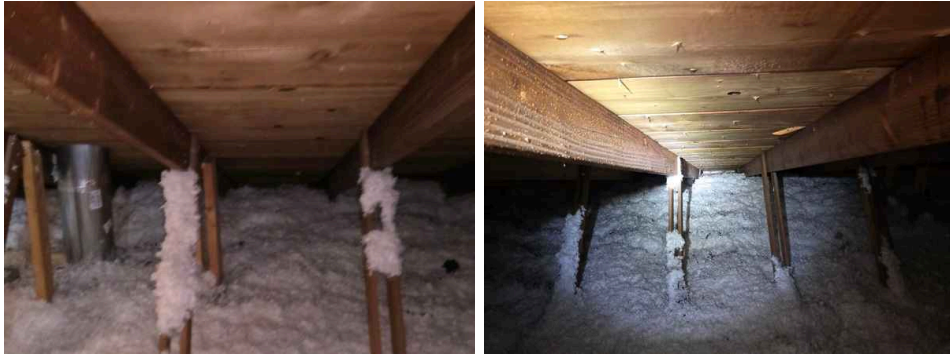
ATTIC VENT(S) - MISSING / OUT OF PLACE BAFFLES

Soffit vent baffles were noted as missing or out of place at the time of inspection. This condition can cause drafting of insulation or allow insulation to suffocate soffit vents. Recommend further evaluation & correction by a qualified contractor.

Recommendation

Contact a qualified professional.

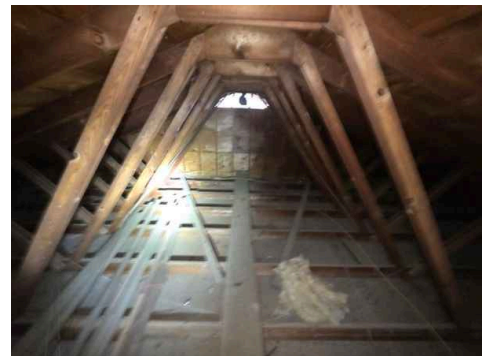
6.3.2 Ventilation

Ridge vents and gable vents were noted in the attic at the time of inspection. Too many exhaust vents work against each other. In situations where ridge vents and gable vents are used in combination, we see the gable vents act as the soffit vents would: drawing in the air, which moves up and out through the ridge vent. This creates a layer of stagnant air near the attic floor that allows moisture and heat to combine. This layer of air traps heat in the living space as well as trapping moisture that condenses in the cooler winter months. Recommend further evaluation & correction by a qualified contractor.

Recommendation

Contact a qualified professional.

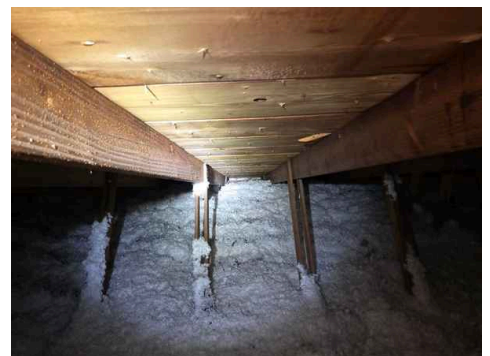
6.4.1 Insulation

INSULATION - MISSING / OUT OF PLACE

Attic insulation was noted as missing or out of place in some areas at the time of the inspection. This will result in energy loss. Recommend further evaluation & correction by a qualified contractor.

Recommendation

Contact a qualified insulation contractor.

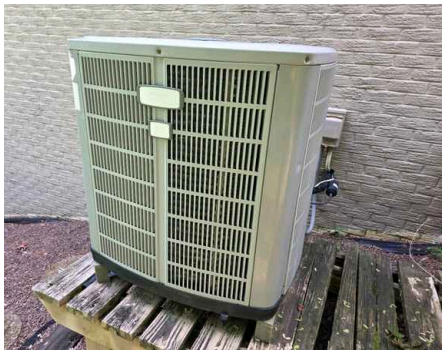
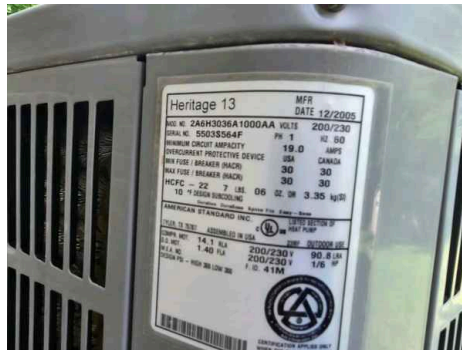
AC / Heat Pump Unit: Manufacture Date
2005

AC units typical life expectancy is between 10 -15 years. While the unit may have been operable at the time of inspection, if unit was operated or otherwise stated, we cannot project how much longer it will continue to provide adequate cooling. Recommend having the unit further evaluated by a HVAC technician and budgeting for replacement.

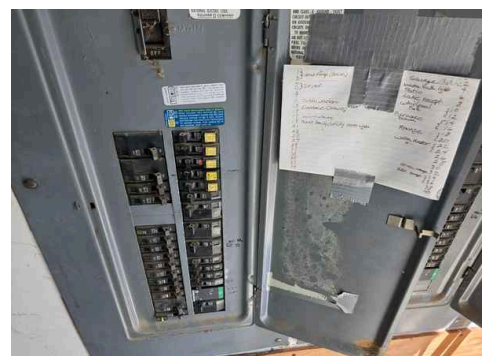
PANEL - MISSING / INCOMPLETE / IMPROPER LABELING

Panel noted not have clear/complete labeling at the time of inspection.

All fuse or breaker panels are required to have an accurate listing of what the circuits are connected to. An unsafe condition can exist if the homeowner turns off a breaker, believing to have killed the power on the circuit, only to find that they tripped the wrong breaker.

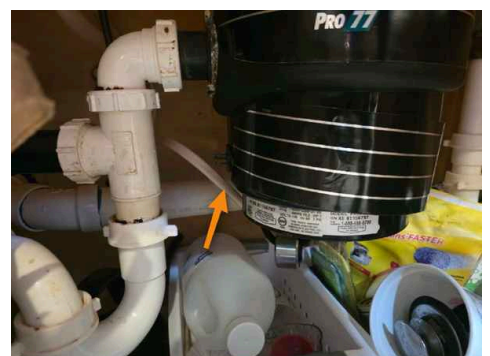
WIRING - EXPOSED WIRING

Unprotected electrical wiring was noted at one or more locations at the time of inspection. Wiring in storage or living areas should be protected in conduit to keep it from being damaged. Wiring on the exterior of home should be rated for exterior exposure or protected by exterior rated conduit. Recommend further evaluation & correction by a qualified contractor.

Contact a qualified electrical contractor.

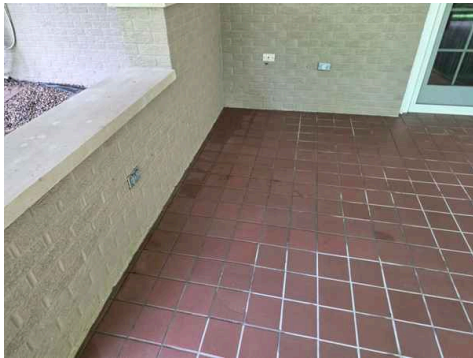
Kitchen 2

GFCIS - MISSING OR IMPROPERLY WIRED

Ground Fault Circuit Interrupter (GFCI) protected receptacles were noted as not installed or defective in some areas where they are required at the time of inspection. While GFCI protection may not have been required by code when the house was built, this is now considered a safety hazard. Recommend further evaluation & correction by a qualified contractor.

Contact a qualified electrical contractor.

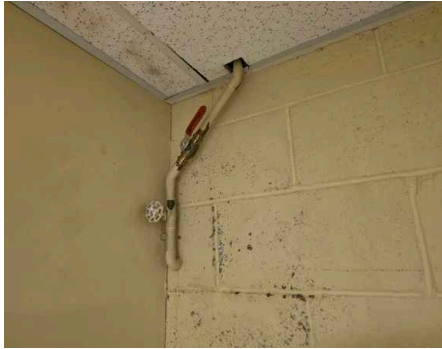
Service: Location of Shut Off Valve
Basement

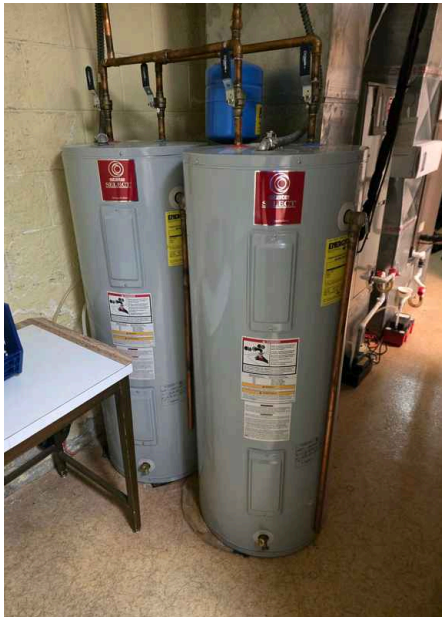
Water Heater: Manufacturer State

Water Heater: Manufacture Date 2005
Water Heater: Capacity 50 Gallon

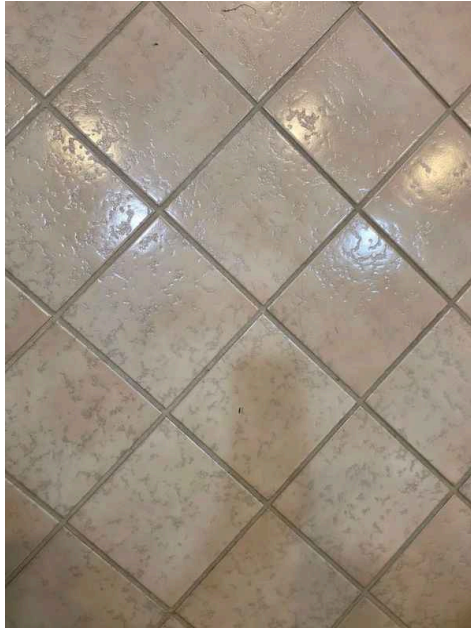
TILE - CRACKED

Hairline cracks were viewed on floor tiles at the time of inspection. This condition typically occurs when tile is laid on insufficient subflooring. Recommend monitoring for any further damage.

Recommend monitoring.
