ATKINS ENGINEERS

FEBRUARY 16, 2007

Hamptons South Condominium
20201 E. Country Club Dr.
Aventura, FL

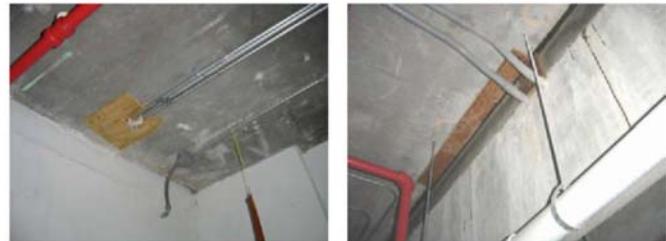
03-02 Formwork*Observation*

There is formwork (plywood) remaining on the structure.

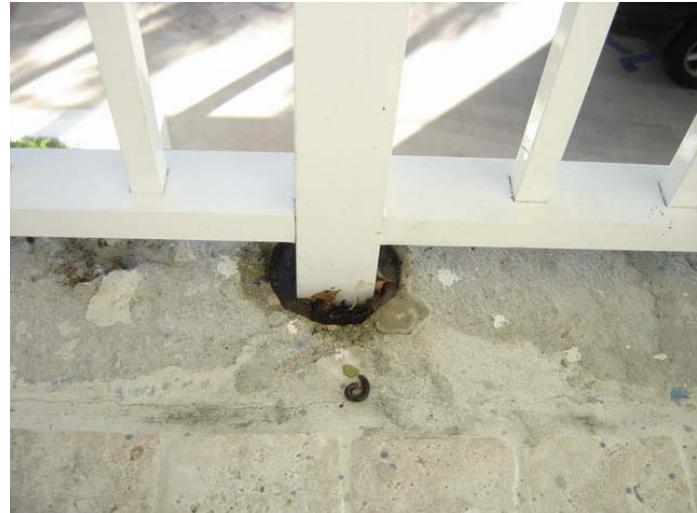
**03-05 Railing Post Pockets***Observation*

The railing post pockets are not completely filled with grout.

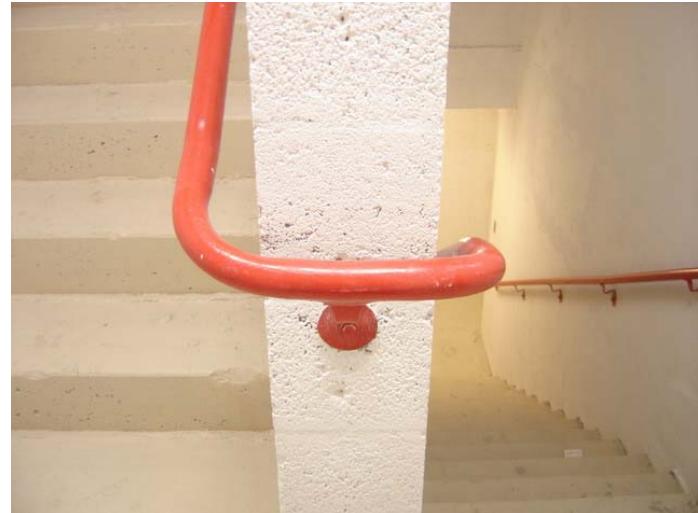
03-07 Stair Riser Height Variations**Observation**

Variations within a flight exceed the 3/16 inch between risers and/or the 3/8 inch in the flight.

Grind, saw cut or otherwise adjust the stairs to eliminate or reduce the riser height variation and meet Code requirements. All other Stair wells should be inspected for the same condition.

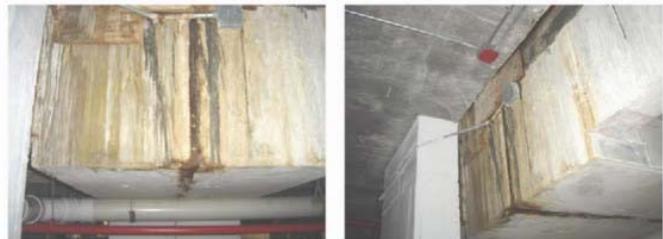
There was evidence of water intrusion through the expansion joint. In addition, there was cracked/spalling concrete and exposed reinforcing.

Remove damaged expansion joint material, clean concrete surfaces, patch concrete as required with non-shrink grout, install new joint material, finish to match existing.

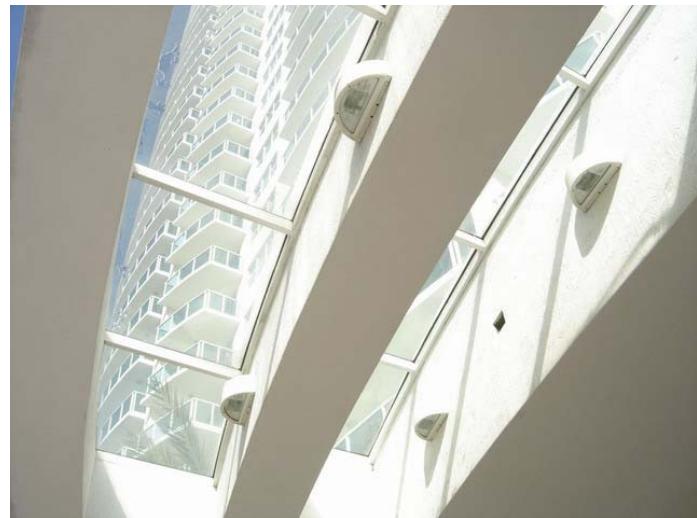
07-05 Skylight**Observation**

The skylights exhibit signs of water intrusion.

Remove and replace damaged flashing and caulk in accordance with manufacturer requirements to preclude water intrusion.

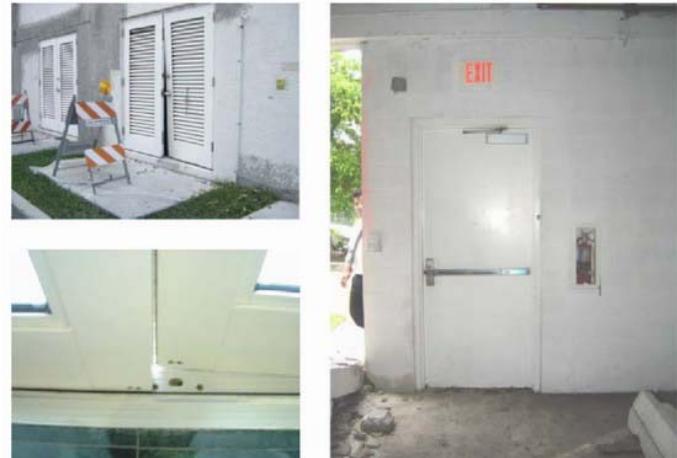
08-02 Door Adjustments**Observation**

Doors do not operate properly and require adjustments and/or alignment.

Adjust doors to insure proper operation, replace as required.

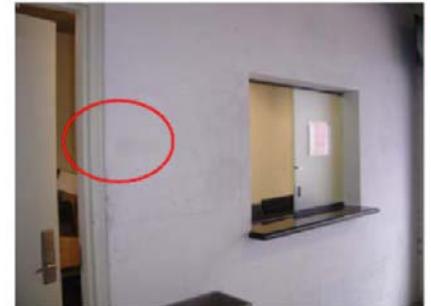
08-05 Door Signage Missing*Observation*

The doors were missing identification signs.

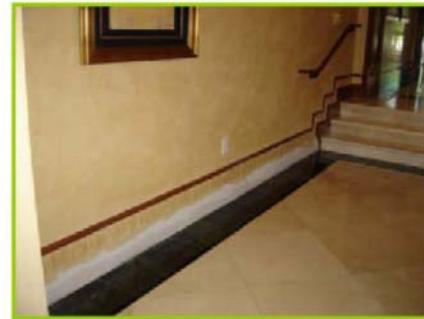
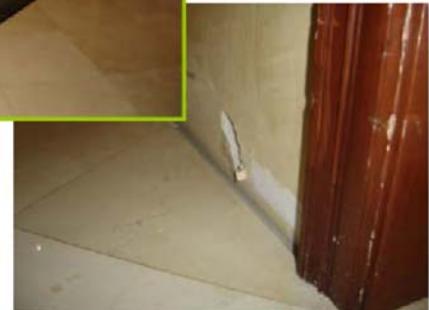
09-02 Base MoldingObservation

The base molding is damaged, missing or improperly installed.

Replace damaged and missing molding. Reinstall the base molding to remove all gaps and finish area to match surrounding.

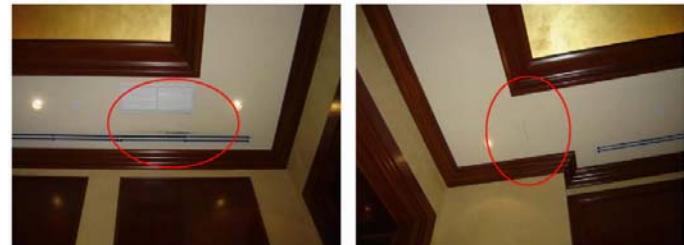
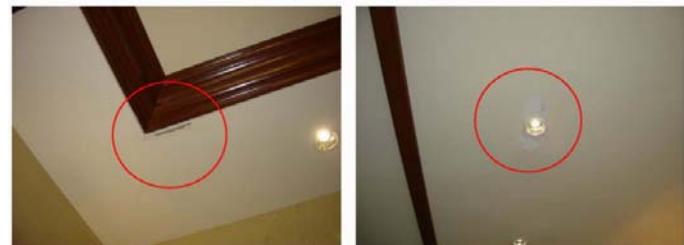
09-03 Ceiling Finish DamageObservation

The ceiling finish is damaged and there is evidence of water intrusion.

Further investigation is required to determine the source and extent of the water intrusion and any remediation required. As a minimum, remove and replace damaged materials and finish to match existing.

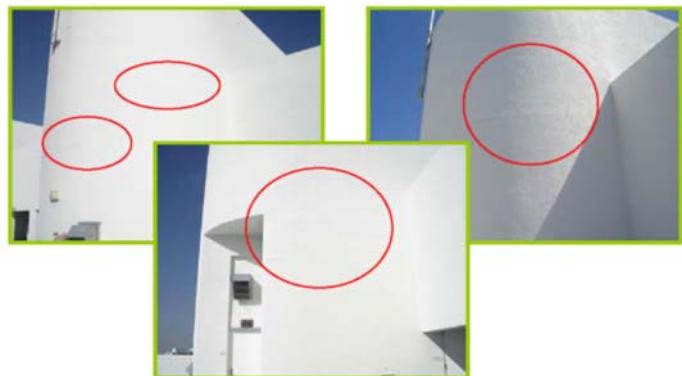
**09-09 Stucco Cracks**Observation

Cracks and/or spalling were observed on the exterior walls.

Remove delaminated stucco, inspect wall for cracks and repair as required. Apply bonding agent as required, re-apply stucco. Detail cracks and seal with flexible sealant. Finish to match existing.

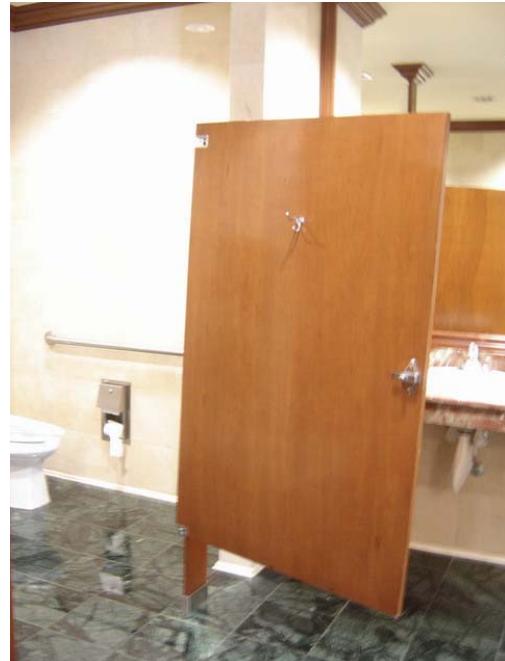
09-11 Toilet Partition**Observation**

The men's room toilet door and partition are out of plumb.

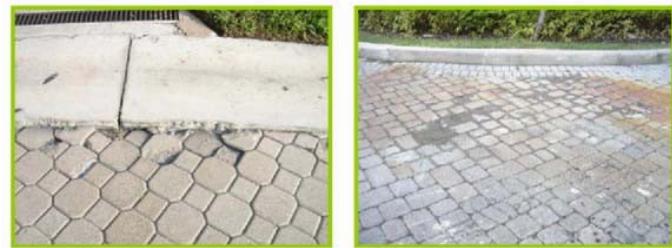
32-01 Damaged Pavers*Observation*

The pavers are loose, cracked, stained and/or improperly installed.

Remove and replace damaged and/or improperly installed pavers.

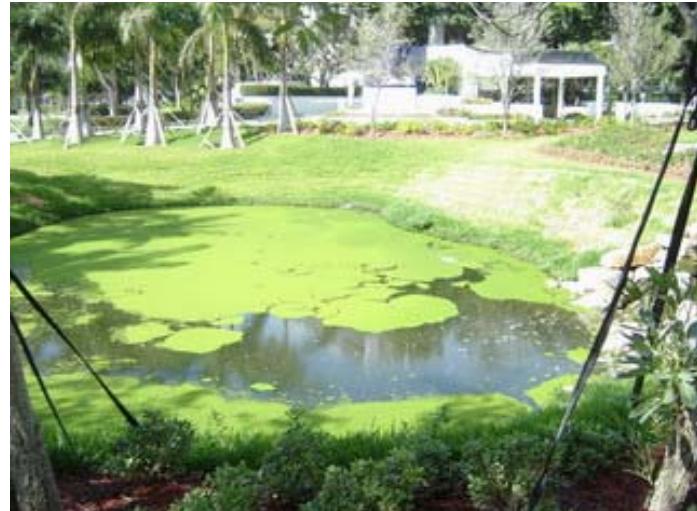
**32-02 Entry Water Feature***Observation*

There is extensive algae build-up on the pond.

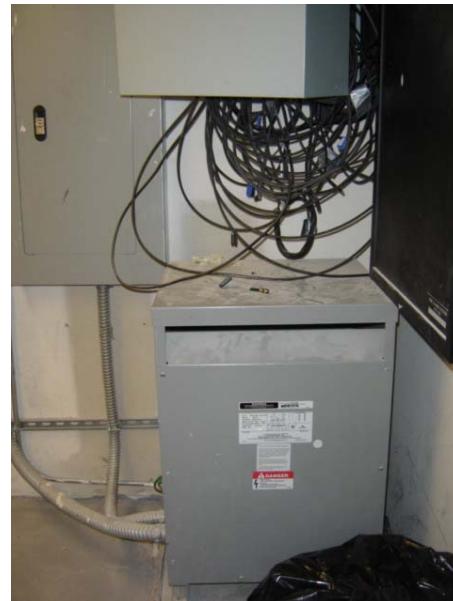
26-01 Communication Equipment Wiring**Observation**

Communication equipment has been installed in close proximity to the transformer.

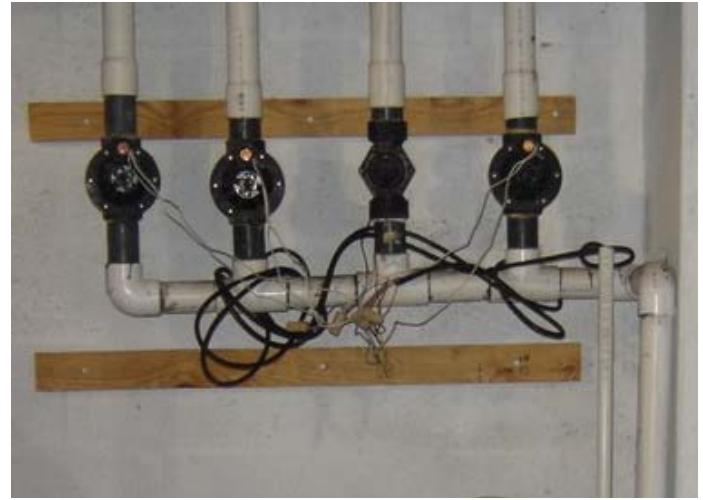
26-03 Electrical Installation Methods*Observation*

Irrigation zone control valve installation is not properly secured.

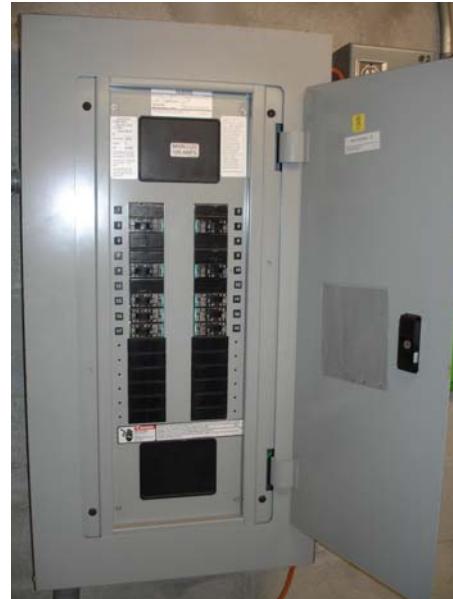
26-05 Electrical Panel Breaker Identification*Observation*

Electrical panels have not been properly identified. Branch circuit breakers are not labeled.

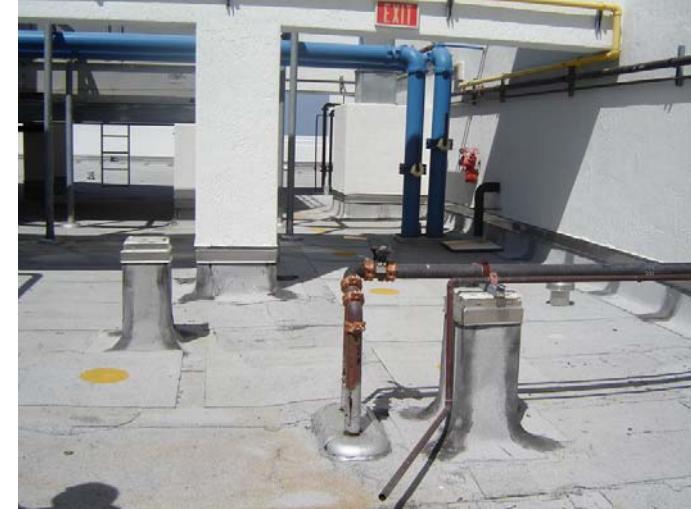
There are short columns on the roof that are not specified on the drawings.

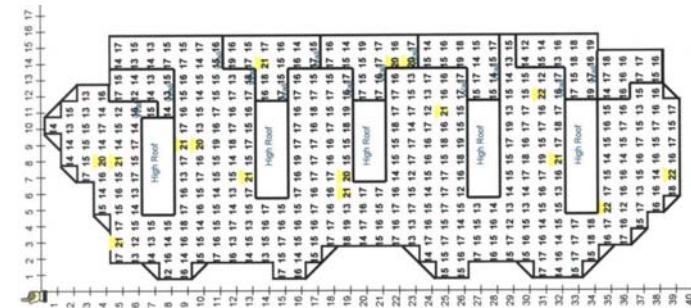
There were areas of the roof membrane that had an elevated level of hydrogen. This indicates that moisture is present.

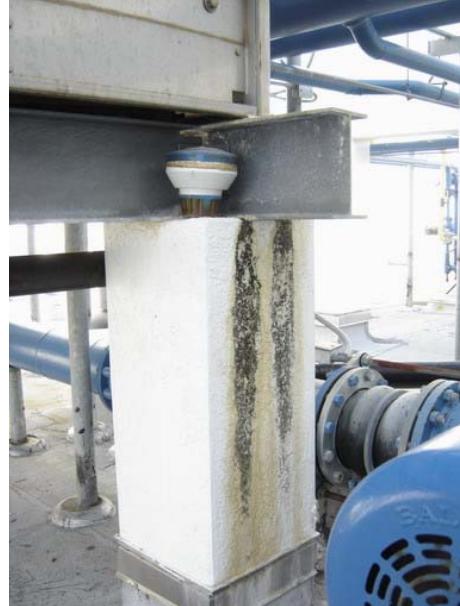
**23-05 Cooling Tower Vibration Isolators***Observation*

Thin isomode pads have been installed instead of spring type vibration isolators. This results in excessive vibration and noise, particularly in the penthouse units below.

Provide stainless steel spring isolators.

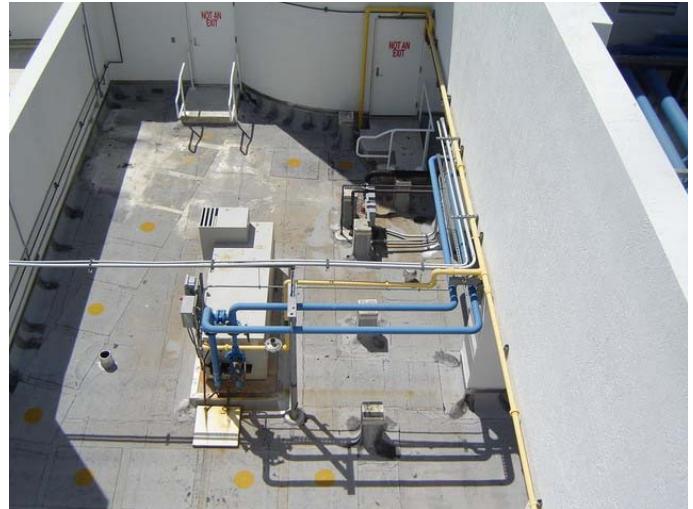
**26-02 Electrical Installations***Observation*

Corroded electrical enclosures, open conduits and unsupported conduits were observed.

Replace damaged electrical components. Support, close and seal conduits. Verify electrical component rating for use in outdoor installations.

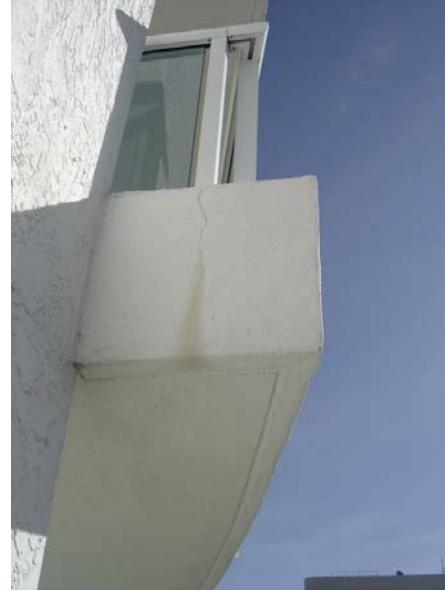
10% of Units observed, including 2710

03-01 Balcony Edge Crack*Observation*

Cracks were observed at the balcony edge emanating from the post pocket. Evidence of water intrusion was observed.

Further investigation and testing is required to determine the cause and extent of the reported condition and any remediation required. The cracks could be the result of improper post pocket material being used.

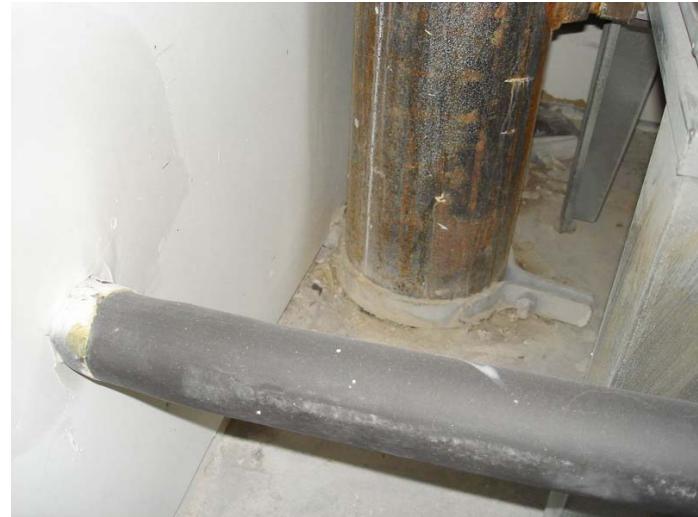
**07-02 Water Intrusion***Observation*

There was evidence of water intrusion at the doors, walls and/or ceiling. See Appendix

See Appendix

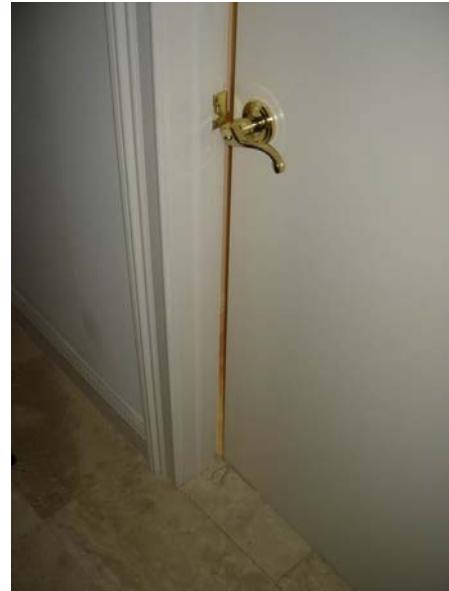
22% of the Units observed, including 1802

08-01 Door Adjustments*Observation*

Doors do not operate properly and require adjustments and/or alignment.

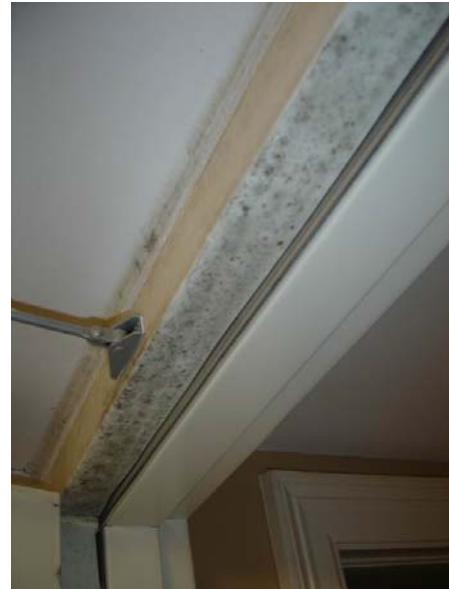
3% of the Units observed, including 1505

08-03 Door Finish*Observation*

Doors and/or frames are not finished properly.

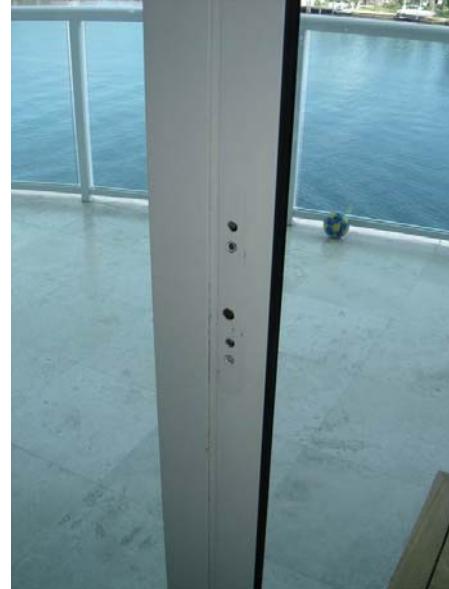
13% of the Units observed, including 1505

08-05 Sliding Glass Door Hardware*Observation*

Sliding glass doors have hardware is not secure and/or is broken.

Replace broken hardware, secure hardware and adjust the locking mechanism to insure proper hardware operation.

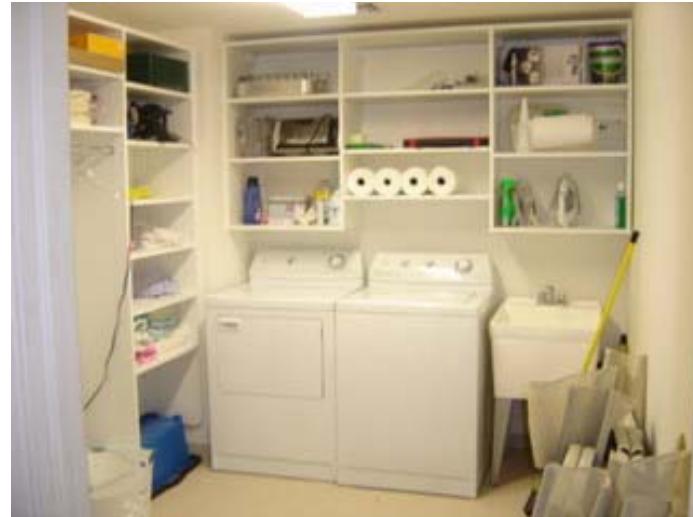
**22-02 Plumbing Leaks***Observation*

Evidence of plumbing pipe and/or sprinkler leaks were observed.

SFBC 4607.1, NFPA 13 Chapter 6

Further investigation is required to determine the cause and extent of the reported condition and any remediation required. As a minimum, remove and replace damaged materials, examine piping and tighten joints as required.

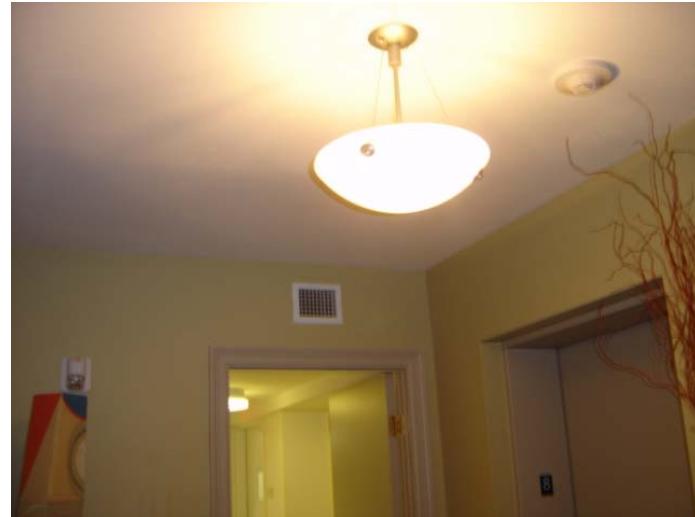
Elevator Lobby

23-02 Return Air Relief Provisions*Observation*

The room has supply air provisions but no return air or relief provisions.

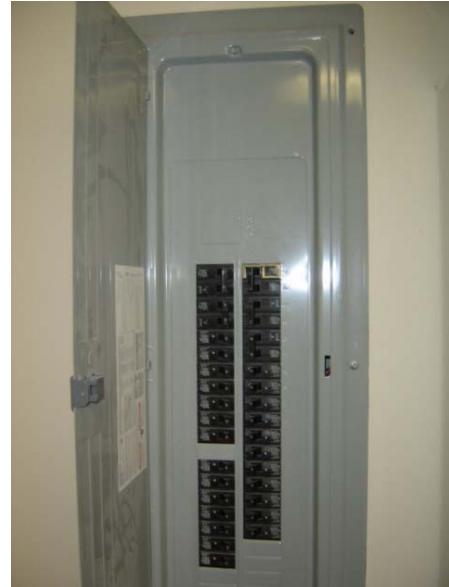
15% of the Units observed, including 1005

26-01 Breakers not Labeled*Observation*

Electrical breakers in panels are not properly labeled.

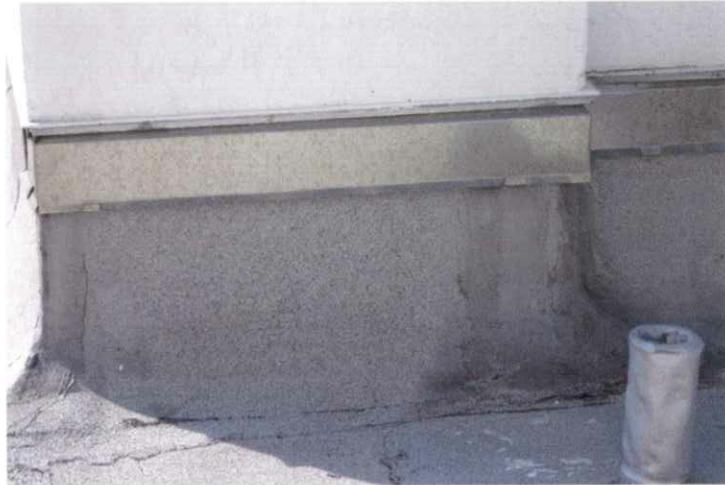
Stainless Steel Counter Flashing (Proper Height)

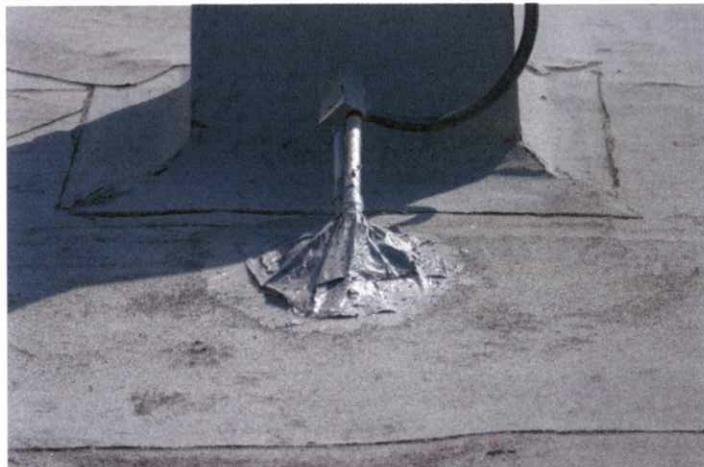
Missing Pitch Pan (must be replaced)

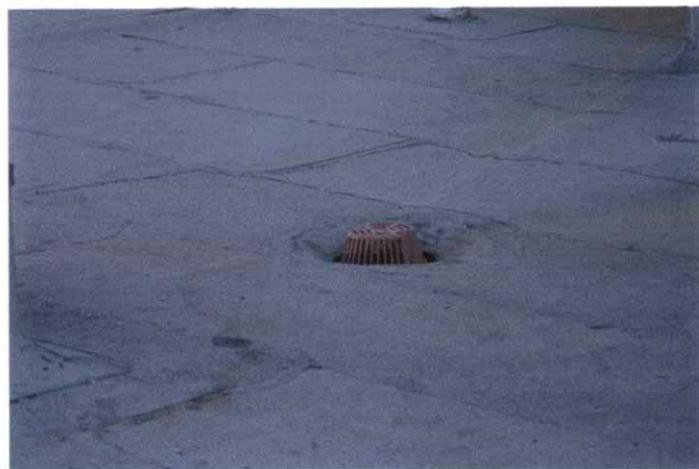
Properly Sumped Daring

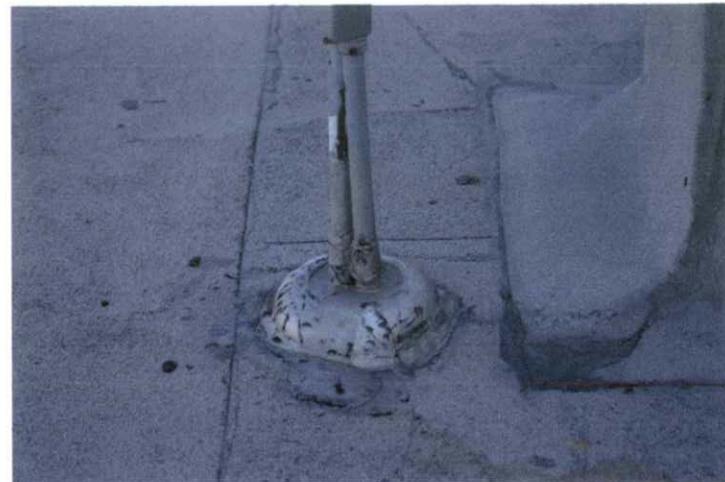
Proper Pitch Pan

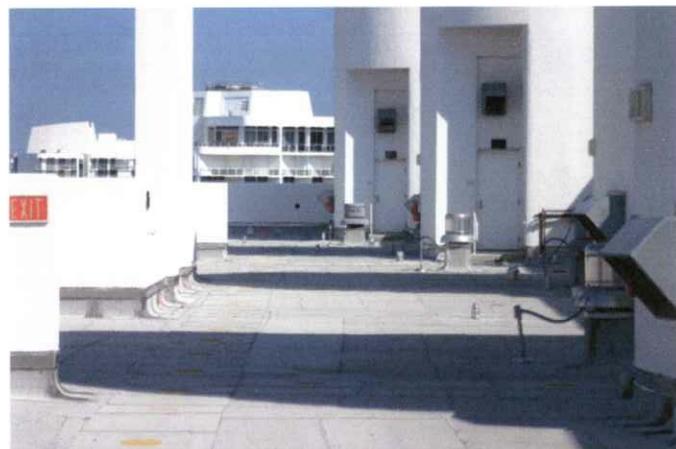
General Overview (Note the Good Drainage)

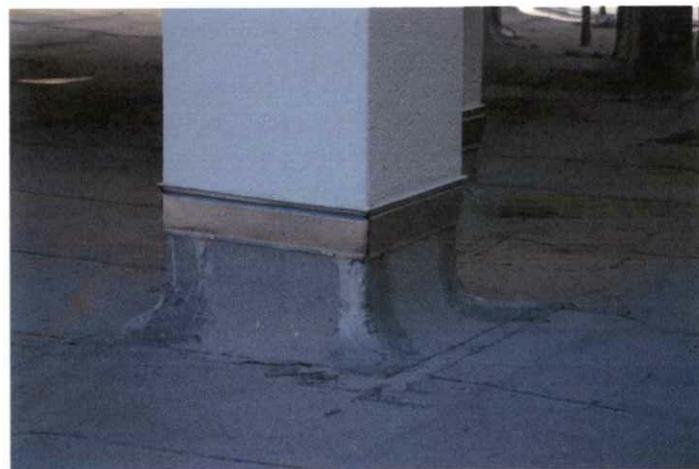
Proper Corner Flashing

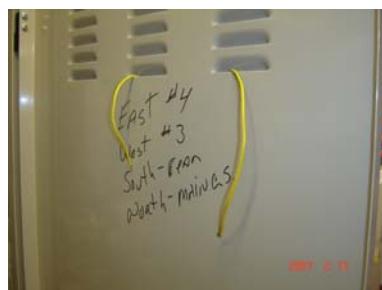
VIEW OF TEMPORARY JUMPER WIRES THAT MUST BE REMOVED FROM
BUILDING TO PREVENT UNSAFE OPERATION OF ELEVATORS.

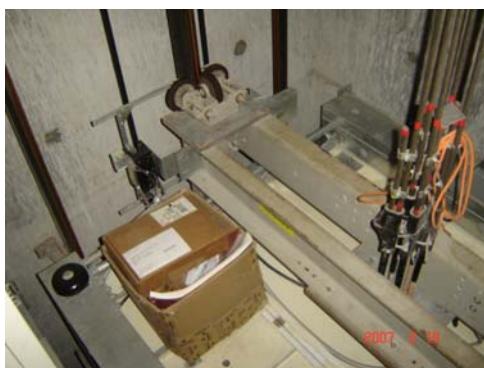
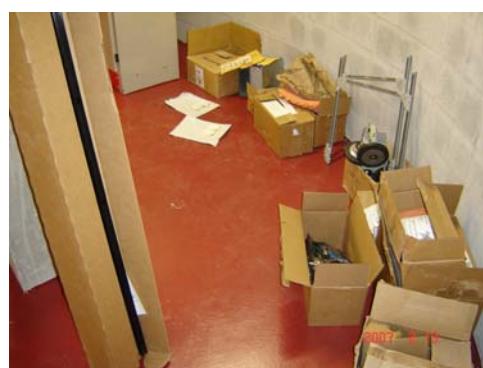
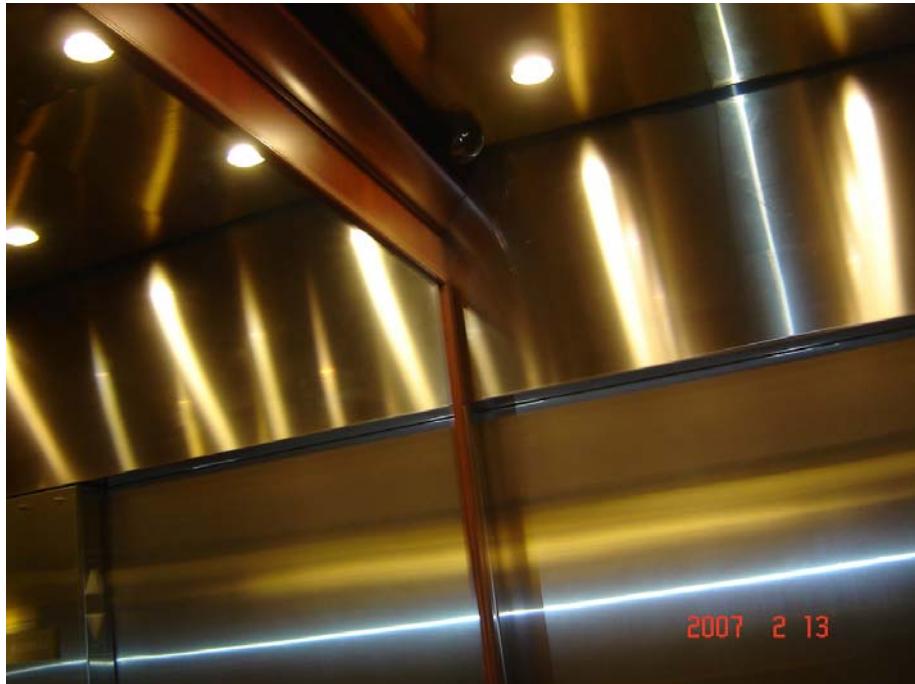
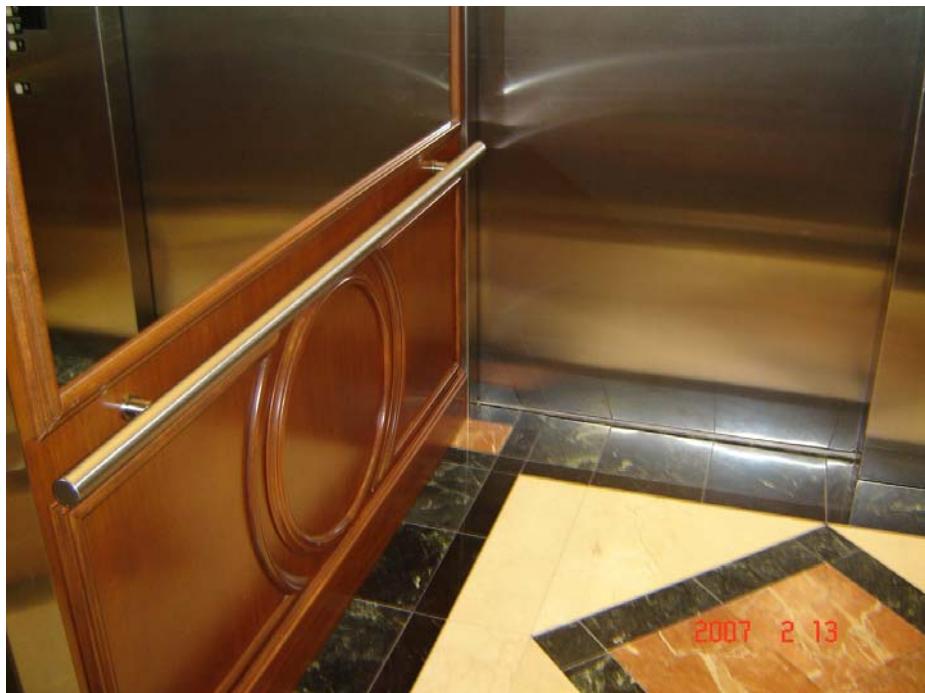
VIEWS OF HIGH RISE ELEVATORS SHOWING DIRTY HOISTWAY PIT CONDITIONS (TOP PHOTO) AND TOP OF CAR (BOTTOM PHOTO) EQUIPMENT INCLUDING DOOR OPERATOR, HOIST ROPES, GUIDE RAILS, ROLLER GUIDES, INSPECTION OPERATION CONTROLS, ETC; ALSO SHOWING SPARE PARTS/PACKAGING (PHOTOS BELOW) WHICH MUST BE PROPERLY STORED IN CABINETS IN ELEVATOR MACHINE ROOMS.

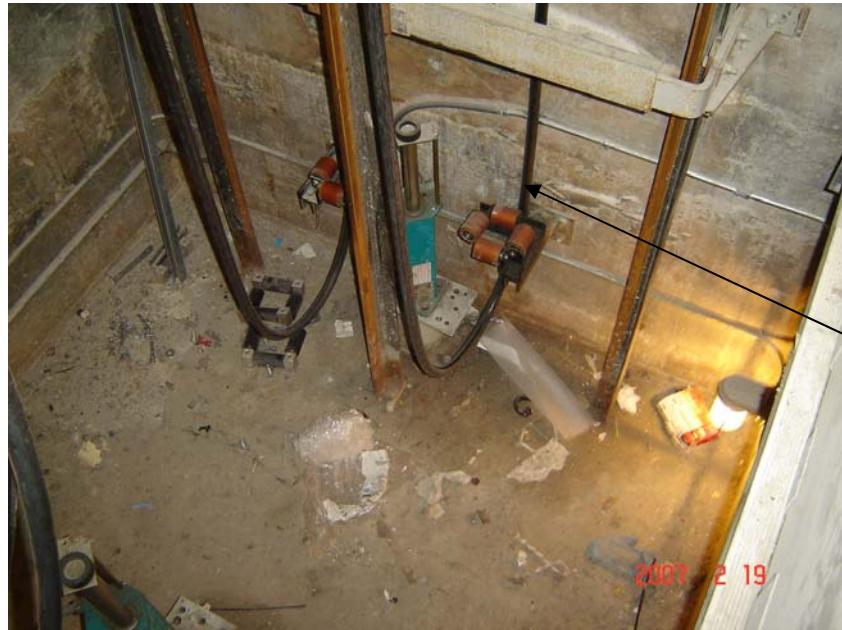
VIEW OF HIGH RISE ELEVATOR PE6 COMPENSATION CABLE SHOWING HOW CABLE IS NOT IN CENTER OF FOUR GUIDE ROLLERS.

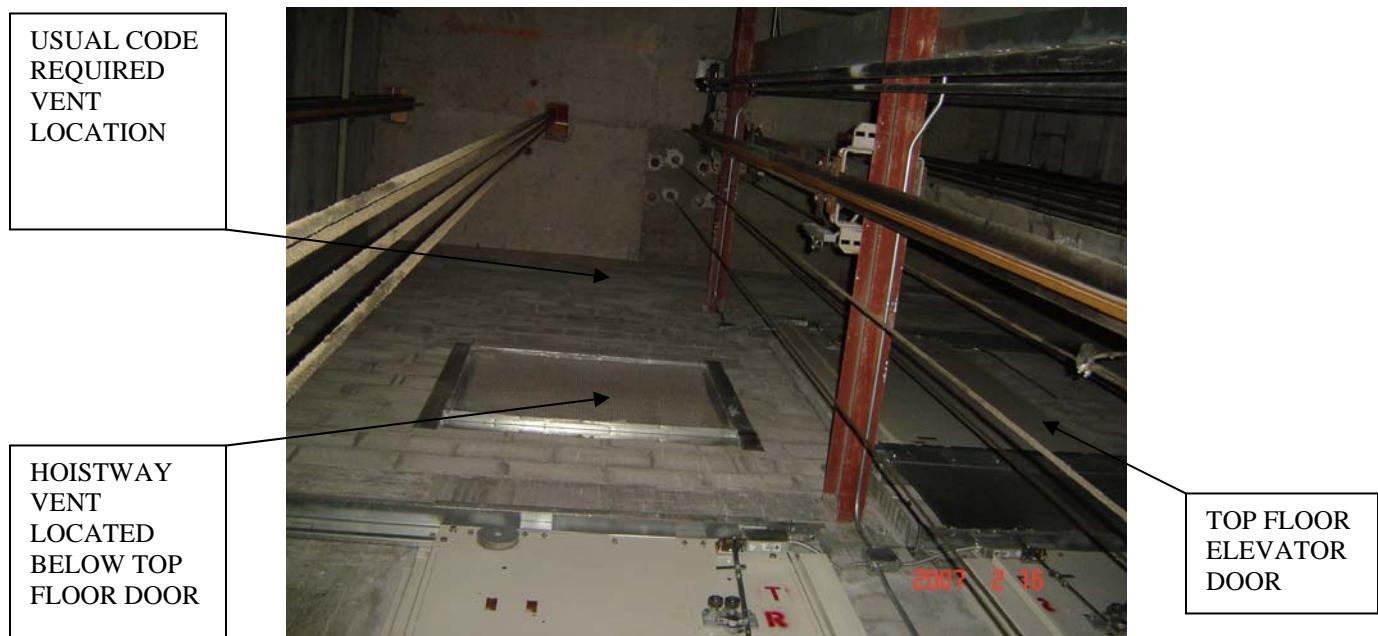
VIEW OF TYPICAL HIGH RISE ELEVATOR HOISTWAY VENT. NOTE LOCATION NEXT TO ROOF FLOOR ELEVATOR DOOR INSTEAD OF CODE REQUIRED LOCATION AT TOP OR HOISTWAY JUST UNDER MACHINE ROOM SLAB. MUST BE INVESTIGATED FOR CONFORMANCE/APPROVAL.

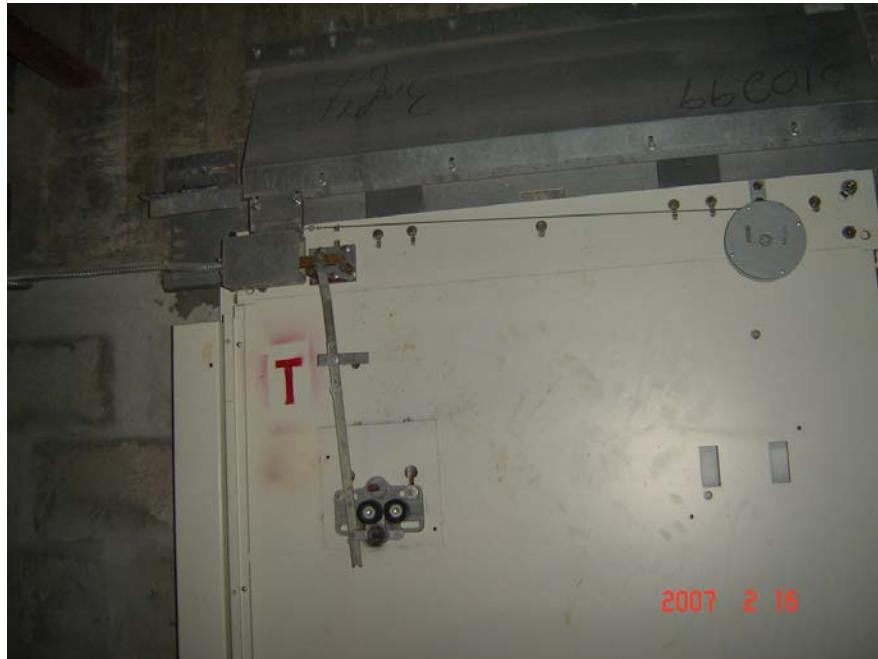
TYPICAL VIEW OF HIGHRISE TRACTION PASSENGER CARS HOISTWAY
DOOR EQUIPMENT SHOWING INTERLOCKS, TRACKS, HANGERS, ROLLERS,
CLOSERS, DOOR PANELS, ETC.

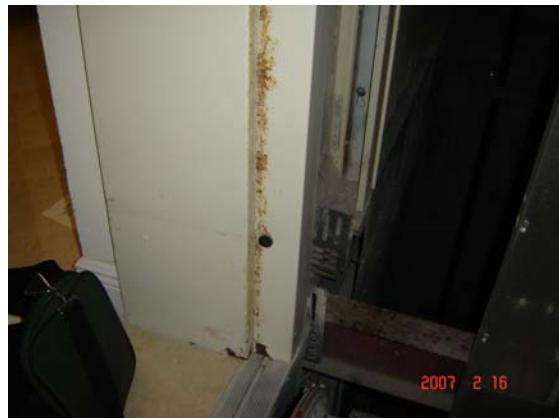
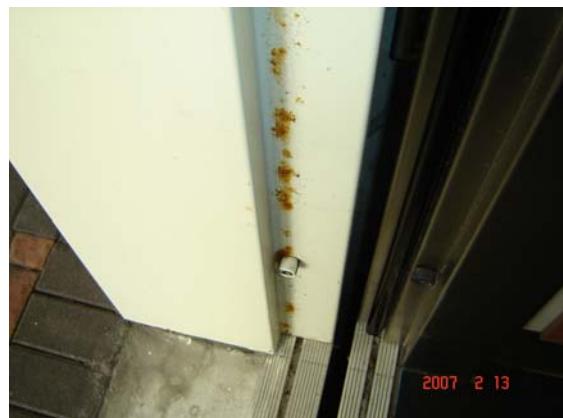
TYPICAL VIEWS OF RUST DEVELOPING ON ELEVATOR ENTRANCE EQUIPMENT REQUIRING CORRECTION TO PREVENT FURTHER DAMAGE.

22. Remove rust, repair rust damage and control/inhibit further rust damage to elevator hoistway door frames.
23. Repair inoperative car riding lantern on elevator PE4, PE5 (rear), PE8 (rear), PE10 (front), PE9.
