PRO-TECH INSPECTIONS

## WHOLE HOME INSPECTION

711 E Suber Rd  
Greer, SC 29650

Mike MacGregor  
09/25/2025

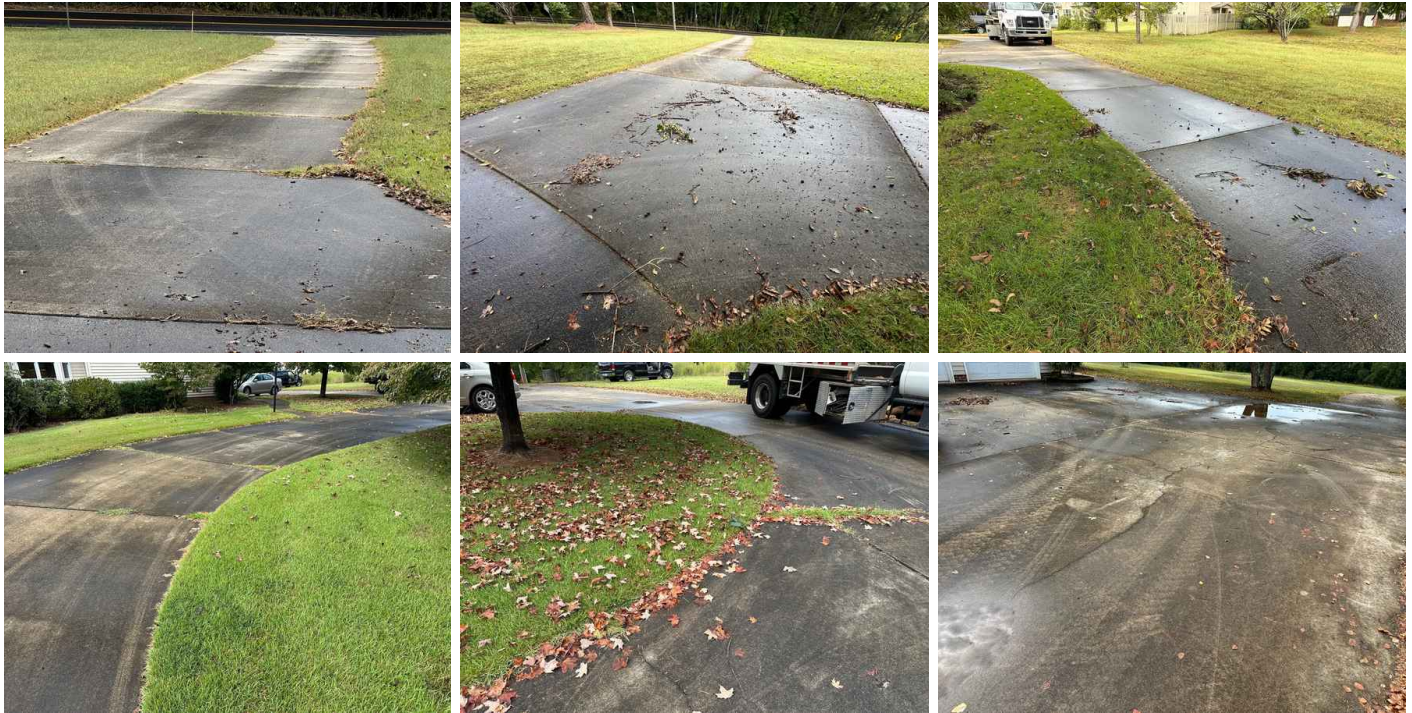
**Driveway(s): Concrete - Common Cracks**

Minor settlement or "hairline" cracks in driveways are normal to properties of any age. They should, however, be monitored for expansion and sealed as necessary.

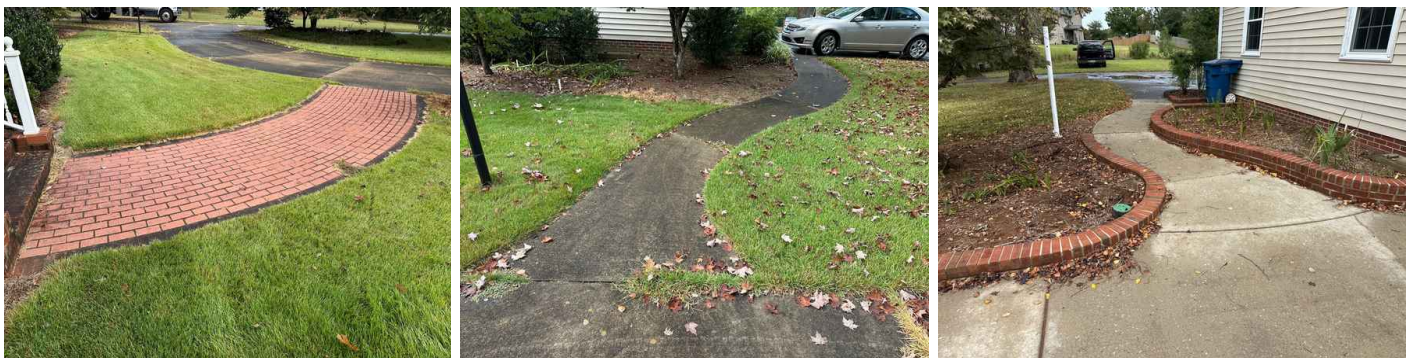
**Walkway(s): Common Cracks**

Minor settlement or "hairline" cracks in walkways are normal to properties of any age. They should, however, be monitored for expansion and sealed as necessary.

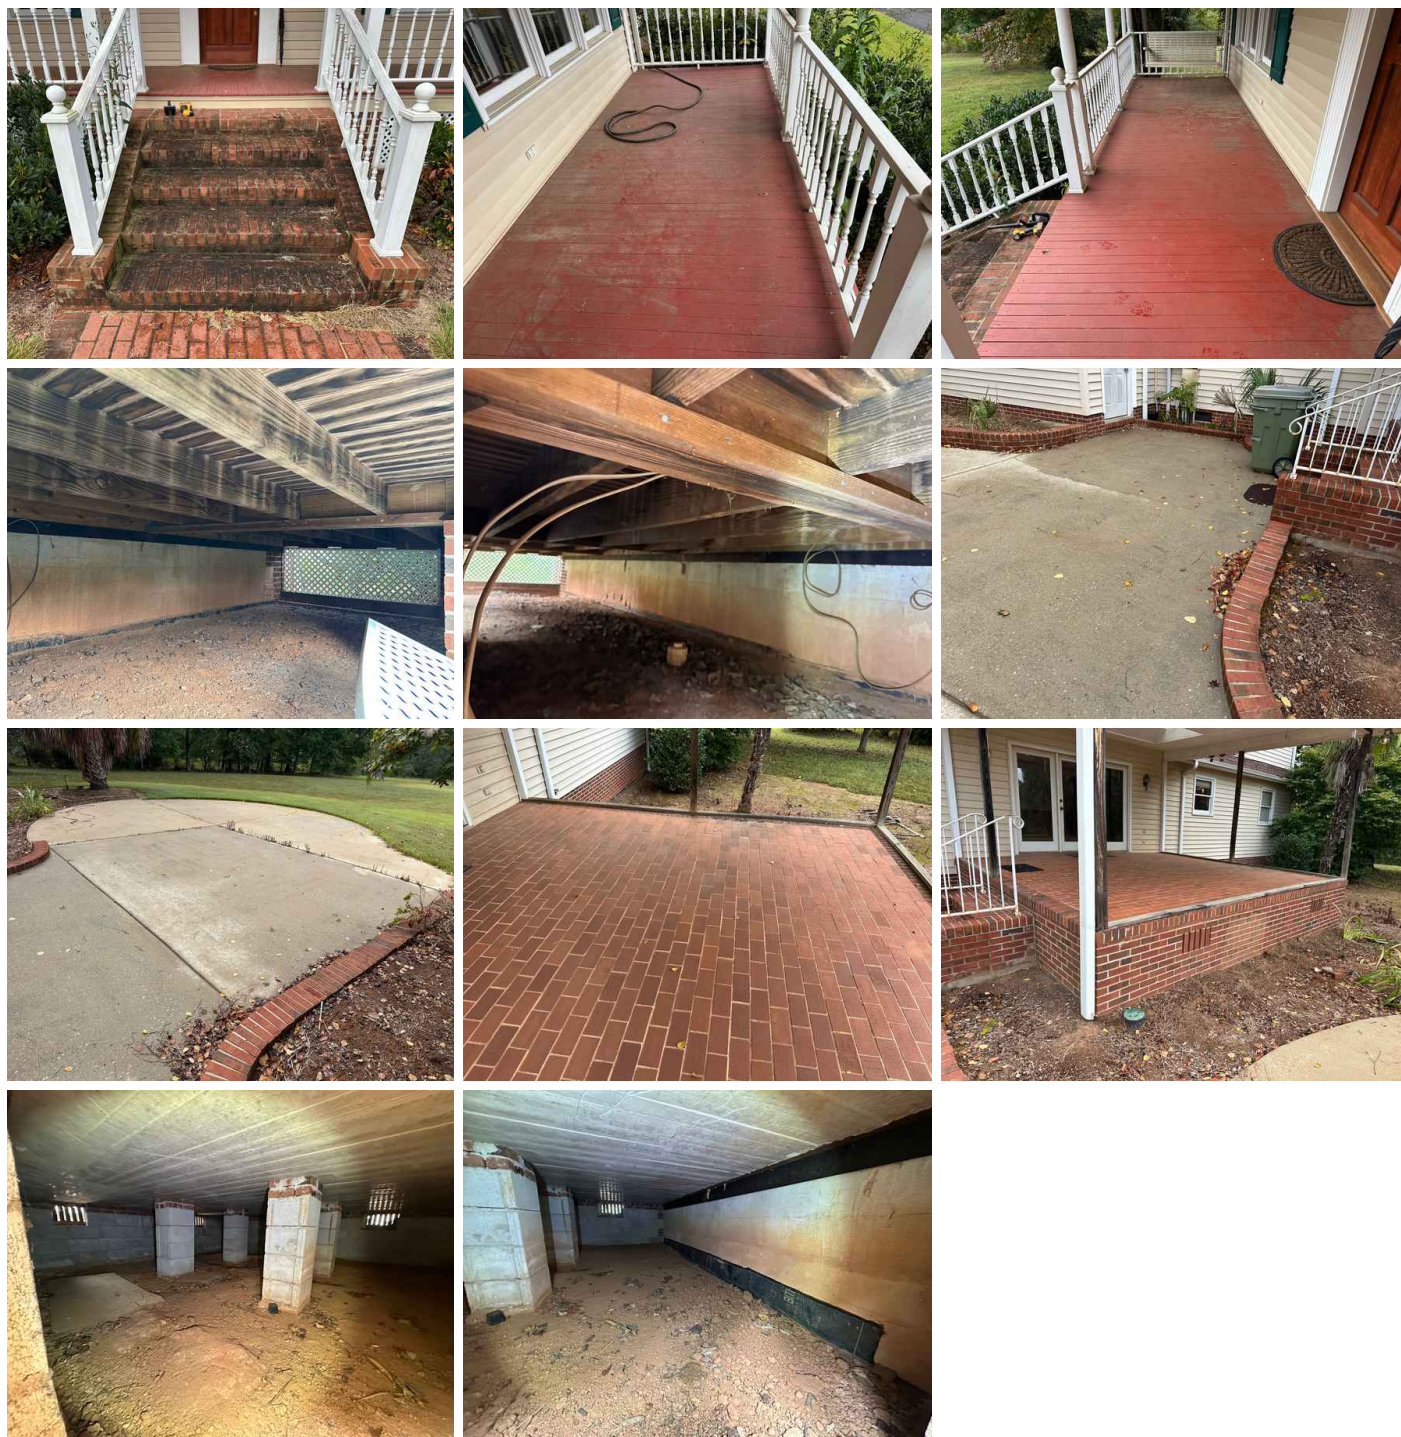
## Porch/Patio: Common Cracks - Concrete

Minor settlement or "hairline" cracks in patios are normal to properties of any age. They should, however, be monitored for expansion and sealed as necessary.

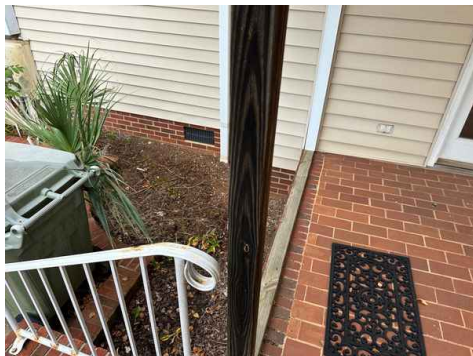
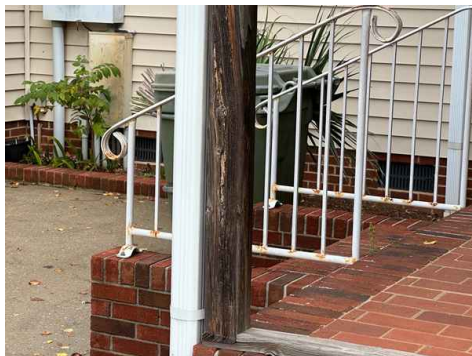
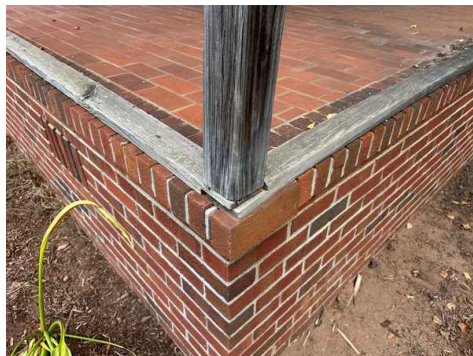
#### 2.4.1 Porch/Patio

### WEATHERED/AGED WOOD

Contact a qualified professional.

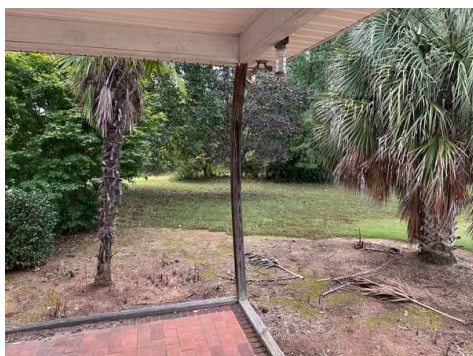
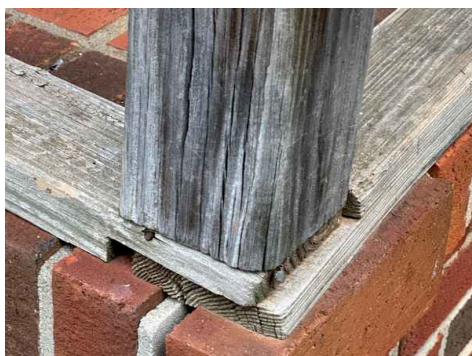
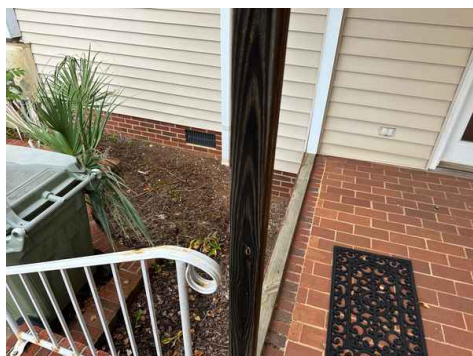
#### 2.4.2 Porch/Patio

### SUPPORT POST CONCERNS

Contact a qualified professional.

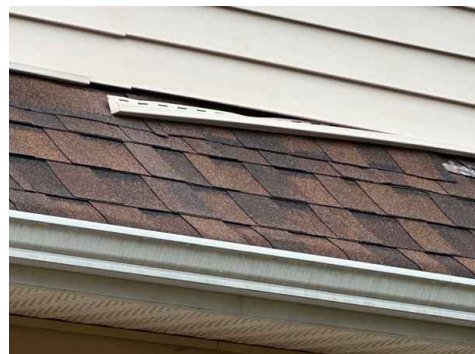
## 2.6.1 Exterior Cladding

**VINYL SIDING DAMAGE PRESENT**

Contact a qualified siding specialist.

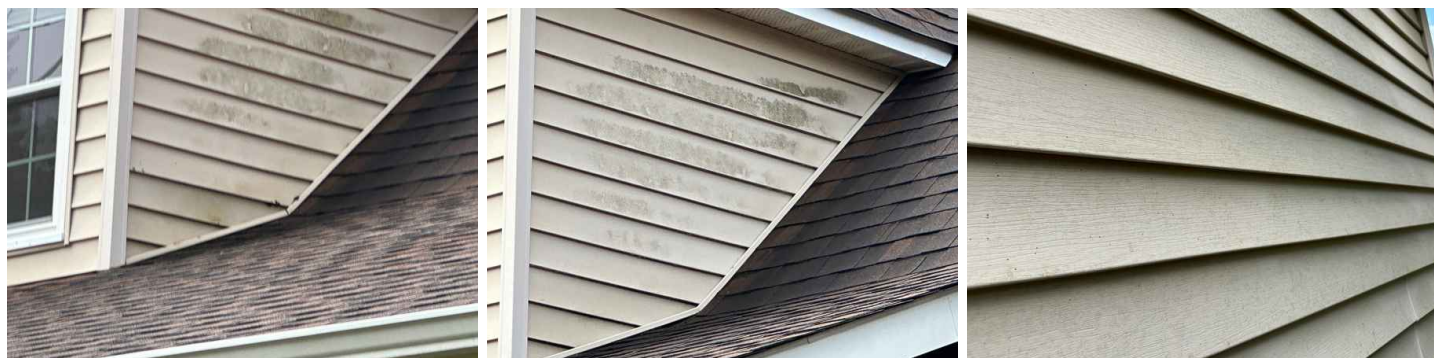
## 2.6.2 Exterior Cladding

**MOISTURE STAINING PRESENT**

Contact a qualified professional.

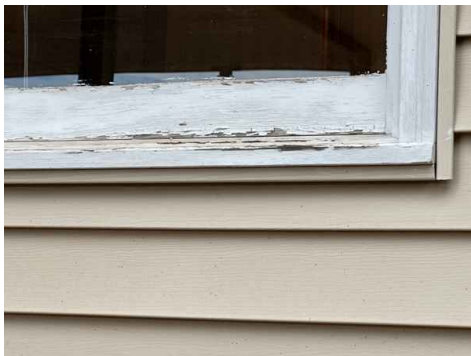
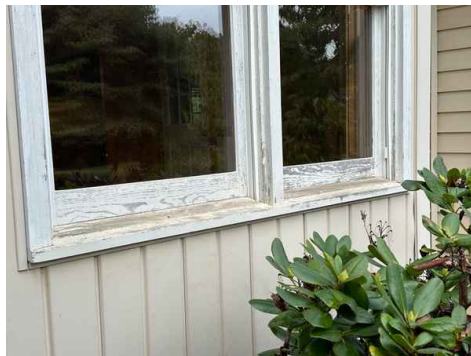
### 2.8.3 Window/Door Trim

## UNPAINTED TRIM - BOTTOM TRIM

The wood below door thresholds should be painted to prolong its lifespan and help deter insect infestation. Regular maintenance, including repainting as needed, is recommended to protect these areas.

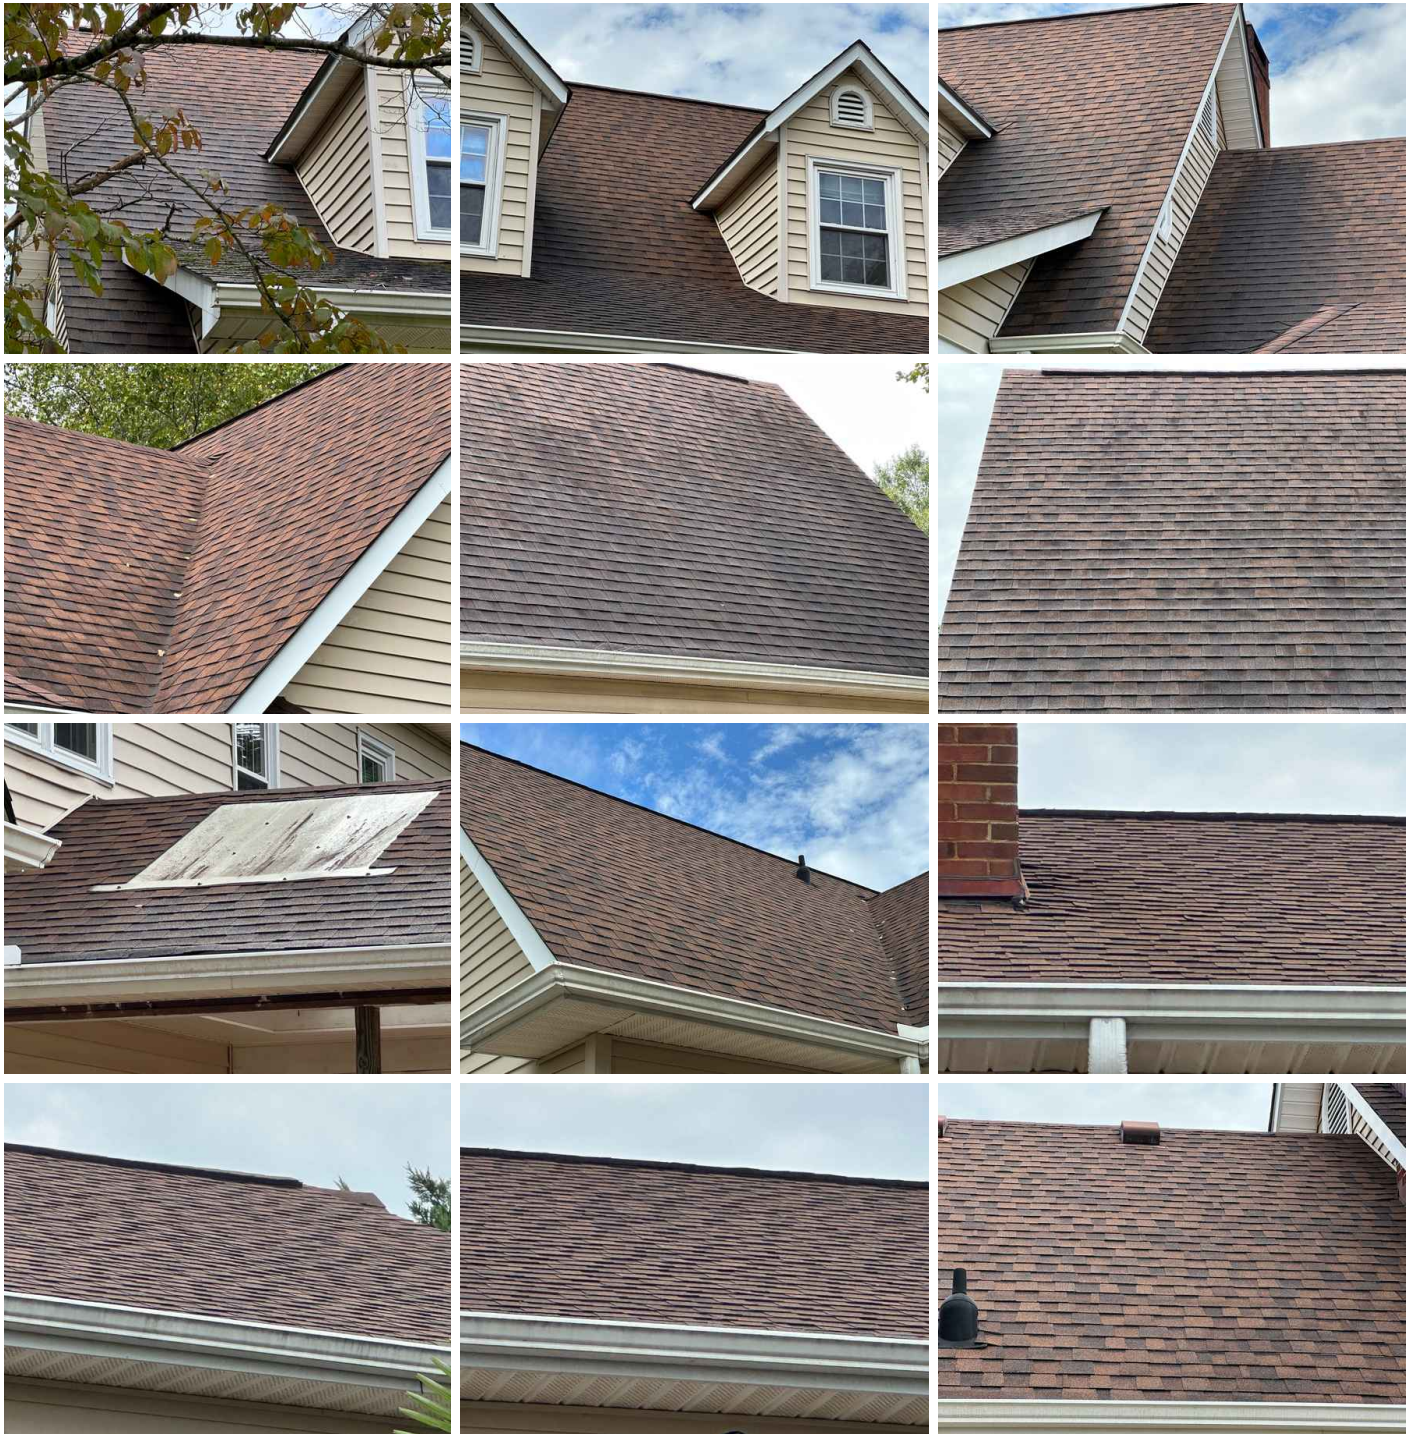
### Roof Surface Condition: Shingles Information - Viewed from Ground

The shingles were inspected from the ground at visibly accessible portions looking for excessive granule loss, signs of curling or delamination, and/or any other signs of damage or excessive age. No significant deficiencies were visibly present at the time of inspection unless otherwise noted in this report.

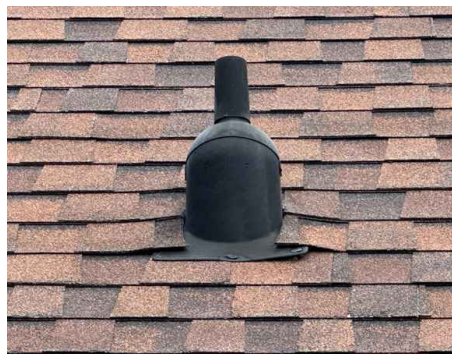
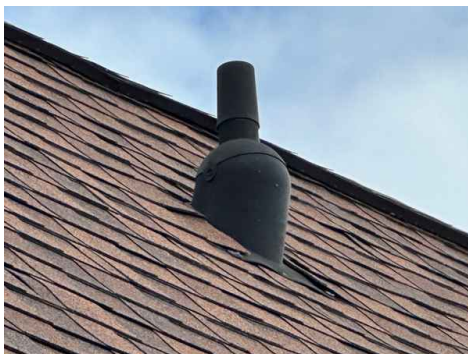
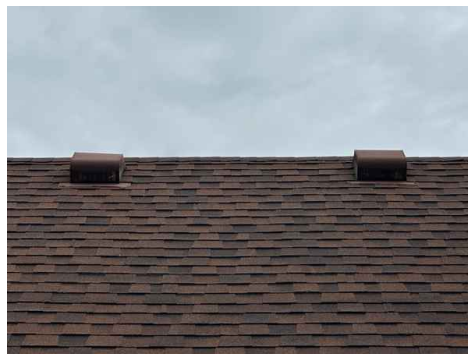
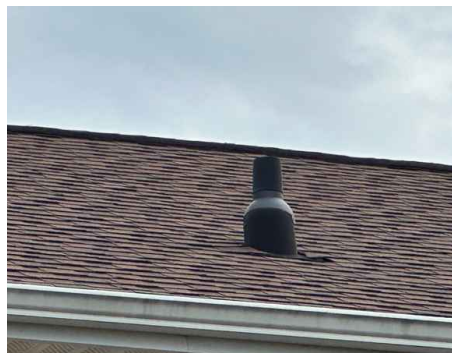
**Roof Penetrations: Roof Penetration(s) Type(s)**

Plumbing Stack Vent(s), Fixed Roof Exhaust Vent(s)

The plumbing stack vents, their related rain boots, and other roof penetrations were inspected by looking at their clearance, the integrity of their boots, for proper installation, or any significant defects. No reportable conditions were present at the time of inspection unless otherwise noted in this report.

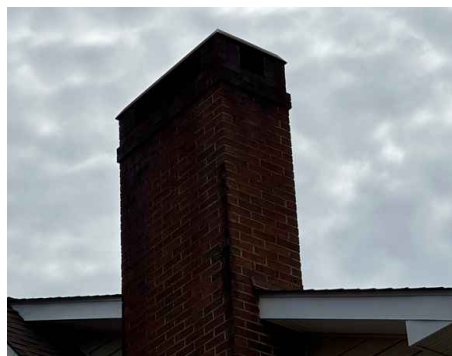
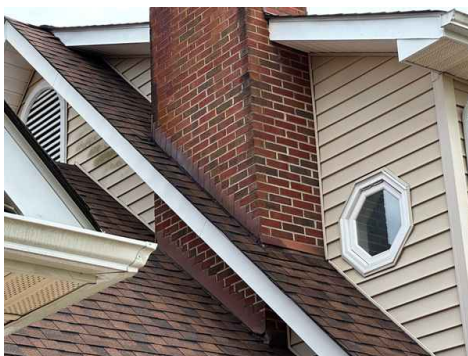
Masonry -- for wood burning fireplace with terracotta flue

The NFPA (National Fire Protection Association) highly recommends an annual inspection of all chimneys, fireplaces, solid fuel-burning appliances, and vents. They also recommend an NFPA 211 Standard, Level II inspection upon sale or transfer of the property. A Level II inspection includes, not only cleaning the interior of the chimney pipe, but also the use of specialized tools and testing procedures such as video cameras, etc. to thoroughly evaluate the serviceability of the entire flue lining and fireplace/chimney system. If one has not been performed over the past 12 months, such an inspection is recommended before home changes ownership---for fire safety reasons.

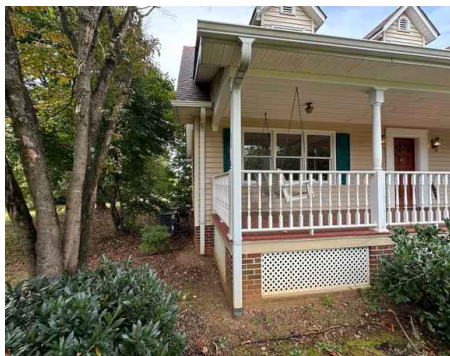
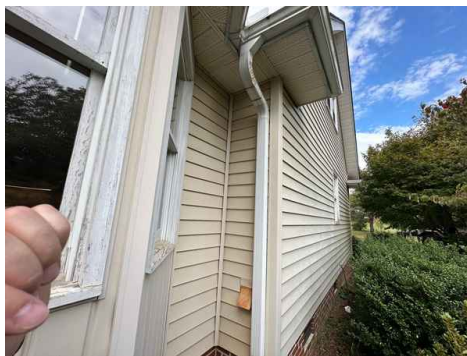
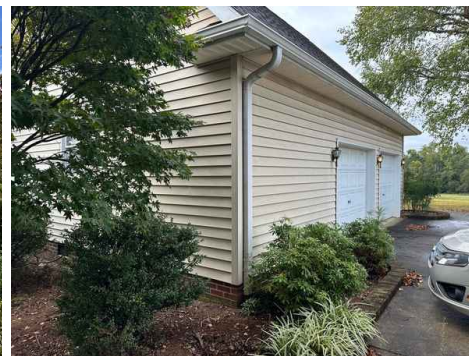
Aluminum

The gutters/downspouts were inspected looking for proper attachment, debris in the channel, standing water, damage, etc. Leaking gutters can not be diagnosed if an active rain was not occurring at the time of inspection, and if leaks are noticed after taking ownership of the home, sealing or repairs may be needed at seams or endcaps.

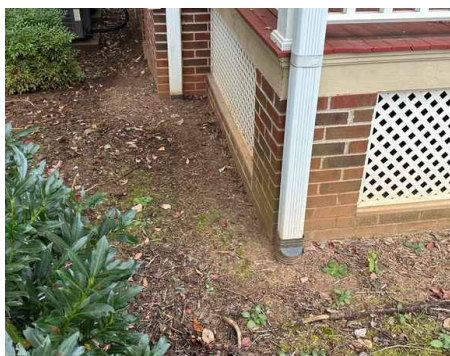
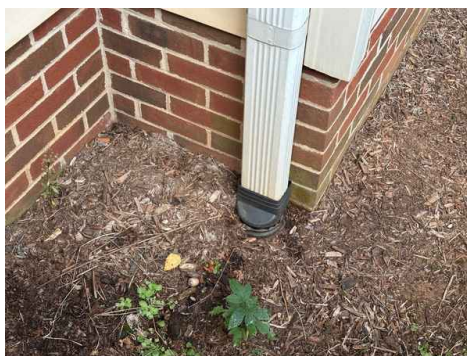
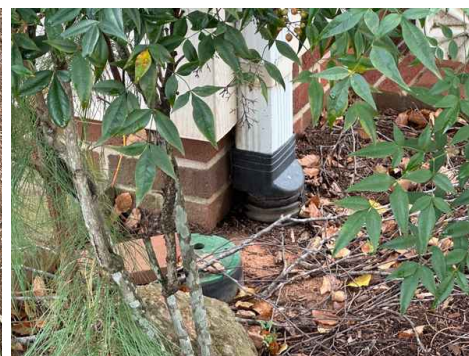
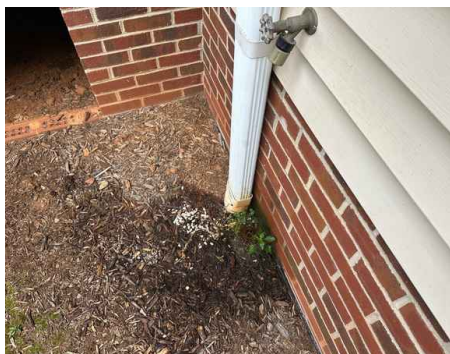
All gutters

Some downspouts terminated below grade. Their connection to a drain tube could not be confirmed.

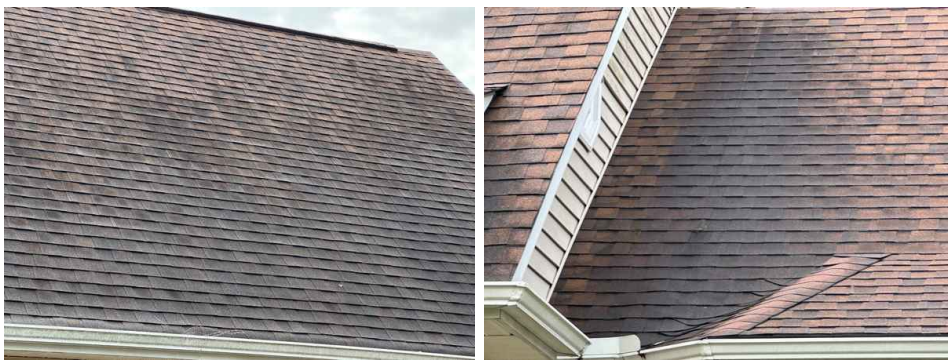
### 3.3.1 Roof Surface Condition

Black streaks and staining were observed on the roof in certain areas. This discoloration is caused by cyanobacteria known as *Gloeocapsa magma*. If left untreated, this cyanobacteria can damage the ceramic granules on the shingles, potentially shortening their overall lifespan. Treatment to remove the growth is recommended to prevent further deterioration and to maintain the roof's integrity.

Contact a qualified roofing professional.

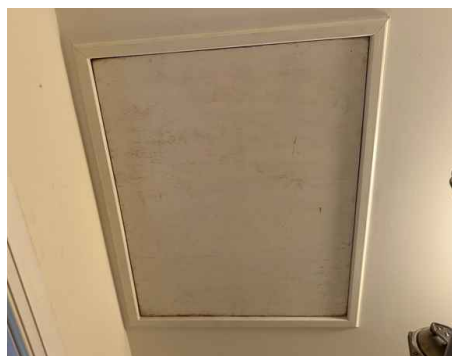
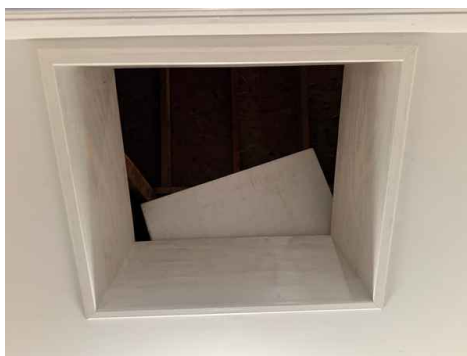
Scuttle Hole(s), Upper Level

The attic access(es) were inspected by reporting on their location and type, as well as looking for any significant defects in association with the access.

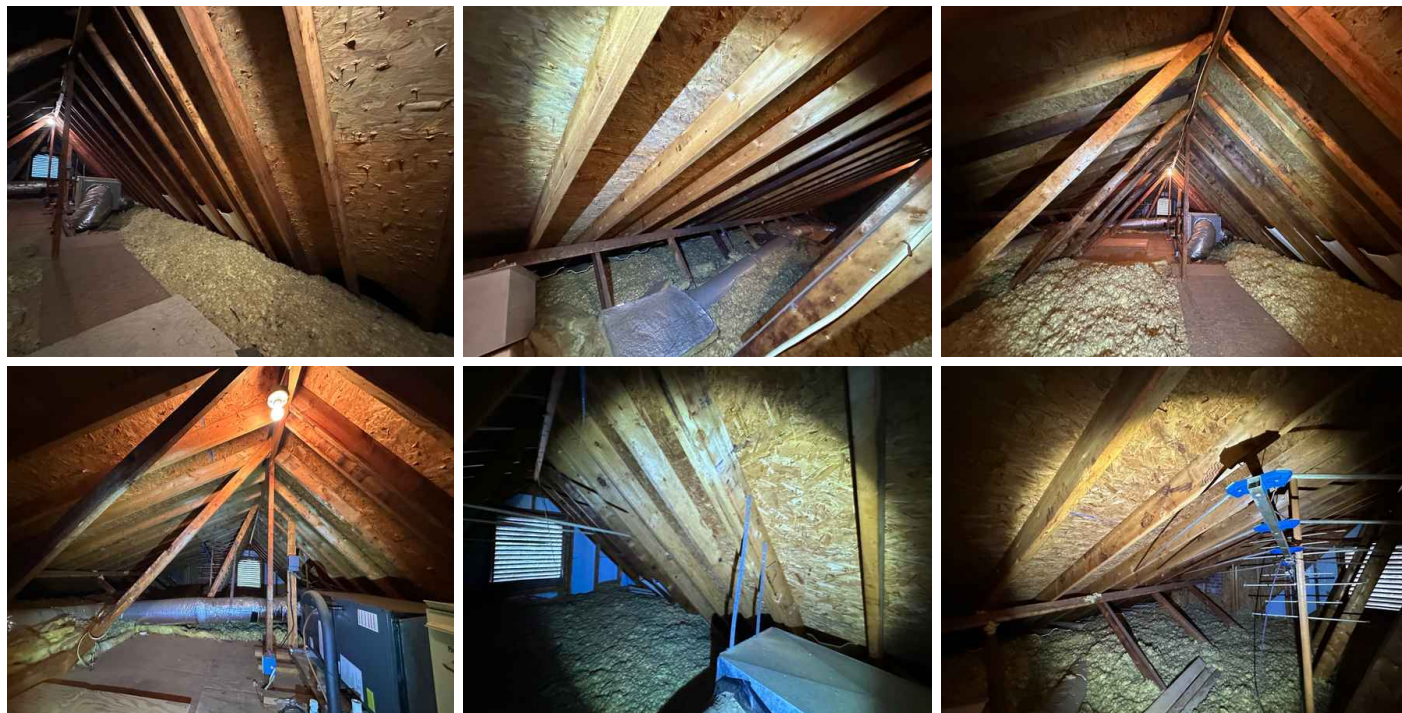
**Roof/Ceiling Structure: Structure Type**

Stick Built, OSB Sheathing

The roof structure was inspected at visible portions looking for any signs of moisture infiltration, damage, or other deficiencies.

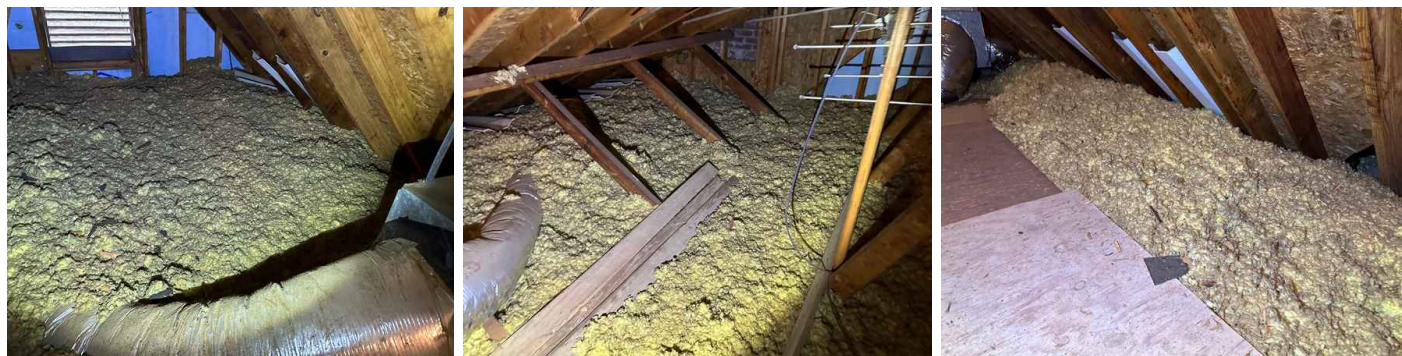
**Insulation: Insulation Type/Average Depth**

Blown In, 10 to 14 inches, Standard for this area is R-30

The insulation was inspected to determine the approximate depth and type. Current building standards recommend approximately 10-14 inches of insulation to achieve an R-30 rating. Depending on when the home was constructed anywhere from 8-14 inches may be present.

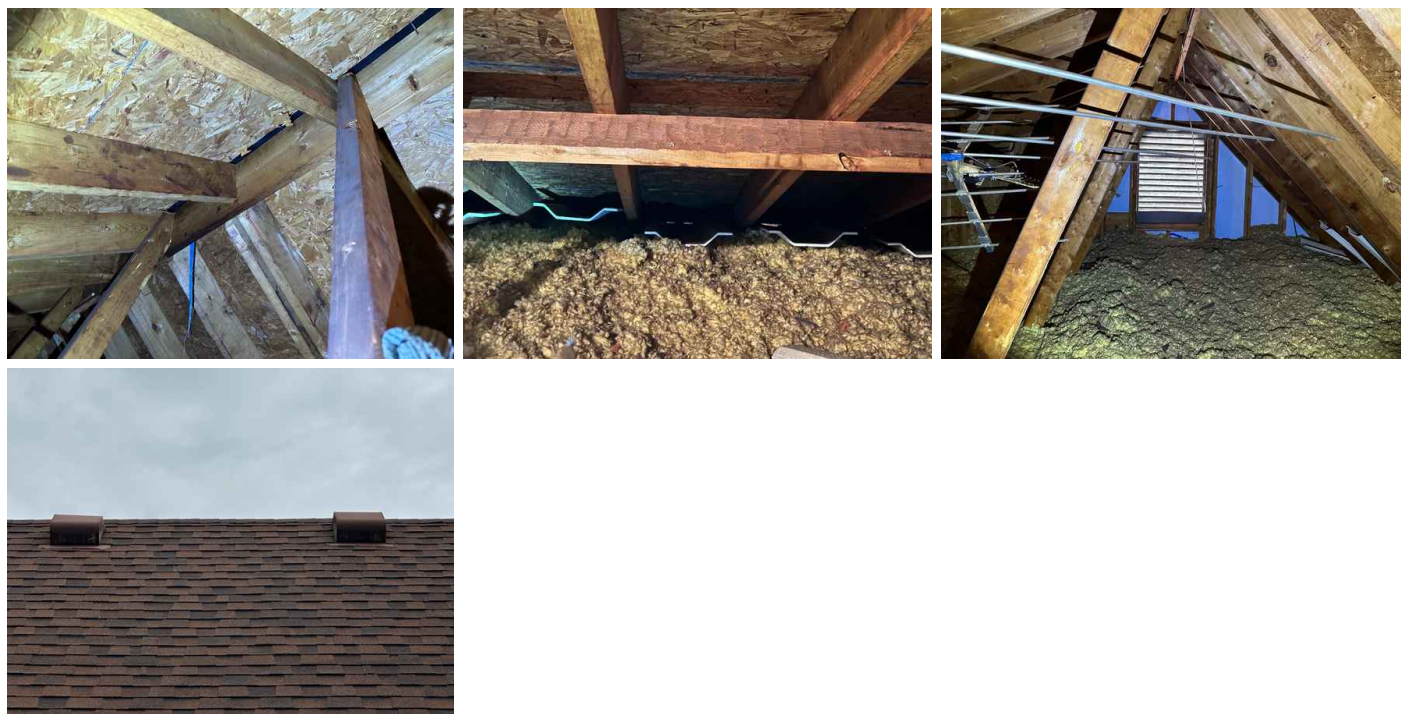
## Ventilation: Ventilation Types

Ridge Exhaust Venting, Soffit Inlet Vents, Gable Vents, Fixed Roof Deck Vents

The attic ventilation was reported on by a visual inspection of the above designated ventilation sources, and looking for indications of improper ventilation. Measurements of ventilation sources are beyond the scope of a home inspection and were not conducted.

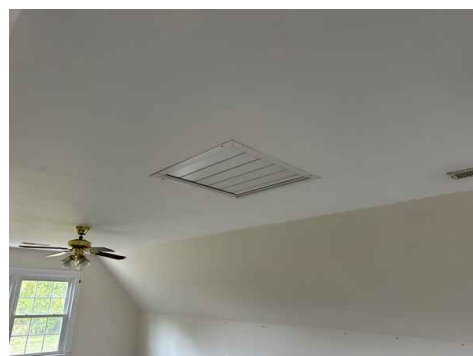
## WHOLE HOUSE FAN - CONTROL NOT FOUND

What appeared to be a whole house fan in the bonus room was not tested as controls could not be found. This area of the attic was inaccessible, so it was not able to be inspected from the attic.

Contact a qualified professional.

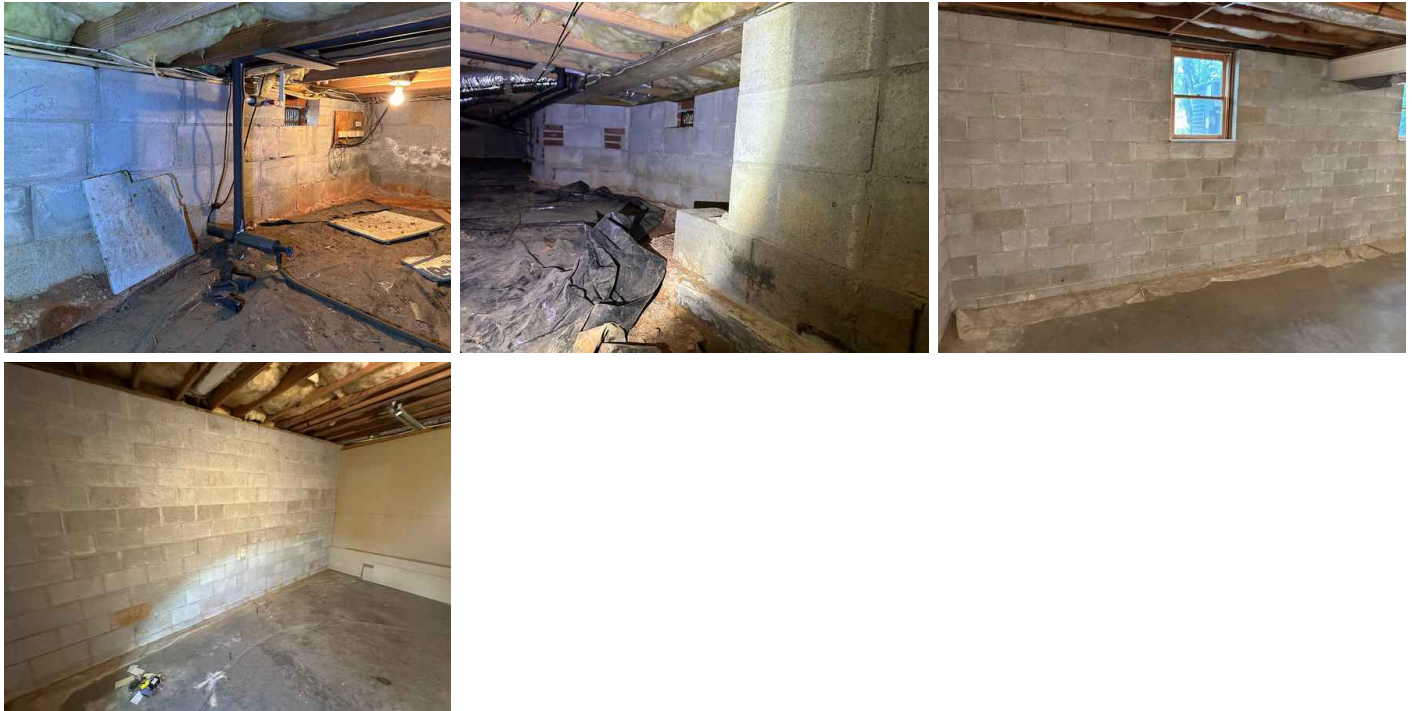
## Foundation Walls: Foundation Wall(s)

### Cinder Block

Visible portions of the foundation walls were inspected looking for significant cracking, moisture intrusion, or any other indications of damage or significant deficiencies.

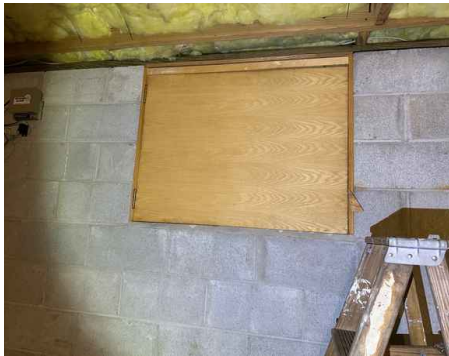
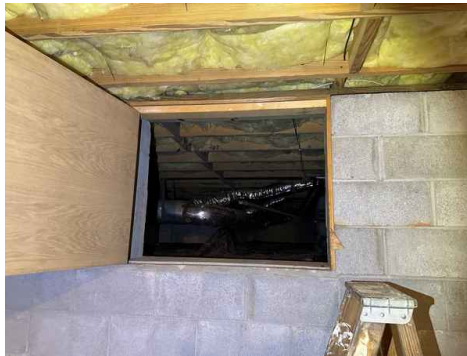
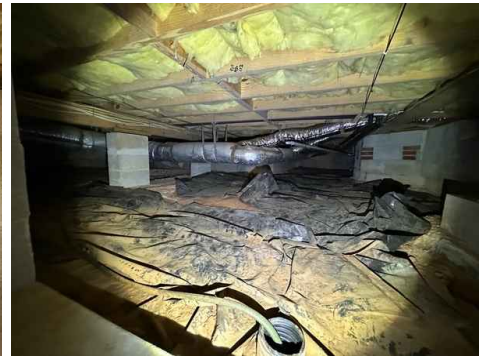
Basement, Wood Framed Access, Crawled

The crawl space area was inspected where possible. I make every attempt to inspect around the perimeter of the crawl space and then throughout the crawl space evaluating areas for moisture intrusion, damage, or other deficiencies. Inherently there are often areas that are either physically or visually inaccessible due to referenced obstructions and/or clearance issues. A percentage of the amount of the crawl space that was safely and visually accessible will be listed above. The inspection of the crawl space area is limited to visual portions only, and any items or areas not visually accessible are excluded from this inspection.

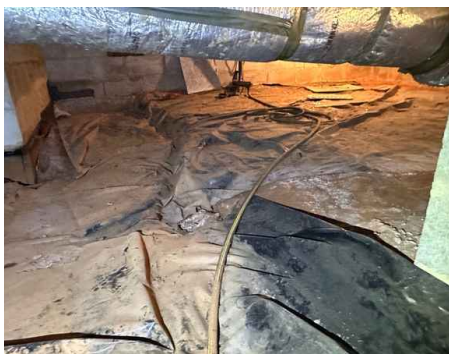
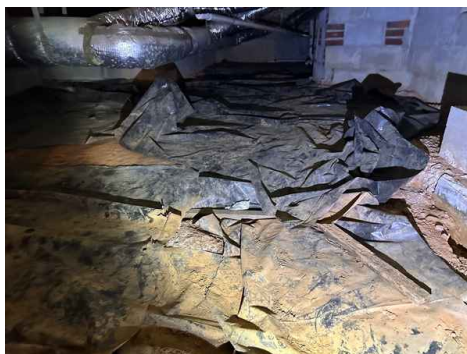
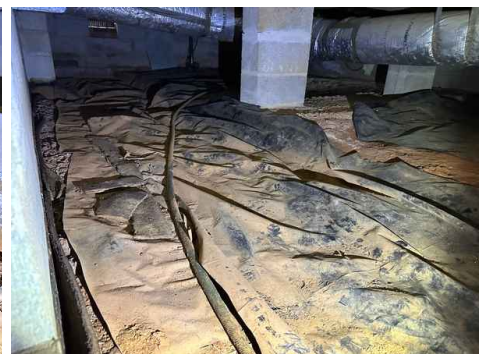
Vapor Barrier Present

Vapor barriers also called ground covers (if present) are inspected to ensure they cover the entirety of the soil in the crawl space, that they are not damaged or dry rotted, and contain no gaps.

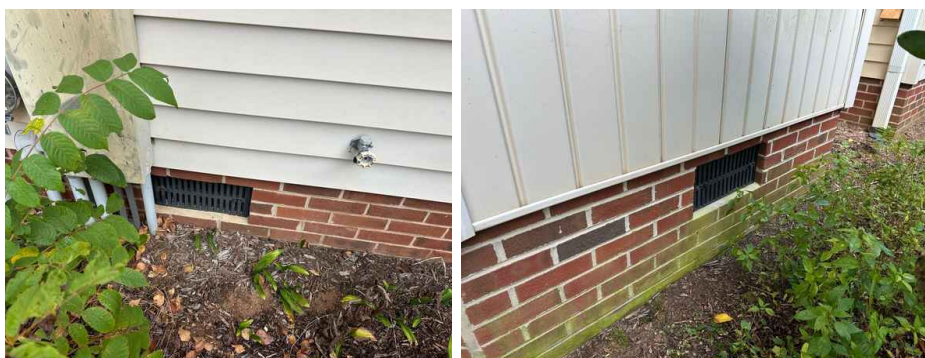
**Ventilation: Ventilation Information**

The crawl space ventilation was reported on by stating its presence and looking for indications of improper ventilation. No reportable conditions were present at the time of inspection unless otherwise noted in this report.

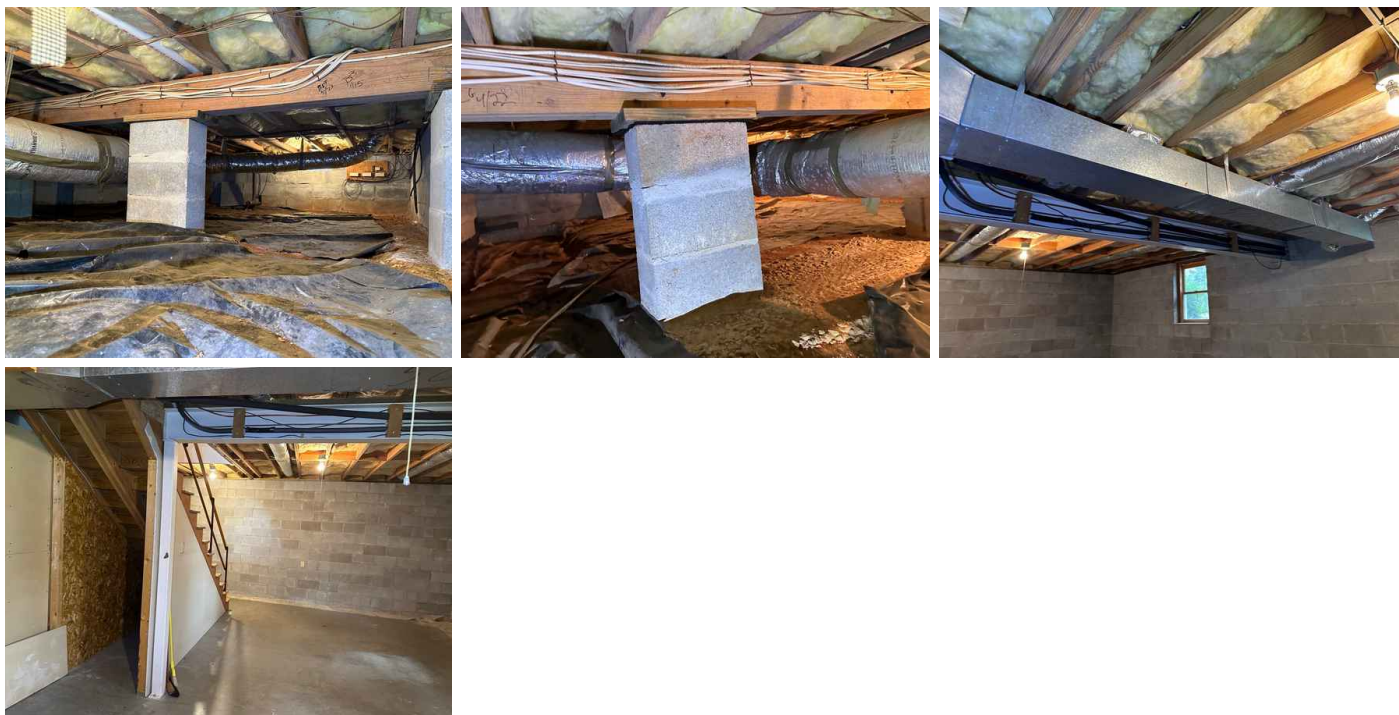
**Columns and Beams: Columns and Beams**

Steel Columns, CMU Columns, Wood Beams, Metal Beams

The floor structure support(s) were inspected at visible portions looking for significant defects.

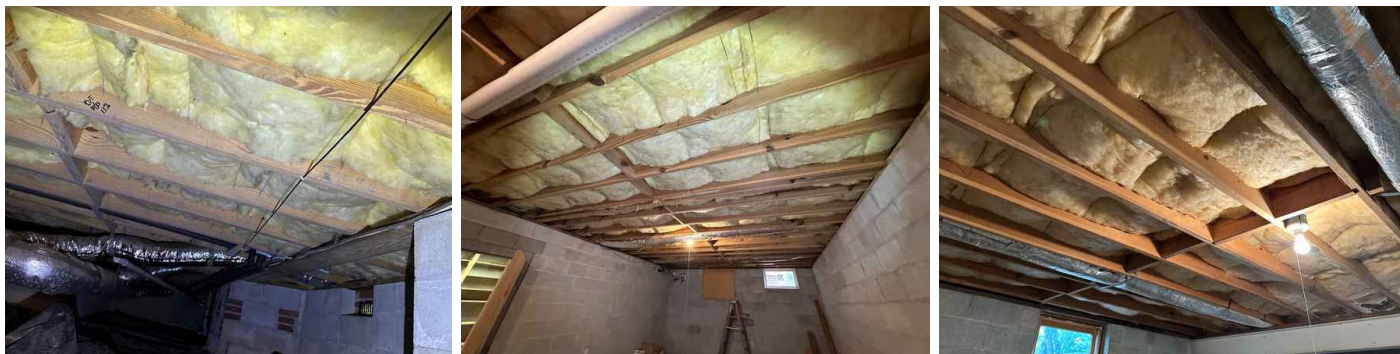
## Floor Structure: Floor Structure

Wood Floor Joist, Upper Level Not Visible

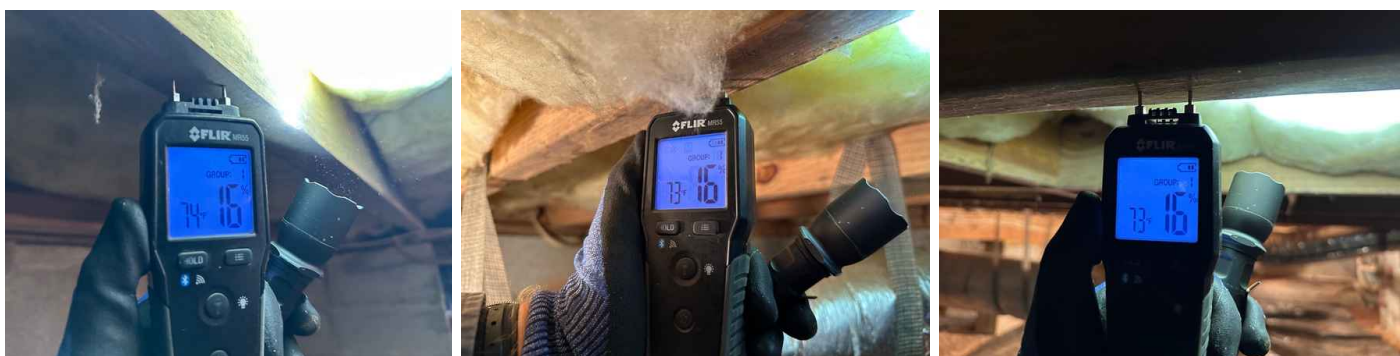
## Floor Structure: Moisture Readings - Within Normal Range

At the time of inspection wood moisture content was measured below 20%. According to state standards, this is considered acceptable. Moisture content will vary throughout the year as humidity and weather conditions change. Thus why it is important to monitor this measurement as it is an early indicator of potential concerns.

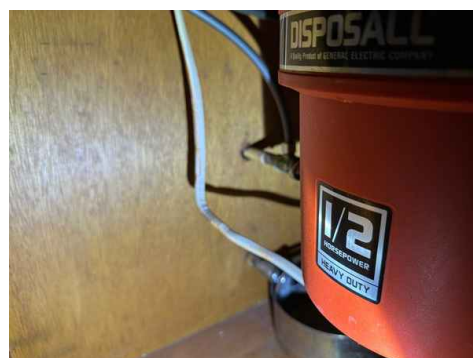
### 6.5.1 Garbage Disposal

**SAFETY CONCERN:** Romex wiring is present. Romex is prone to nicking and this area is commonly associated with storage. Recommend installation of protective covering for safety.

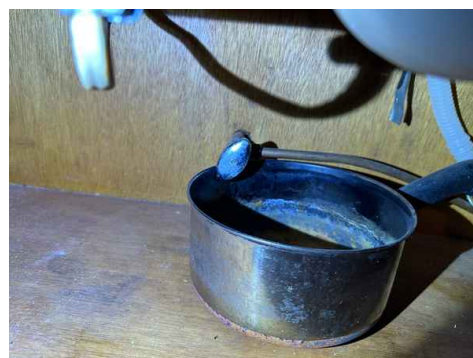
### 6.6.1 Dishwasher

#### WATER VALVE OFF - NOT TESTED

The water valve for the dishwasher was in the "off" position and the dishwasher was not inspected for functionality. I recommend confirming proper operation prior to closing.

A leak was present at the valve. Recommend repair.

**Repaired by licensed plumber on 10/9/2025- see attached invoice**

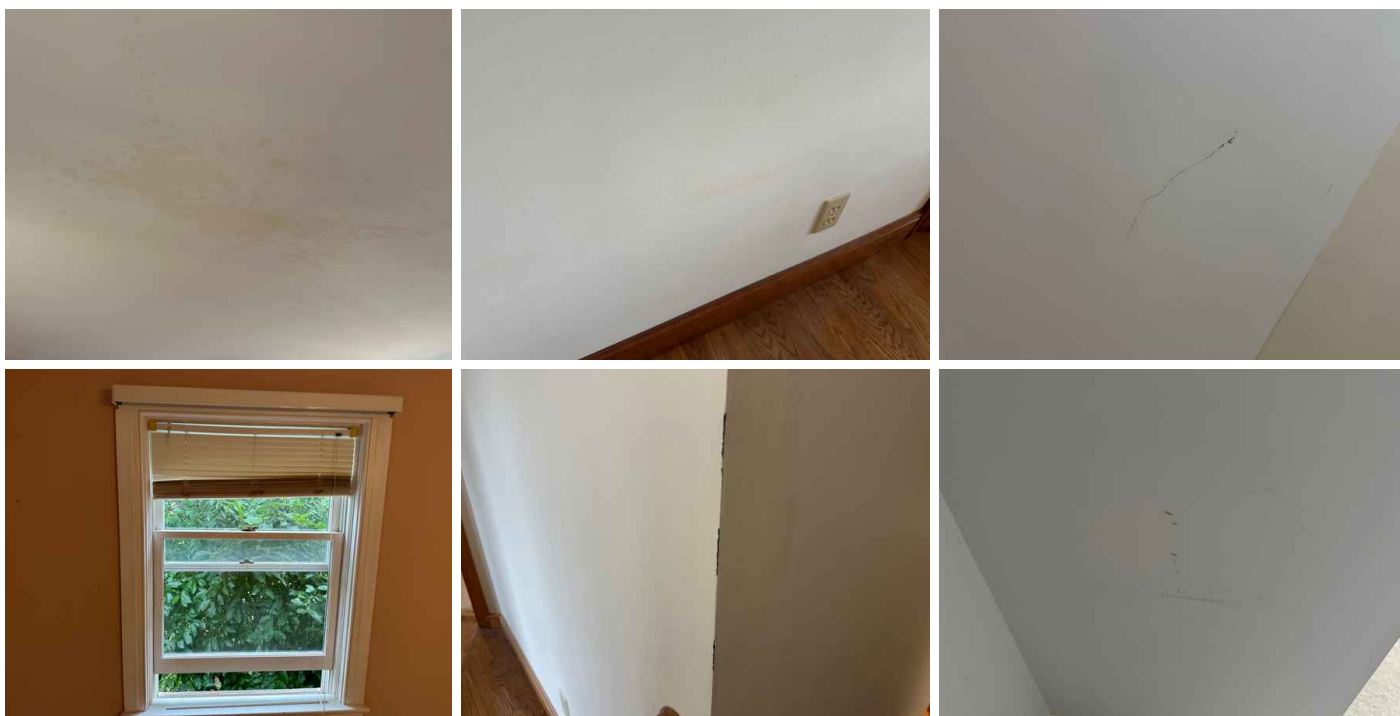
Throughout

## Walls/Ceilings: Cosmetic Deficiencies

**FYI** - Cosmetic deficiencies were present to wall, floor, and/or ceiling surfaces.

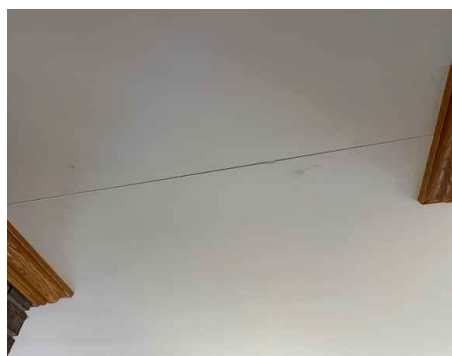
### **Kitchen**

## **Walls/Ceilings: Cracking Present on Walls/Ceilings**

**FYI** - Cracking was present on the wall(s) and/or ceiling(s). Some cracks in homes may be present due to standard settlement of the structure and/or expansion and contraction; but if the cracking is accompanied by sloping or un-level floors, binding doors, or settlement cracking on foundation walls, a structural problem may exist. Evaluation of the structure by a structural engineer is recommended if cracks are present with any accompanying signs of settlement.

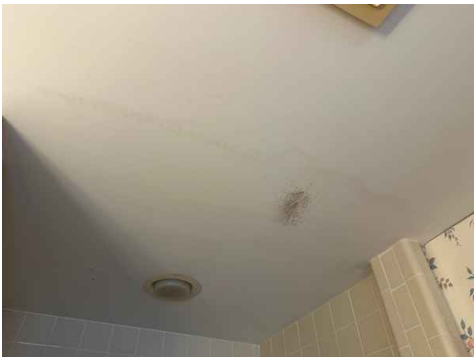
7.3.2 Walls/Ceilings

PEELING PAINT PRESENT

An area of peeling paint was present on the ceiling, and the cause could not be determined. I recommend consulting with the sellers.

Contact the seller for more info

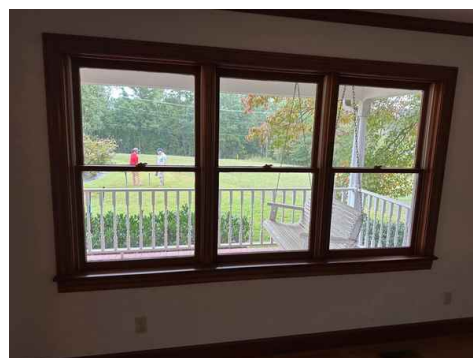
#### 7.7.2 Windows

### MOISTURE/CONDENSATION DAMAGE PRESENT

There were windows present with moisture damage to the interior sash and frames that is typically associated with condensation forming on the inner pane of glass. Repairs to any affected areas is recommended.

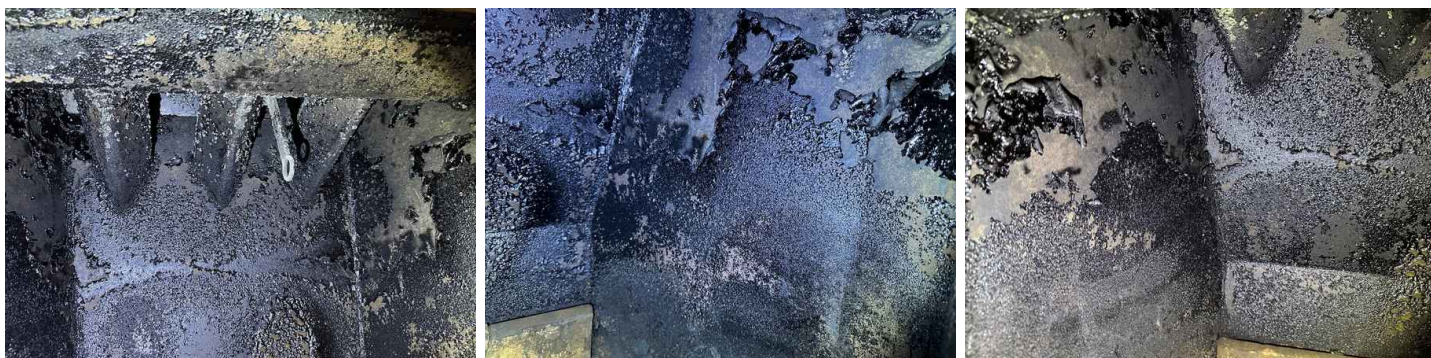
Repair/Replace**CREOSOTE BUILD-UP**

Some degree of creosote build-up was present at visible portions of the firebox and flue. Maintenance and cleaning is recommended to be performed by a chimney sweep.

Contact a qualified fireplace contractor.

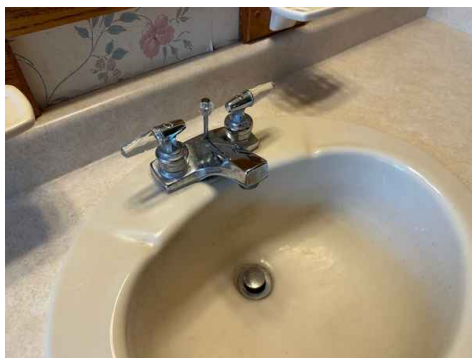
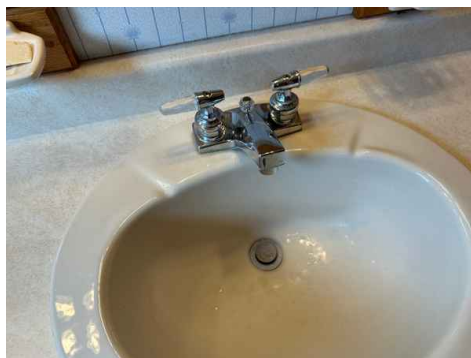
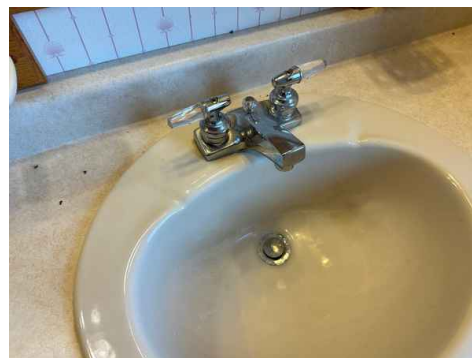
### 8.3.1 Bath Sinks

Repairs are recommended

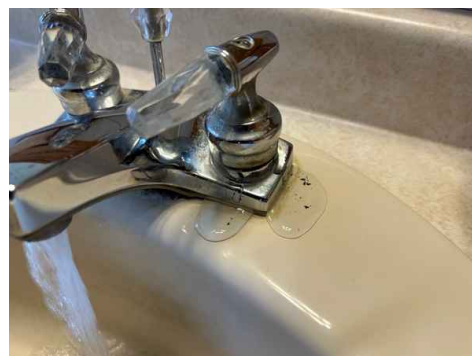
### 8.3.2 Bath Sinks

#### LEAK PRESENT FROM FIXTURE BASE

Leaking was present from the faucet/fixtures base. Repair to rectify the leaking is recommended.
