PRO-TECH INSPECTIONS

## WHOLE HOME INSPECTION

711 E Suber Rd  
Greer, SC 29650

Mike MacGregor  
09/25/2025

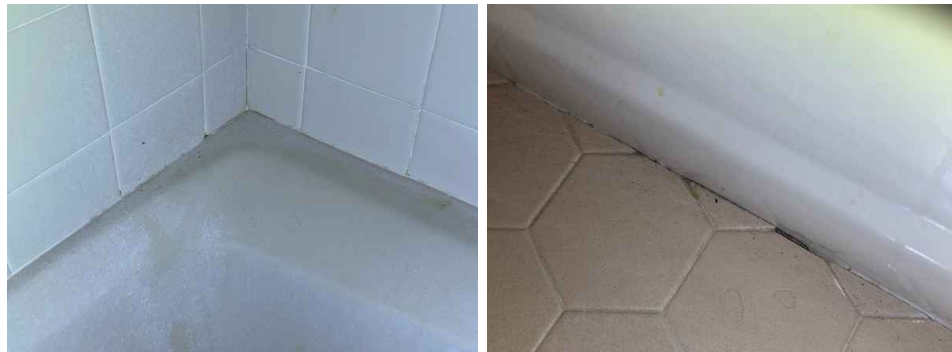
## 8.5.1 Tub(s)

Gaps were present where the bathroom floor transitions to the tub. Sealing the area where the floor transitions to the bathtub is recommended to prevent water intrusion to the subfloor below.

Contact a qualified professional.

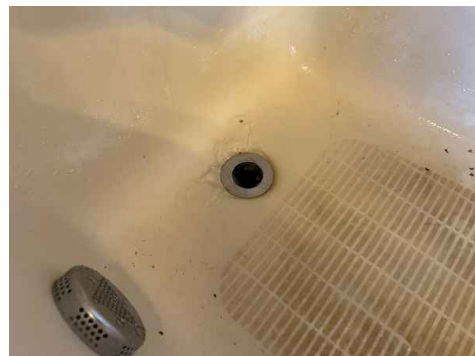
## 8.5.2 Tub(s)

**STOPPER MISSING**

A stopper / pop-up was not present in the tub. The installation of a proper stopper is recommended.

Contact a qualified professional.

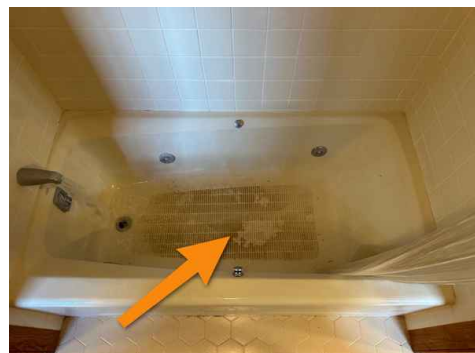
## 8.5.3 Tub(s)

**DAMAGE TO FINISH**

Minor damage was present in the finish of the tub. Repairs are recommended.

Contact a qualified professional.

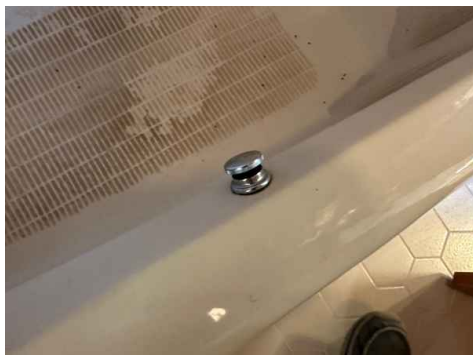
## 8.5.4 Tub(s)

The jetted tub motor was not functional at time of inspection. Repairs are recommended for proper operation.

Contact a qualified electrical contractor.

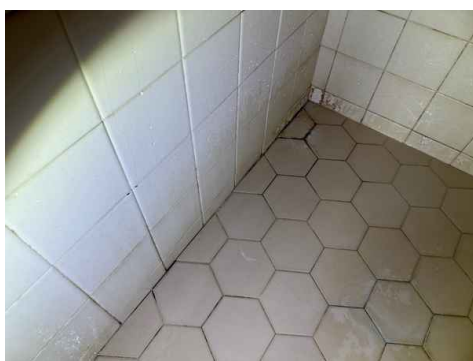
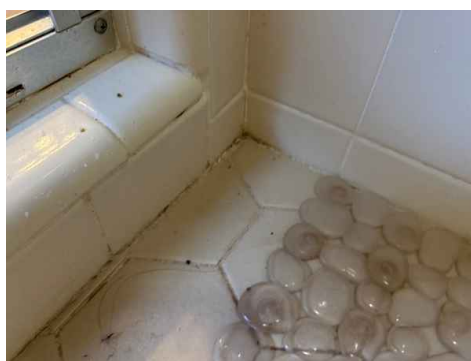
### 8.6.1 Shower(s)

## CAULKING/GROUT RECOMMENDED

Failure to keep shower walls sealed can cause deterioration and extensive moisture damage to the interior walls and surrounding sub-flooring. This damage is not always visible or accessible to the inspector at the time of inspection.

Contact a qualified professional.

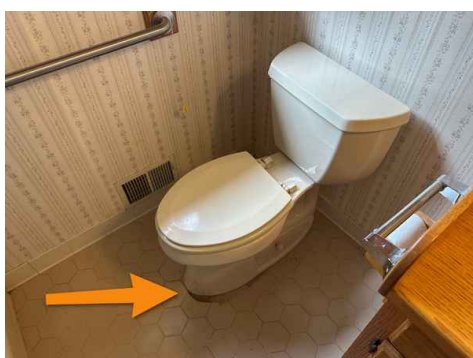
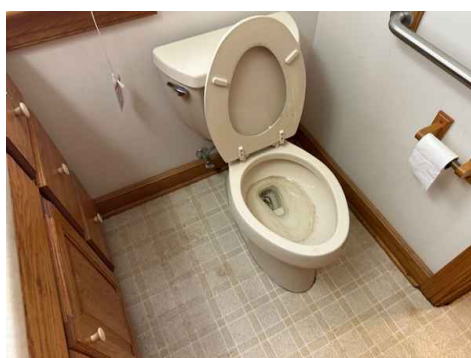
### 8.7.1 Toilet(s)

## TOILETS NOT TESTED

The main level toilets were not tested as one was shifted and not attached at the base, and the other had a known leak. Recommend repair and verification of proper function.

Contact a qualified professional.

**Repaired by  
licensed plumber on  
10/9/2025-see attached  
invoice**

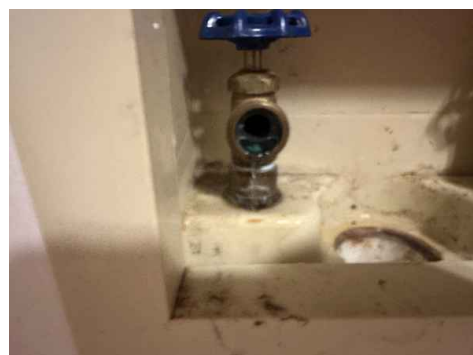
### 9.2.1 Laundry Appliances

#### VALVE(S) LEAKING

A drip leak was present from the water valve(s). Repairs are recommended to rectify any leaks.

Contact a qualified professional.

**Repaired by licensed plumber on  
10/9/2025-**

**see attached invoice**

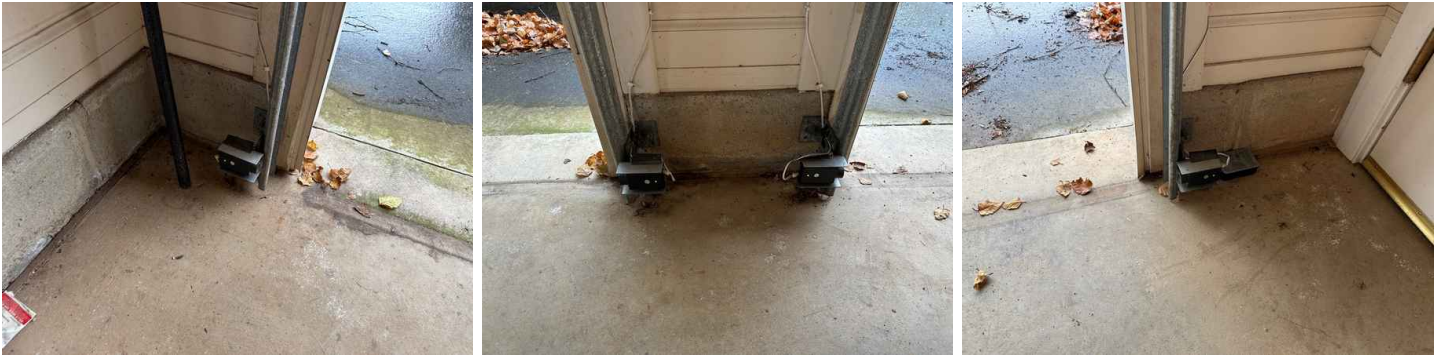
The photoelectric eye sensors were installed too low. These sensors are recommended to be installed between 6 and 8 inches from the floor (dependent on manufacturer). Repairs are recommended to achieve the proper height.

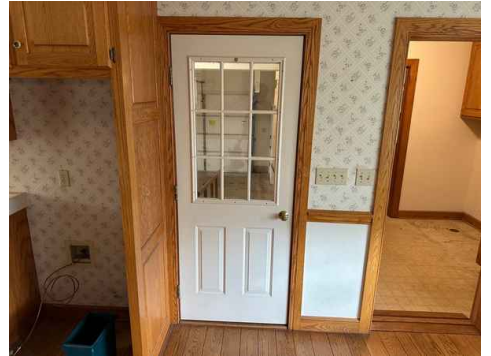
#### 10.7.1 Fire Door

### SEPARATION DOOR CONTAINS GLASS

**SAFETY CONCERN:** The door between the garage and living areas contained glass. This prevents the door from providing proper separation from the garage area in case of a garage oriented fire. A steel or solid wood door measuring at least 1 3/8" thick is recommended.

Contact a qualified door repair/installation contractor.

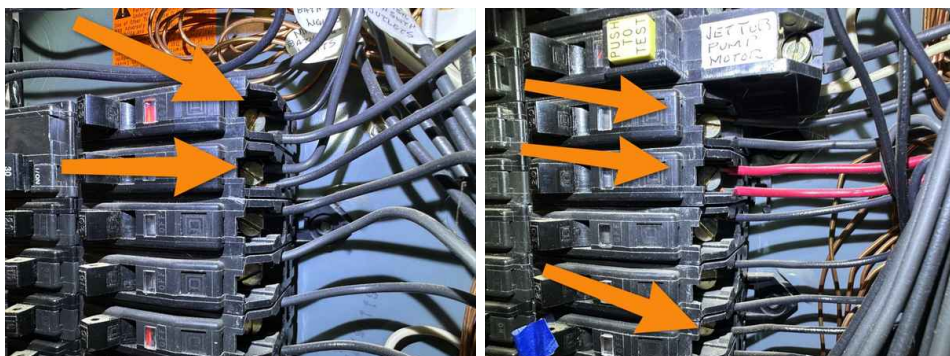
**SAFETY CONCERN:** "Double Tapping" observed on one or more circuit breakers--two wires on single breaker. These breakers appear not to be rated for double tapping. Qualified electrician repair.

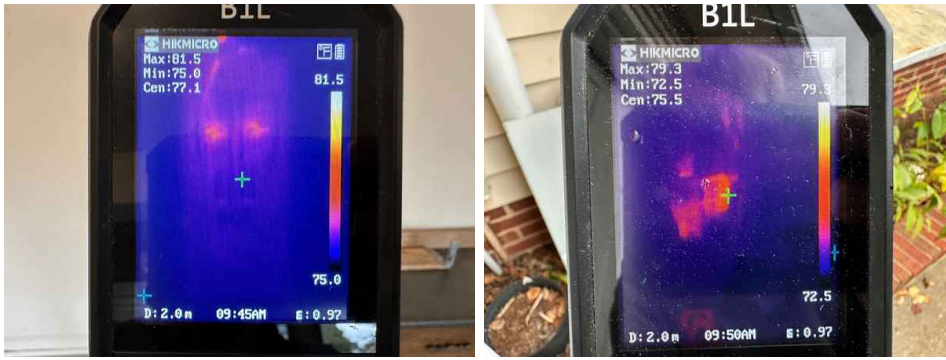
### 13.5.2 Main Service Panel

## NO THERMAL HOT SPOTS OBSERVED - INFRARED

No hot spots were observed with an infrared camera in the distribution panel(s), under current loading conditions at the time of inspection.

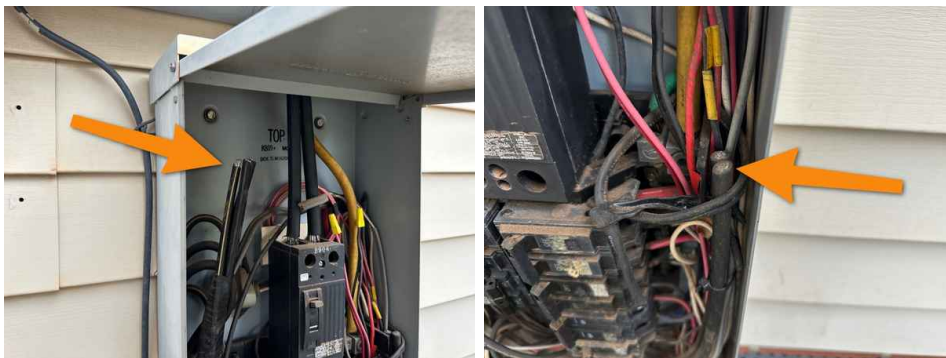
### 13.7.1 Distribution Wiring

## WIRING - EXPOSED TERMINATIONS PRESENT

**SAFETY CONCERN:** There were exposed wiring terminations/exposed wire ends present at the referenced area(s). Any exposed wire termination (live or not) in the home are recommended to either be removed, or terminated into a junction box.

Contact a qualified electrical contractor.

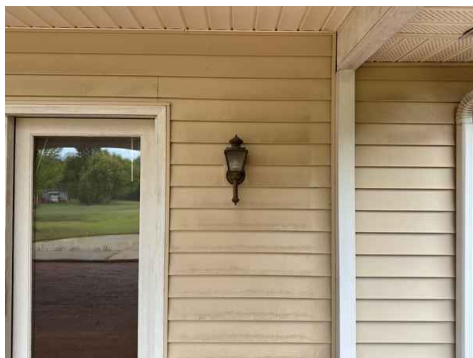
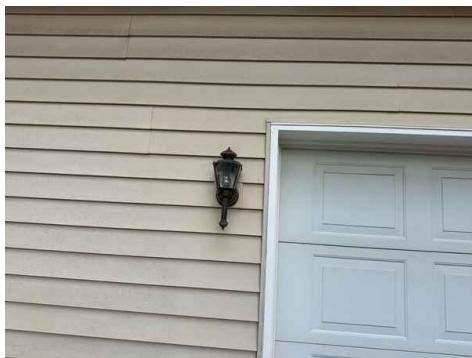
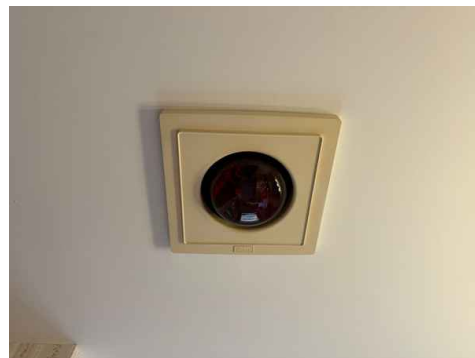
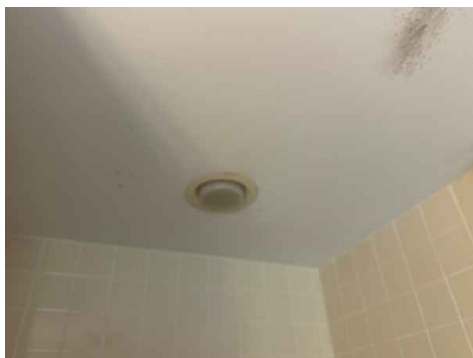
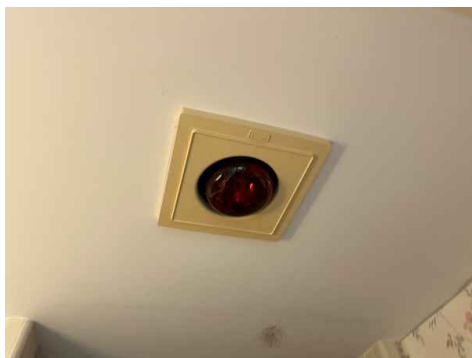
### 13.8.1 Switches, Lights, and Receptacles

## LIGHT(S) NOT FUNCTIONAL

There were light(s) present that were not functional. This could be something as simple as a burned out or missing bulb, a hidden or unknown switch that controls it, or be more extensive. I recommend confirming proper operation with the sellers prior to the end of your inspection contingency period. If these lights can not be verified to be functional prior to closing, repair as needed for proper operation is recommended.

**All light bulbs have been replaced**

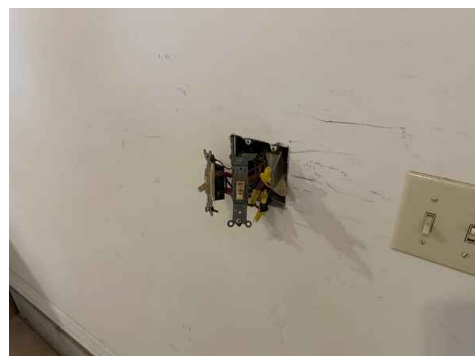
### 13.8.2 Switches, Lights, and Receptacles

**SAFETY CONCERN:** Unsecured switches were present. This is a safety hazard as the wiring connection can be compromised if the receptacle is disturbed. Proper mounting of the switches is recommended.

Contact a qualified electrical contractor.

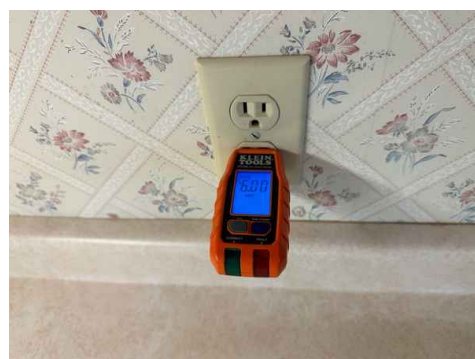
### 13.9.1 GFCI Protection

#### **GFCI PROTECTION NOT PRESENT/FOUND - AGE**

**FYI** - GFCI protection was not present/found at the referenced area(s), at the time of inspection. Likely not required when this home was built. GFCI protection is recommended to be present for the exterior, garage, basement, laundry area, and crawl space receptacles for safety, as well as kitchen and bathroom receptacles within 6 feet of a sink's edge. Repairs or upgrades as needed to ensure GFCI protection is present at all recommended locations for safety is recommended.

Contact a qualified electrical contractor.

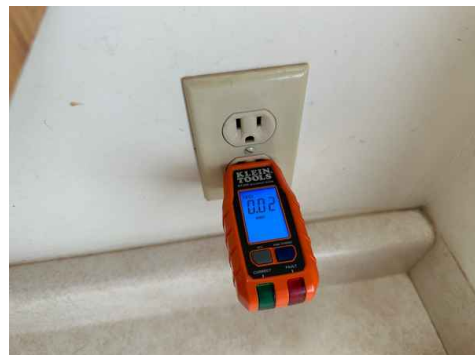
### 13.9.2 GFCI Protection

## NOT ALL BATHROOM RECEPTACLES PROTECTED

**SAFETY CONCERN:** There were bathroom receptacle(s) present that were farther than 6 feet from a sink that were not GFCI protected. This was acceptable when this home was constructed as GFCI protection was required on bathroom receptacles within 6 feet of a sink's edge. Repairs are recommended.

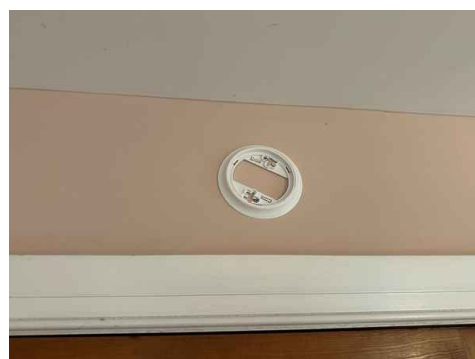
### 13.11.1 Smoke Alarms / Detectors

## SMOKE ALARMS NOT PRESENT AT ALL REQUIRED LOCATIONS

MISSING FROM UPPER LEVEL BEDROOM

**SAFETY CONCERN:** Smoke alarms were not present at all locations required by today's standards (referenced above). The installation of smoke detectors is recommended to be installed at all recommended locations for fire safety.

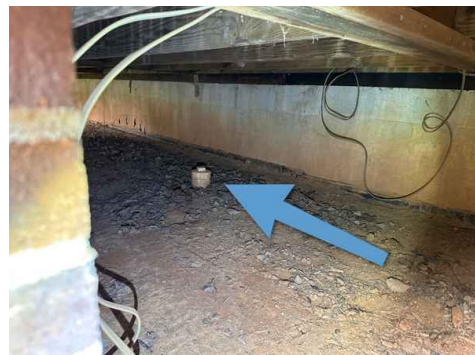
### SEWER SCOPE RECOMMENDED

Sewer lines repairs can be very expensive. The average repair cost nationally is around \$6500.00. Locally, we see more common estimates of \$3-5 thousand. Client is recommended to have a sewer scope performed to determine the condition of the underground sewer lines, which are not visible to the Inspector, from the home to the septic tank or municipal system.

Contact a qualified sewer scope inspection

**Sewer Scope  
Inspection  
completed - see  
attached report**

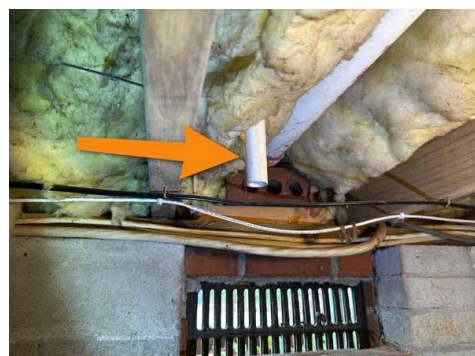
#### 14.5.2 Drain, Waste, and Vent Pipes (DWV)

Disconnected waste pipe(s) were present. The purpose of this pipe could not be determined, though no leaks were present. If a concern recommend review by licensed plumber.

Contact a qualified plumbing contractor.
