SUMMARY

8211 Yorkridge Dr, Newburgh, IN
47630

JoAnn Hendrickson
11/24/2025

Von Lamey
InterNACHI Certified Professional
Inspector, IAC2 Certified Mold Inspector,
NRSB Certified Radon Measurement
Specialist
Precision Home Inspections

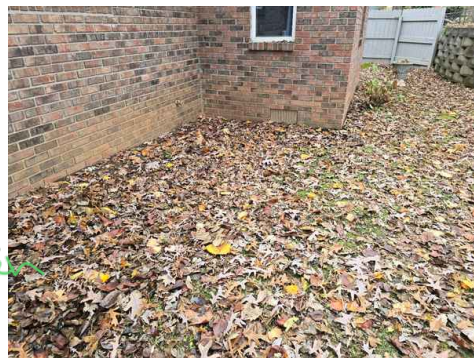
French Drain installed yrs. ago. No water intrusion since, Drain does not require leaves to be kept clear.

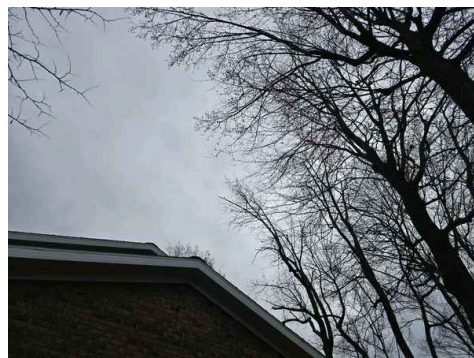
Trees observed overhanging the roof. This can cause damage to the roof and prevent proper drainage. Recommend a qualified tree service trim to help prevent damage.

Seller addressing

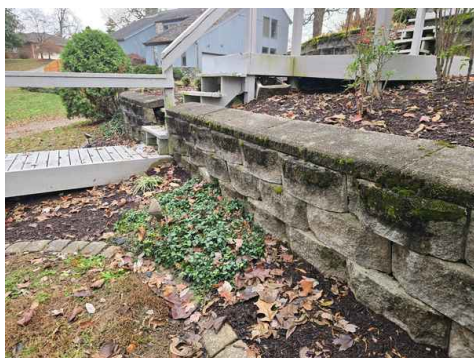
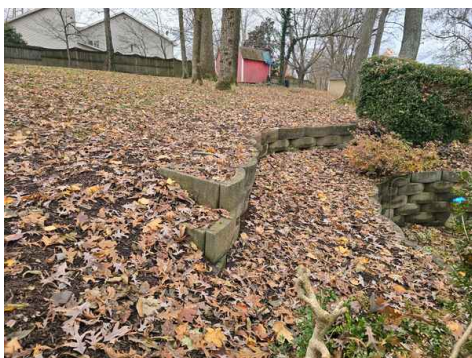
2.6.3 Vegetation, Grading, Drainage & Retaining Walls

Retaining wall was leaning at the time of the inspection. This may indicate the wall was not supported properly when built. This may cause the wall to further deteriorate. Recommend a qualified contractor repair.

Seller reports wall made of 3 parts per piece and not likely to move.

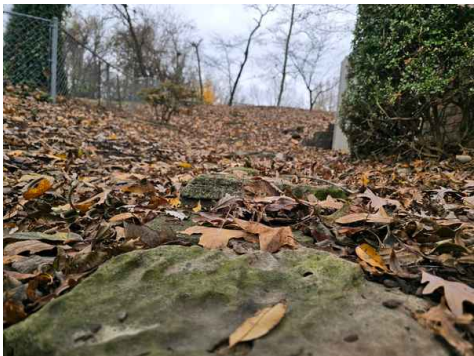
2.7.1 Walkways, Patios & Driveways

WALKWAY TRIP HAZARD

Walkway had areas of elevation that may create a trip/fall hazard. Recommend a qualified concrete contractor repair.

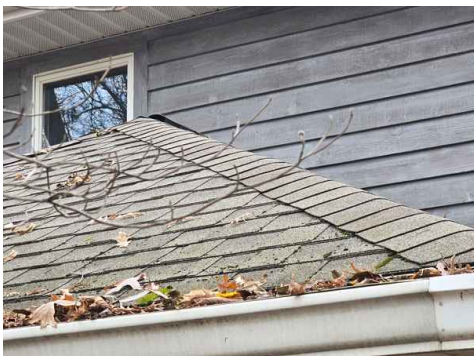
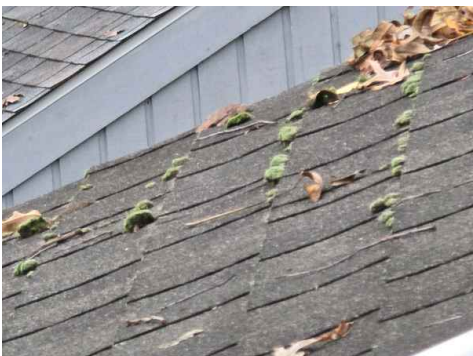
3.1.1 Coverings
ORGANIC GROWTH
FRONT & BACK

Organic growth present on roof covering at the time of the inspection. This can cause moisture to become trapped on the asphalt shingle and reduce the life expectancy of the roof covering. Recommend a qualified roof cleaning company clean the roof surface.

Recommendation
Contact a qualified professional.

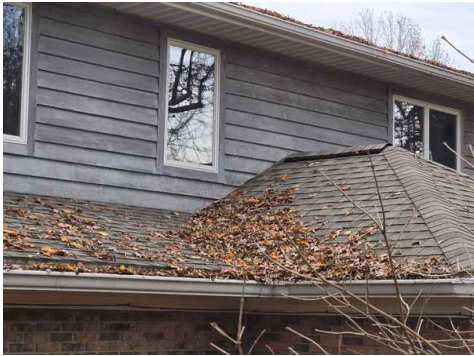
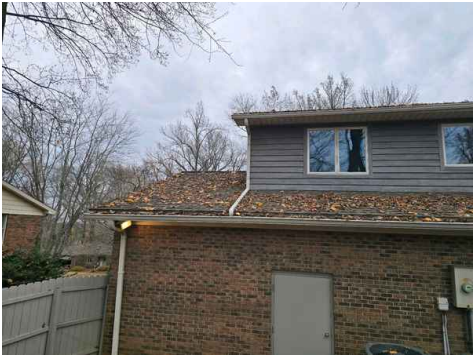
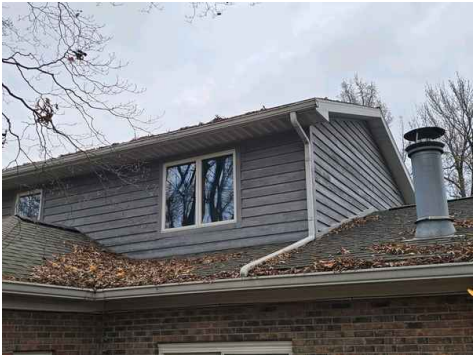
3.1.2 Coverings
TREE DEBRIS
ALL ROOF SURFACES

Roof had tree debris on the surface. Debris can trap moisture on the asphalt shingle and reduce life expectancy. Recommend having debris removed from roof surface.

*Seller addressed
(debris removed)*

Recommendation
Contact a handyman or DIY project

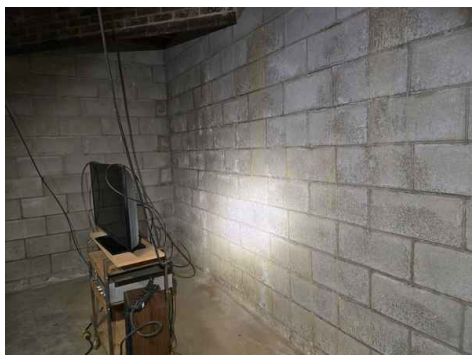
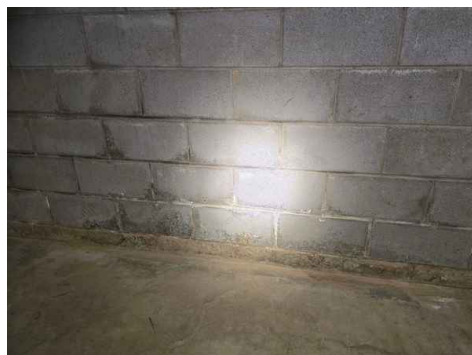
Efflorescence noted on the basement surface. This is a white, powdery deposit that is consistent with moisture intrusion. This can compromise the soil's ability to support the home structure and/or lead to mold growth. Recommend a qualified contractor identify source of moisture and correct.

Treated w/ mold Killer by contractor

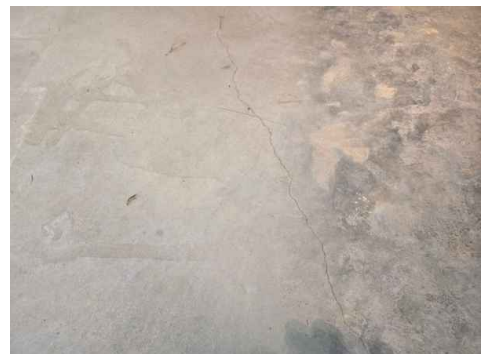
CRACKING - MINOR

Minor cracking was observed on the basement floor structure. Recommend sealing cracks to help prevent moisture intrusion.

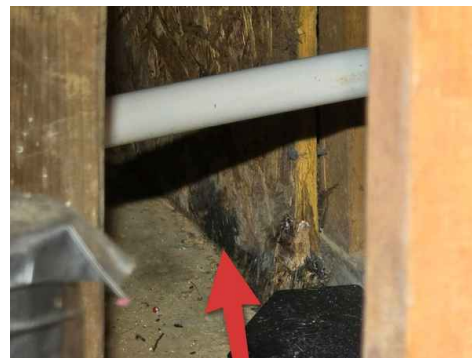
4.5.1 Wall Structure

ORGANIC GROWTH

Observed signs of organic growth on one or more areas in the wall structure. Recommend identifying source or moisture intrusion and sending samples to a lab for testing.

Seller Addressed

**Contractor treated*

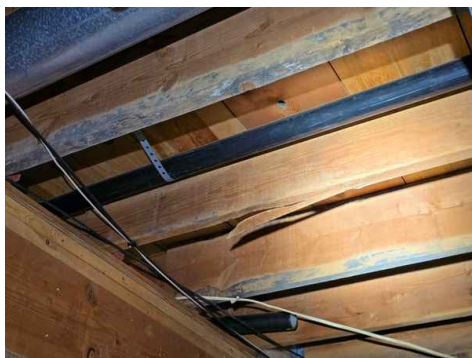
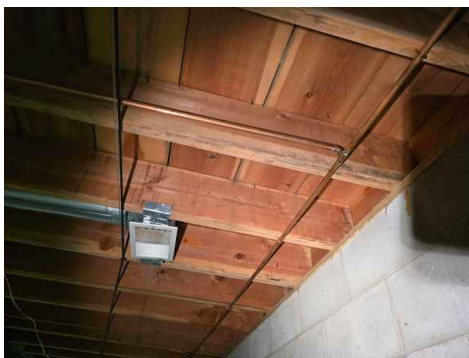
Observed signs of organic growth on one or more areas of the ceiling structure. Recommend identifying source or moisture intrusion and sending samples to a lab for testing.

Seller addressed

**contractor treated*

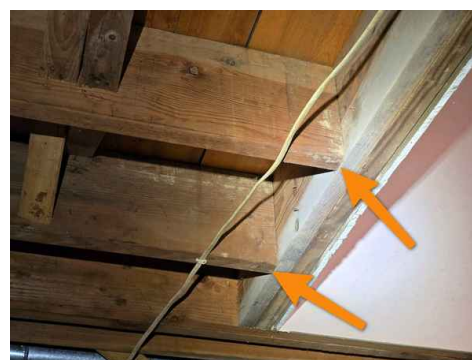
4.6.2 Ceiling Structure

MISSING JOIST SUPPORTS

Joist supports or hangers were missing at the time of the inspection. This may cause weakness in the structure. Recommend a qualified contractor repair.

Seller addressed.

Contractor added hangers

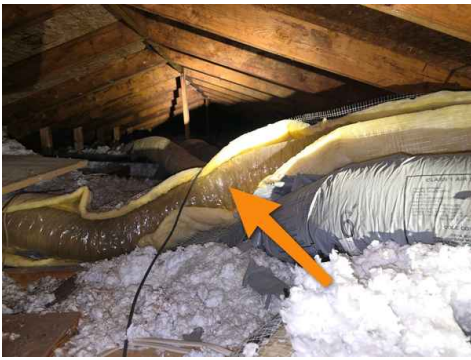
5.3.1 Distribution Systems

INSULATION DAMAGED

Insulation damaged on supply duct. Recommend repairing loose insulation.

Seller addressed.

loose insulation secured

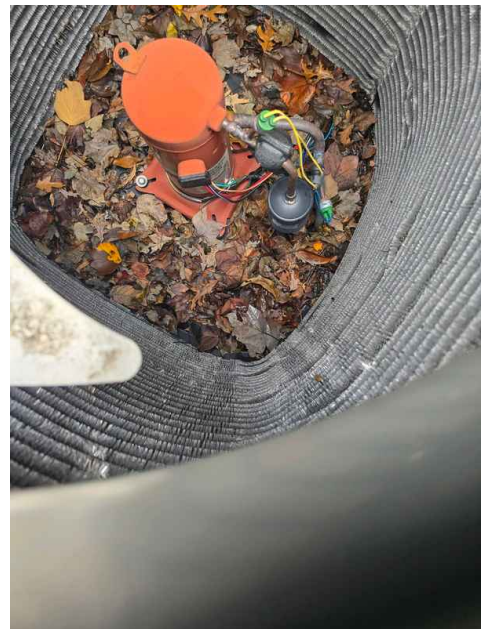
Exterior air conditioning unit was in need of service/cleaning. Recommend a qualified HVAC professional service.

*Seller addressed.
Cleaned*

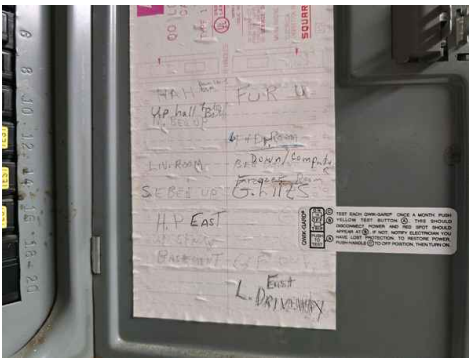
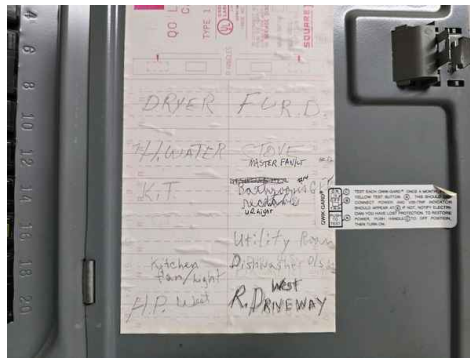
MISSING LABELS ON PANEL

At the time of inspection, panel was missing labeling. Recommend a qualified electrical contractor identify and map out locations.

*seller
addressing*

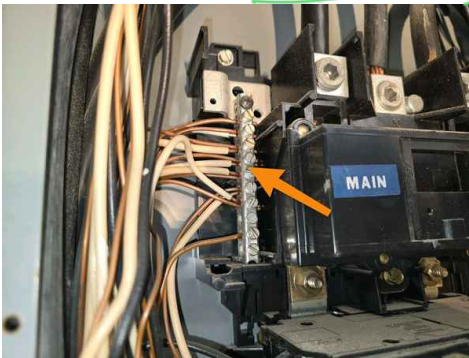
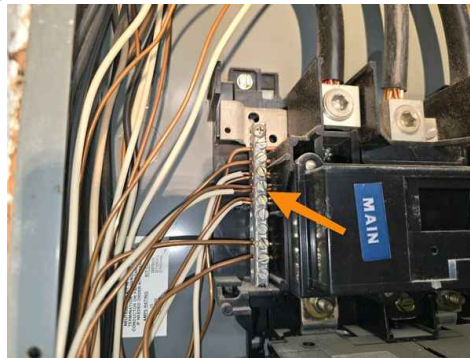
Neutral wires and ground wires were secured under the same lug at the time of the inspection. Neutral wires and ground wires should have their own lug. Recommend a qualified electrical contractor repair.

seller addressing

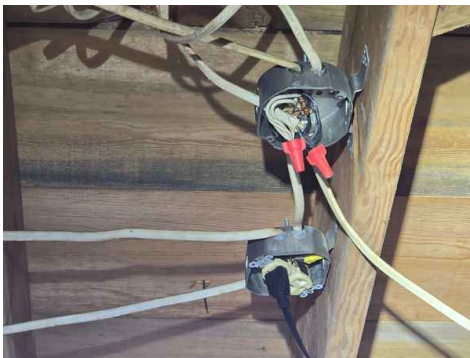
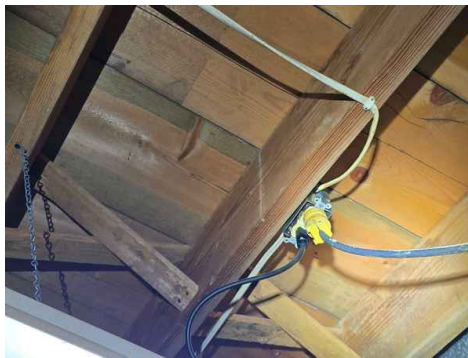
COVER PLATES MISSING

Seller addressed.

Corrected

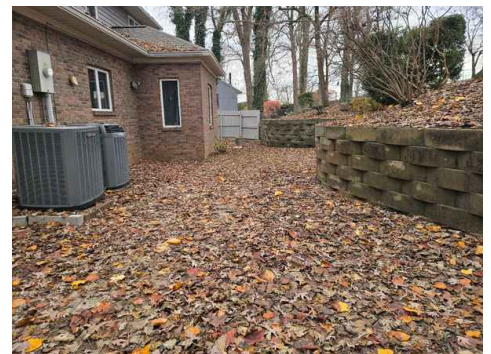
Walkways, Patios & Driveways

NOT OBSERVABLE

Portions of exterior driveway, walkway and/or patio were not viewable.

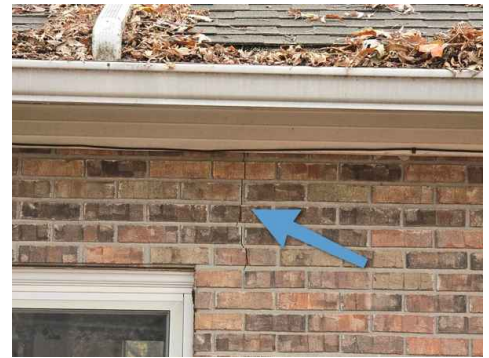
2.2.1 Siding, Flashing & Trim

CRACKING - MINOR

Siding had cracks in one or more places. This may be a result of an impact or temperature changes. Recommend a qualified professional evaluate and repair as necessary.

Seller addressing

(Contractor says needs
to be above 50°)

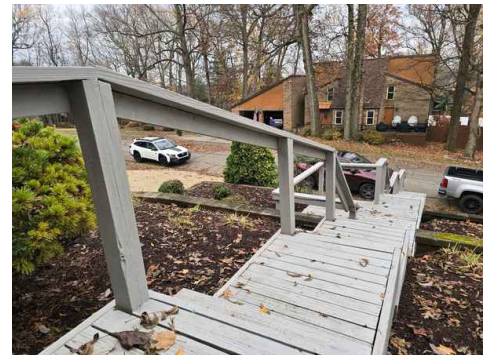
2.4.1 Decks, Balconies, Porches & Steps

NO BALLUSTERS

Balusters were not present on handrails. This can create a fall hazard. Recommend a qualified carpentry contractor install balusters for safety.

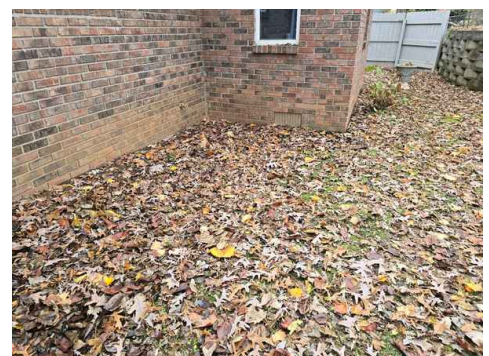
2.6.1 Vegetation, Grading, Drainage & Retaining Walls

NEGATIVE GRADING

Grading was sloped toward the structure in areas. This could lead to water intrusion and foundation issues. Recommend a qualified landscaper regrade so water flows away from home.

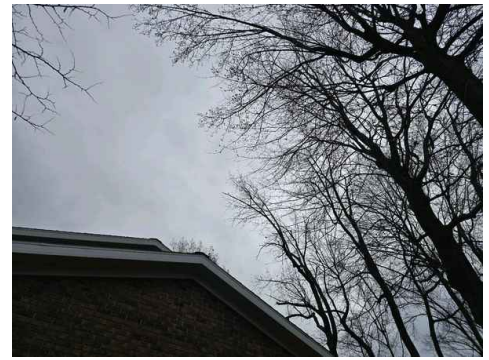
TREE OVERHANG

Trees observed overhanging the roof. This can cause damage to the roof and prevent proper drainage. Recommend a qualified tree service trim to help prevent damage.

Contact a qualified tree service company.

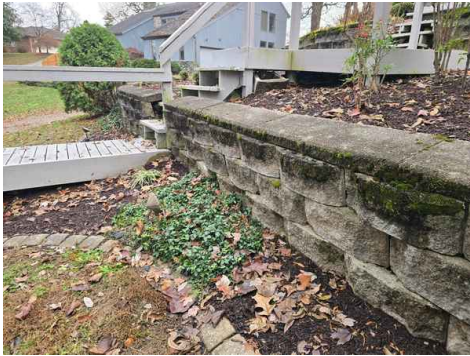
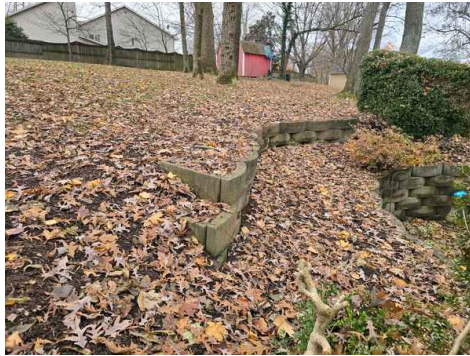
RETAINING WALL LEANING

Retaining wall was leaning at the time of the inspection. This may indicate the wall was not supported properly when built. This may cause the wall to further deteriorate. Recommend a qualified contractor repair.

Contact a qualified professional.

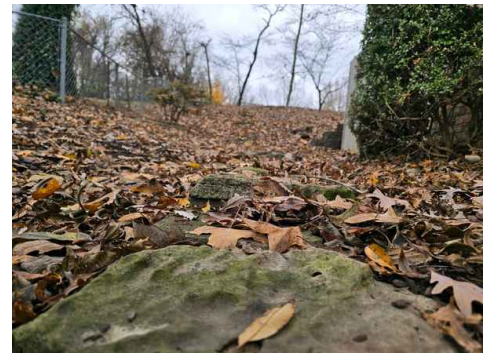
WALKWAY TRIP HAZARD

Walkway had areas of elevation that may create a trip/fall hazard. Recommend a qualified concrete contractor repair.

Contact a qualified concrete contractor.

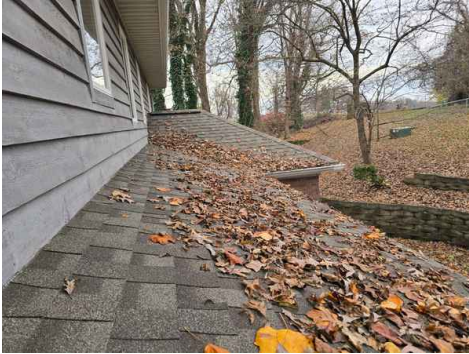
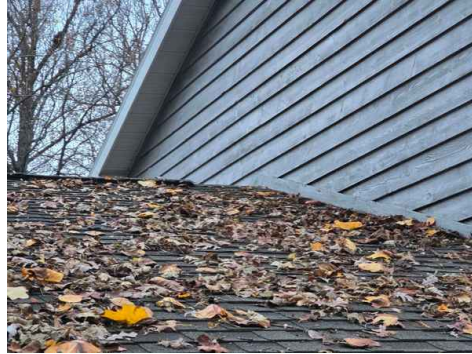
UNSAFE CONDITIONS

Inspector unable to walk certain areas of roof structure. Variables that impact the ability of inspectors to walk roof surfaces include: 1. Weather conditions (high or gusty winds, rain, ice, snow,...); 2. Steep roof slope; 3. Roof decking condition; 4. Roof surface condition (especially metal roofs); 5. Loose/weak gutters; 6. Unstable ground surface that does not allow safe placement of a ladder.

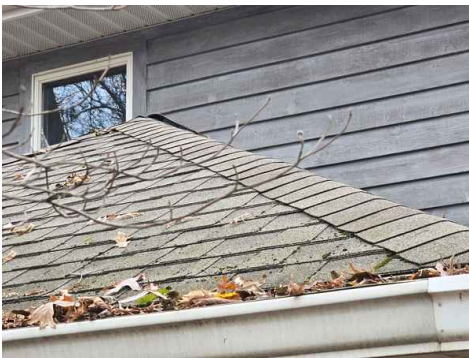
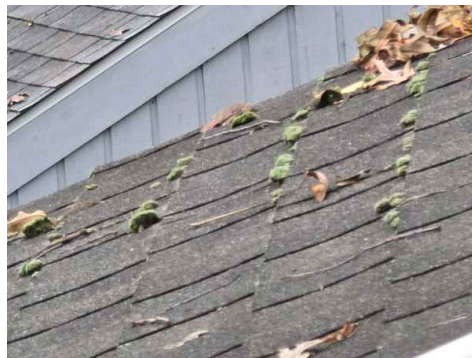
3.1.1 Coverings

Organic growth present on roof covering at the time of the inspection. This can cause moisture to become trapped on the asphalt shingle and reduce the life expectancy of the roof covering. Recommend a qualified roof cleaning company clean the roof surface.

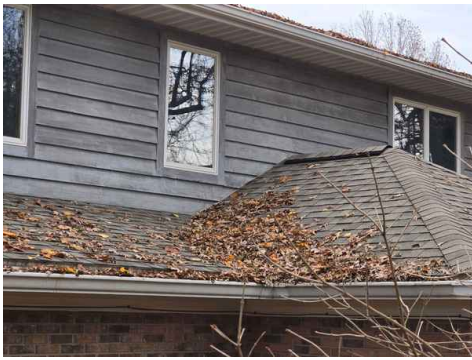
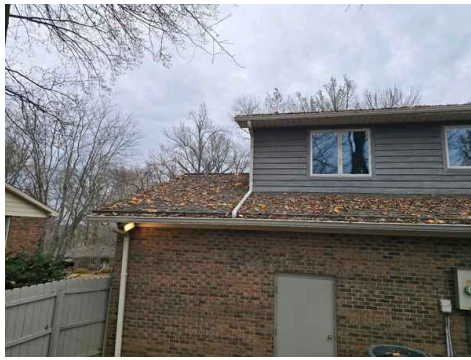
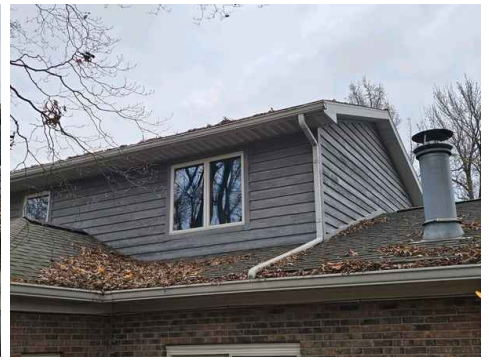
Roof had tree debris on the surface. Debris can trap moisture on the asphalt shingle and reduce life expectancy. Recommend having debris removed from roof surface.

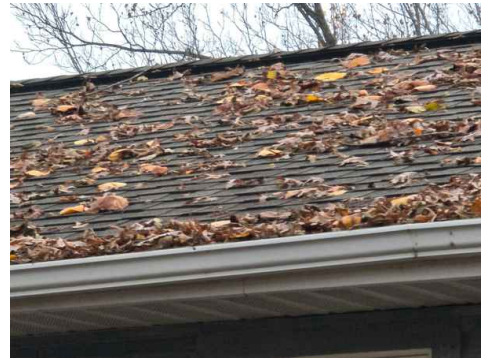
DEBRIS

Debris has accumulated in the gutters. Recommend cleaning to facilitate water flow.

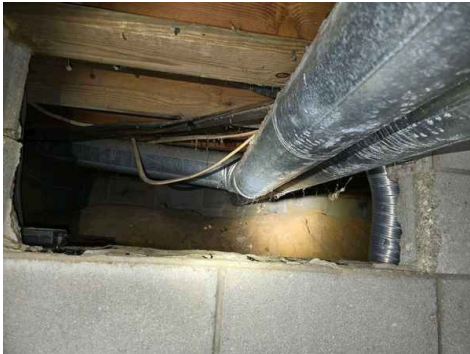
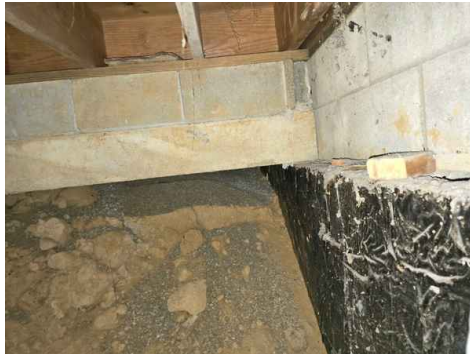
CRAWLSPACE - INACCESSIBLE

Crawlspace opening was not sufficient to safely access the crawlspace.

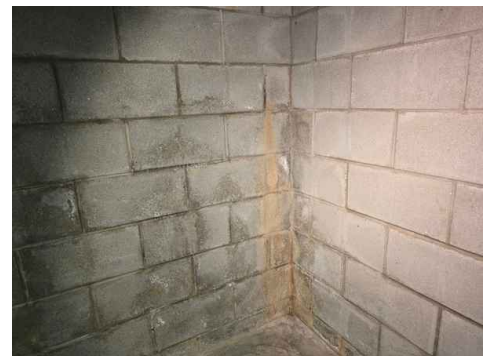
Evidence of moisture intrusion on the surface of the wall in the basement. This can compromise the soil's ability to stabilize the structure. Recommend a qualified contractor identify the source of moisture and remedy.

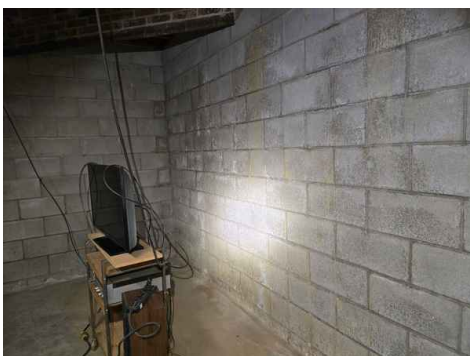
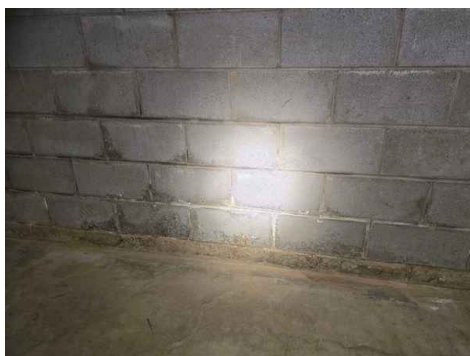
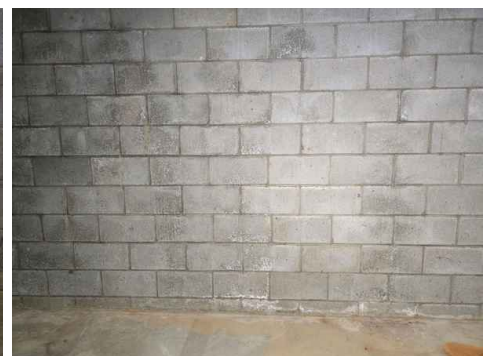
EFFLORESCENCE

Efflorescence noted on the basement surface. This is a white, powdery deposit that is consistent with moisture intrusion. This can compromise the soil's ability to support the home structure and/or lead to mold growth. Recommend a qualified contractor identify source of moisture and correct.

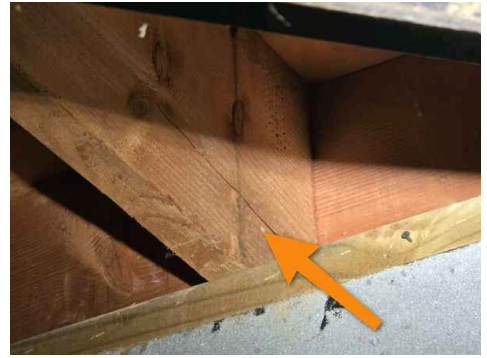
FLOOR JOISTS DAMAGED

Floor joists were damaged at the time of the inspection. This can cause floors to sag and become unlevel. Recommend a qualified carpentry contractor repair.

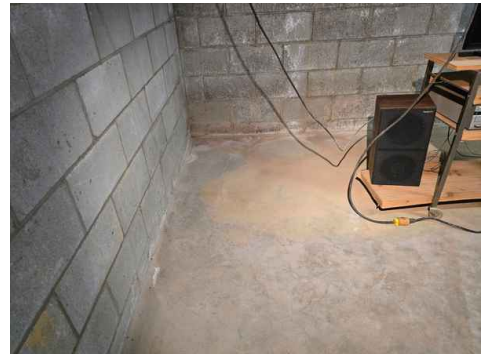
There were signs of water intrusion at the floor structure. Recommend a qualified contractor identify source of moisture and remedy.

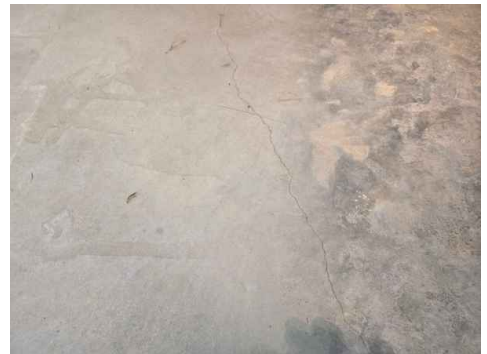
CRACKING - MINOR

Minor cracking was observed on the basement floor structure. Recommend sealing cracks to help prevent moisture intrusion.

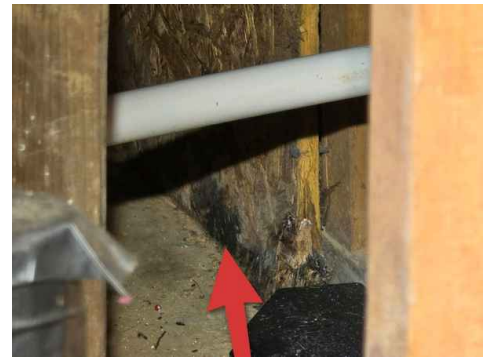
ORGANIC GROWTH

Observed signs of organic growth on one or more areas in the wall structure. Recommend identifying source or moisture intrusion and sending samples to a lab for testing.

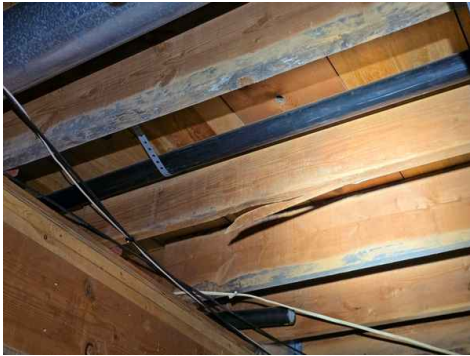
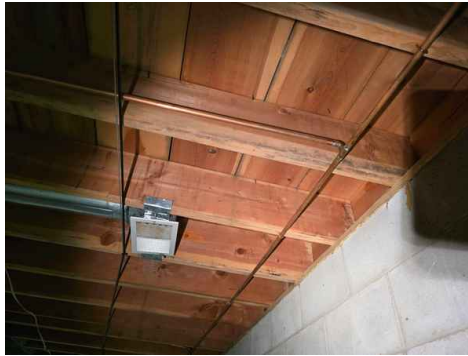
ORGANIC GROWTH

Observed signs of organic growth on one or more areas of the ceiling structure. Recommend identifying source or moisture intrusion and sending samples to a lab for testing.

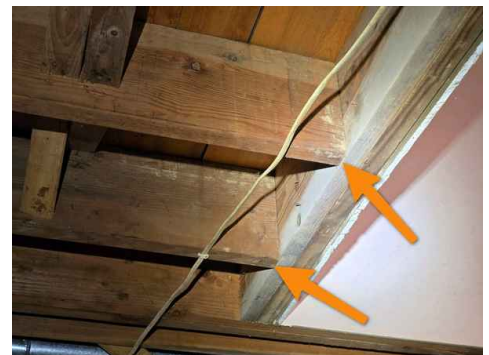
MISSING JOIST SUPPORTS

Joist supports or hangers were missing at the time of the inspection. This may cause weakness in the structure. Recommend a qualified contractor repair.

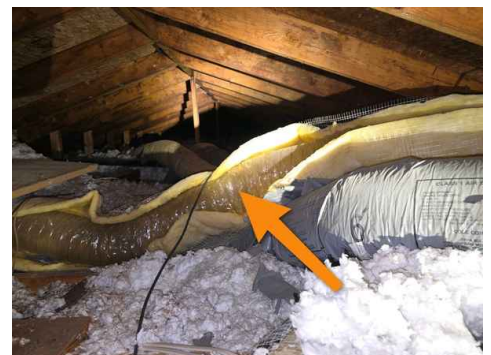
INSULATION DAMAGED

Insulation damaged on supply duct. Recommend repairing loose insulation.

Recommendation

Contact a handyman or DIY project

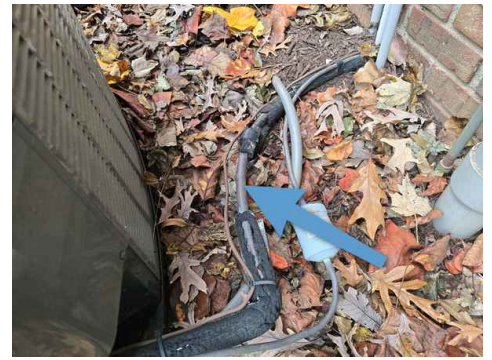
6.1.1 Cooling Equipment

INSULATION MISSING OR DAMAGED

Missing or damaged insulation on refrigerant line can cause energy loss and condensation.

Recommendation

Contact a handyman or DIY project

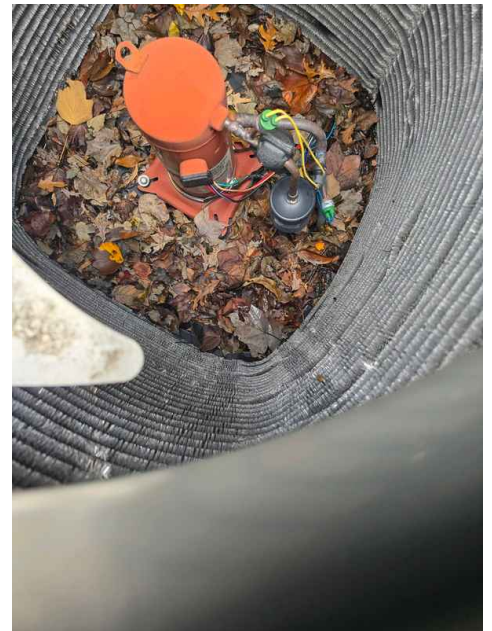
6.1.2 Cooling Equipment

NEEDS SERVICE/CLEANING

Exterior air conditioning unit was in need of service/cleaning. Recommend a qualified HVAC professional service.

Recommendation

Contact a qualified HVAC professional.

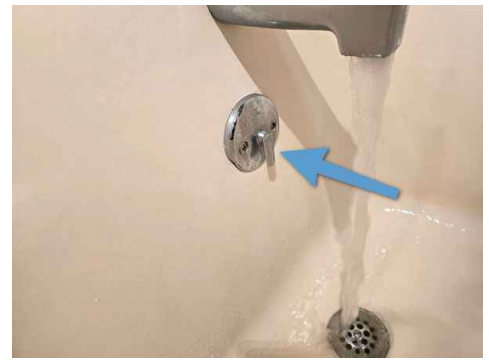
One or more plumbing hardware devices were not working at the time of the inspection. Recommend a qualified plumber replace or repair.

Recommendation

Contact a qualified plumbing contractor.

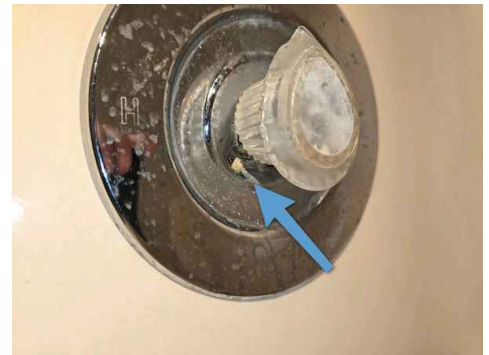
7.3.2 Water Supply, Distribution Systems & Fixtures

PLUMBING HARDWARE MISSING OR DAMAGED

Plumbing hardware was missing at the time of the inspection. Recommend a qualified plumbing contractor install new plumbing hardware.

Recommendation

Contact a qualified plumbing contractor.

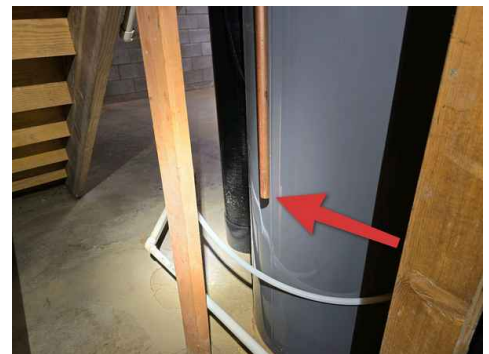
7.4.1 Hot Water Systems, Controls, Flues & Vents

Safety Hazard

The TPR (Temperature Pressure Release) Valve pipe was too short. The TPR valve pipe should be no more than 6 inches from the floor surface. This will help prevent a burn hazard from very hot water. Recommend a qualified plumbing contractor install TPR valve pipe with proper floor clearance.

Recommendation

Contact a qualified plumbing contractor.

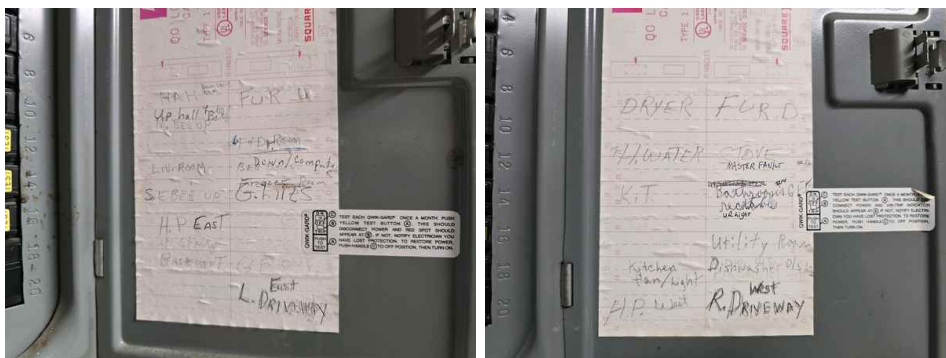
MISSING LABELS ON PANEL

At the time of inspection, panel was missing labeling. Recommend a qualified electrical contractor identify and map out locations.

Recommendation

Contact a qualified electrical contractor.

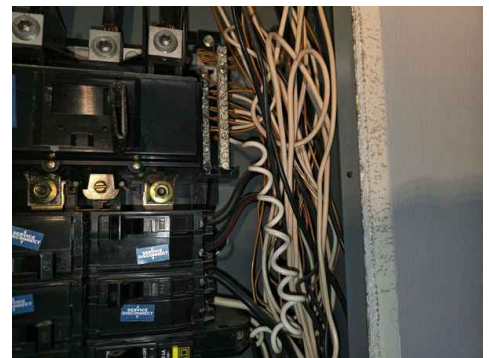
8.2.2 Main & Subpanels, Service & Grounding, Main Overcurrent Device

IMPROPERLY BONDED

Improper or no bonding at the time of the inspection. Inspector was unable to identify proper bonding. Recommend a qualified electrical contractor evaluate and remedy.

Recommendation

Contact a qualified electrical contractor.

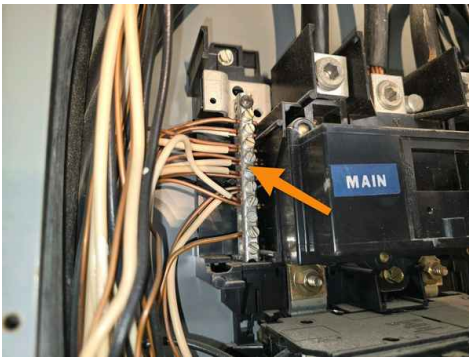
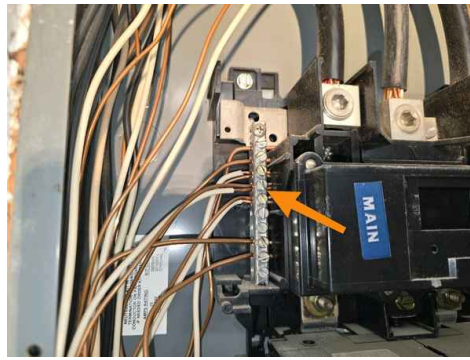
Neutral wires and ground wires were secured under the same lug at the time of the inspection. Neutral wires and ground wires should have their own lug. Recommend a qualified electrical contractor repair.

Contact a qualified electrical contractor.

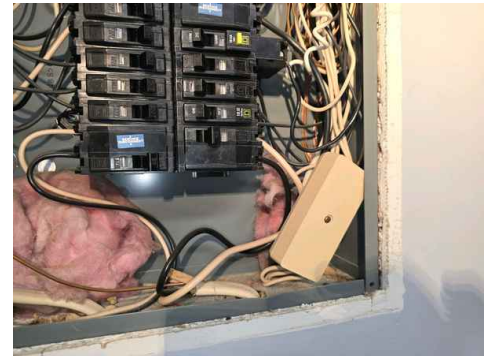
8.3.2 Branch Wiring Circuits, Breakers & Fuses

LOW VOLTAGE WIRES INSIDE ELECTRICAL PANEL

Low voltage wires located inside electrical panel. Class 2 conductors should not be mixed with service conductors inside the panel. Recommend a qualified electrical contractor evaluate and remedy.

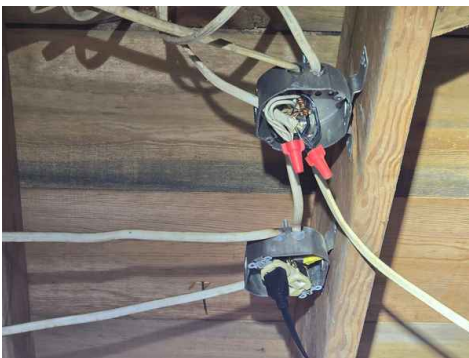
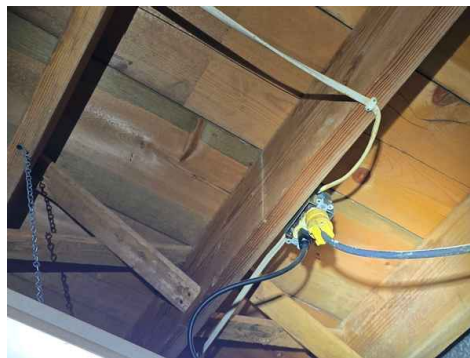
8.4.1 Lighting Fixtures, Switches & Receptacles

COVER PLATES MISSING

One or more receptacles, boxes or fixtures were missing a cover plate. This may create a short and shock risk. Recommend a qualified electrical contractor install cover plates.

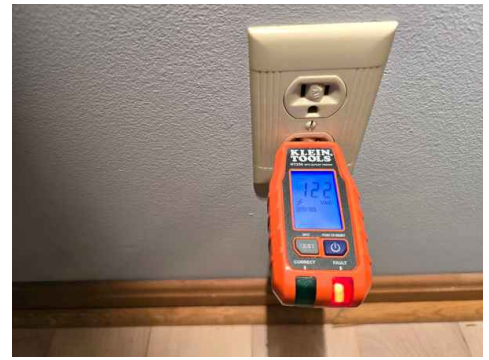
8.4.2 Lighting Fixtures, Switches & Receptacles

OPEN GROUND

One or more outlets indicated "Open Ground". Outlets that are not grounded can create a shock hazard. Recommend a qualified electrical contractor outlets and remedy.

Contact a qualified electrical contractor.

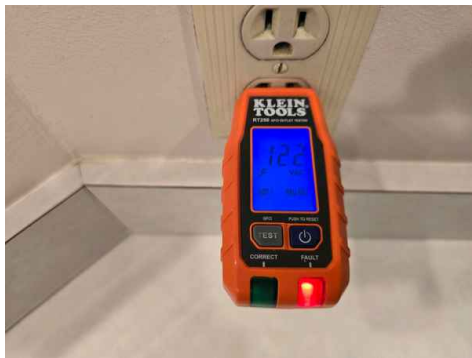
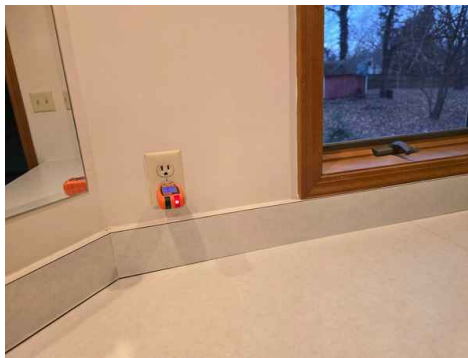
8.4.3 Lighting Fixtures, Switches & Receptacles

REVERSE POLARITY

One or more receptacles have been wired with reverse polarity. This can create a shock hazard. Recommend licensed electrician evaluate & repair.

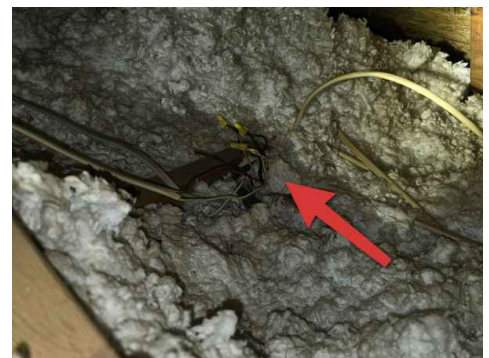
8.4.4 Lighting Fixtures, Switches & Receptacles

MISSING JUNCTION BOX

Junction box was missing at the time of the inspection. Recommend a qualified electrical contractor house wires in a new junction box.

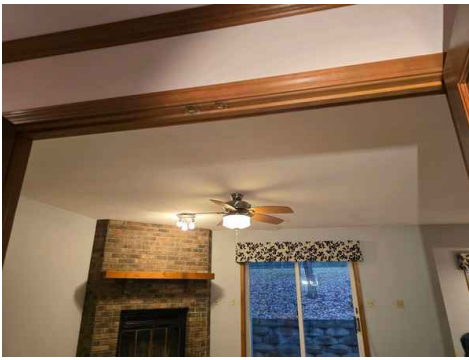
8.4.5 Lighting Fixtures, Switches & Receptacles

FAN INOPERABLE

Ceiling fan was not working at the time of the inspection. Recommend a qualified handyman repair.

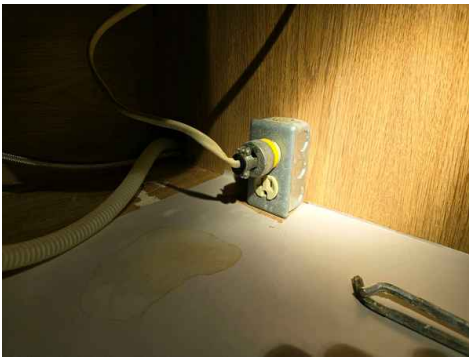
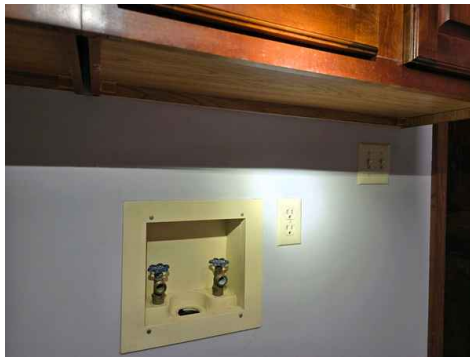
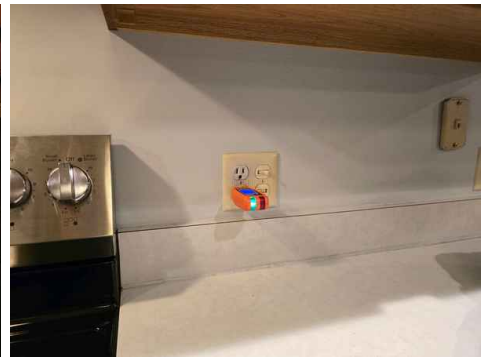
8.5.1 GFCI & AFCI

NO GFCI PROTECTION INSTALLED

No GFCI protection present. Recommend a licensed electrician upgrade by installing ground fault receptacles in proper locations to help prevent shock hazard.

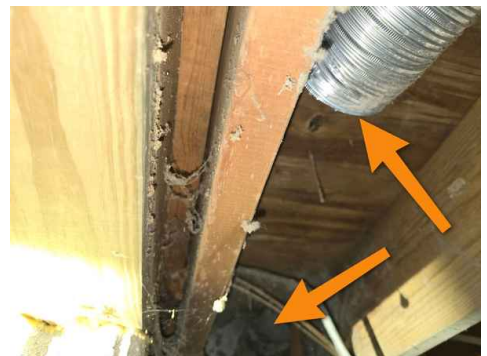
10.3.1 Exhaust Systems

Dryer vent was detached at the time of the inspection. Recommend a qualified handyman re-attach and seal dryer vent.

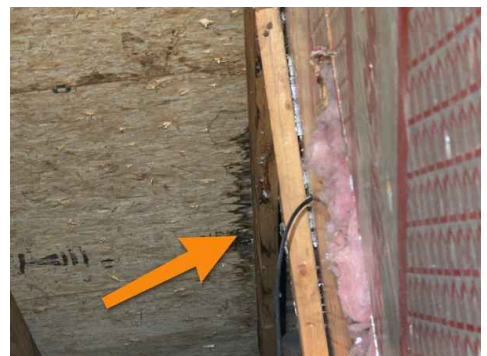
10.4.1 Roof Decking

MOISTURE / STAINING

Areas of the roof decking showed signs of water intrusion. There was no active moisture at the time of the inspection. Recommend a qualified roofing contractor evaluate and repair as necessary.

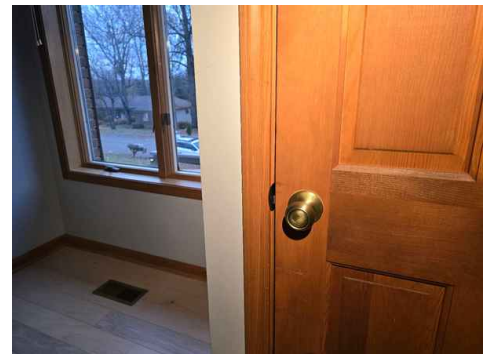
11.1.1 Doors

Doors did not latch properly. Recommend handyman repair latch and/or strike plate.

Recommendation

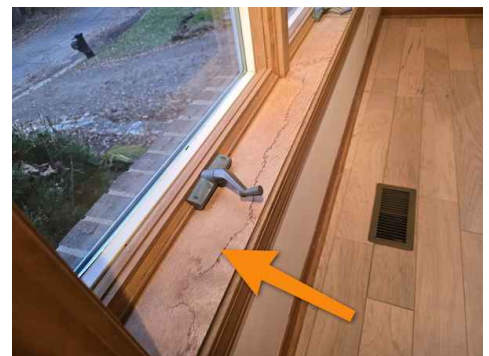
11.2.1 Windows

WINDOW TRIM STAINS

Water staining observed around window trim areas. Recommend a qualified window contractor evaluate for moisture and repair as necessary.

Contact a qualified window repair/installation contractor.

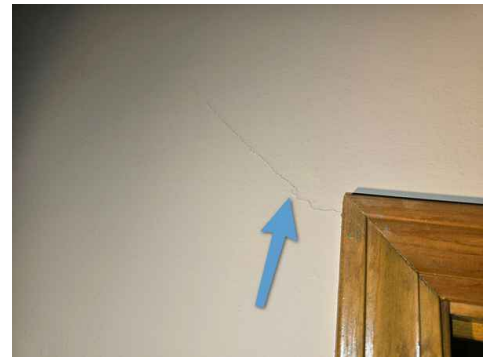
11.4.1 Walls

MINOR CORNER CRACKS

Minor cracks at the corners of doors and windows in walls. This may be the result of long-term settling. Some settling is not unusual but should be evaluated by a qualified contractor.

Contact a qualified drywall contractor.

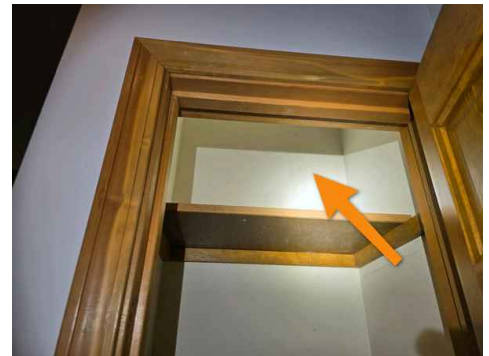
11.4.2 Walls

Evidence of organic growth on wall structure. Recommend a qualified mold inspector sample and send to lab for testing.

Contact a qualified mold inspection professional.

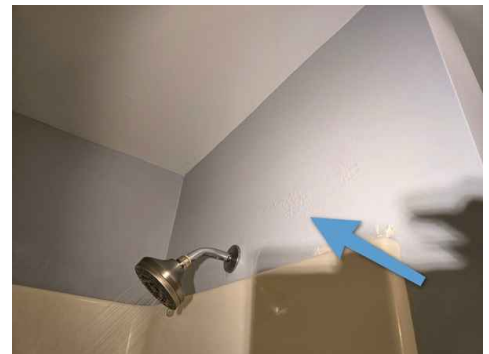
11.4.3 Walls

PAINT CRACKING

Wall paint was cracking in one or more areas. Recommend a qualified painter evaluate and apply a new coat.

Contact a qualified painting contractor.

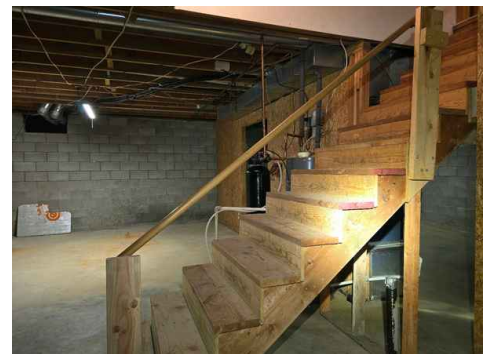
11.6.1 Steps, Stairways & Railings

There were no balusters present on the stairwell. Recommend carpentry contractor install balusters to prevent fall hazard.

Contact a qualified carpenter.

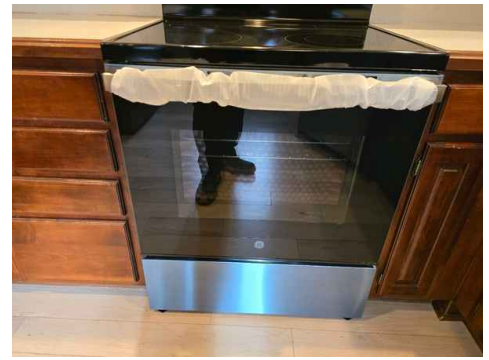
Range/Oven/Cooktop

BRAND NEW

Range/Oven still contained packaging materials. Not tested.

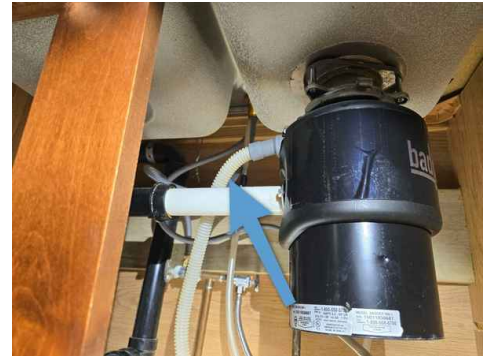
12.1.1 Dishwasher

There was no high loop present from the dishwasher. Recommend a qualified plumbing contractor repair.

Contact a qualified plumbing contractor.

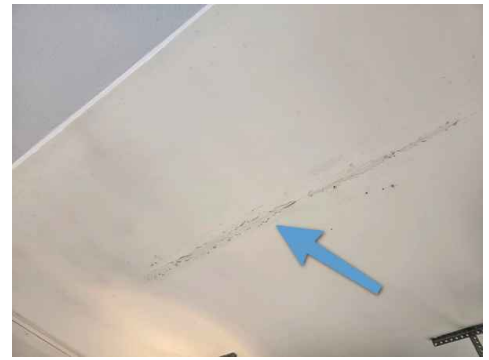
13.1.1 Ceiling

PEELING/CRACKING

Garage ceiling showed signs of peeling and/or cracking. This may be due to moisture. Recommend a qualified contractor evaluate and repair.

Contact a qualified professional.

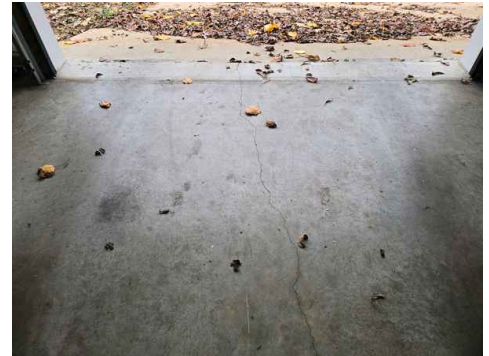
13.2.1 Floor

CRACKING - MINOR

Minor cracking was evident on the garage floor at the time of the inspection. Recommend monitoring or sealing any open cracks.

Recommended DIY Project
