PROPERTY INSPECTION REPORT

1108 Sidney Ave
Inspection Prepared For: Michael McBride
Agent: Breona Enbom - Infinity Real Estate

Date of Inspection: 7/19/2023
Age of Home: 118 Size: 1483
Weather: Sunny

This report was updated on 8 August, 2023 to reflect corrected deficiencies. Only deficiencies identified in the original report conducted 19 July, 2023 which were reported by the client or the client's agent as being corrected were inspected.

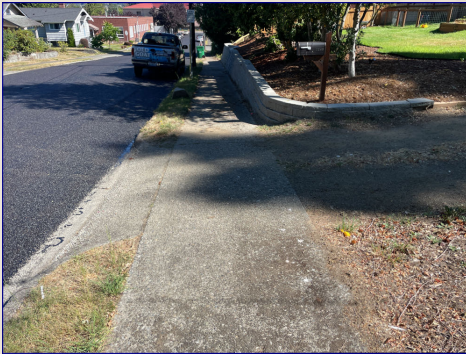
The Service Walk View

- **There are uneven slabs at the walkways, which could be a tripping hazard. Recommend using additional caution in these areas. Recommend having a licensed contractor repair or replace as needed.**

There are uneven slabs at the walkways, which could be a tripping hazard. Recommend using additional caution in these areas. Recommend having a licensed contractor repair or replace as needed.

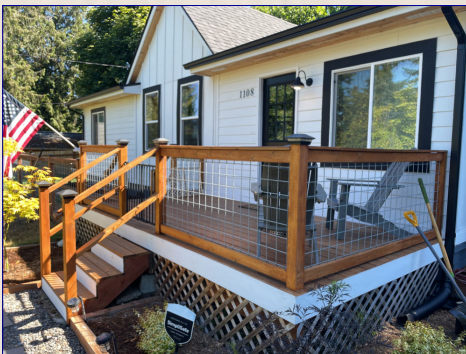
The Deck/Balcony View

- The deck stairs are missing or have an improper landing, which is a tripping concern. Recommend a licensed contractor repair.

The deck stairs are missing or have an improper landing, which is a tripping concern. Recommend a licensed contractor repair.

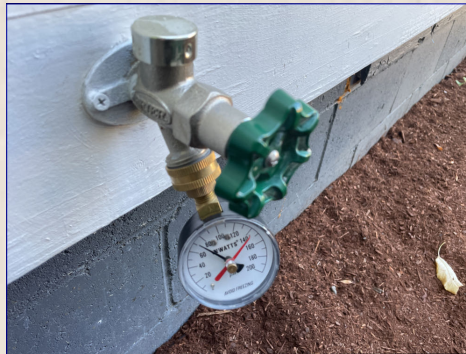
Hose bib operational.
