Whitehall Mill Condominium Association, Inc.

Athens, GA • September 27, 2022

FULL RESERVE STUDY

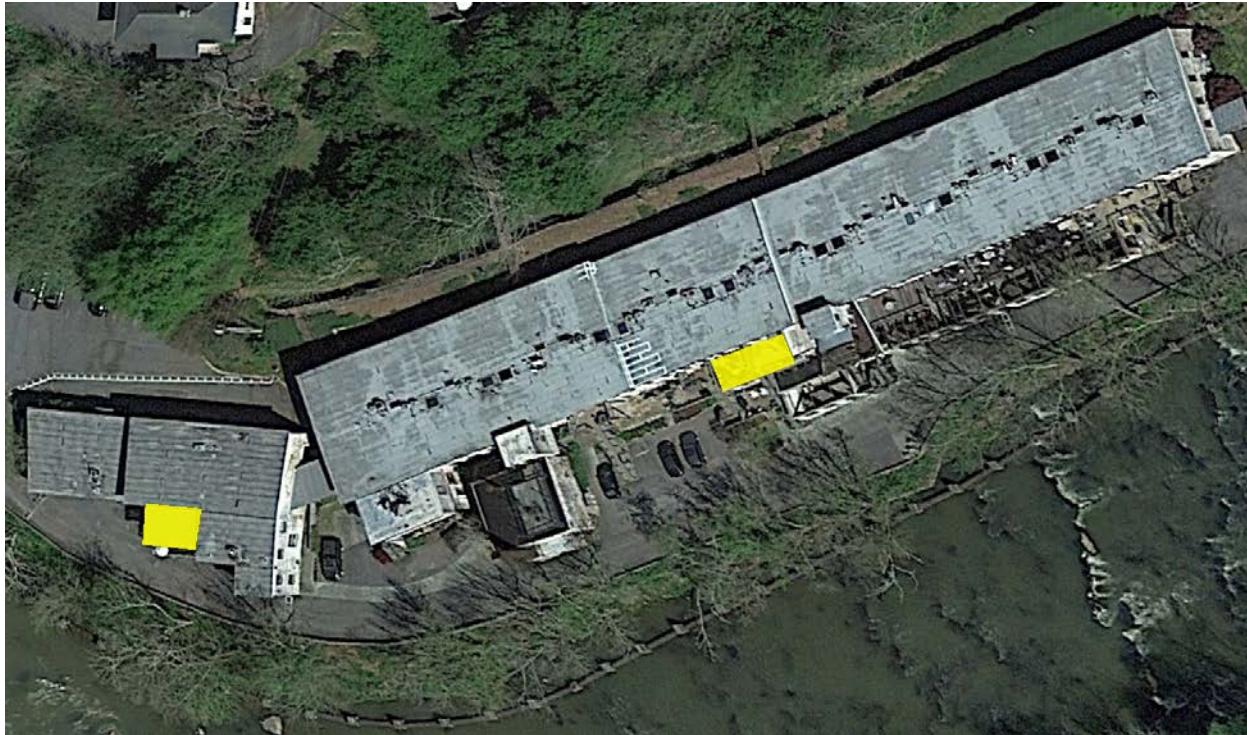
Condition: We note difficulty ascertaining a condition of these balconies due to a lack of access. We base our recommendations and timing on conversations with Management and the Board.

Locations of Association maintained balconies over living space

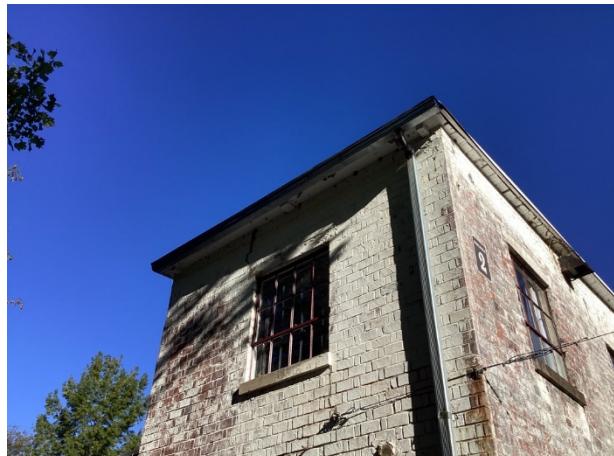
Condition: Good to fair overall with rust evident.

Galvanized gutters and downspouts

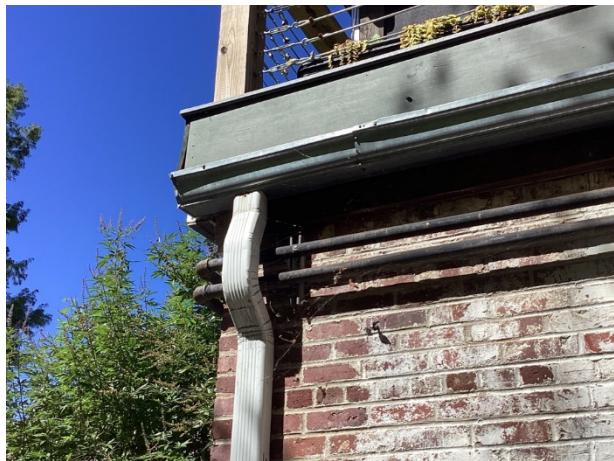
Galvanized and aluminum gutters and downspouts

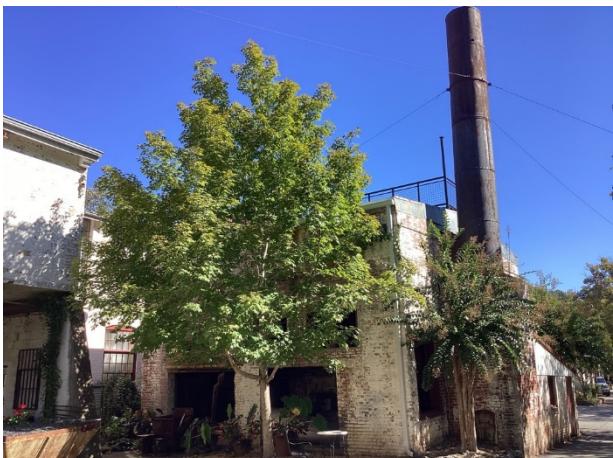
Historic mill equipment house, note chimney stack secured with cables

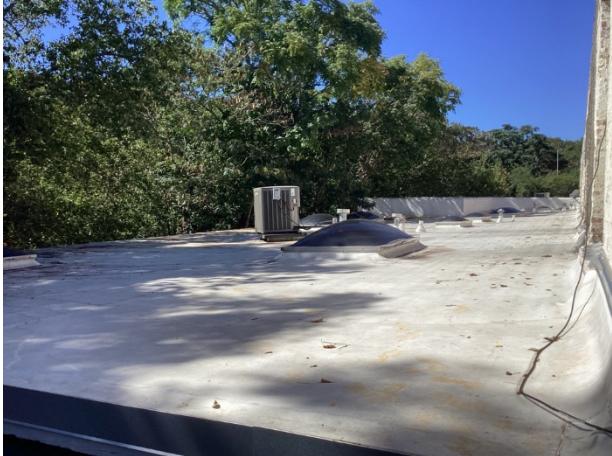
Condition: We note due to the configuration of buildings 1 and 2, we were unable to ascertain the condition of the roofs. Management and the Board expect near term replacement or recovery of these roofs. The roofs at Buildings 4 and 5 are in good to fair condition with evidence of standing water.

Roof overview at building 4 (lower)

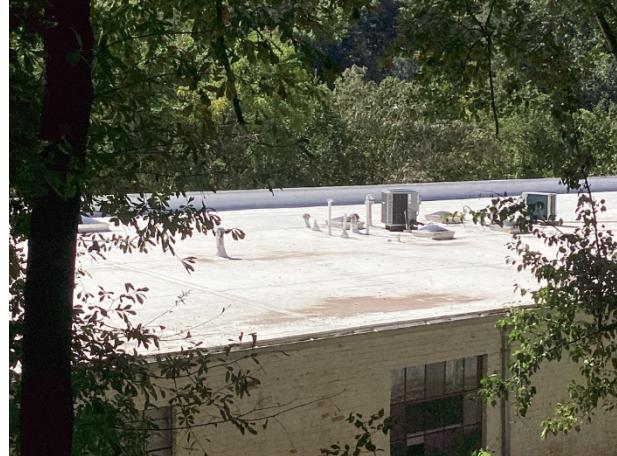
Evidence of standing water at building 4

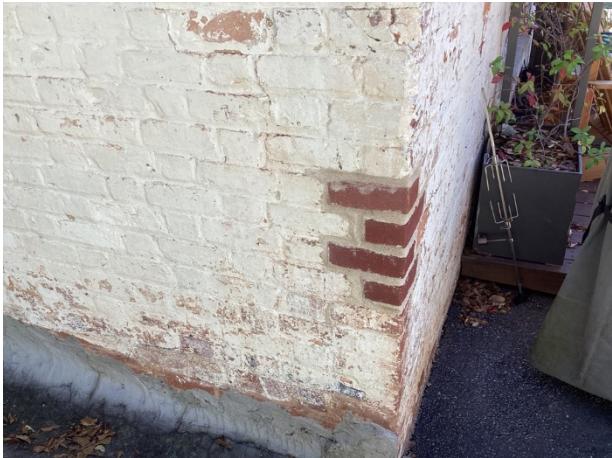
Repairs at building 4

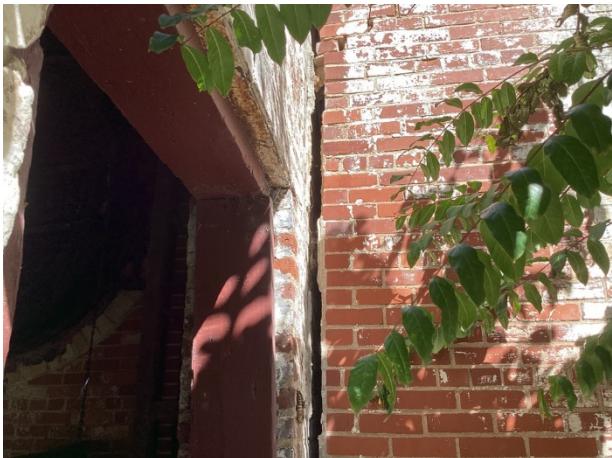
Separation at chimney joint at historic equipment house

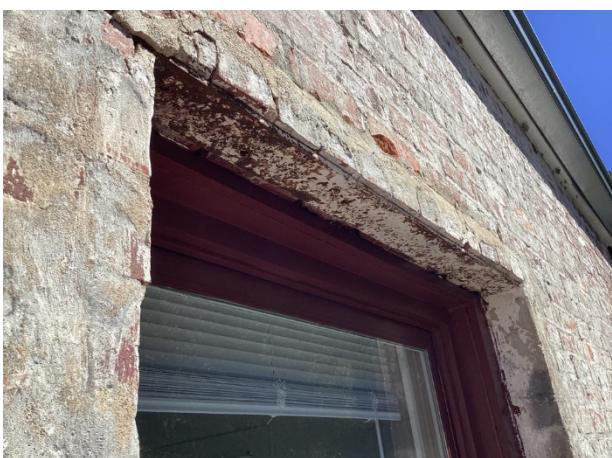
- Common Brick Masonry and Limited Quantities of River Rock and Concrete Construction
- Extensive previous repairs evident
- Excessive lintel rust is evident
- Masonry exhibits systemic cracks, spalls and significant weathering.
- We note significant concrete deterioration with exposed reinforcement evident.

Significantly weathered lintel

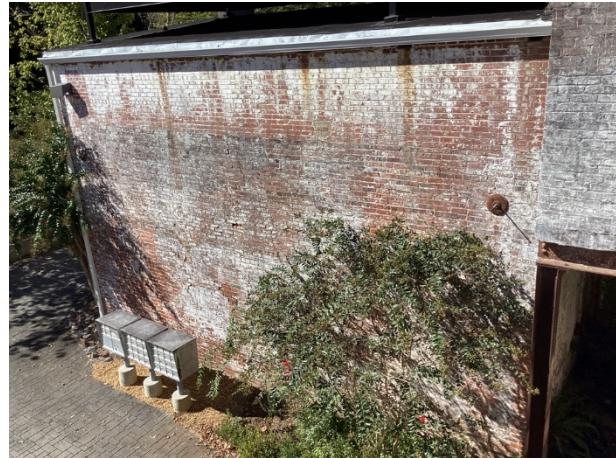
Historic equipment housing facade

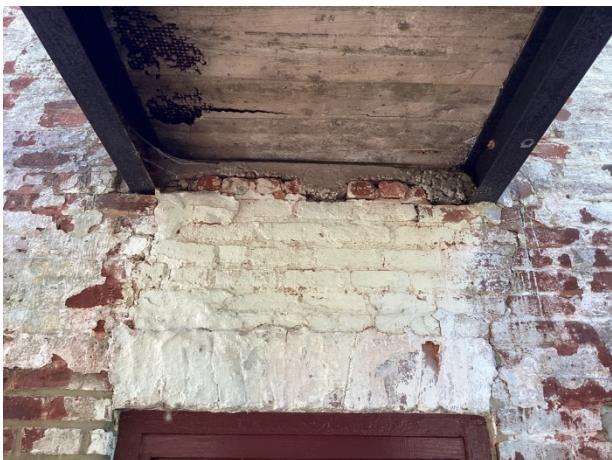
Masonry facade at unit 31 exit

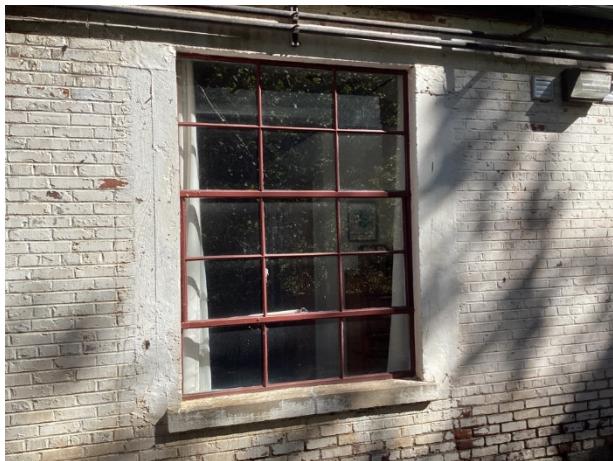
Condition: Fair overall condition.

Steel frame windows

- Complete inspection and paint finishes to the window frames
- Replacement of up to thirty-three percent (33%) of the sealants
- Repairs and partial replacements of up to fifteen percent (15%) of the window frames.

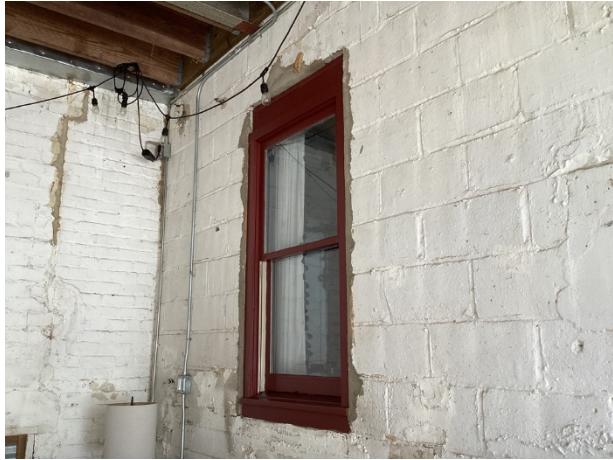
Wood frame windows

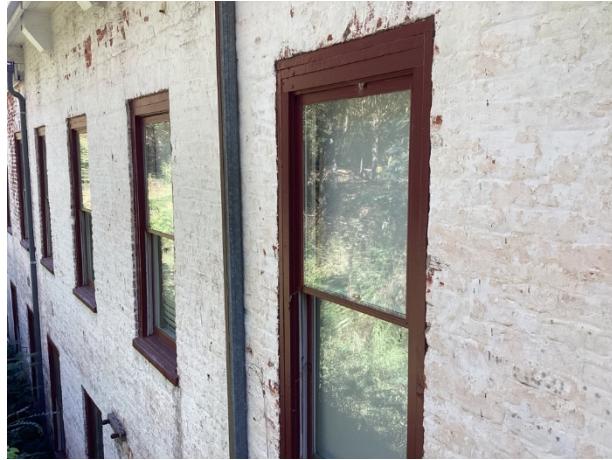
Wood frame windows

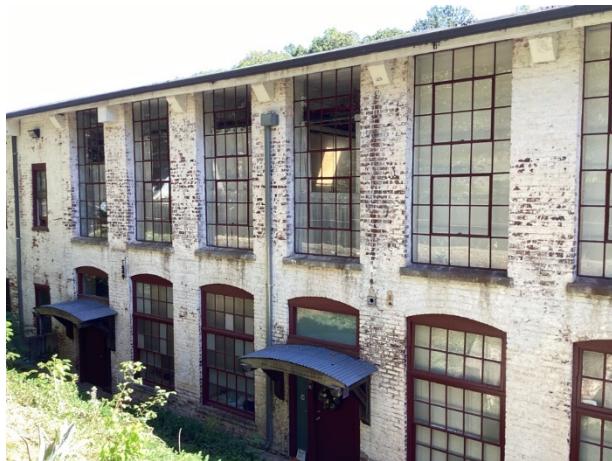
Original factory steel window frames

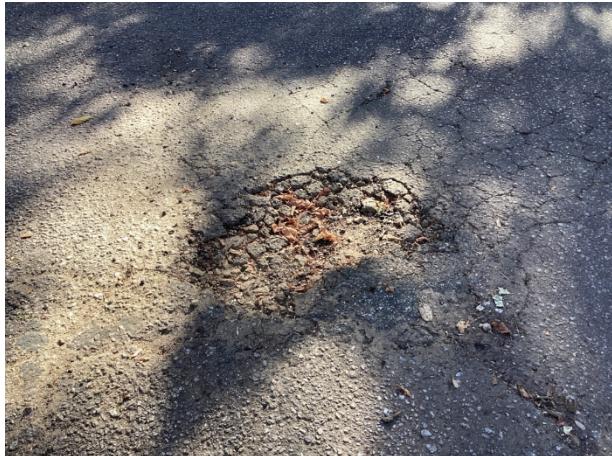
Condition: Fair to poor overall with significant deterioration including pothole formation and alligator cracks.

Pothole formation

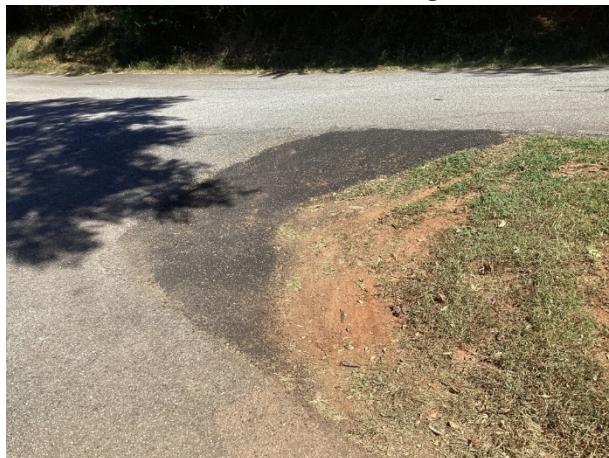
Pavement patch

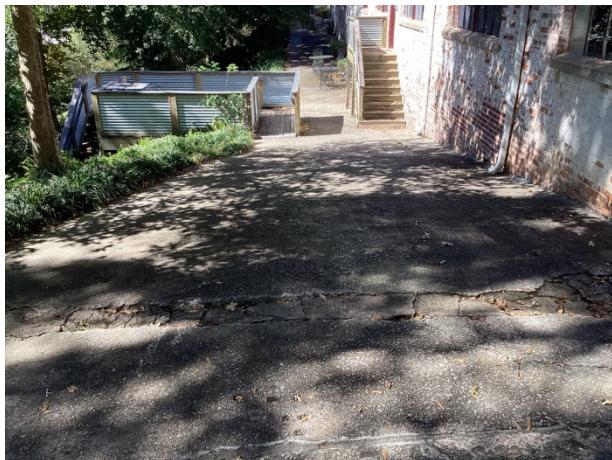
Condition: The sidewalks and stairs vary in condition from fair to poor, we note damage and trip hazards evident. We note significant deterioration at the pedestrian bridge. We recommend the Association to contract a structural engineer to opine on whether or not the pedestrian bridge should be remediated or restored, as opposed to completely replaced.

Concrete flatwork near building 5

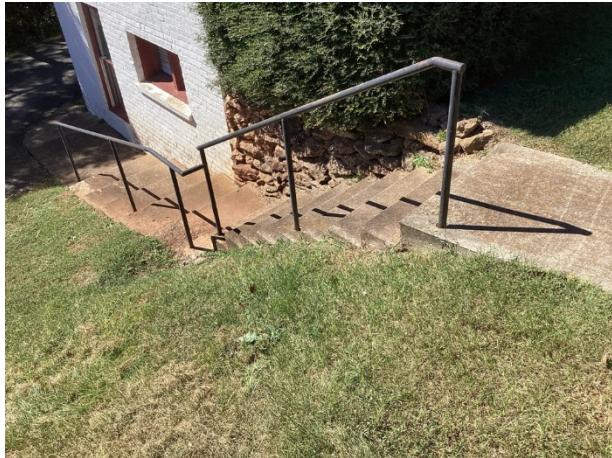
Concrete stairs at building 3

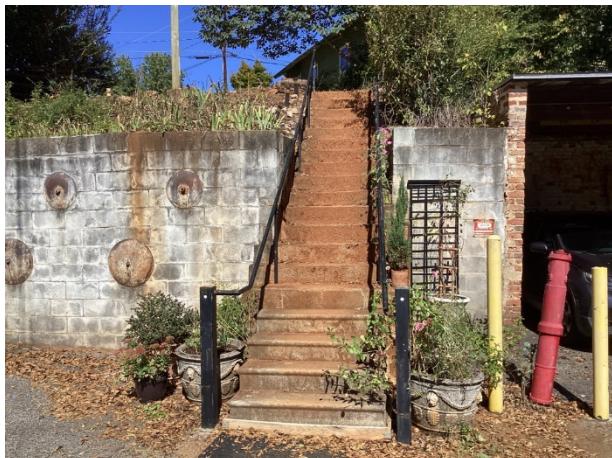
Concrete stairs near building 4

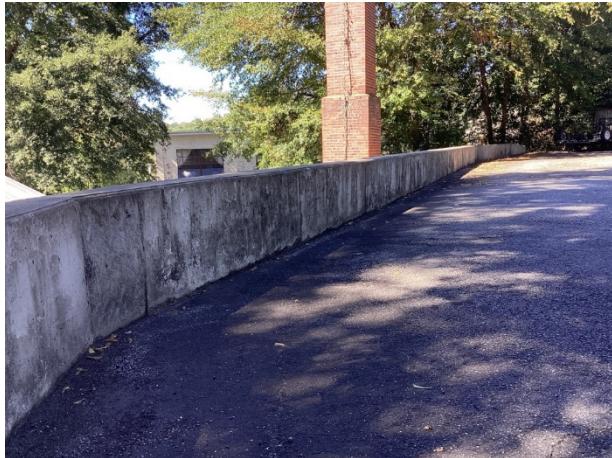
Condition: Fair overall with frequent stains, cracks and isolated exposed concrete reinforcement evident

Concrete wall at upper parking area

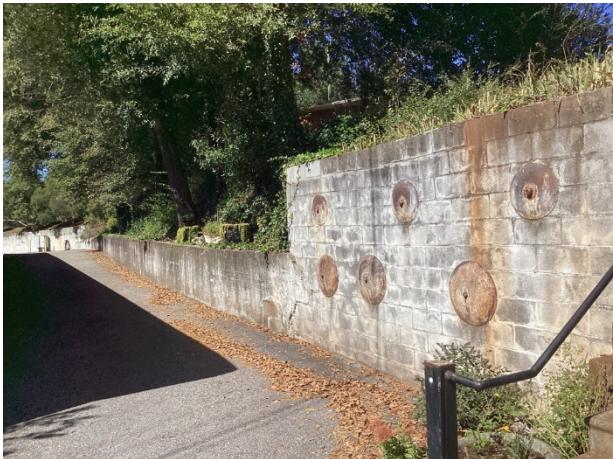
Condition: Varying from fair to poor overall condition. We note stabilization at the retaining wall near building 4.

Retaining wall near building 4

- Inspections of the entirety of the masonry and concrete retaining walls
- Replacement of approximately fifteen percent (15%) of the retaining walls
- Crack repairs and repointing of up to fifteen percent (15%) of the retaining walls.

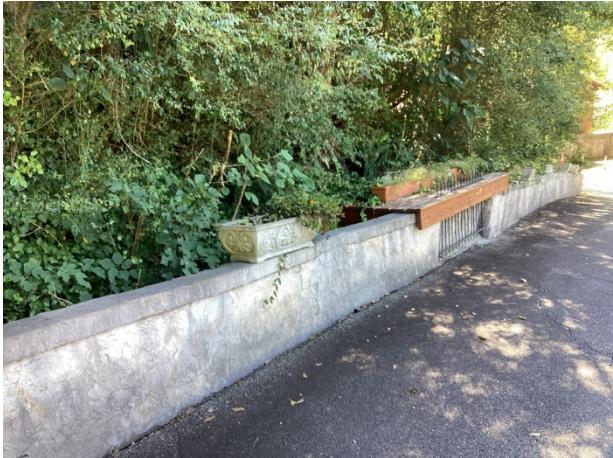
Retaining wall near building 5 and barn

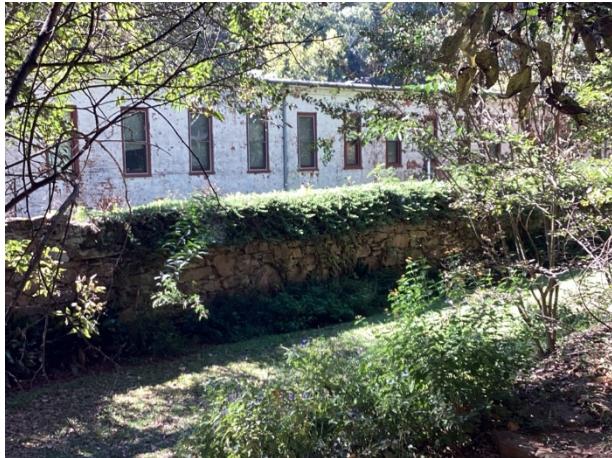
Condition: We do not note significant deterioration, leaning or eroded sections of the wall. Vegetative growth is present.

Stone retaining wall

Expenditure Detail Notes: Expenditure timing and costs are depicted in the **Reserve Expenditures** table in Section 3. Our cost includes an allowance for an inspection, partial resetting and replacement of up to seven percent (7%). Updates of this Reserve Study will continue to monitor the rate of deterioration and incorporate any available inspection reports. Due to the historic nature of this wall, the method of capital repairs and preservation of the wall may vary from our recommendations.

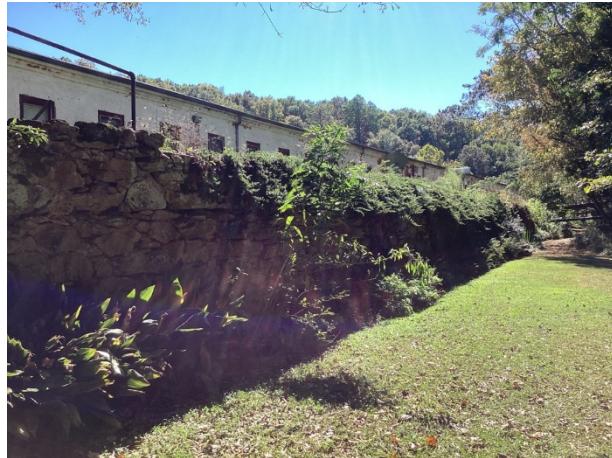
Stone retaining wall near building 3

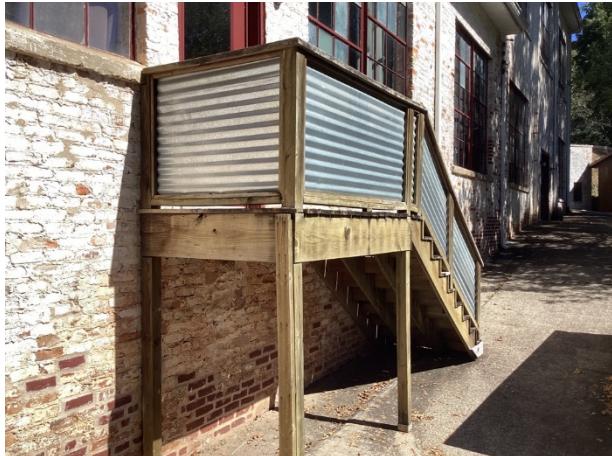
Condition: Good to fair overall condition with damaged composite railings and weathered wood decking evident.

**Access at building 5**

- Complete deck board replacement
- Repairs to the railings and wood frame as-necessary

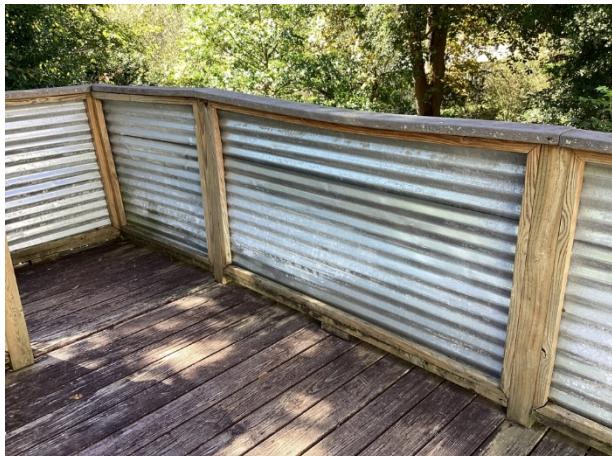
**Galvanized steel and wood railing**
